Research
Paper
FPL-RP-589

Roof Temperature Histories in Matched Attics in Mississippi and Wisconsin

Jerrold E. Winandy
H. Michael Barnes
Cherilyn A. Hatfield

December 2000

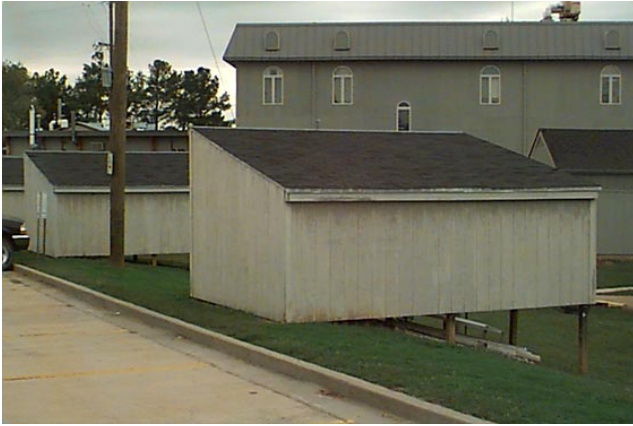
Figure 1—Exposure structures at Mississippi Forest Products Laboratory, Mississippi State University, Starkville, Mississippi.

In 1994, a USDA Competitive Grant was received to construct and monitor matched exposure structures at the Mississippi Forest Products Laboratory, Mississippi State University, in Starkville, Mississippi (33.5° latitude). This research was part of an ongoing effort to relate temperatures in matched northern to southern U.S. roof systems (Barnes and others 1993). In Starkville, the average incidence angle of sunlight is 32.3° from the southern horizon on the winter solstice and 74.8° on the summer solstice. The annual average declination angle is 53.5°. The five exposure structures in Mississippi (MS structures) were constructed to face south in a shadeless area open to direct sunlight. As for the WI structures, the MS structures were spaced far enough apart to prevent any one structure from shading the next structure. The data from the MS structures provide a direct measure of a more severe (higher solar loading) location compared with Madison, Wisconsin (Winandy and Beaumont 1995). A typical exposure structure is shown in Figure 1.

Because of the slope of the Starkville test site, the east side of the MS structures was situated from 0.46 to 1.2 m off the ground, whereas the west side ranged from 0.15 to 0.46 m off the ground (Fig. 1). The WI structures were located on fairly flat ground and were approximately 0.5 m above grade.

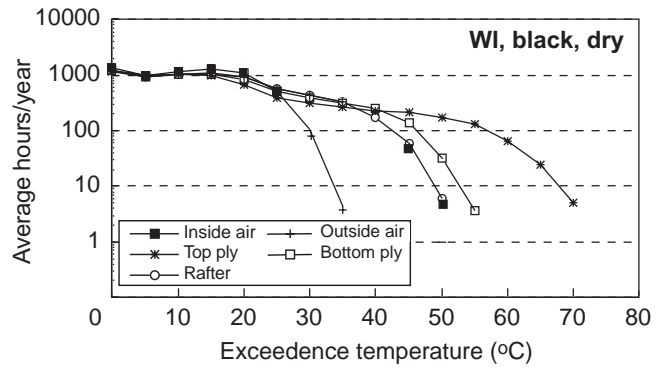
Figure 3—Annualized 8-year temperature history for dry black-shingled structure in Wisconsin.

The average 8- or 4-year temperature histories for each thermocouple in each exposure structure are plotted for the WI structures in Figures 3 to 5 and for the MS structures in Figures 6 and 7. Note the general similarity in relative form of the exceedance temperature distributions between each exposure site, roof color, and attic humidity configuration. As expected, the MS structures experienced many more hours of exposure to high air temperatures than did the WI structures. However, although air temperatures were often warmer in Mississippi than in Wisconsin, the differences in annual maximum temperatures of the top and bottom of the plywood roof sheathing were very similar. We observed that the higher portions of the roof sheathing temperature histories were clearly controlled by solar radiation and not the outside air temperature (Figs. 3 to 7), which reaffirms the earlier observations of Winandy and Beaumont (1995) and the predictions of the TenWolde (1997) model. Figures 3 to 7 also show how internal rafter temperature is nearly coincident with inside attic air temperature and how both track relatively closely with outside air temperature. Thus, although solar radiation may control sheathing temperature, attic air space or rafter temperature is strongly influenced by outside air temperatures during most of the year.

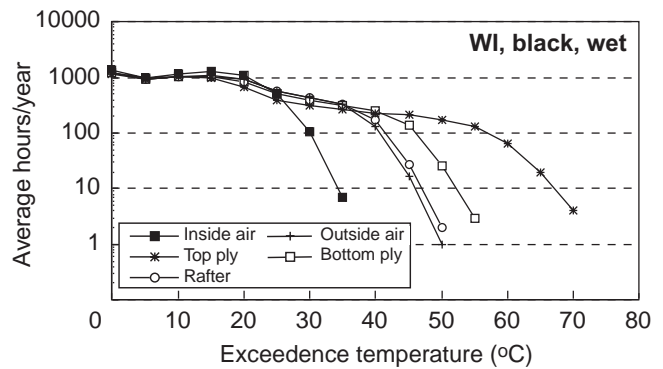
Figure 4—Annualized 4-year temperature history for wet black-shingled structure in Wisconsin.

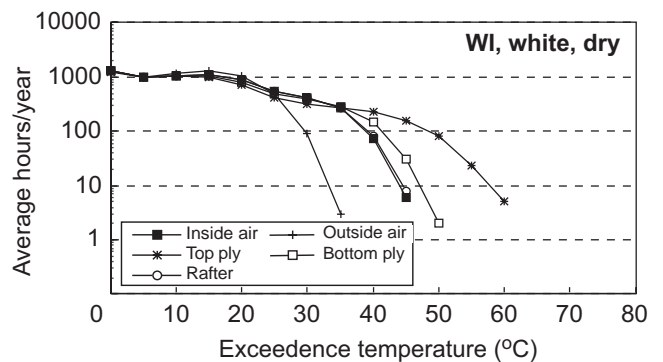
Figure 5—Annualized 8-year temperature history for dry white-shingled structure in Wisconsin.

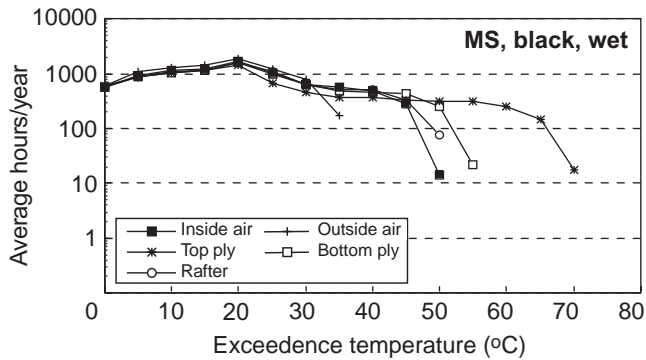
Figure 7—Annualized 4-year temperature history for wet black-shingled structure in Mississippi.

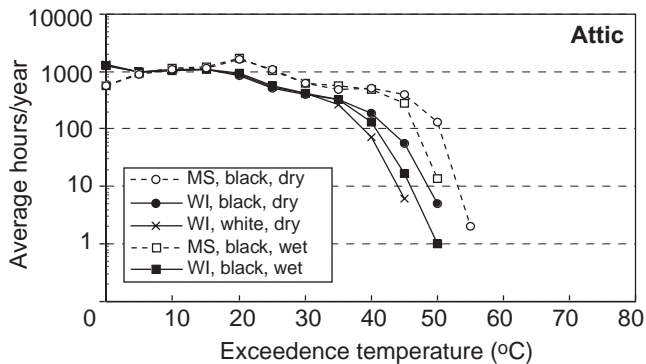
Figure 8—Attic air temperature history for test structures.

Figures 8 to 11 show a direct comparison of temperatures recorded by individual thermocouples for each building configuration. Note that for both Mississippi and Wisconsin, the wet (heavily humidified) roof systems were generally similar in temperature to dry roof systems except during the hottest days or the highest portions of the temperature range. In the high temperature range, the thermocouples in nearly every location within the wet MS structures were usually 3°C to 4°C cooler than matched thermocouples in the dry MS structures. We believe that this was caused by evaporative

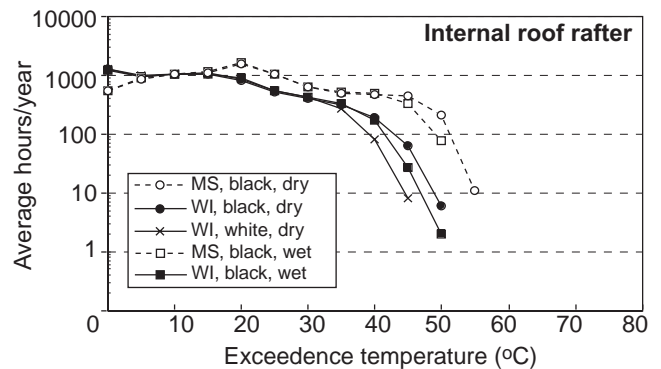
Figure 11—Air temperature history for internal rafters.
