THE PROPERTIES OF LUMBER AND TIMBER RECYCLED FROM DECONSTRUCTED BUILDINGS

Robert H. Falk, Research Engineer
*USDA Forest Service, Forest Products Laboratory
 Madison, Wisconsin, USA*

PTEC '99

PACIFIC TIMBER ENGINEERING CONFERENCE

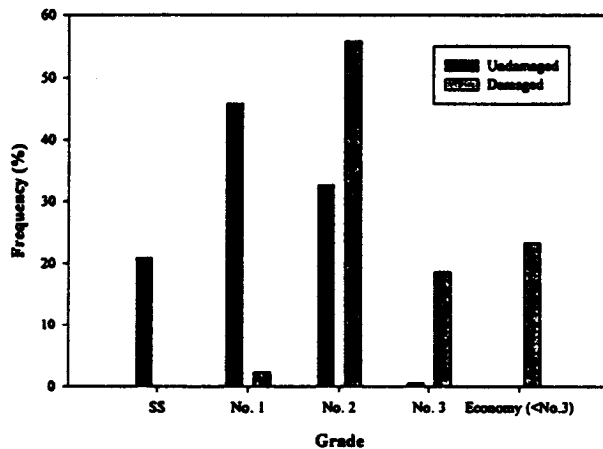
Figure 4—Grade reduction of 2 by 8 lumber resulting from damage. $n = 504$.

Fir (6%) and sugar pine (2%) were also present. From the standpoint of structural use, the most distinguishing feature of recycled lumber compared to freshly sawn lumber is the presence of damage, which may be a result of the original construction process (for example, nail holes, bolt holes, saw cuts, notches), building use (drying defects, decay and termite damage), and/or the deconstruction process (edge damage, end splitting, gouges). Damage reduced the average grade of the lumber (Fig. 4).
