Research
Paper
FPL-RP-515

Field Performance of Timber Bridges

1. Teal River Stress-Laminated Deck Bridge

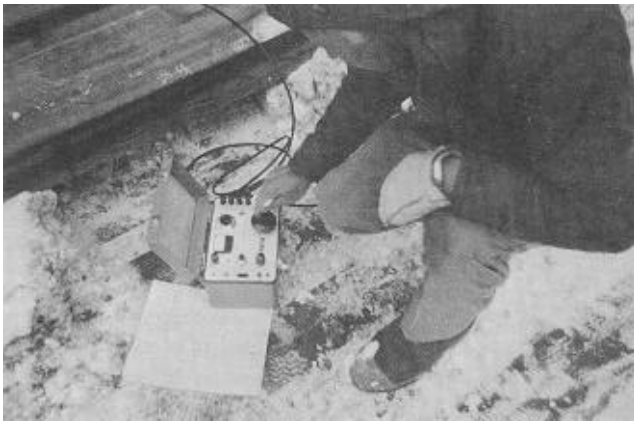
Figure 12—Reading a load cell with a portable strain indicator. (M92 0001-27A)

Load cell measurements were obtained by connecting a portable strain indicator to a plug on the load cell body (Fig. 12). Measurements were taken on a biweekly basis for the first year and monthly thereafter. Approximately midway through the monitoring period, 1 year after bridge construction, the load cells were unloaded and checked for zero balance shift.

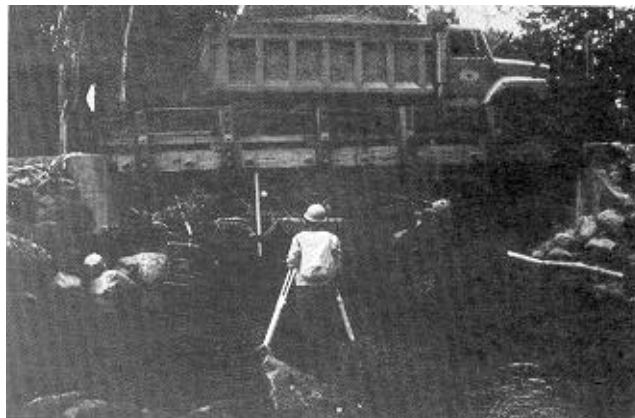
Figure 15—Measuring bridge deflection with surveyor's rod. (M92 0009-9)

were obtained by placing a surveying rod on the deck underside and reading values with a surveyor's level to the nearest 0.005 ft (Fig. 15). The accuracy of this method for repetitive readings is estimated to be ± 0.06 in.

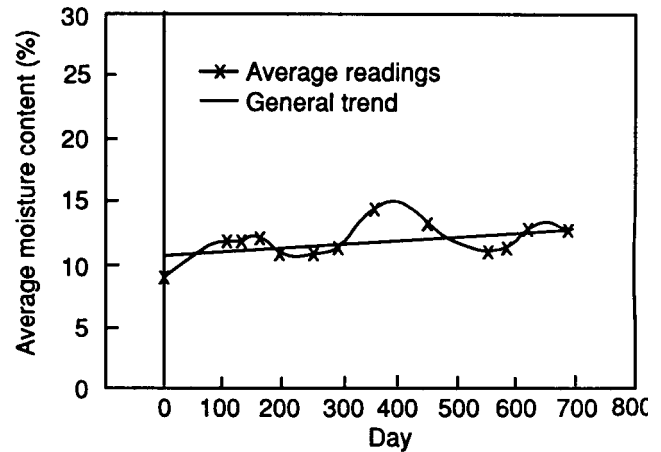
Figure 20—Trend of average moisture content changes in the bridge deck.

The trend of average moisture content changes in the bridge deck is shown in Figure 20. The beam-laminations were initially installed at an average moisture content of less than 10 percent. Since installation, moisture content gradually increased to an average level of approximately 13 percent at the conclusion of the monitoring period. Moisture content fluctuated following seasonal climate changes, with a maximum average moisture content of approximately 15 percent occurring in the fall of 1990 (Fig. 20). These changes will continue to occur over the life of the structure and were generally most apparent in the outer 1 to 3 in. of the deck, where moisture measurements were taken. Moisture changes in the interior portion of the deck were gradual, where the moisture content will continue to increase until an equilibrium level is reached. It is anticipated that the average moisture content of the deck will eventually stabilize at an equilibrium value of 18 to 20 percent (McCutcheon and others 1986), although short-term seasonal changes will continue to occur, primarily in the outer 2 to 3 in. of the deck.

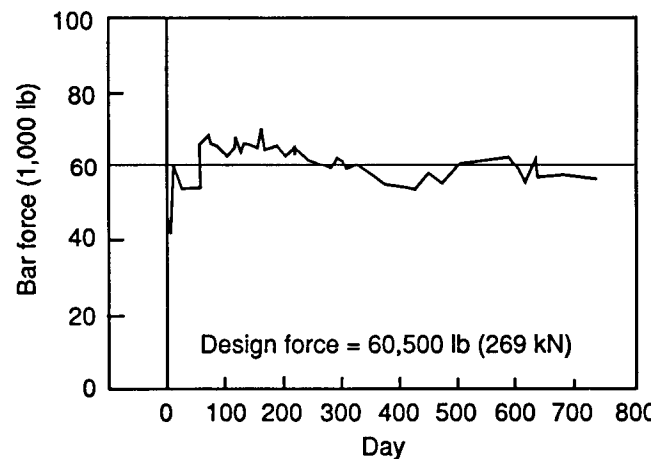
Figure 21—Average trend in bar tension force obtained from load cells installed on two stressing bars.

Figure 21 also reflects the minor fluctuations in bar force as a result of moisture changes and stress relaxation in the deck. However, force losses were minimal, and the average bar force was within 10 percent of the design force at the end of the monitoring period. This can be attributed to several factors, the most significant of which was the initial low moisture content level of the beam laminations. As the deck slowly gained moisture in reaching an equilibrium moisture content, the wood swelled slightly, which tended to offset force losses as a result of transverse stress relaxation. Other stress-laminated decks installed at relatively high moisture content levels had bar force losses as much as 80 percent during 2 years (Ritter and others 1990). On a comparative basis, the Teal River bridge vividly illustrates the advantage of low wood moisture content levels at the time of construction in reducing the rate of bar force loss.

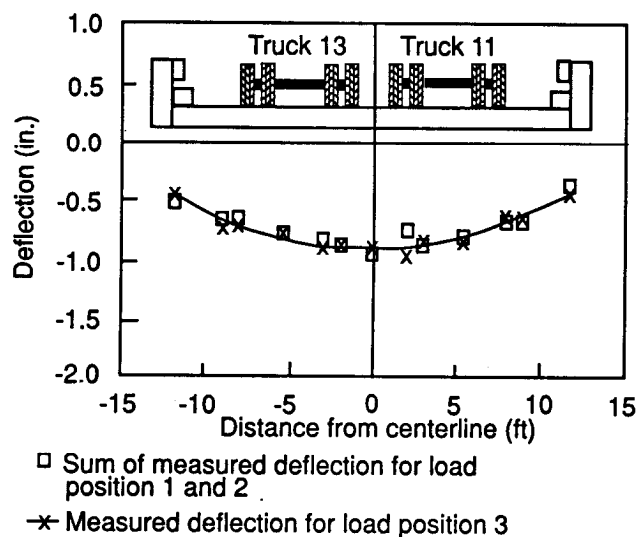
Figure 24—Load Test 2 showing the sum of measured deflections from load positions 1 and 2 compared to a fitted curve of the measured deflections for load position 3.

The measured deflection points for load positions 1 plus 2 compared to a fitted curve for load position 3 are shown in Figure 24. Assuming linear elastic behavior, the deflection resulting from the sum of the two individual truck loads should equal the deflection from both trucks applied simultaneously. As observed in Figure 24, the two curves are similar with only minor variations. These variations are within the accuracy of the measurement methods. From this information, it is concluded that bridge behavior under the applied loads is within the expected linear elastic range.

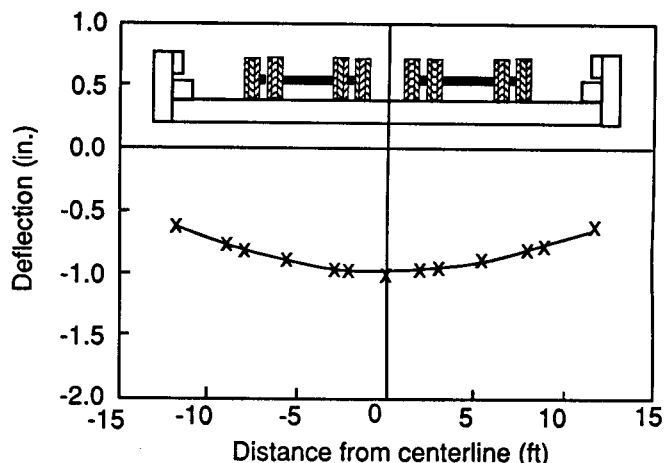
Figure 25—Predicted deflection profile at the bridge centerspan for two HS20-44 trucks, each positioned 2 ft on either side of the bridge longitudinal centerline.

Based on an analysis of both load tests, the maximum deflection of the Teal River bridge subjected to two lanes of HS20-44 loading was estimated at 0.99 in., or where the bridge span is 31 ft measured center-to-center of bearings (Fig. 25). Further orthotropic plate analysis of Load Test 2 compared to Load Test 1
