Research
Paper
FPL-RP-536

Field Performance of Timber Bridges

2. Cooper Creek Stress-Laminated Deck Bridge

Michael A. Ritter
James P. Wacker
Everett D. Tice

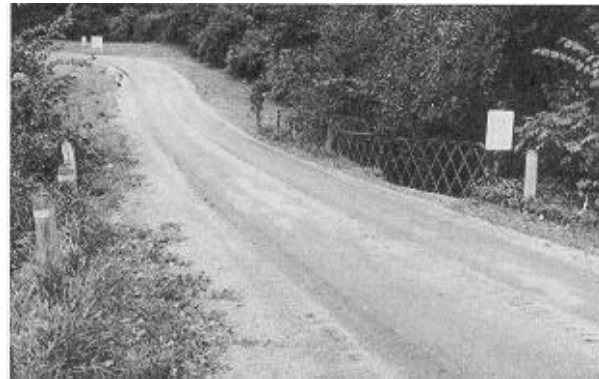
Figure 2—Original Cooper Creek bridge constructed in the 1940s.

The original Cooper Creek bridge was constructed in the 1940s and consisted of steel stringers with a concrete deck supported by concrete abutments (Fig. 2). Inspection of the bridge in the mid-1980s indicated that the concrete deck was in poor condition and steel stringers were badly corroded. Replacement of the bridge, along with another bridge in the reservoir area, was subsequently included within a large waterworks project at the Centerville reservoir. This project was made possible through a grant from the Chariton Valley Resource Conservation and Development Council (RC&D) to the State of Iowa and was initiated to improve the city's water supply system. In the initial stages of the project, both bridges were scheduled to be constructed using reinforced concrete. However, information obtained through the TBIRC prompted the Chariton Valley RC&D to change the Cooper Creek bridge to a timber structure using the relatively new stress-laminated deck design concept. A timber bridge was considered the best option by the RC&D because of the opportunity to use native Iowa materials and the aesthetics of a timber bridge would blend well into the natural park setting.

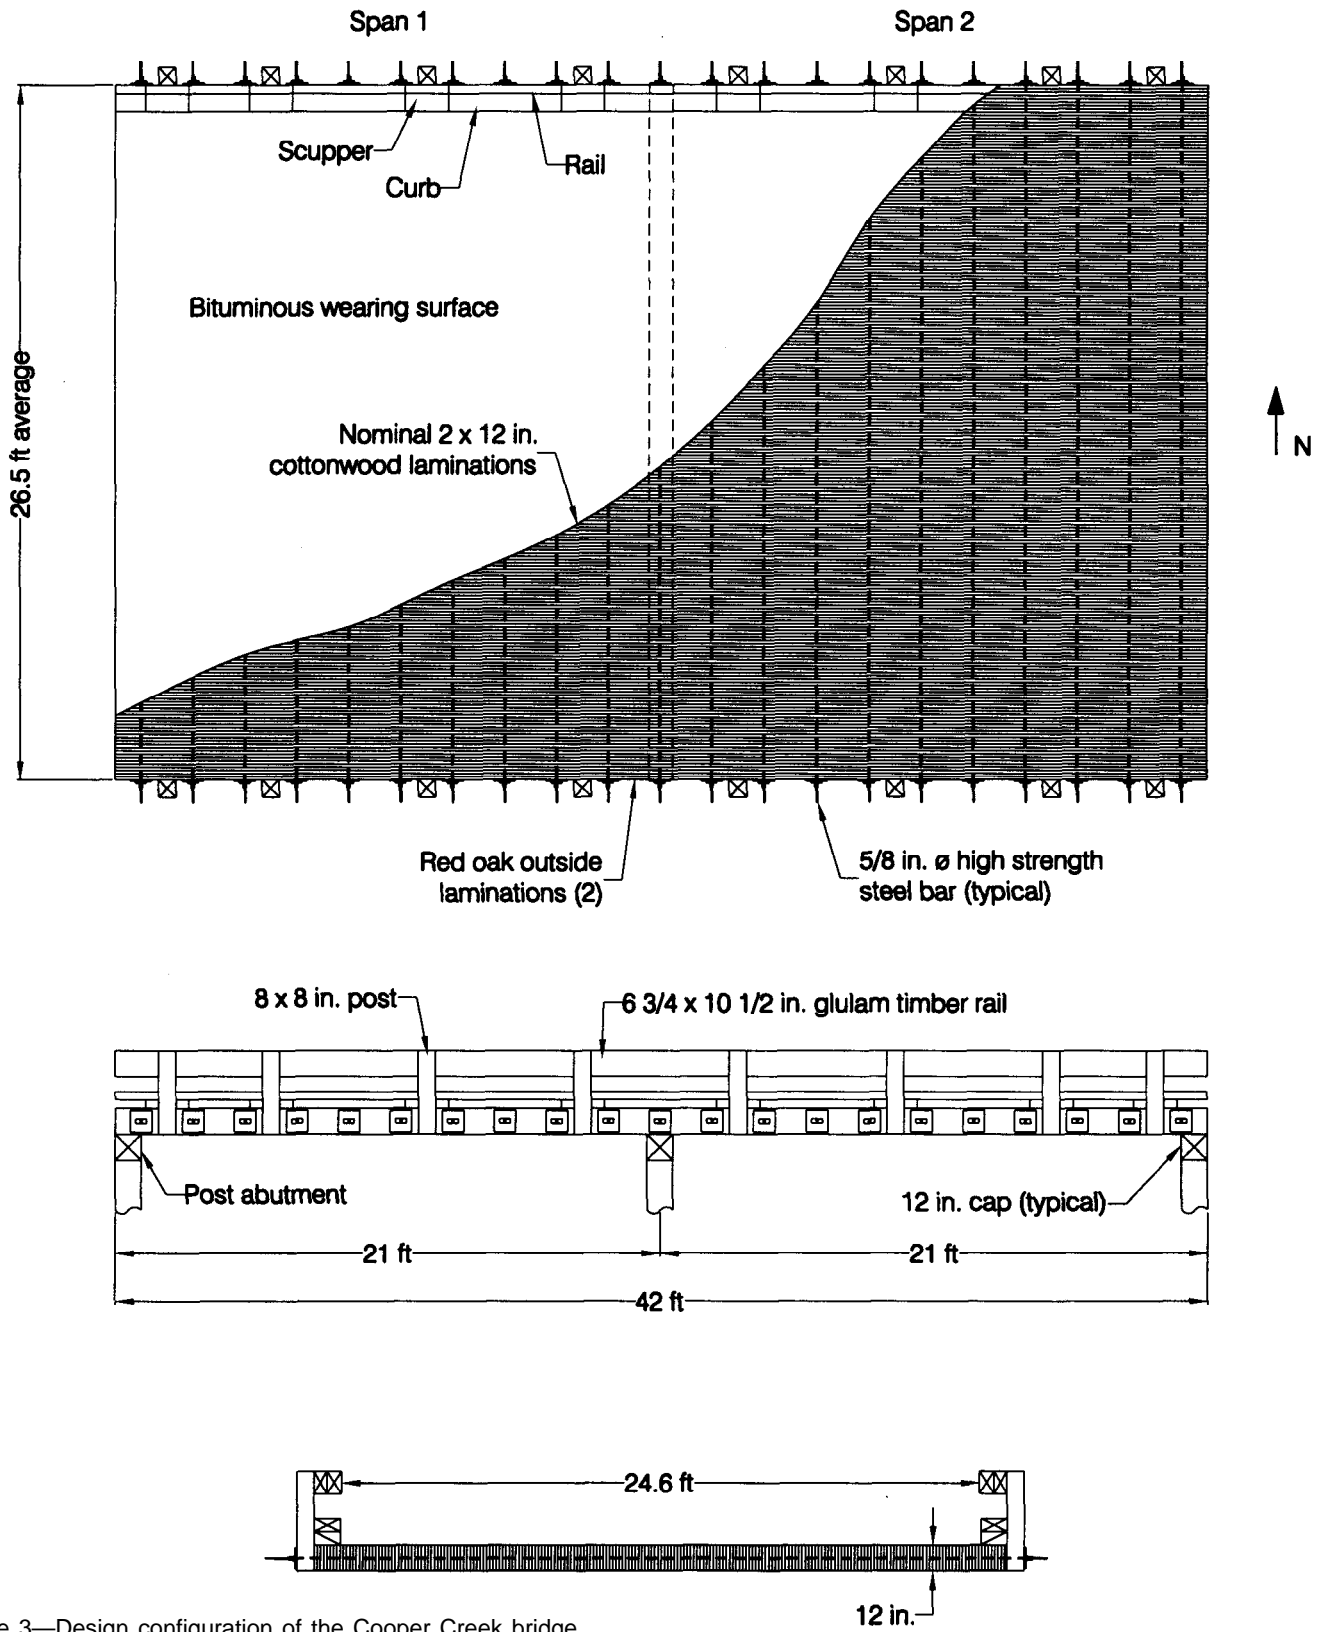
Figure 3—Design configuration of the Cooper Creek bridge.

Given the required bridge length and limitations on material size, a two-span continuous structure with equal span lengths was selected for the final design (Fig. 3). The layout of the bridge laminations was based on available lamination lengths of 4 to 18 ft in 2-ft increments. To meet span requirements for the continuous deck, a butt joint frequency of 1:4 at a 4-ft spacing was used (Fig. 4). As in most stress-laminated timber bridge decks, it was anticipated that bridge stiffness rather than strength would control the design. After adjusting tabulated design values for wet-use conditions and other applicable modification factors required by AASHTO, it was determined that a full-sawn deck 12 in. thick would meet design requirements if visually graded No. 1 lumber was used. Using this configuration, the design live-load deflection for HS 20-44 loading was 0.52 in., or 1/473 of the bridge span. A check of bending stress indicated that the applied stress of 931 lb/in² was less than the allowable 968 lb/in².

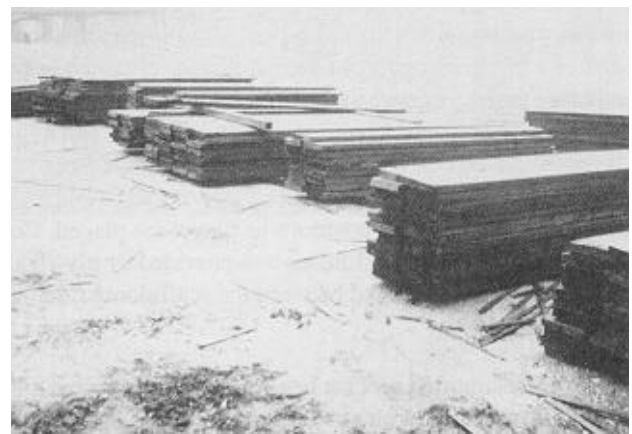
Figure 6—Eastern cottonwood laminations stacked at bridge site prior to construction.

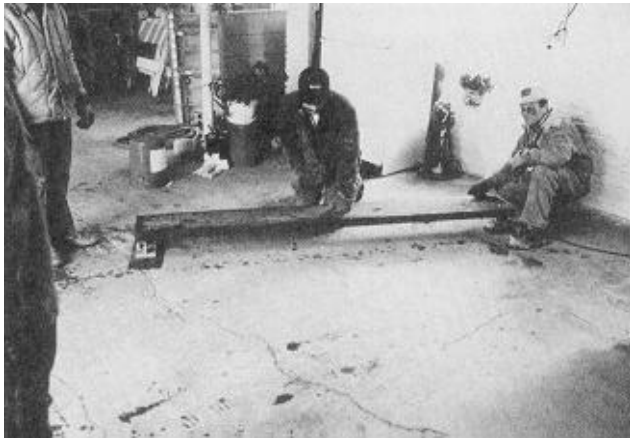
Figure 11—Measurement of bridge lamination MOE using the transverse vibration technique. Measurements were taken in the garage of the Centerville Water Department adjacent to the bridge site.

At the time of the Cooper Creek bridge design, eastern cottonwood was not widely used for structural applications, and verification of the assumed design MOE was considered necessary. To measure actual lamination MOE values, portable equipment was taken to the bridge site and a group of laminations was tested just prior to bridge construction using the transverse vibration method (Ross and others 1991). Using this method, laminations are placed flatwise on instrumented supports and impacted to induce a transverse vibration (Fig. 11). Based on the vibratory response, the natural frequency of the lamination is measured and converted to MOE. For the Cooper Creek bridge, 50 laminations were tested using this method: 10 each in lengths of 8, 10, 12, 14, and 16 ft.

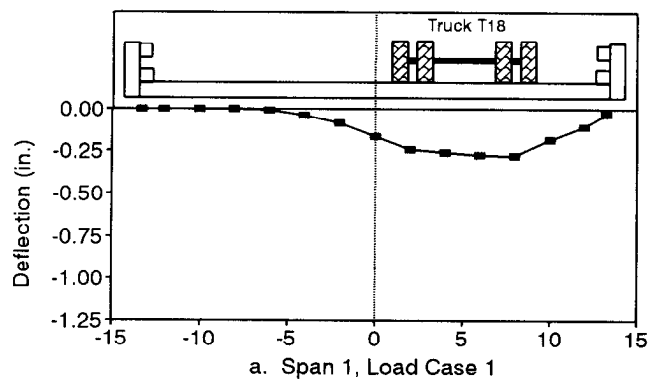
Figure 18—Transverse deflection for the Cooper Creek load test, measured at the bridge centerspan (looking west). Bridge cross-sections and vehicle positions are shown to aid interpretation and are not to scale.

Transverse deflection for span 1 and 2 are shown in Figure 18. For span 1, load case 1 resulted in a maximum deflection of 0.28 in. under the outside wheel line nearest the north deck edge (Fig. 18a). The maximum deflection of 0.26 in. for load case 2 was measured under the outside wheel line nearest the south deck edge (Fig. 18b). For load case 3, the maximum deflection of 0.36 in. occurred under the inside wheel line of truck T18, 2 ft from the span centerline (Fig. 18c). As could be expected for the same loading on similar spans, the results for span 2 were similar to those for span 1. Load case 1 resulted in a maximum deflection of 0.27 in. under the outside wheel line nearest the north deck edge (Fig. 18d). The maximum deflection of 0.26 in. for load case 2 occurred under the outside wheel line nearest the south deck edge (Fig. 18e). For load case 3, the maximum deflection of 0.35 in. occurred under the inside wheel line of truck T18, 2 ft from the span centerline (Fig. 18f).
