Research
Paper
FPL-RP-555

Field Performance of Timber Bridges

10. Sanborn Brook Stress-Laminated Deck Bridge

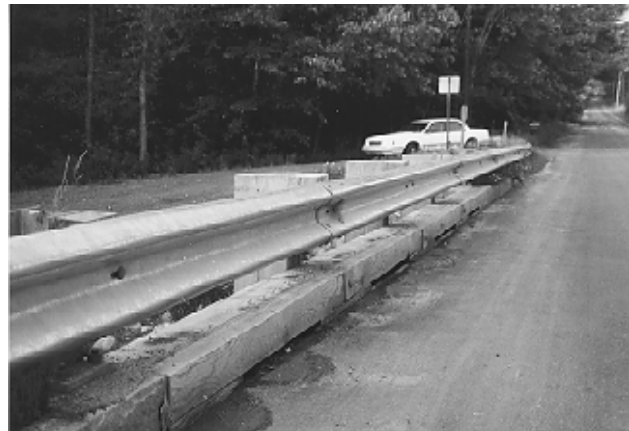
Figure 5—Completed Sanborn Brook bridge rail.

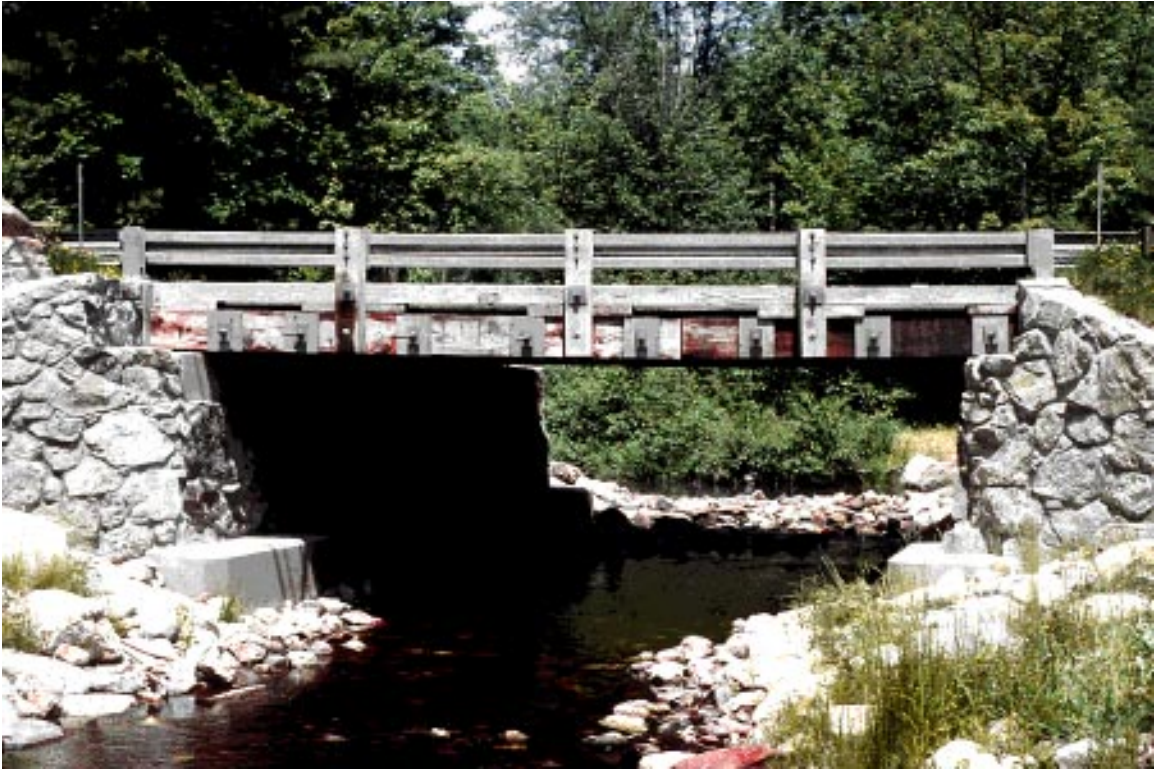
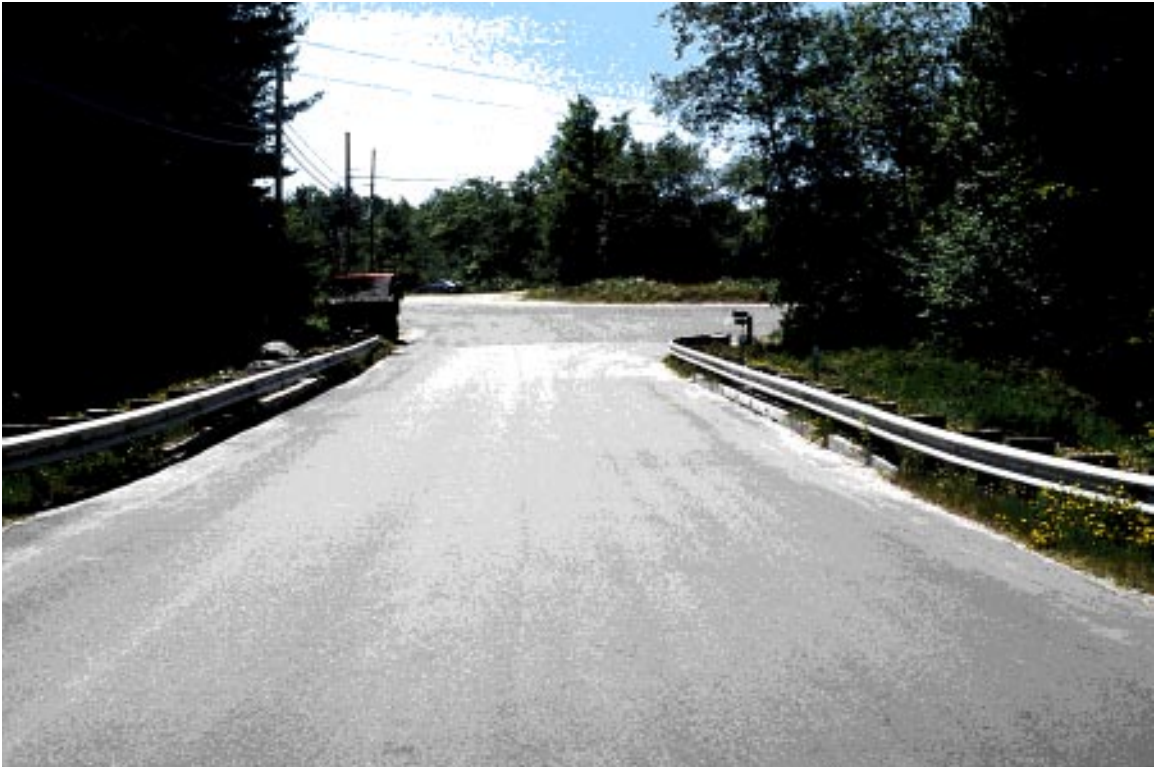
Figure 6—Completed Sanborn Brook bridge.

The as-built configuration of the Sanborn Brook bridge varied slightly from the design configurations in Figure 2. After the final stressing, the average out-to-out bridge width measured 27.7 ft, and the bridge length measured 24.9 ft. The bridge span, measured center-center of bearings, was 24.1 ft. The completed bridge is shown in Figure 6.

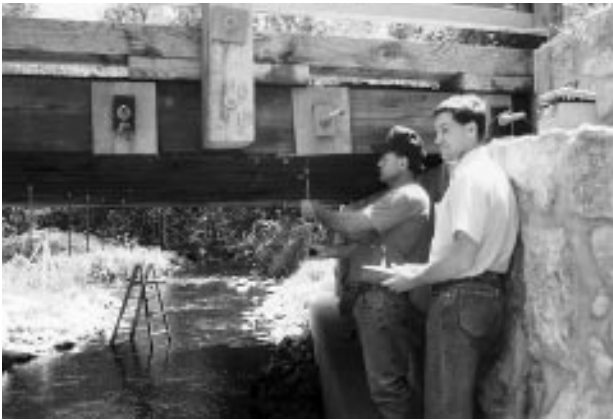
Figure 7—Measuring moisture content with an electrical-resistance moisture meter.

The deck moisture content of the Sanborn Brook bridge was measured using an electrical-resistance moisture meter with 3-in. insulated probe pins in accordance with ASTM D4444–84 (ASTM 1990) (Fig. 7). Measurements were obtained by the New Hampshire DOT on a monthly basis by driving the pins into the underside of deck at depths of 2 to 3 in., recording the moisture content values, and adjusting the values for temperature and wood species (Forintek 1984).

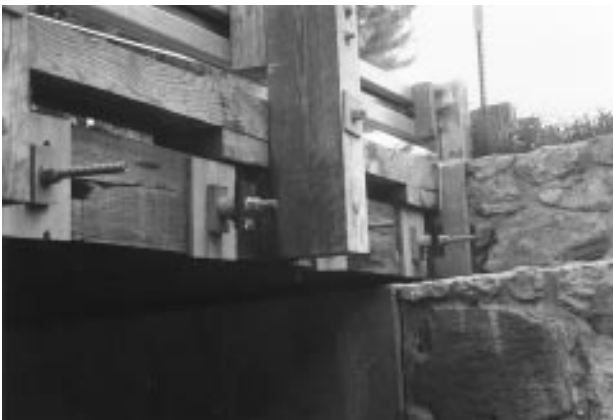
Figure 8—Load cells positioned on stressing bars to monitor bar force.

For stress-laminated bridges to perform properly, adequate bar force levels must be maintained in order to achieve an acceptable level of interlaminar compression. To monitor bar force, load cells developed by FPL were installed on the first and third stressing bars from the west abutment, along the upstream bridge edge (Fig. 8). Load cell measurements were obtained by the New Hampshire DOT, using a portable strain indicator (Fig. 9). Strain from the indicator was

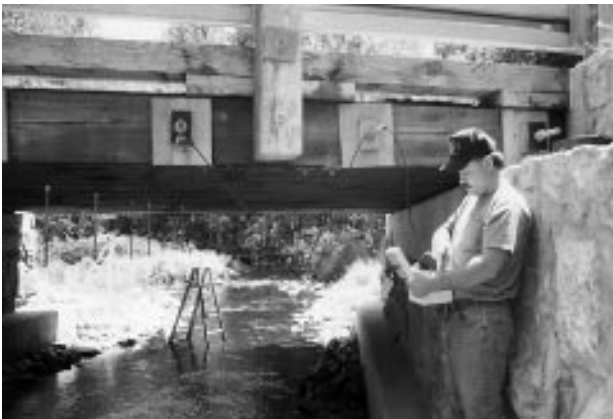
Figure 9—Obtaining a load cell reading with a portable strain indicator.

converted to units of bar tensile force by applying a laboratory conversion factor to the strain indicator reading. Bar force measurements were taken on a weekly basis for 2 months following load cell installation and monthly thereafter. At the end of the monitoring period, the load cells were unloaded and checked for zero balance shift, and the measurements were adjusted accordingly.

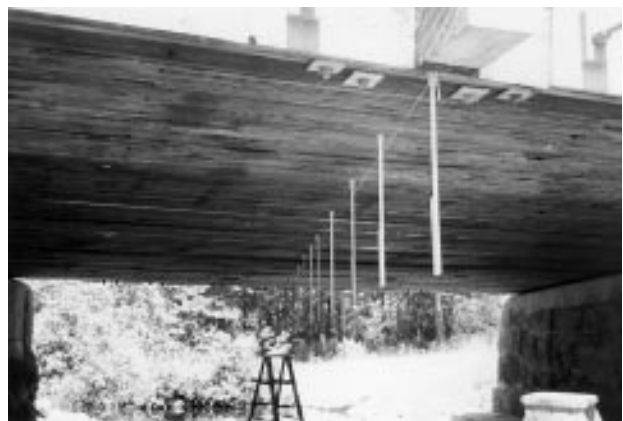
Figure 13—Load tests 1 and 2 (load test 2 shown) deflection measurements were obtained by reading values from calibrated rules suspended from the underside of the deck with a surveyor's level.

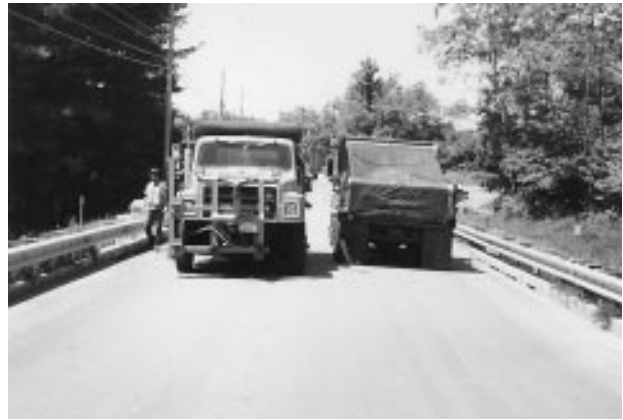
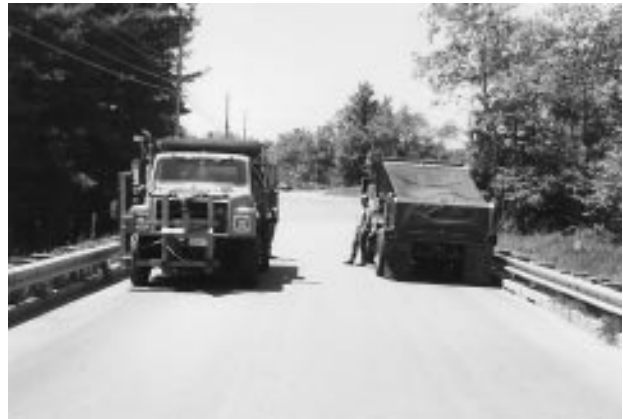
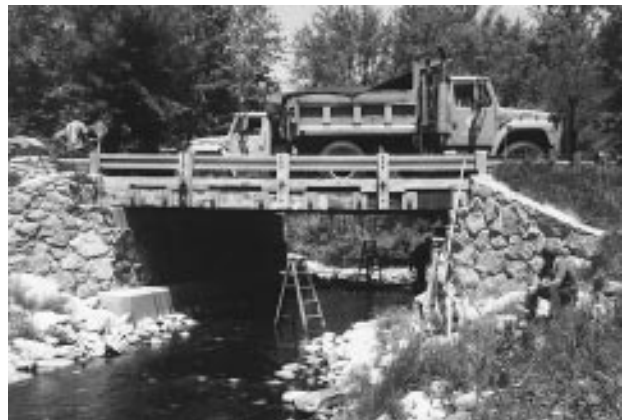
Figure 15—Transverse load positions used for load test 2. From top to bottom: load position 3, load position 6, load position 6 (side view) are shown.

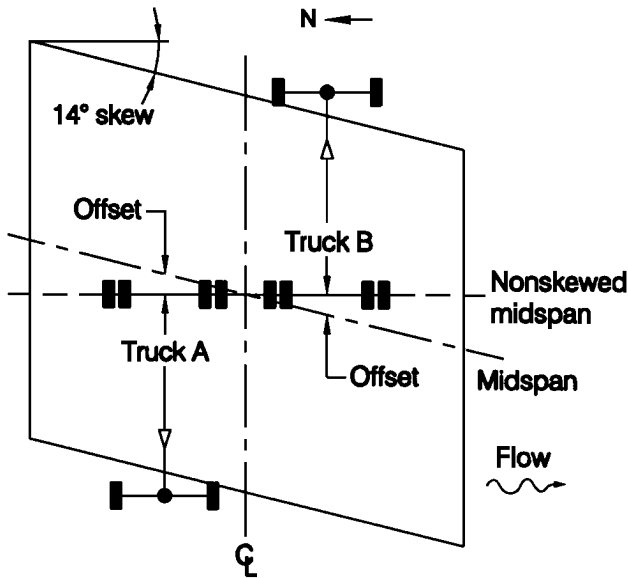
Figure 16—Typical configuration of longitudinal vehicle placement for load test 2. For all positions, rear axles were placed at the nonskewed midspan.

The second load test was conducted June 23, 1993, approximately 21 months after bridge installation. At the time of the test, the interlaminar compression was 39 lb/in². Two test vehicles were used: truck A with a gross vehicle weight of 30,340 lb and truck B with a gross vehicle weight of 38,540 lb (Fig. 14). The six transverse load positions (Fig. 11, 15) and measurement method were identical to those employed during load test 1. Values were read to the nearest 0.04 in., and the measurement accuracy is estimated to be ±0.02 in. Longitudinally, the vehicles were positioned with the rear axle centered along the nonskewed midspan of the bridge, perpendicular to the roadway (Fig. 16).

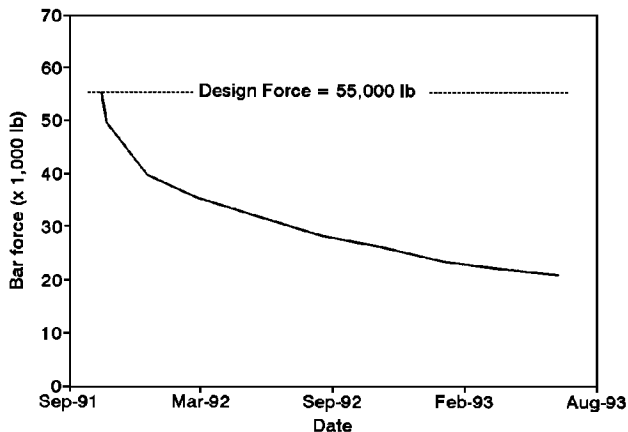
Figure 17—Average trend in bar force.

The average trend in bar force, beginning at the time of the third bar retensioning, is shown in Figure 17. The third retensioning, which occurred in October 1991, was to the design force of 55,000 lb. Immediately following the retensioning procedure, the force began a rapid decline that continued about 3 months. The time-related rate of bar force loss then decreased and remained approximately linear for the remainder of the monitoring period. In June 1993, at the conclusion of monitoring, the bar force had decreased to approximately 21,300 lb, 39 percent of the design force.

The bar force loss is attributed to stress relaxation of the lumber laminations caused by the applied compressive force and enhanced by the high moisture content. Although the bar force decreased approximately 60 percent during the

monitoring period, it did not fall below acceptable levels. Because the decline in bar force was expected to continue as a result of further stress relaxation and an eventual decrease in the moisture content, the bridge was restressed at the conclusion of the monitoring period to the full design force.

- During the monitoring period, the average bar force for the Sanborn Brook bridge decreased from the design force of 55,000 lb to approximately 21,300 lb (39 lb/in² interlaminar compression). The decline in bar force is attributed to stress relaxation of the lumber laminations, which was enhanced by the high moisture content. Every 2 years, future bridge inspections should verify bar forces to ensure adequate interlaminar compression. Bars should be retensioned as required.

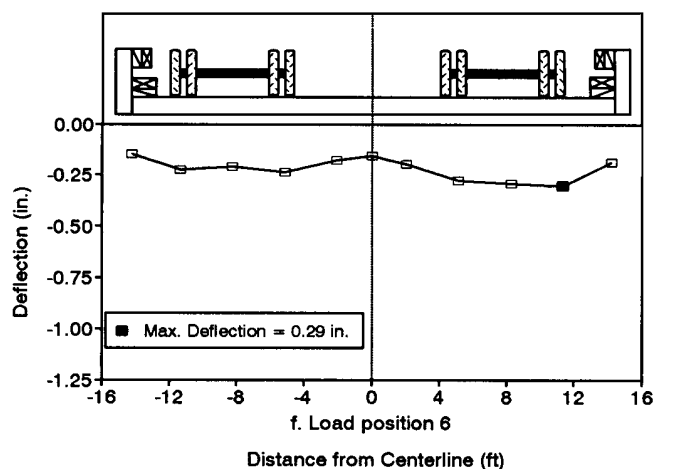
Transverse deflections for load test 2 are shown in Figure 20. As with load test 1, the plots are indicative of orthotropic plate behavior (Ritter and others 1990). For load position 6, the maximum deflection occurred beneath the outside wheel line of the heavier truck (Fig. 20f). The absolute maximum measured deflection of 0.39 in. occurred at the data point immediately to the right of the bridge centerline during load position 3. For load positions 1 and 2, the maximum deflections occurred between the truck wheel lines and under the outside truck wheel line, respectively (Fig. 20a,b). The maximum deflection for load position 4 occurred under the outside wheel line, and the maximum deflection for load position 5 occurred at the three locations indicated (Fig. 20d,e). A single maximum point cannot be identified for load position 5 for the same reasons as indicated in load test 1.

Figure 20—Transverse deflections for load test 2 (looking east), measured at the midspan of the bridge. Bridge cross-sections and vehicle positions are shown to aid interpretation and are not to scale.

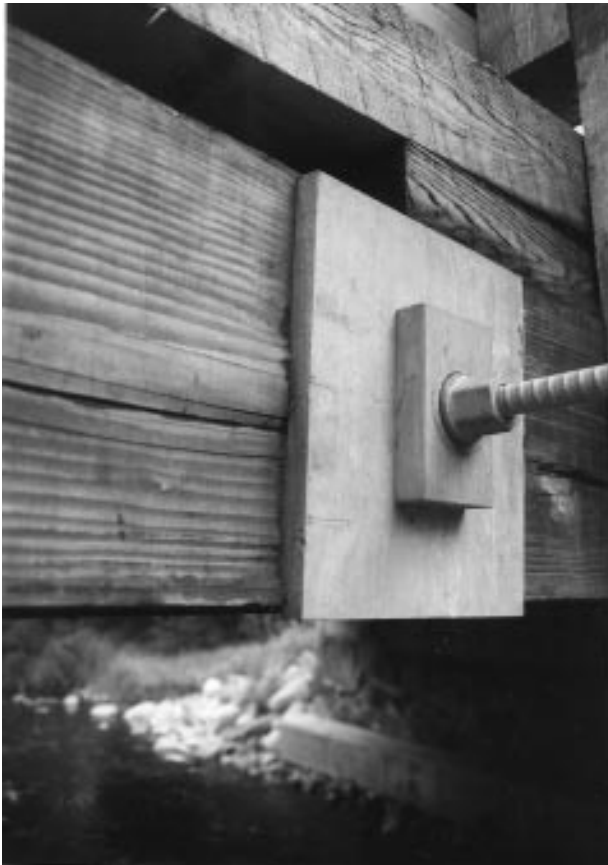
Inspection of the wood components of the bridge showed no signs of deterioration, although minor checking was evident in timber members exposed to wet-dry cycles. The top end-grain surfaces of the timber railposts exhibited minor checking. This probably could have been prevented if a bituminous end grain sealer had been applied at the time of construction. In addition, minor checks appeared along the sides of exposed exterior deck laminations (Fig. 25). There was no evidence of wood preservative loss and no preservative or solvent accumulations on the wood surface.

Figure 25—A check in an exterior lamination noted during condition assessment.

- Visual inspections of the bridge indicate that performance of wood components is satisfactory. Minor checks and splits were noted in some wood members. This could be avoided by installing the laminations at a lower moisture content level and applying a bituminous sealer to any exposed end grain.

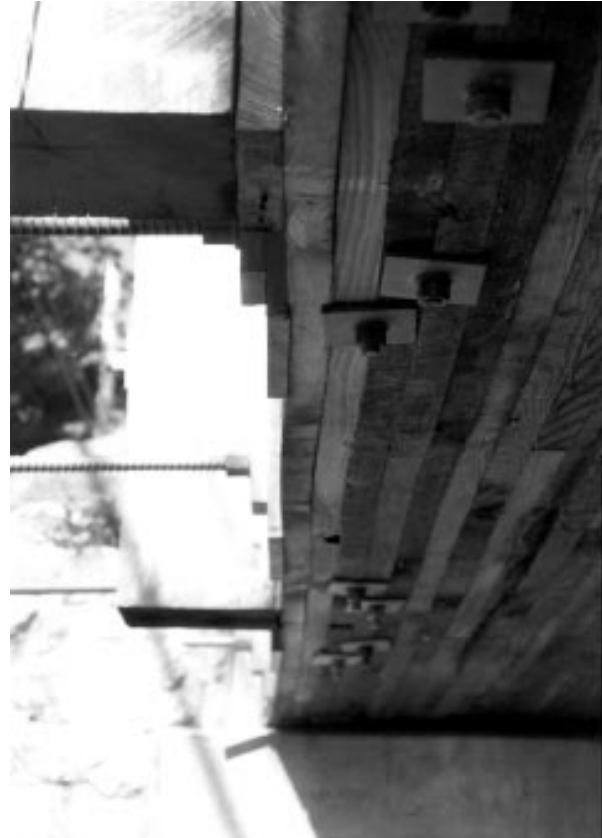
- The wearing surface appears to be in good condition and shows no signs of distress.
- The exposed steel stressing bars and discrete anchorage plates showed no visible signs of corrosion or other distress. The plates were not distorted and crushing of the exterior lumber laminations was negligible, although the exterior laminations did appear distorted and wavy along the length of the bridge.

Figure 26—Distorted exterior lumber lamination noted during condition assessment at the time of load test 2.
