In: Proceedings of 6th International conference on low-volume roads;
1995 June 25–29; Minneapolis, MN. Washington, DC: National Academy
Press: 357-372; 1995. Vol. 2. 1995.

Design and Evaluation of Two Bridge Railings for Low-Volume Roads

Ronald K. Faller, Barry T. Rosson, and Dean L. Sicking, *University of Nebraska-Lincoln*
Michael A. Ritter, *Forest Products Laboratory, USDA Forest Service*
Steve Bunnell, *USDA Forest Service, Washington, D.C.*

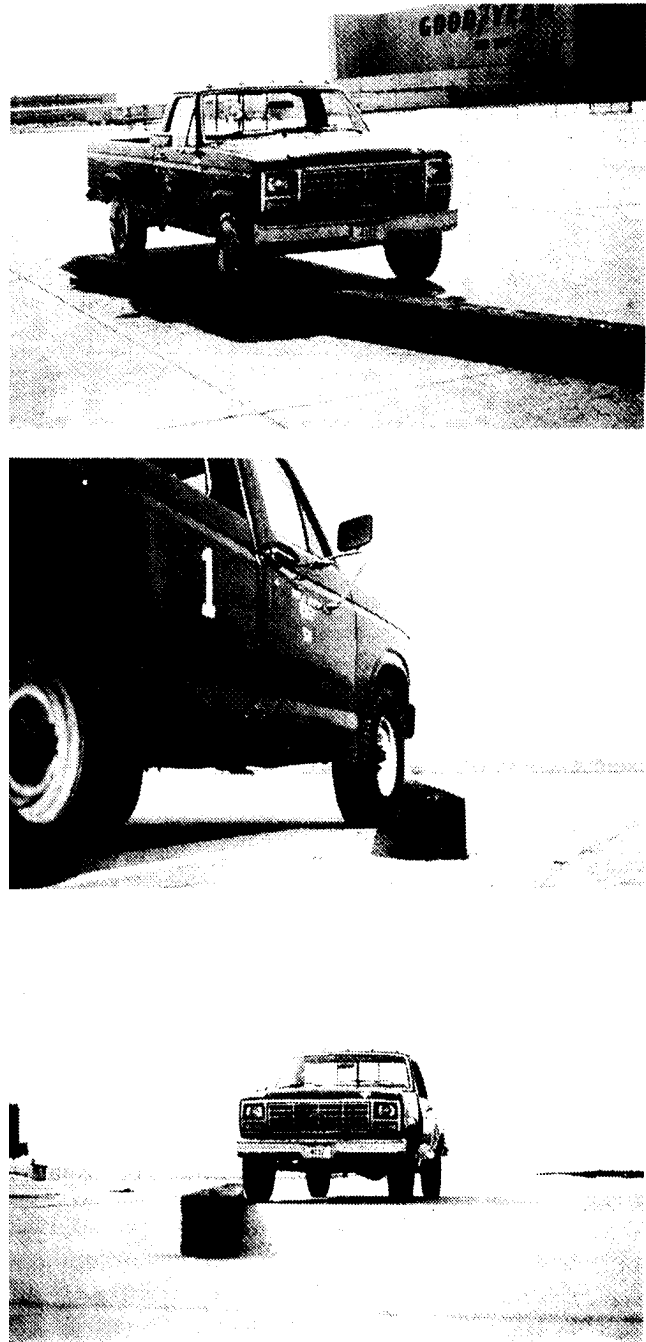
FIGURE 3 Square curb rail attached to concrete apron, three views.

The curb shapes were attached to a continuous concrete slab, as shown in Figure 3, with two 1.6-cm (5/8 in.) diameter ASTM A307 bolts spaced on 2.90-m (9-ft 6-in.) centers. If necessary, timber scupper blocks were placed below the rail shapes in order to mount the curb rails 20.3, 25.4, and 30.5 cm (8, 10, and 12 in.) above the surface.

Impact tests were performed on the three curb shapes mounted at three different heights for a total of nine curb configurations. The developmental testing phase consisted of 19 impact tests on the rail attached to the concrete slab, as shown in Table 2. For impacts at 24 km/hr (15 mph) and 15 degrees, the trapezoidal and rectangular shapes with a 20.3-cm (8-in.) mounting height successfully redirected the test vehicle with no tendency for the vehicle to climb. However, for the same impact conditions, the square shape with a 20.3-cm (8-in.) mounting height allowed the vehicle to climb over the top of the rail. Following these tests, it was determined that one full-scale vehicle crash test would be performed on one of the two successful curb shapes attached to the longitudinal timber deck. The trapezoidal shape with a 20.3-cm (8-in.) mounting height was selected for this crash testing because it appeared to provide a higher redirective capacity than the rectangular shape.

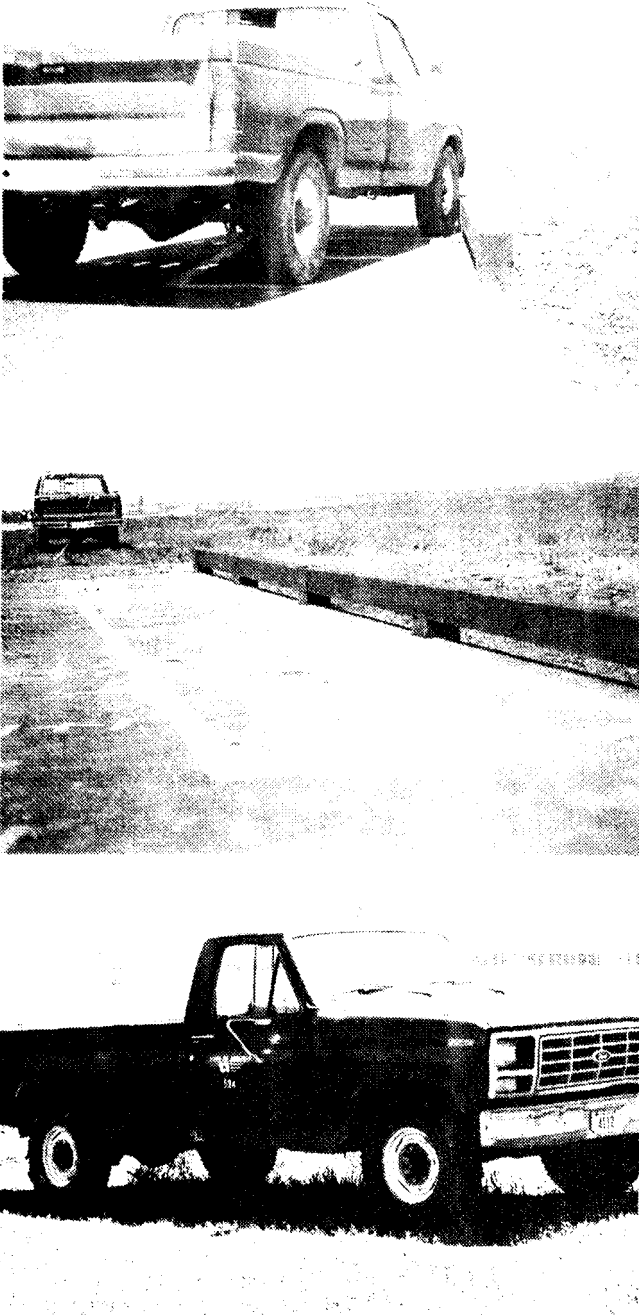
FIGURE 4 Impact location, vehicle trajectory, and vehicle damage, Test LVCS-4.

Except for minor scuff marks on the right-side tires, there was no visible vehicle damage, as shown in Figure 4. No damage occurred to the curb rail or steel hardware. In addition, the glulam timber deck was not damaged.

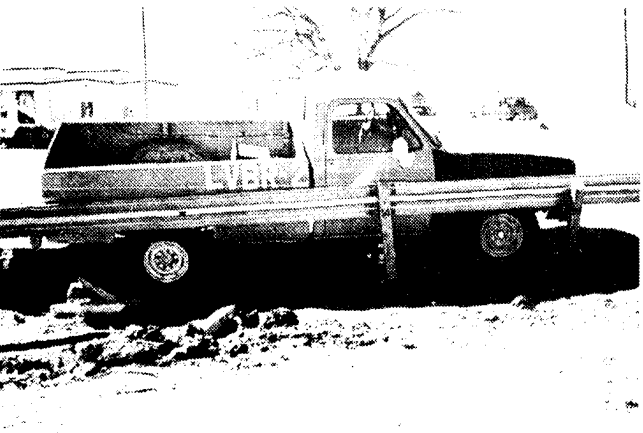
FIGURE 7 Impact location, vehicle trajectory, and vehicle damage, Test LVBR-2.

A 1985 Chevrolet C-20 pickup truck weighing 2043 kg (4,504 lb) struck the bridge rail at Post No. 7 at 49.2 km/hr (30.6 mph) and 24.9 degrees, as shown in Figure 7. A summary of the test results and the sequential photographs are shown in Figure 8. The vehicle became parallel to the bridge railing at 0.652 sec with a velocity of 38.8 km/hr (24.1 mph). Although the vehicle was redirected, it did not exit the bridge railing. The vehicle came to rest 13.4 m (44 ft) downstream from impact with the vehicle's left-side tires and right-side undercarriage resting on the deck surface, as shown in Figure 7. At no time, during impact or at any time thereafter did the vehicle's right-side tires contact the ground.

Vehicle damage was minor. Following the crash test, the vehicle's right-side tires were lifted onto the deck, and the vehicle was driven away. Damage on the right-front quarter panel was caused by vehicle-rail contact, and damage to the right-side undercarriage was caused by contact with the outer top surface of the deck, as

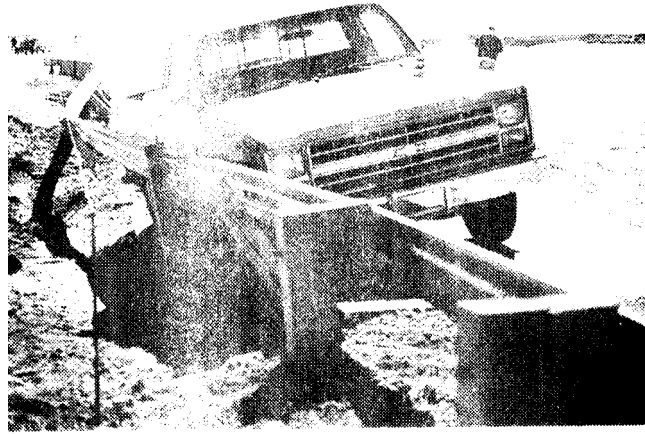
FIGURE 9 Bridge rail damage, Test LVBR-2, three views.

shown in Figure 7. Bridge rail damage was also minimal, as shown in Figure 9. One 1.90-m (6-ft 3-in.) section of W-beam rail was permanently damaged. Eleven posts, Nos. 4 through 14, fractured away from the deck attachment. Five steel angles were deformed downstream of impact because of contact between the angles and the undercarriage of the vehicle.
