# Performance Level 2 and Test Level 4 Bridge Railings for Timber Decks

BARRY T. ROSSON, RONALD K. FALLER, AND MICHAEL A. RITTER

The Midwest Roadside Safety Facility, in cooperation with the Federal Highway Administration and U.S. Department of Agriculture Forest Service, Forest Products Laboratory, developed and tested two bridge railings for use on longitudinal timber bridge decks: (a) a steel railing system (TBC-8000) and (b) a glulam timber railing system (GC-8000). The test for the TBC-8000 was conducted according to Performance Level 2 as specified in the AASHTO *Guide Specifications for Bridge Railings* (1989). The tests for the GC-8000 were conducted according to Test Level 4 as specified in *NCHRP Report 350*. The safety performance of each of the bridge railings was acceptable according to each applicable crash test criterion. Both railings provide aesthetically pleasing and economical alternatives for use on higher-service-level timber bridges.

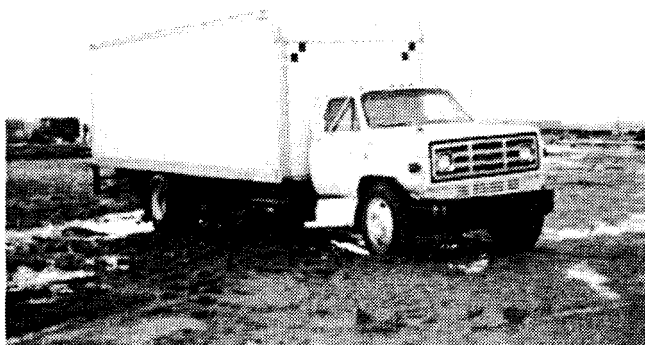
**FIGURE 2** Impact location, vehicle damage, and bridge rail damage, Test FSTC-1.

Vehicle damage was relatively minor and was limited to the right-front corner of the truck cab, box, and front bumper (Figure 2). The bridge rail damage was moderate, consisting mostly of deformed thrie-beam sections, C-rail sections, and steel posts (Figure 2). Examination of the top and bottom surfaces of the timber deck laminations revealed no physical damage or separation.

The length of vehicle contact along the top of the C-rail was approximately 11.4 m (37 ft 6 in.). Physical evidence revealed that lateral buckling of the C-rail occurred between Post Nos. 4 and 5 (Figure 2). The physical damage to the thrie-beam rail revealed that approximately 7.6 m (25 ft) of rail was damaged. The maximum permanent set deflections of the C-rail and thrie-beam rail were 19.3 cm (7.6 in.) and 20.8 cm (8.2 in.), respectively.

Test FSTC- 1 [8, 165-kg (18,000-lb), 76.3 km/hr (47.4 mph), 16.1 degrees] struck the bridge railing at Post No. 4 (Figure 2). A summary of the test results and the sequential photographs is presented in Figure 3.

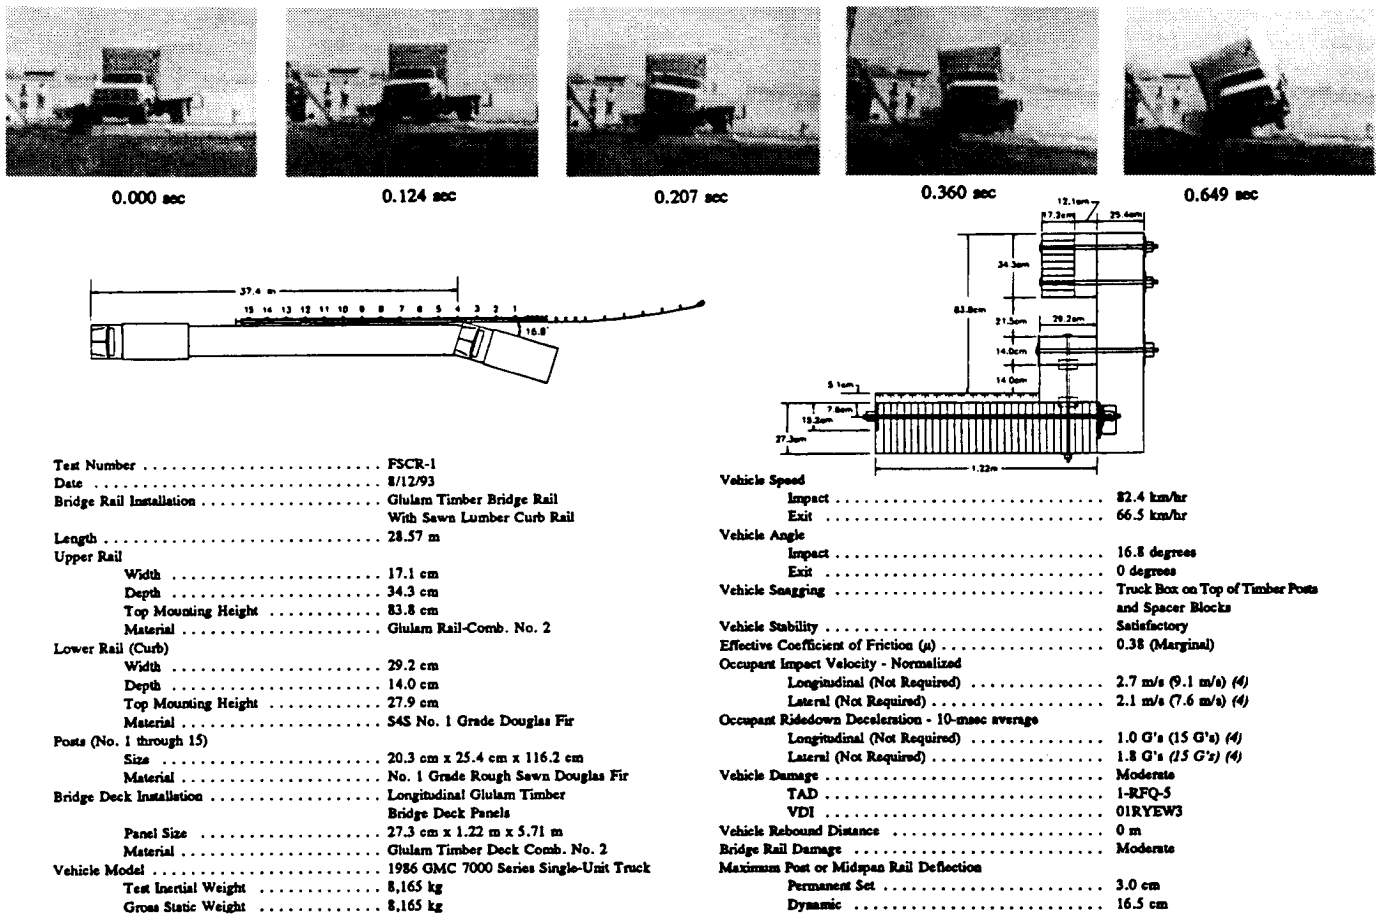
FIGURE 6 Summary of test results and sequential photographs, Test FSCR-1.

upstream from Post No. 4 (Figure 5). A summary of the test results and the sequential photographs are presented in Figure 6.
