STRESS-LAMINATED SCL BRIDGES WITH PRESTRESSING

Michael A. Ritter

USDA Forest Service, Forest Products Laboratory, Madison, Wisconsin, USA

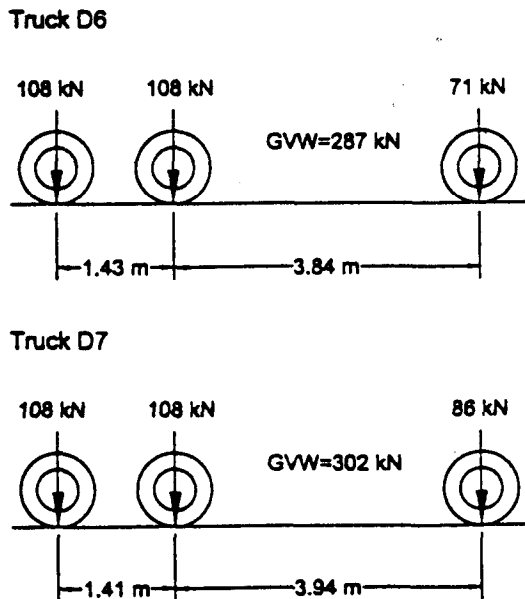
Figure 8 - Load test truck configurations and axle loads.

calibrated rules at the bottom center of each web and at the box corners and reading values with a surveyor's level to the nearest 0.5 mm. The load test vehicles were fully-loaded 3-axle dump trucks (Figure 8). The trucks were positioned longitudinally on the bridge so that the two rear axles were centered at midspan. Transversely, six different load positions were used with the trucks 0.61 m from centerline for load positions 1 through 3, and 1.17 m from centerline for load positions 4 through 6 (Figure 9).
