Two Test Level 4 Bridge Railing and Transition Systems for Transverse Timber Deck Bridges

Ronald K. Faller, Michael A. Ritter, Barry T. Rosson, Michael D. Fowler, and Sheila R. Duwadi

The Midwest Roadside Safety Facility, in cooperation with the Forest Products Laboratory, which is part of the U.S. Department of Agriculture's Forest Service, and FHWA, designed two bridge railing and approach guardrail transition systems for use on bridges with transverse glue-laminated timber decks. The bridge railing and transition systems were developed and crash tested for use on higher-service-level roadways and evaluated according to the Test Level 4 safety performance criteria presented in *NCHRP Report 350: Recommended Procedures for the Safety Performance Evaluation of Highway Features*. The first railing system was constructed with glulam timber components, whereas the second railing system was configured with steel hardware. Eight full-scale crash tests were performed, and the bridge railing and transition systems were acceptable according to current safety standards.

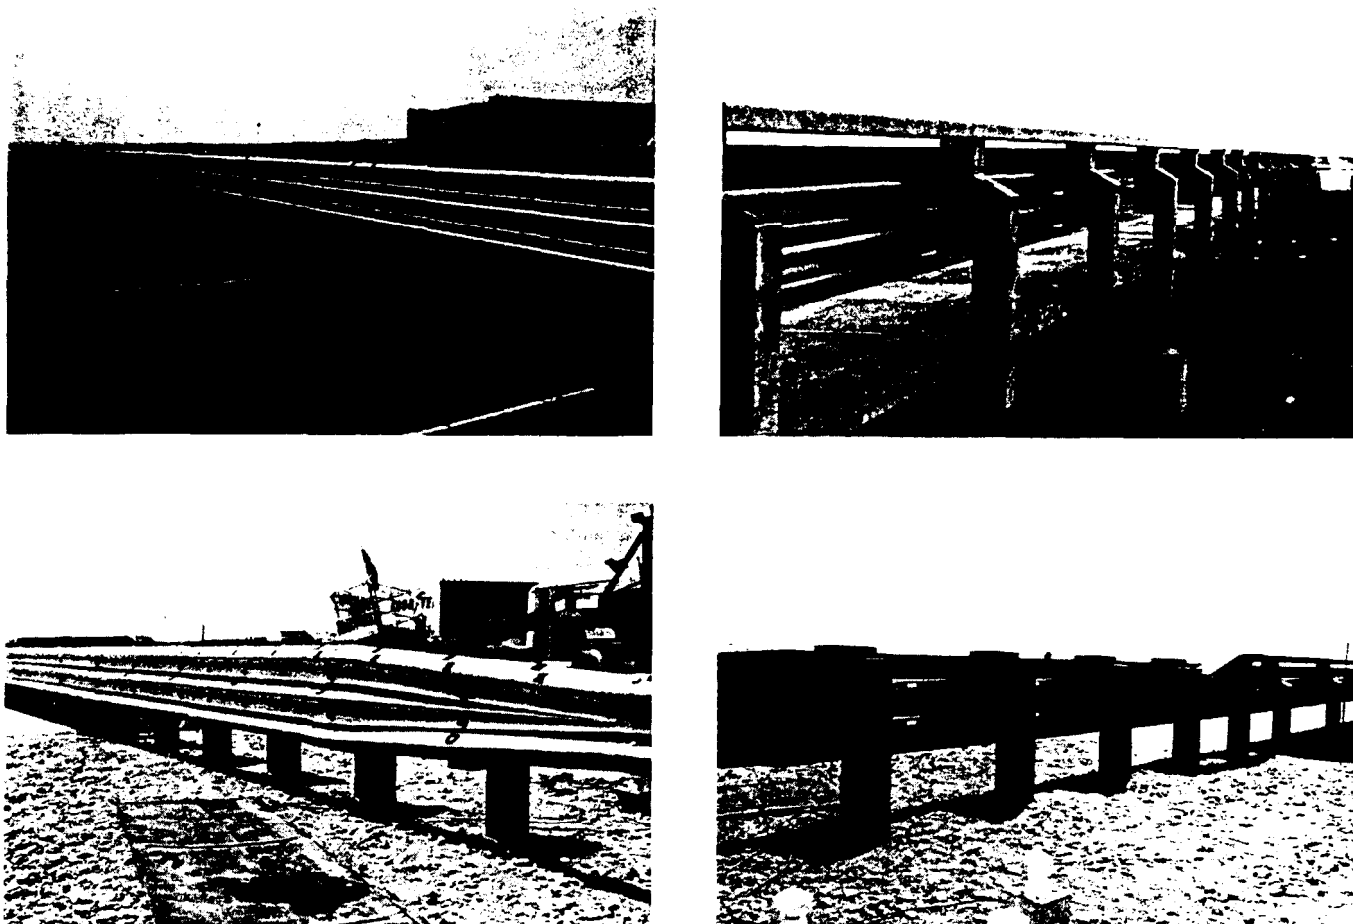
FIGURE 2 System No. 2: steel thrie beam with tube bridge railing [top] and thrie beam with tube transition [bottom].

The first bridge railing, referred to as System No. 1, was a wood system that was constructed with an upper rail, a lower curb rail, scupper blocks, posts, and blockouts, all of which were manufactured from glulam timber. Photographs of the railing system of the wood bridge and the attached approach guardrail transition are shown in Figure 1. The second bridge railing, referred to as System No. 2, was a steel system that was constructed with a three-beam rail, an upper structural tube rail, and wide flange posts and blockouts. Photographs of the steel bridge railing system and the attached approach guardrail transition are provided in Figure 2.

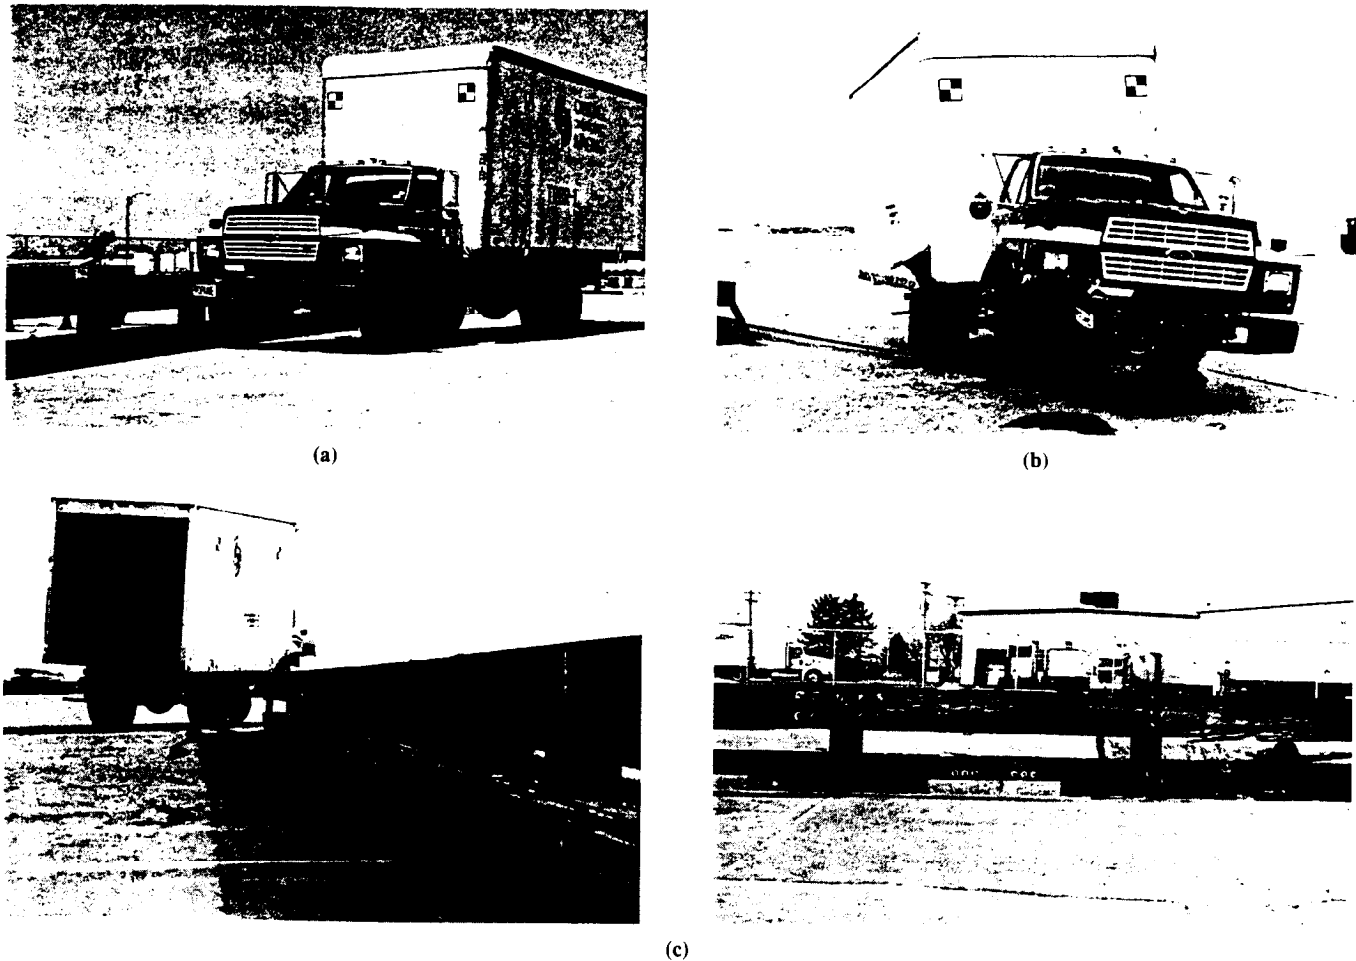
FIGURE 5 Test TRBR-1: (a) impact location, (b) vehicle damage, and (c) bridge railing damage,

The first crash test, Test TRBR-1, was successfully performed with a 1986 Ford F-800 Series, single-unit truck with a test inertial mass of 8000 kg and at impact conditions of 74.8 km/h and at an angle of 16 degrees. During impact, the vehicle exited the railing system at a speed of 47.3 km/h and at an angle of 0 degrees. The maximum lateral permanent set deflection and the dynamic rail deflection were observed to be 10 and 84 mm, respectively. The location of vehicle impact with the bridge railing, vehicle damage, and barrier damage are shown in Figure 5.

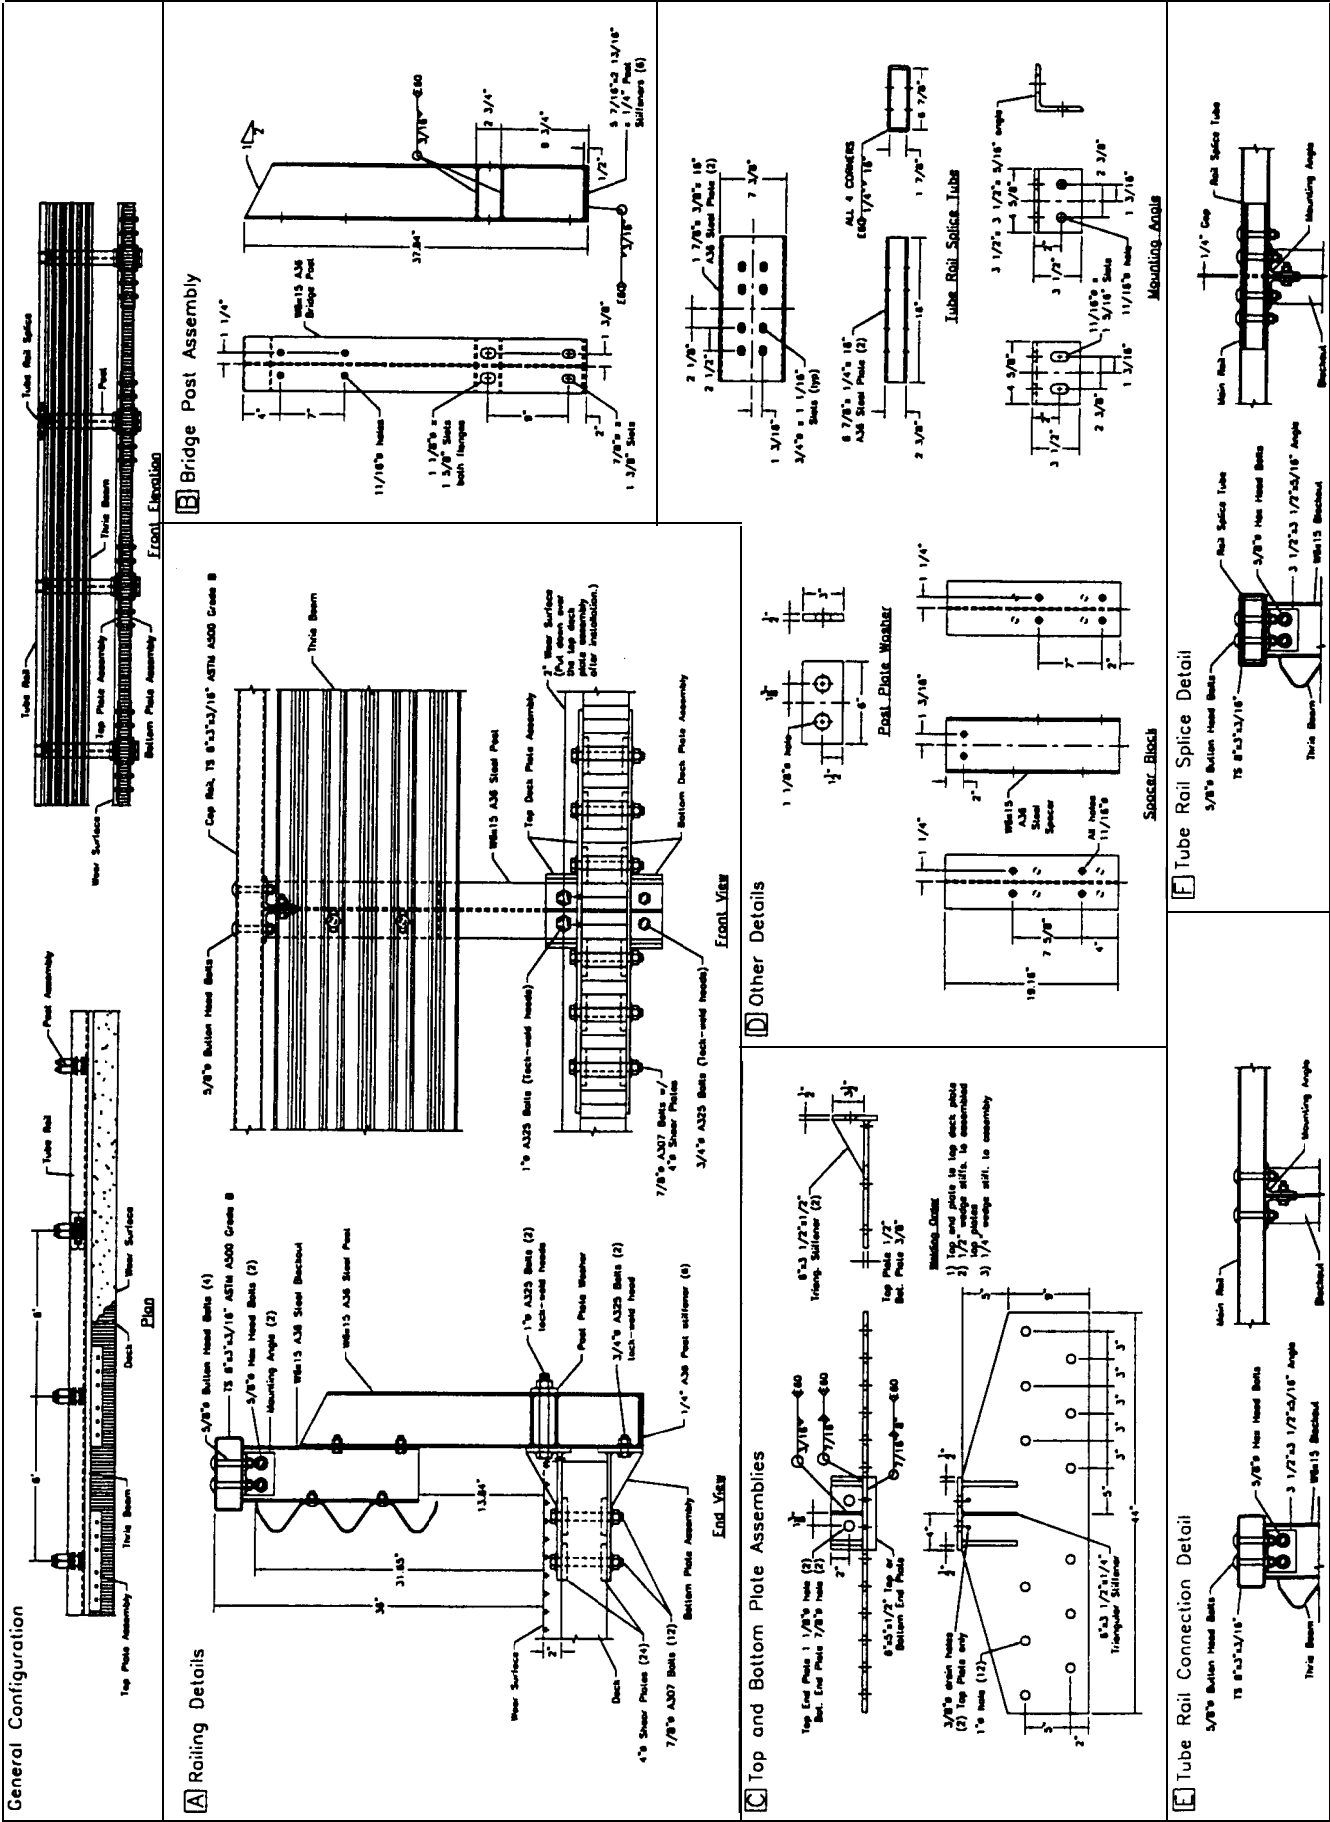
FIGURE 9 System No. 2: steel bridge railing design details (1 in. = 25.4 mm).

The second bridge railing system was designed as an all-steel system. This system was constructed with a thrie-beam rail, an upper structural tube rail, wide flange bridge posts and rail blockouts, and deck-mounting plates. Specific details of this system are provided in Figure 9. For the steel system, a 10-gauge, thrie-beam rail was blocked from the wide flange posts with wide flange spacers. A structural tube rail was then attached to the top of the spacer blocks. The lower end of each post was bolted to two steel plates that were connected to the top and bottom surfaces of the bridge deck with vertical bolts.

System No. 2 was configured similarly to the PL-2 steel thrie beam and channel bridge railing system that was developed for longitudinal decks (13,15-16). However, for this system a structural tube member was used for the upper rail instead of using a channel section to account for the increased post spacing from 1905 to 2438 mm. The change was made to provide greater load distribution and increased resistance to lateral buckling of the upper rail.
