APPENDIX A

REPORT ON THE INSTALLATION OF THE NATIONAL CORS PROTOTYPE MONUMENT

Written by
Dennis A. Hoar
Team Leader
Process Action Team 20
July 2000

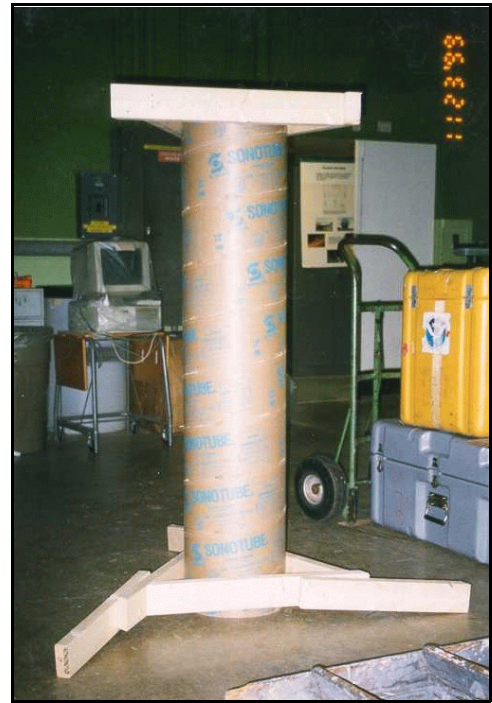
Figure 2

A form (Figure 2) for the 5-ft.-long pier portion of the monument was constructed out of a 12-in.-diameter, 12-ft.-long Sonotube (12 ft. is the shortest standard length available). The height of the pier was limited to 5 ft. not only to ensure that the center of gravity remained well below ground but also to allow precise levels to be used in determining the orthometric height of the top of the antenna adapter, i.e., the antenna reference point (ARP). Thus, a 5-ft. length and a 1-ft. length were each cut from the Sonotube. Six pieces of 2x4 lumber were cut into 30-in. lengths with one end beveled at 60 degrees. Three each of these 2x4 lengths were attached in a triangular shape to the top and bottom of the 5-ft.-long form. These constructions were used to attach braces to the form to hold it in place during the pouring and curing of the concrete. The 1-ft. section of Sonotube was used to mark the approximate center of the mass of concrete poured into the ground. This simplified the process of placing the 5-ft. form in the correct position.

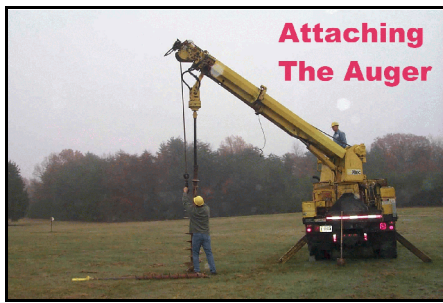
Figure 4

The auger truck arrived 8:10 on November 23 at the selected monument site that was pre-approved as a safe location to dig by "Miss Utility." The truck is owned by the Rappahannock Electric Cooperative and was outfitted with a 21-in.-diameter flight auger capable of drilling a hole to a depth of 15 ft. The truck was manned by a two-person crew of which one person operated the auger while the other directed the position, angle, and depth of the drilling. It took about 10 minutes for them to set up the rig and to attach the flight auger (Figure 4). The drilling process (Figure 5) took only 15 minutes to reach a depth of 11 ft., 4

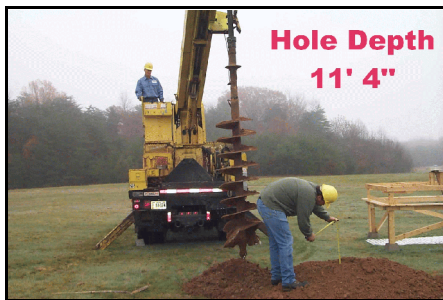
Figure 6

in. (Figure 6). This time period included the operator stopping the drilling to occasionally lift the auger out of the hole to clear away excess soil from the hole and flight augers. The ease with which the hole was drilled is attributed to the local soil composition of loam, sand, and clay. The top 1 ft. was loam, followed by a layer of sand, and the remaining soil was clay. This soil composition was soft and dry, but contained enough moisture that the surrounding soil did not collapse into the hole. The diameter of the finished hole was 22 in. The water table was of sufficient depth that water did not seep into the hole, even after setting overnight. This was an unexpected bonus since the presence of water would have complicated the pouring of the concrete. The truck departed at 8:45, for a total of 35 minutes on site.

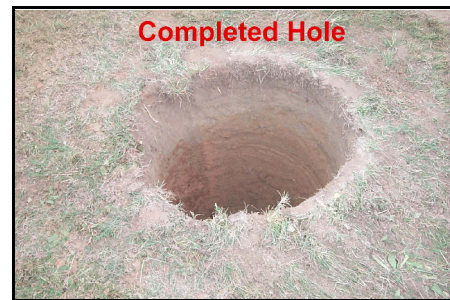
Figure 7

The large pile of soil was then removed from around the hole (Figure 7). Eric Murray of the U.S. Geological Survey volunteered to operate his agency's front end loader to assist in the removal of the soil. This greatly reduced the amount of manual labor required to accomplish this task. It took almost twice as long (1 hour) to remove the soil as it did to drill the hole. The soil was hand shoveled into the bucket of the front end loader to minimize the possibility of soil falling back into the hole. The soil was then spread over low areas near the monument to smooth out the grounds.

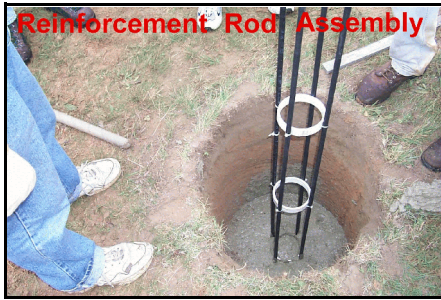
Figure 10

This process was repeated until the hole was filled to within a couple of feet of the ground surface. At this point the reinforcement rod assembly was centered into the hole and pushed down into the concrete until approximately 2 ft. of the assembly was above the ground level (Figure 10). The pouring was resumed until the concrete was within a couple of inches of the ground surface. The 1-ft.-long section of Sonotube was placed over the rod assembly and, after measuring to ensure that the rod assembly was in the center, was gently pushed down into the concrete just enough to make a small indentation that could serve as a guide for centering the 5-ft.-long form (Figure 11). The 1-ft. piece of Sonotube was then removed and replaced with the 5-ft. form (Figure 12). Wooden stakes were driven into the ground next to the bottom wooden triangle that was attached to the form, and a 24-in.-long hand level was used to level the form before securing the triangular sides to the stakes using sheet rock screws (Figure 13). Long 2x4s were then attached to the top wooden triangle and secured to stakes (Figure 14). This arrangement was designed to hold the form securely in place while it was filled with concrete. The pouring of the concrete resumed at an even slower pace to ensure that the level would be maintained. The operator of the concrete truck advised against using the concrete vibrator inside the form as there would be a good chance that the force of

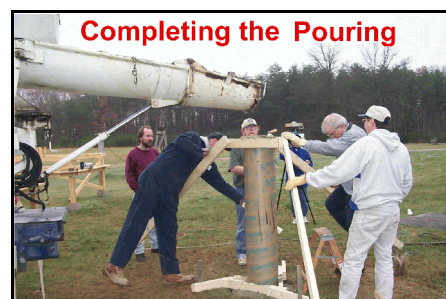
Figure 15

the vibrator settling the concrete would rupture the form. A section of a 2x4 was used instead of the vibrator to tamp down the concrete after about 2 ft. of concrete had been poured into the form. This process was repeated until the concrete was about 1 in. higher than the form (Figure 15). The bracing worked as intended, as the form did not move out of level. This concluded the concrete pouring phase of the monument construction. The concrete truck departed the Corbin facility at about 10:00, for a total of about 1 hour on site.
