Space Heaters

Examples of Improper Space Heater Usage

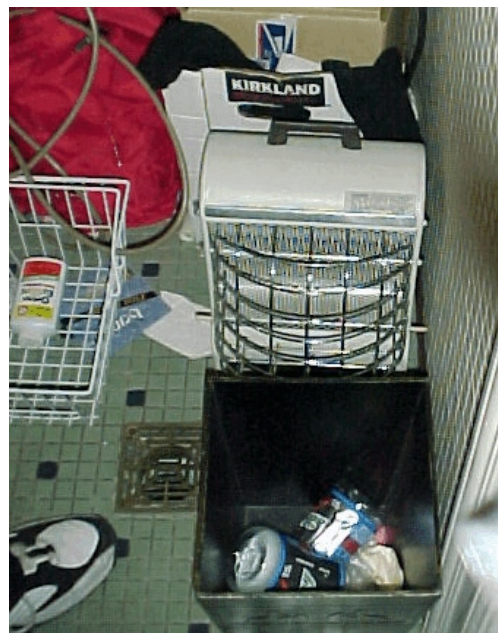
To the right is an image of an improperly utilized space heater in a Congressional facility. The space heater is located beneath a sink and could easily come in contact with water. In addition, it is surrounded by trash and other items, including a plastic waste bin, that could easily be caught on fire.

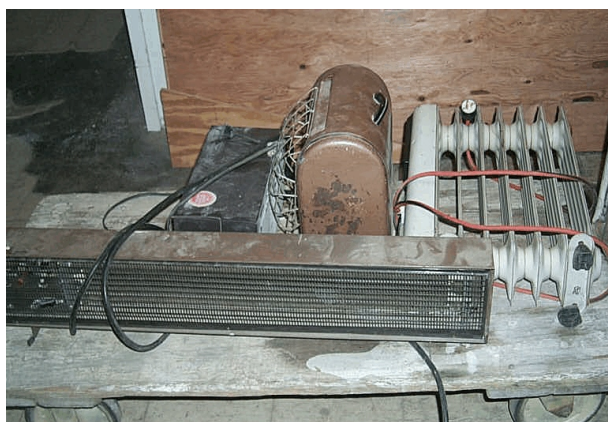
To the left are improper space heaters that were found in use in Congressional facilities. The space heaters are old and damaged and several were covered with rust. None of these space heaters were approved by a recognized laboratory for commercial use.
