The Naval Safety Center's Aviation Maintenance Magazine

Five-Minute Move

Vol. 3, No. 1, Jan – Mar 2000

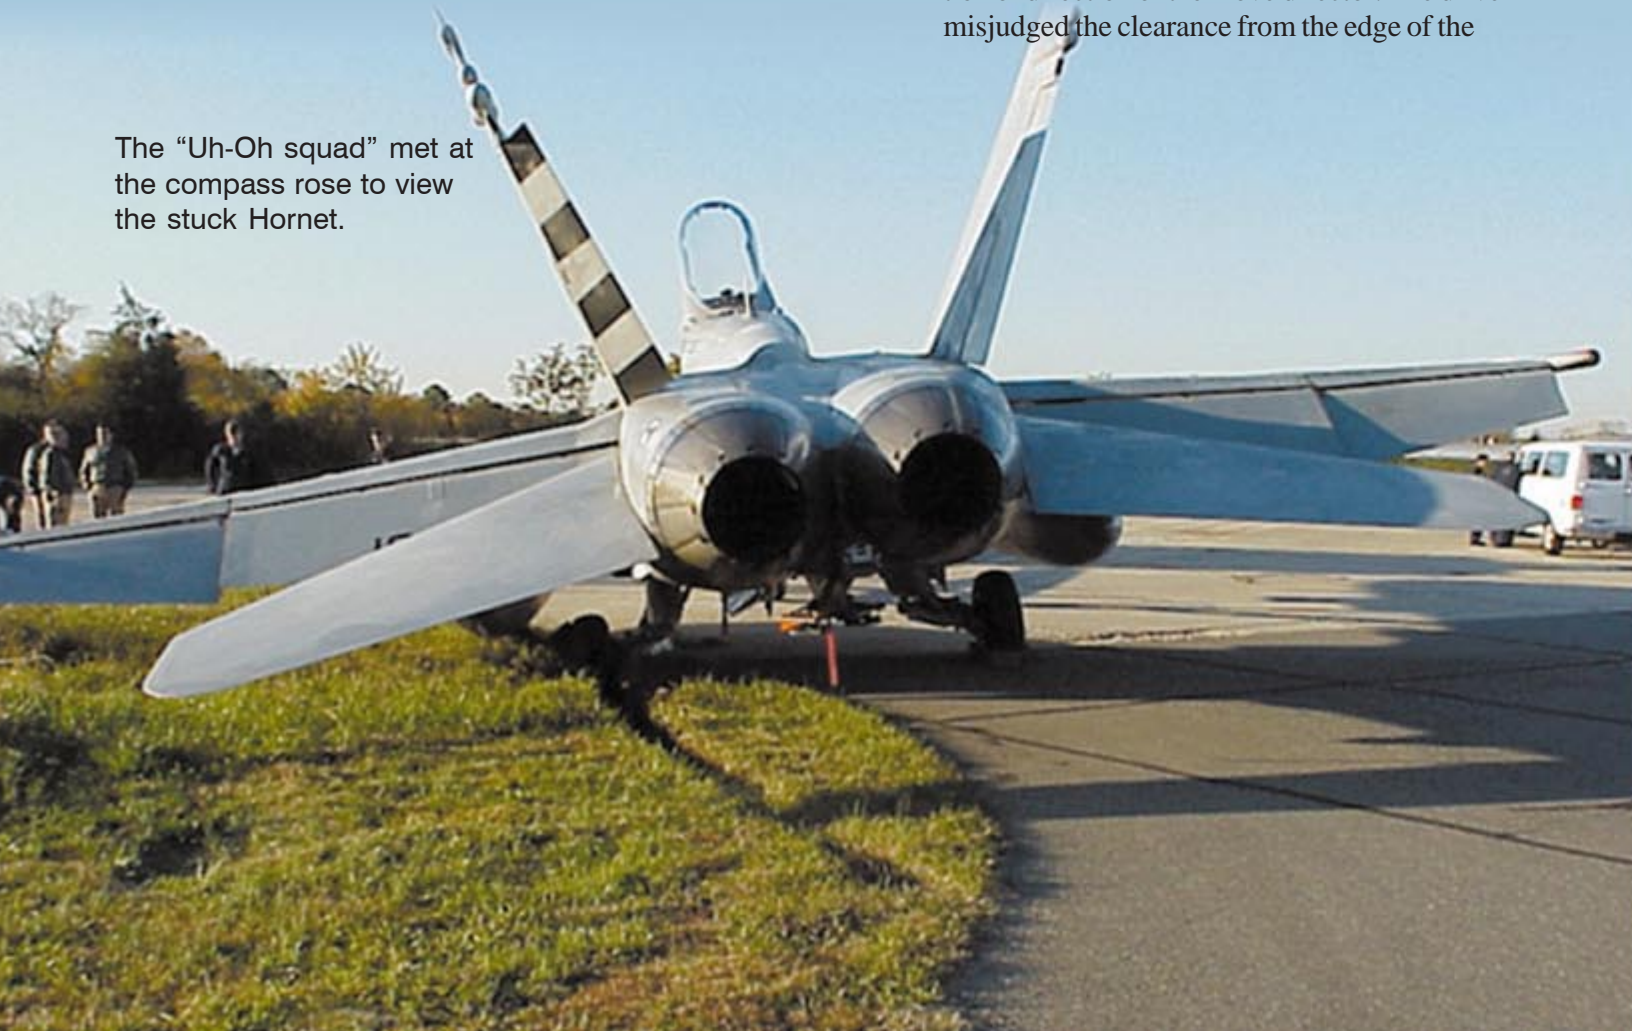
The "Uh-Oh squad" met at the compass rose to view the stuck Hornet.

As the Hornet re-entered the compass rose, the tractor driver pressed on without the attention or direction of the move director. The driver misjudged the clearance from the edge of the

taxiway, and the port mainmount rolled off the concrete and onto the soft grass. It took only a few seconds for the 39,000-pound aircraft to sink into the unpaved surface up to the axle. The crew leader immediately notified Maintenance Control.

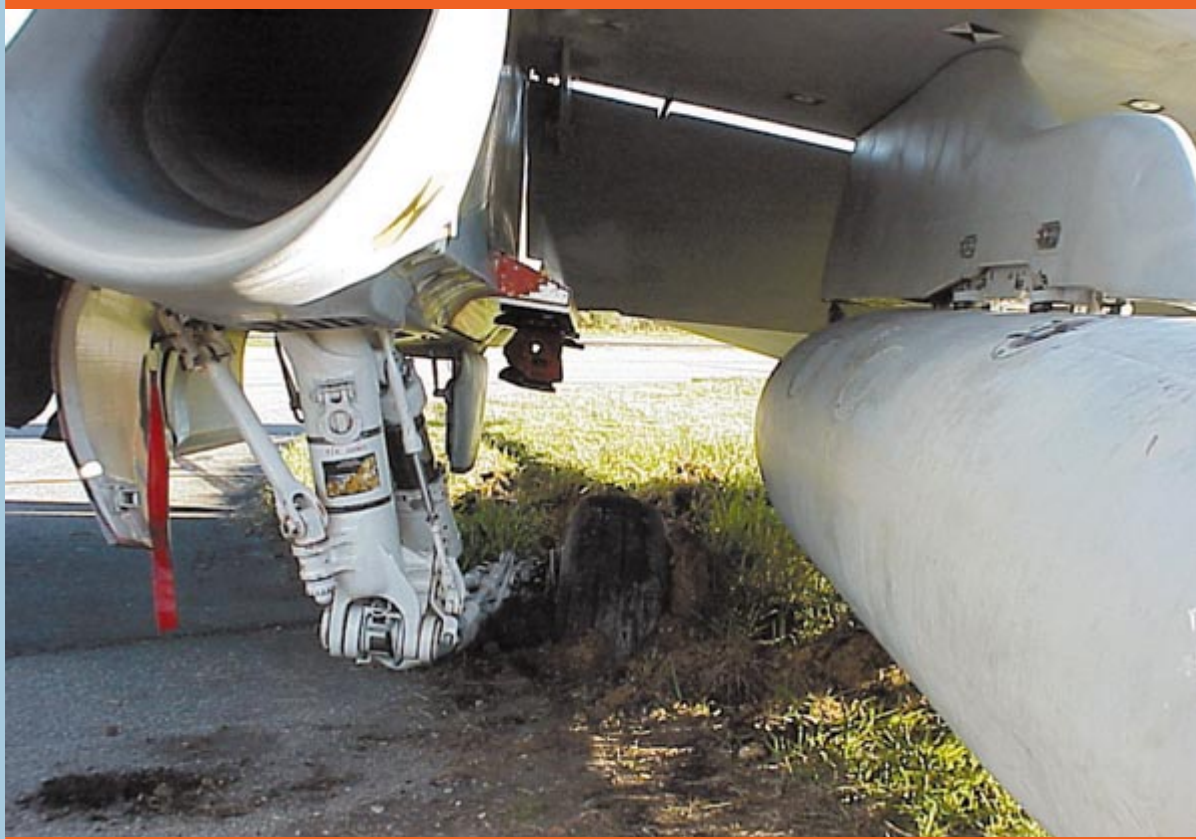
The troops used shovels and a bigger tow tractor, but it took a crane to get the Hornet back on the concrete surface.

AIMD spent many extra manhours completing a non-destructive inspection of the landing gear, and the airframes shop had to drop-check the bird and do a conditional inspection. It was nearly 24 hours before we were able to finish the compass swing that we had been so close to completing the day before.

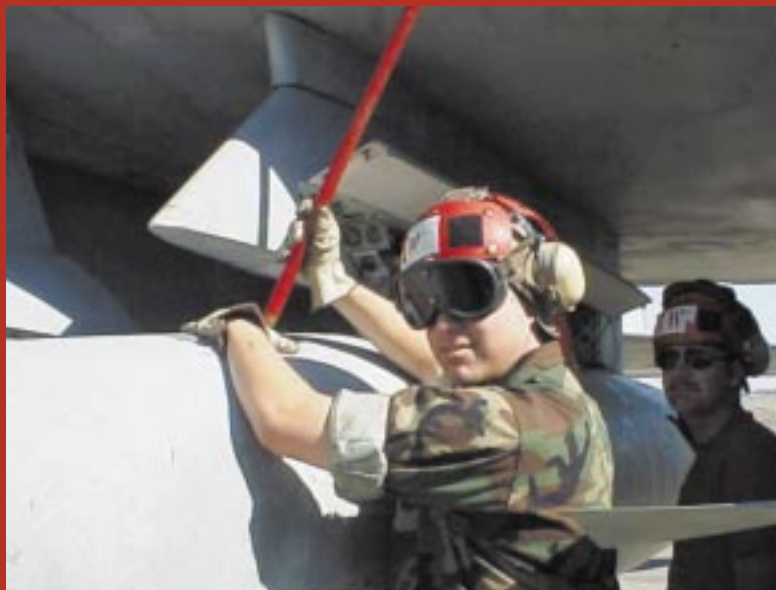
Step 1
“Thump tests” don't work, and you can't always believe gauges. Dip the tank before you try to drop it.

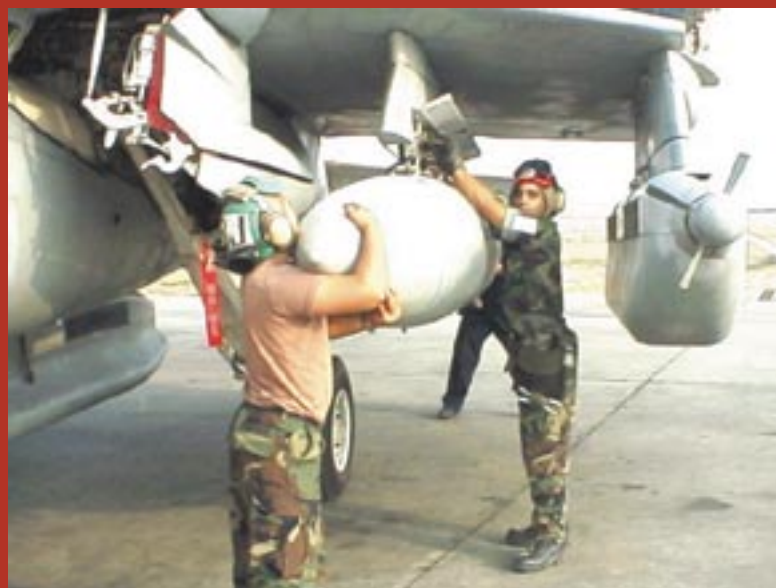
Step 2
After dipping the tank to make sure it's empty, be sure the people at both ends of the tank are ready before you release it.

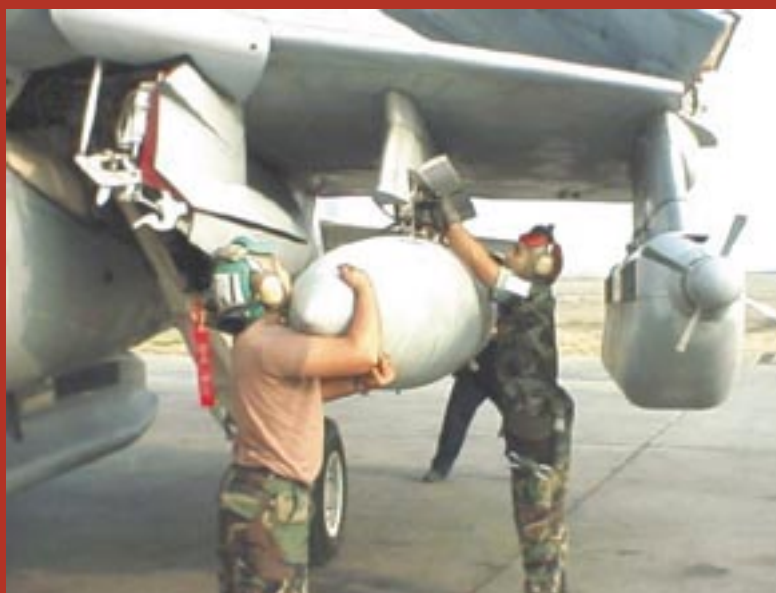
Step 3
If the man releasing the tank from the bomb rack doesn't dip the tank first, the Sailors at both ends are going to be holding roughly 2,000 pounds of thump-tested grief.

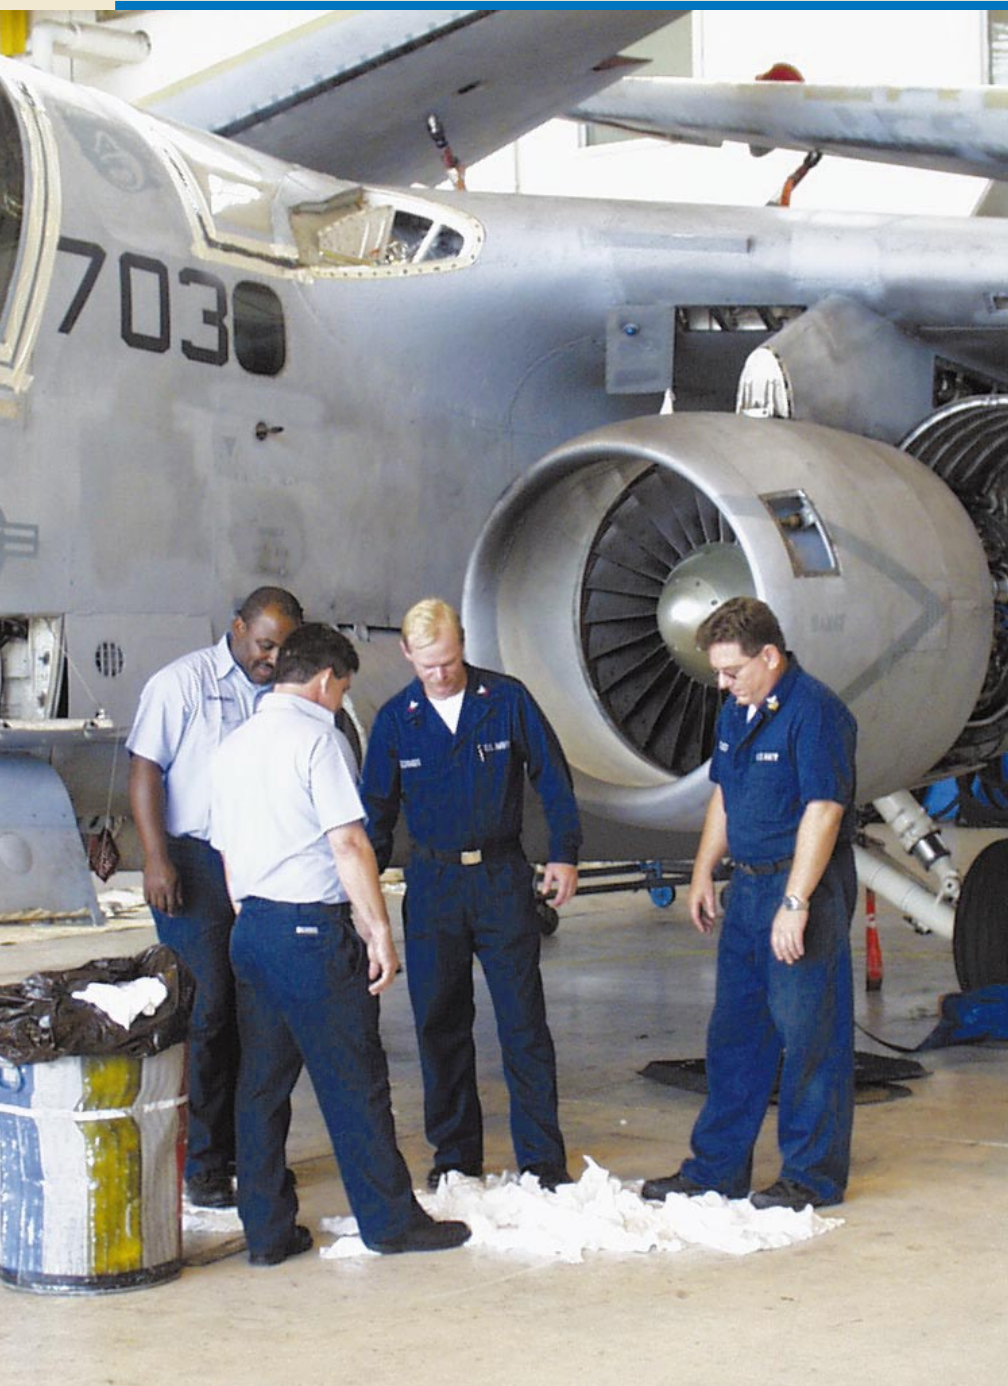
Cleaning up a fuel spill is slow work, a pain in the tail-feathers and messy—did I also mention dangerous?

Failures that led to the spill:

- Not trying to defuel. You always should assume the worst case—a fuel load.
- Misunderstanding the trickle of fuel. If something leaks, there is fluid behind it.
- Jacking one wing is not in the MIMs.
- Beating a panel damages the panel. Why was the panel stuck?
- Not checking the fuel dump and fuel-tank drain. These procedures are in the MIMs.

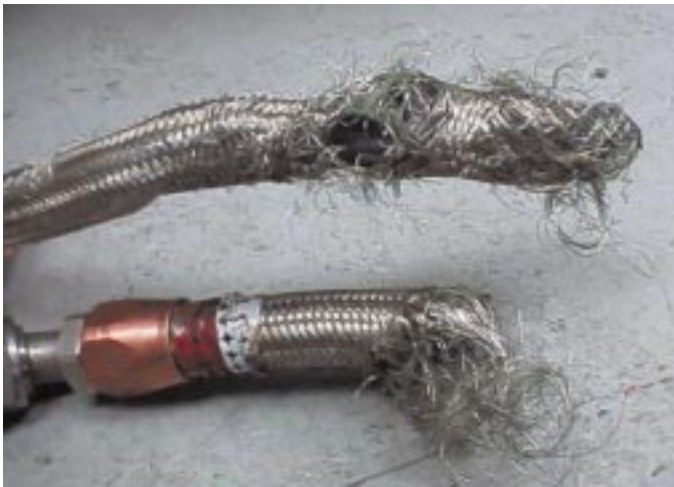
A rag become entangled in the engines' cross-feed fuel lines and damaged them.

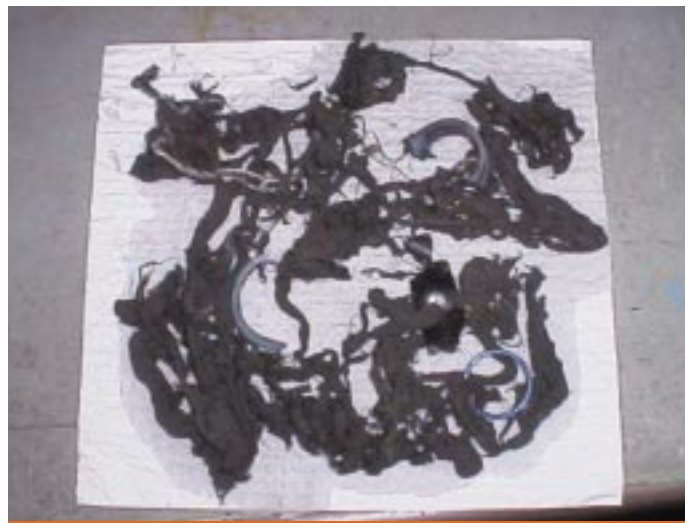
A plane captain found these remains of a rag wrapped around the NR 1 section of the tail-rotor driveshaft.
