Performance of Selected Event Data Recorders

**Vehicle Research and Test Center
National Highway Traffic Safety Administration
US Department of Transportation**

September 2001

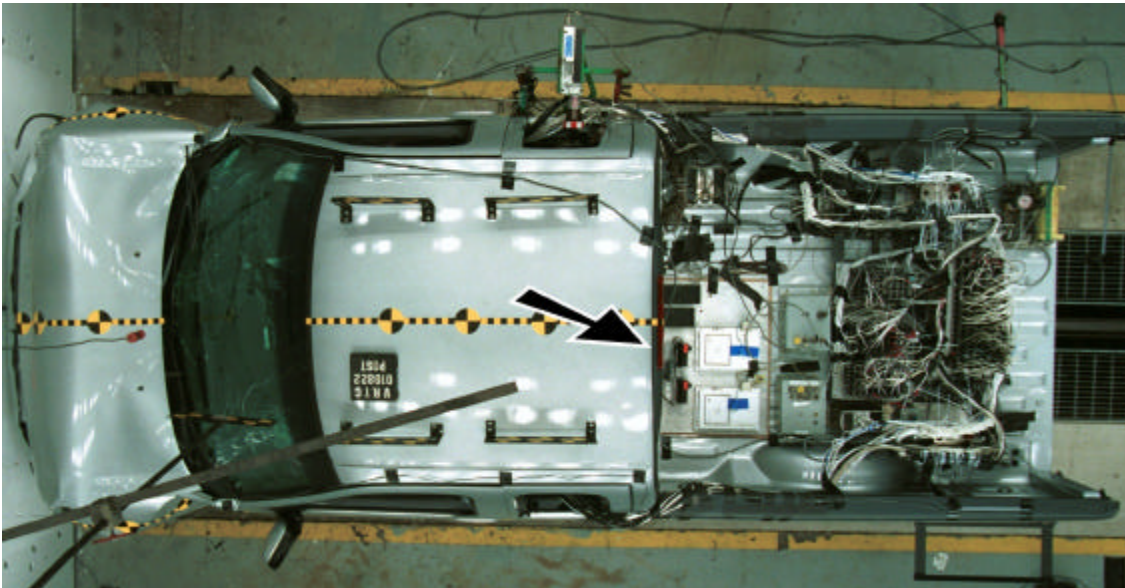
Figure 1 Test Setup

The EDR's were attached to the bed of a 2001 Ford F-150 pickup which was crashed into a flat fixed rigid barrier at 30 mph (48 kph). The EDR's were mounted on an aluminum plate which was attached to the bed of the truck. Self tapping screws were used to attach the EDR's to the plate and the plate to the truck.

A picture of the setup is shown in Figure 1.

The plate with the EDR's is marked with the arrow. The detailed view of the plate is shown in Figure 2.

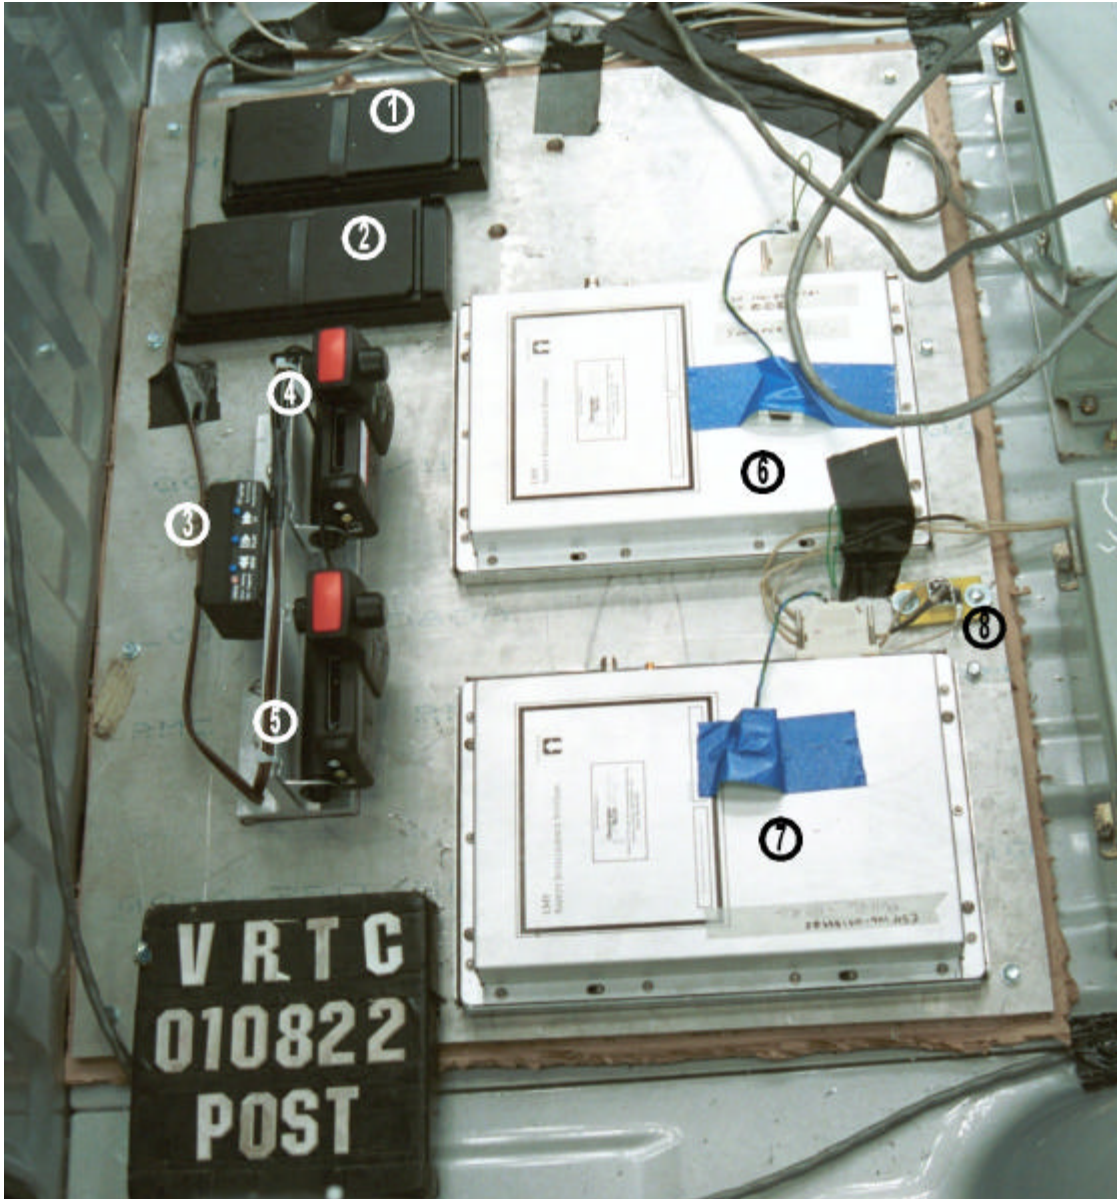
Figure 2 Plate with EDR's

The EDR's identified in Figure 2 are

- 1 and 2) IWI
- 3, 4 and 5) DriveCam
- 6 and 7) G.Tech.MACBOX
- 8) Three Endevco 7460 accelerometers (baseline)

The two units from IWI were "B6 Witness Unit". There were six DriveCam units installed. The plate had DriveCam-1, DriveCam-II ver 1.1, and DriveCam-II ver 1.5 (under development) units. Similar units were attached to the windshield (near the rear-view mirror). The two units provided by Ga. Tech. are MACBOX (Phase 1 box), owned by Safety Intelligence System Corporation "SIS".

The output of the EDR's shown in Figure 2 were compared to reference accelerometers on the plate. The output of the DriveCam units attached to the windshield and the Ford RCM was compared to reference accelerometers in the passenger cabin, on the center tunnel near the vehicle center of gravity. This was done to compare the output of the EDR's to the suitable crash environment, which is different at different locations in the vehicle.

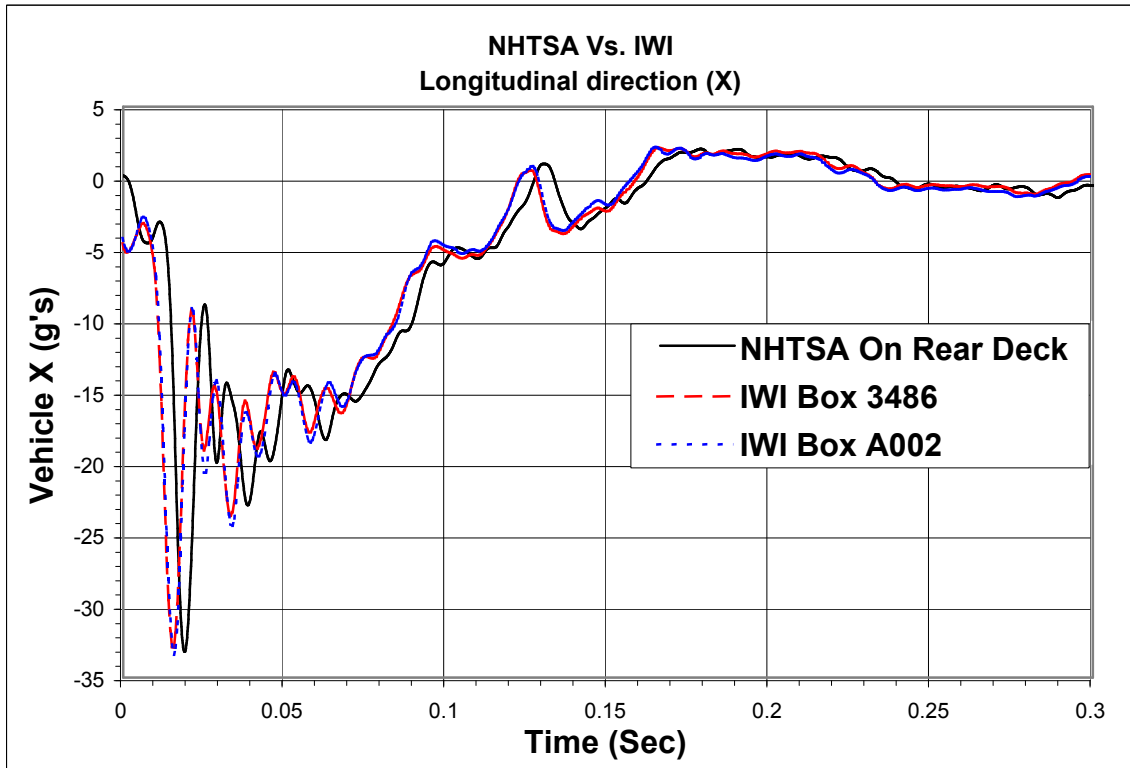
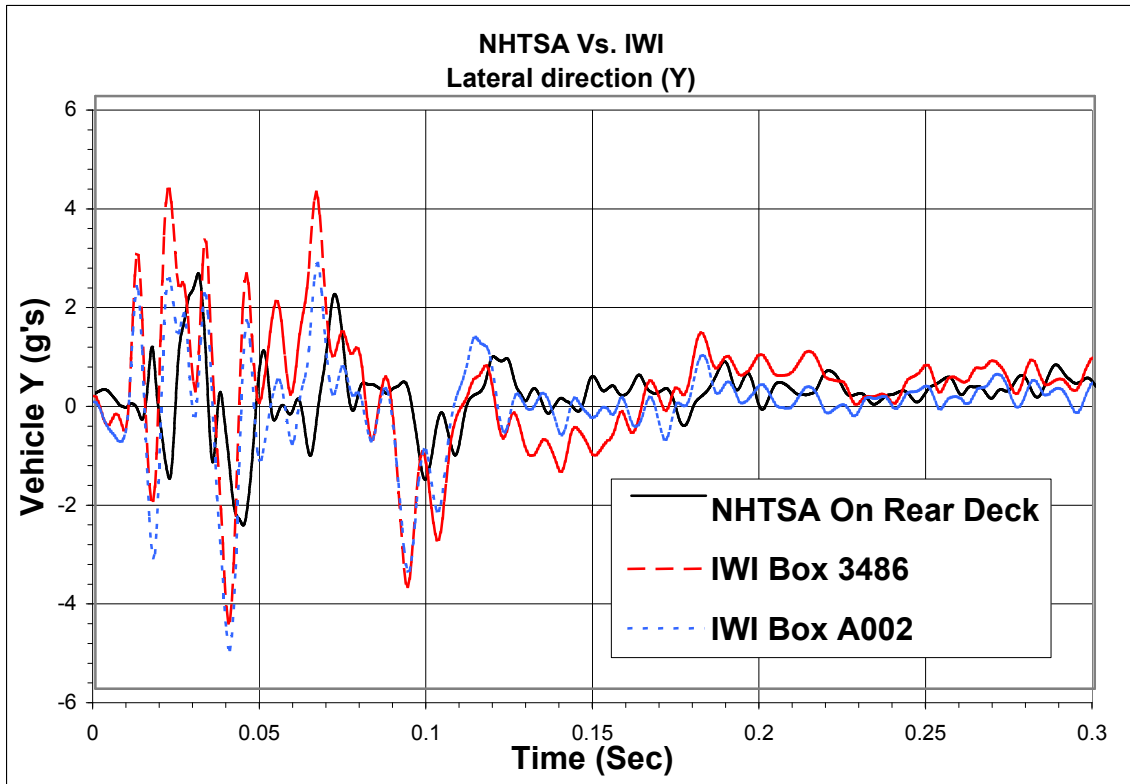
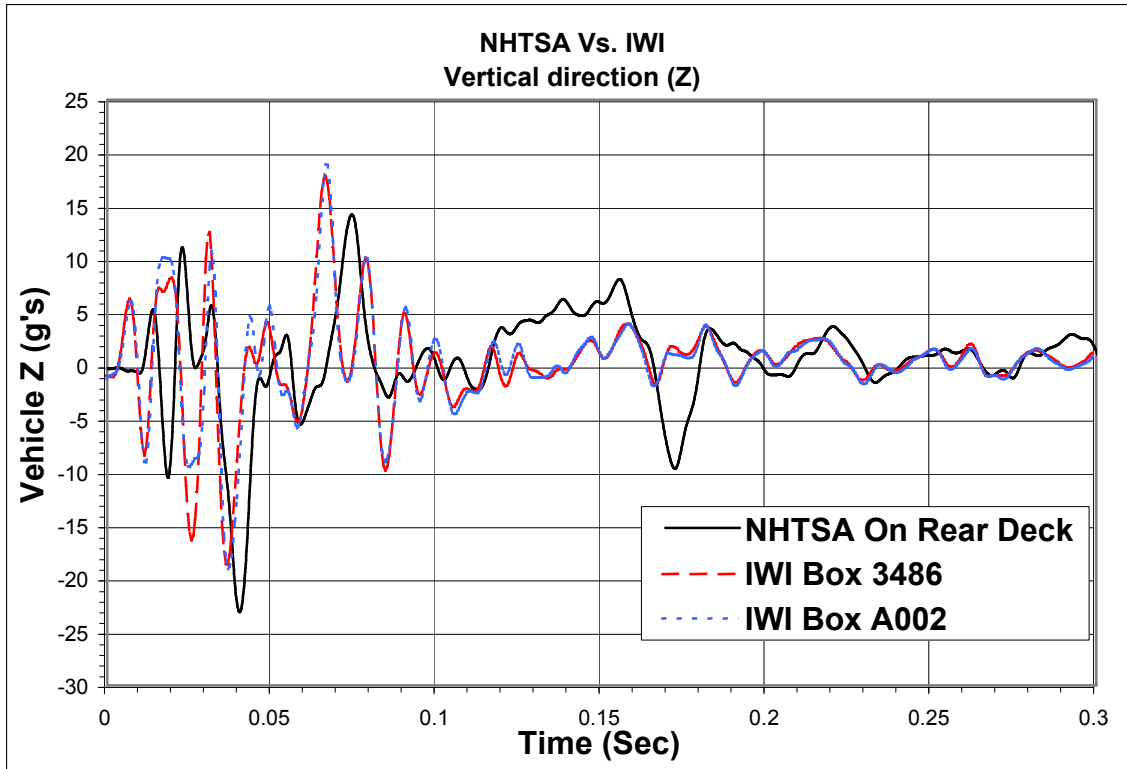
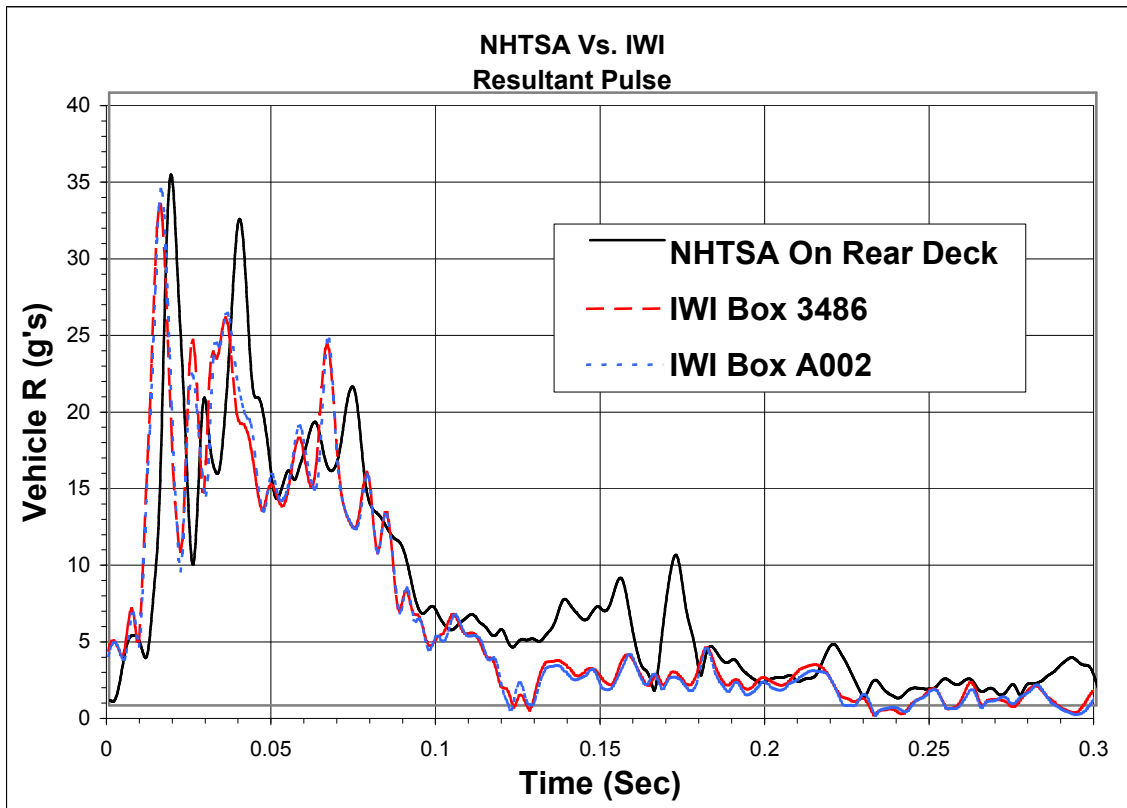
3.1.1 Compared to NHTSA accelerometers on the plate

The data from the NHTSA accelerometers and IWI data were filtered to SAE J211 Class 60 (cutoff frequency of 100 Hz).

3.1 Performance of IWI EDRs

Amongst the EDR's tested, the IWI B6 Witness units were the closest to the reference accelerometers. Both the IWI units produced virtually identical acceleration readings, and were very close to the NHTSA accelerometers except for the event trigger. The IWI boxes use a certain threshold (approx 5 g) to trigger data capture for the event, and hence, lag the reference accelerometers by a few milliseconds. The time zero for the reference accelerometers is determined by a contact switch attached to the rigid barrier. The peak values and the shape of the crash pulse recorded by the IWI EDR's were similar to those from the reference accelerometers.

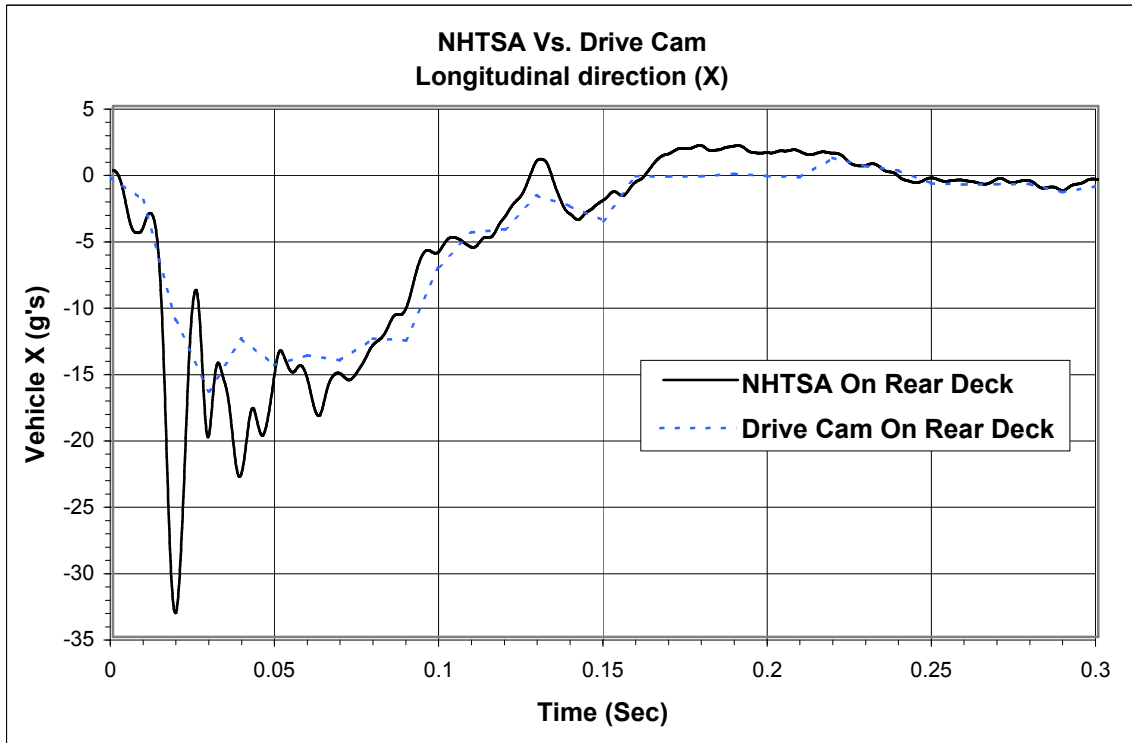
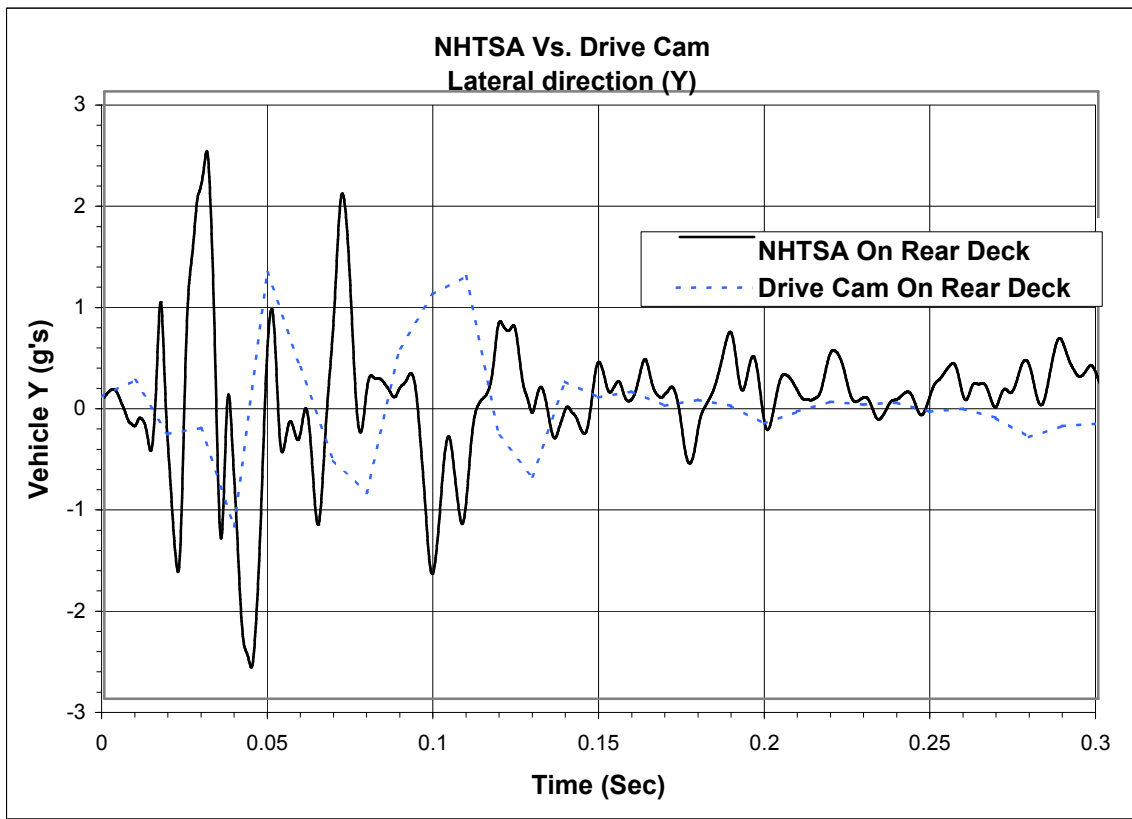
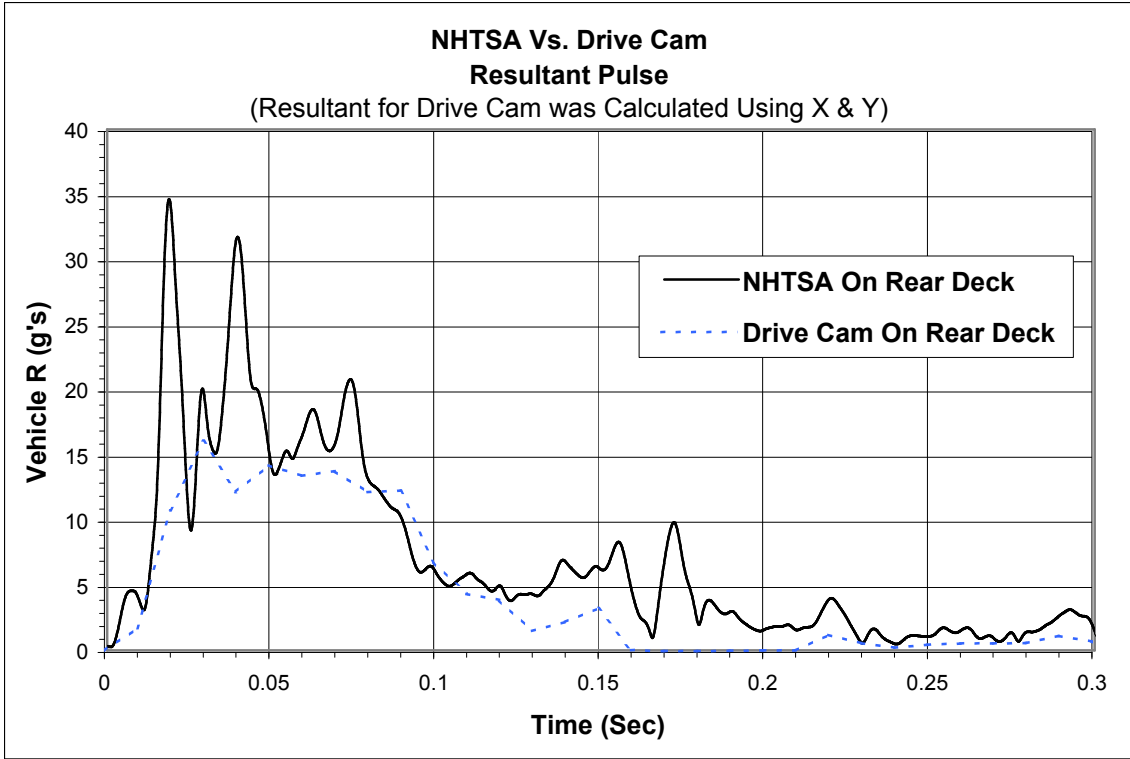
3.2.1 Compared to NHTSA accelerometers on the plate

The DriveCam units used in the crash test recorded accelerations in longitudinal and lateral directions only. The units attached to the windshield had an earlier version of the controlling software and had a lower sampling rate than the units attached to the plate in

the bed of the truck. The sampling rate of all DriveCam units tested was considered to be too low to allow accurate calculations of delta-V.

3.2 Performance of DriveCam EDRs

The DriveCam-II ver 1.5 (pre release) had lower sampling rate than the IWI EDR's. The G.Tech MACBOX devices were not developed enough to be evaluated in this study.

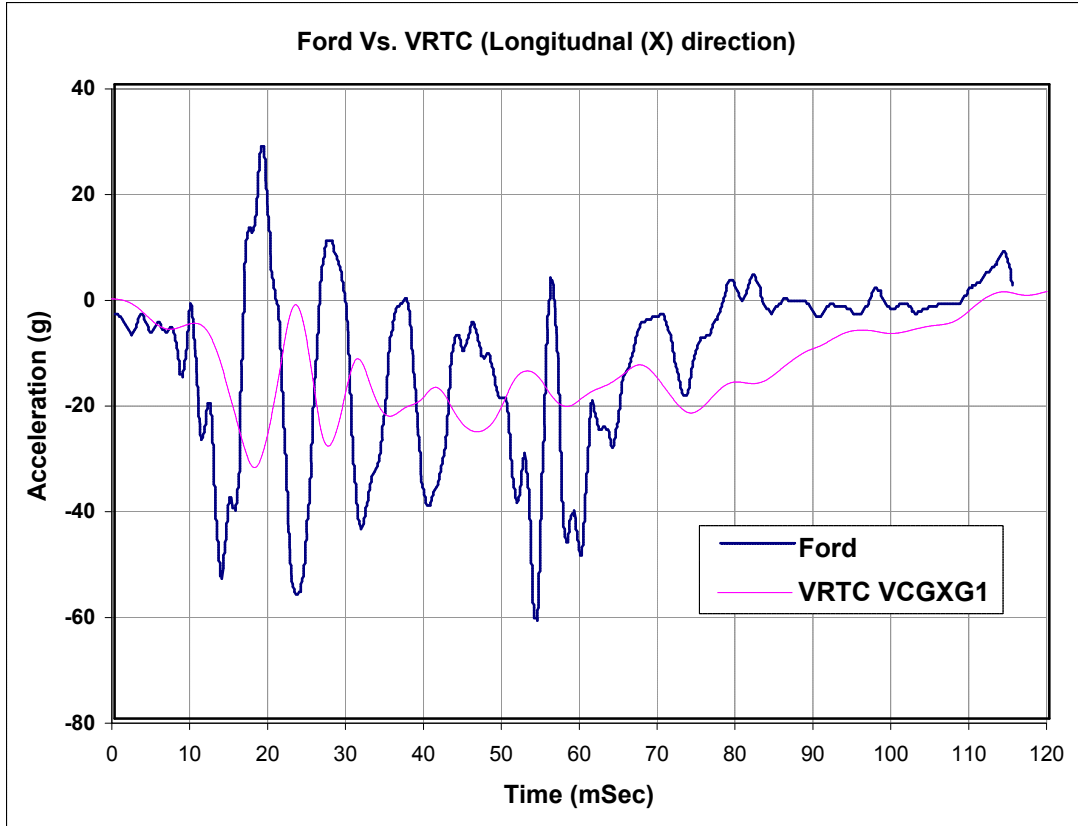
3.3 Performance of Ford OEM RCM data.

Additionally, crash pulse and delta-V data from the EDR used by Ford in the F-150 OEM Restraint Control Module (RCM) was extracted by Ford and is reproduced in the report. This RCM was located on the vehicle centerline, behind the dashboard, approximately vertically under the radio.

The crash pulse from the Ford RCM was extracted and compared to the NHTSA accelerometers at the vehicle CG.

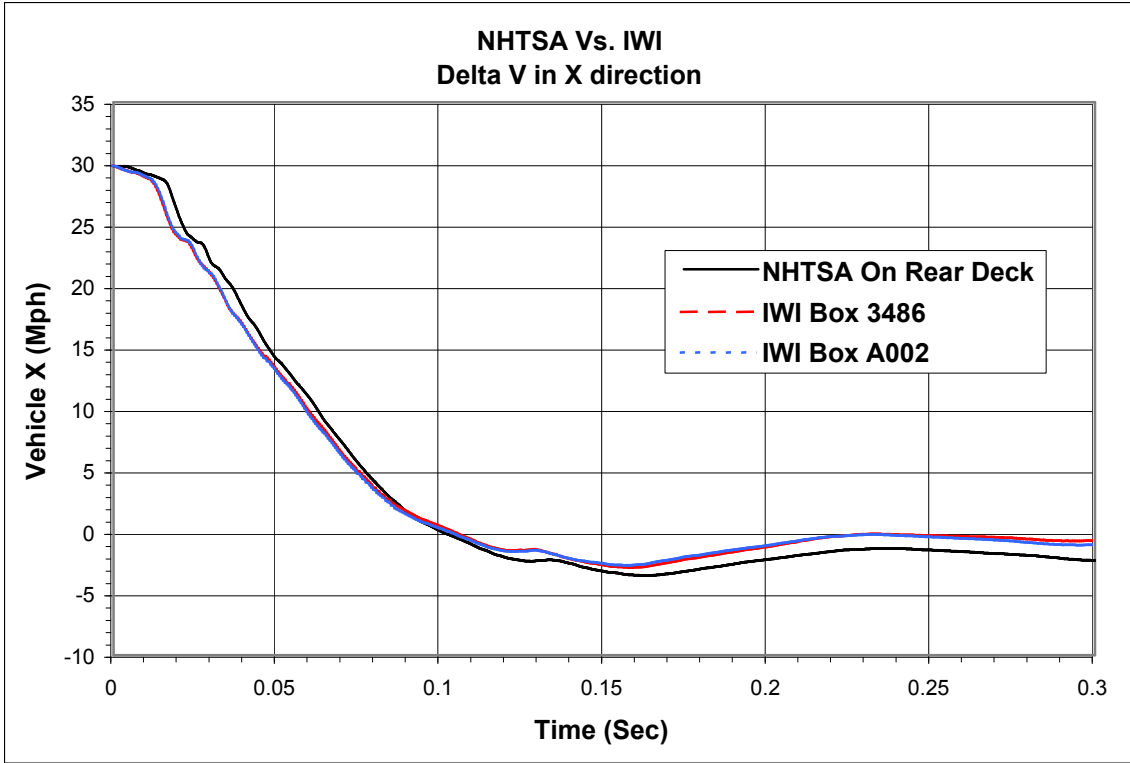
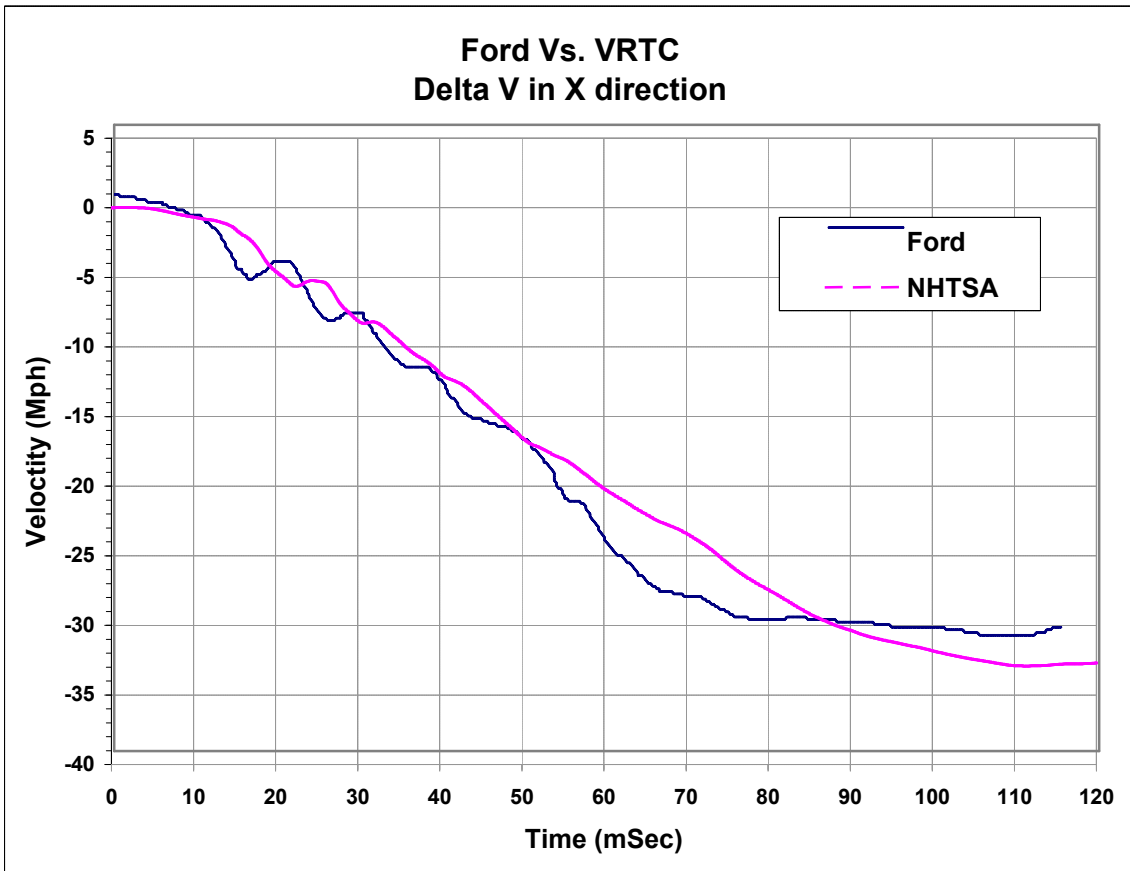
3.4 Comparison of velocities from EDR data.

Data from the IWI EDR was integrated to get the velocity-time history and compared to similar curves from the reference accelerometers on the plate. Similarly, the delta-V data was extracted from the Ford EDR and compared to the delta-V from reference accelerometers at the vehicle CG.

As previously mentioned, the sampling rate of the devices from DriveCam units tested was considered to be too low for getting accurate velocity profiles and was not included in this comparison.

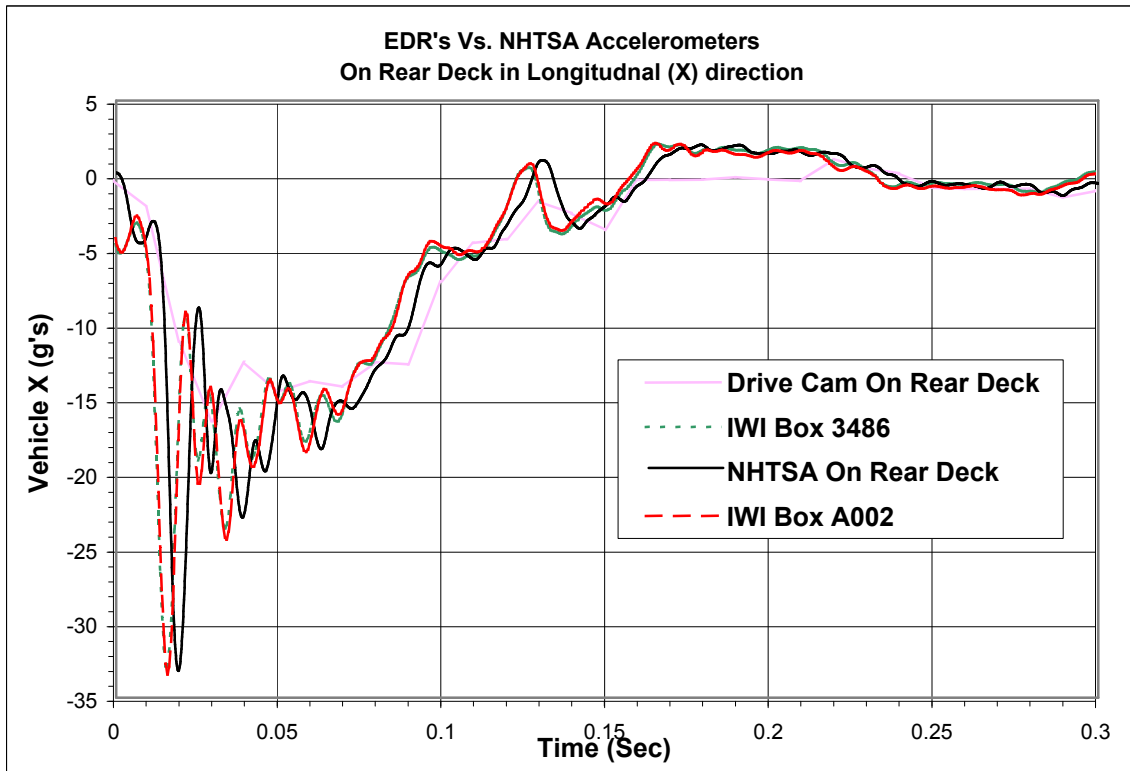
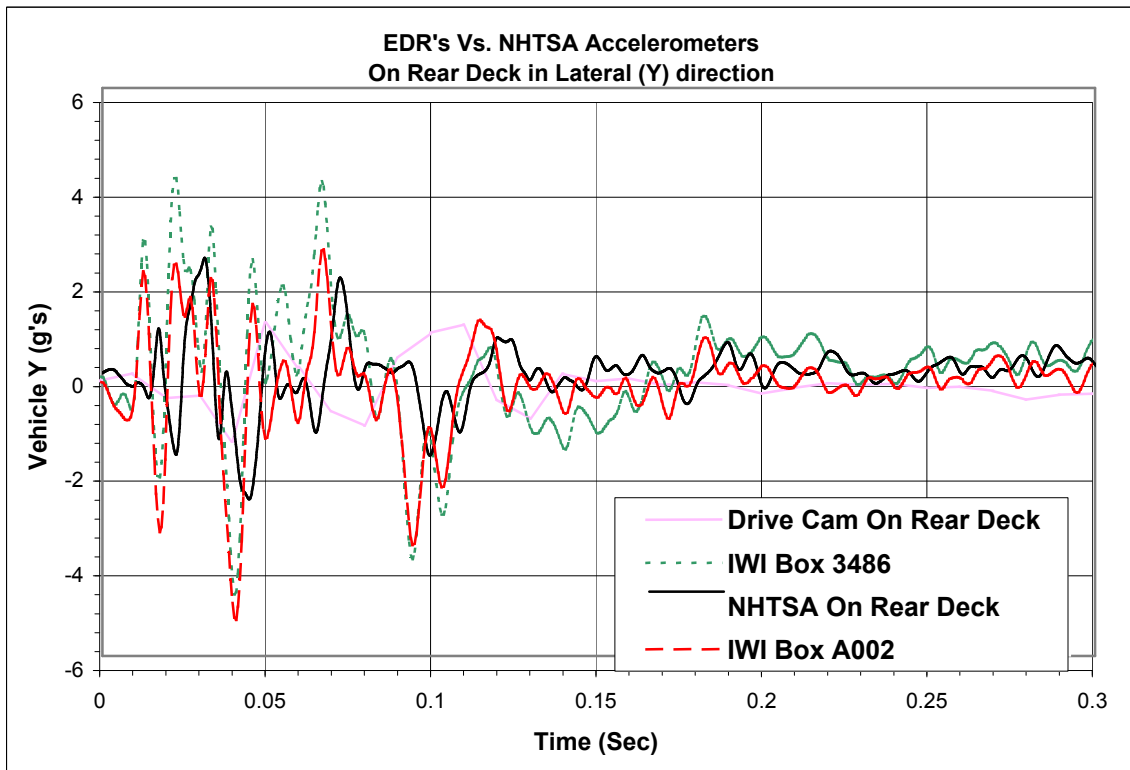
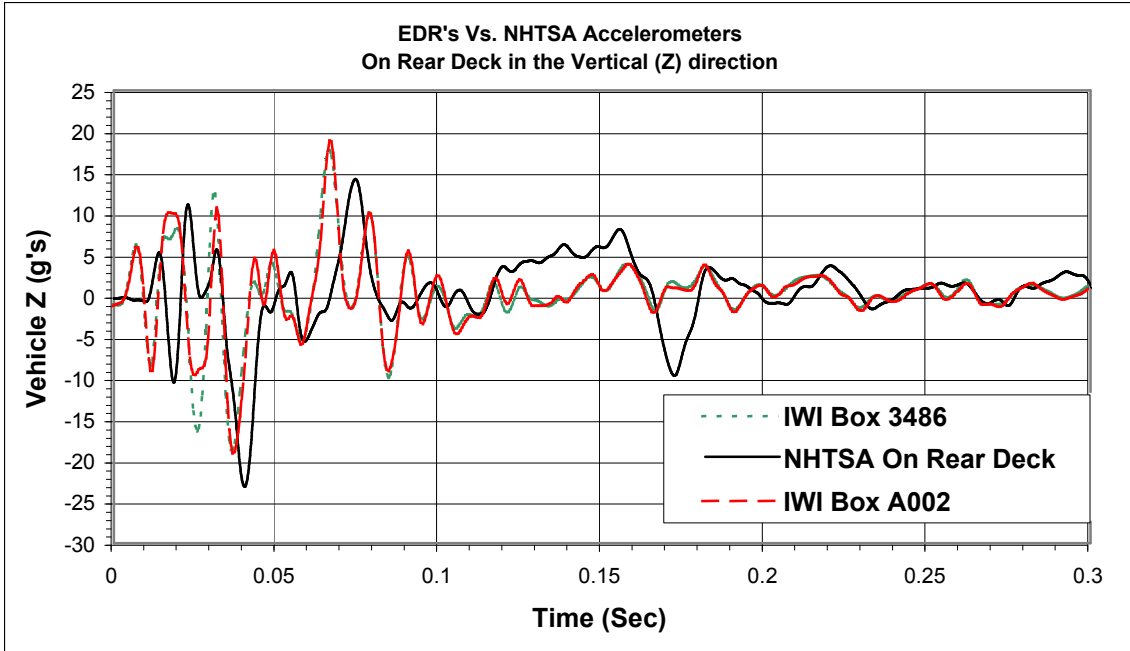
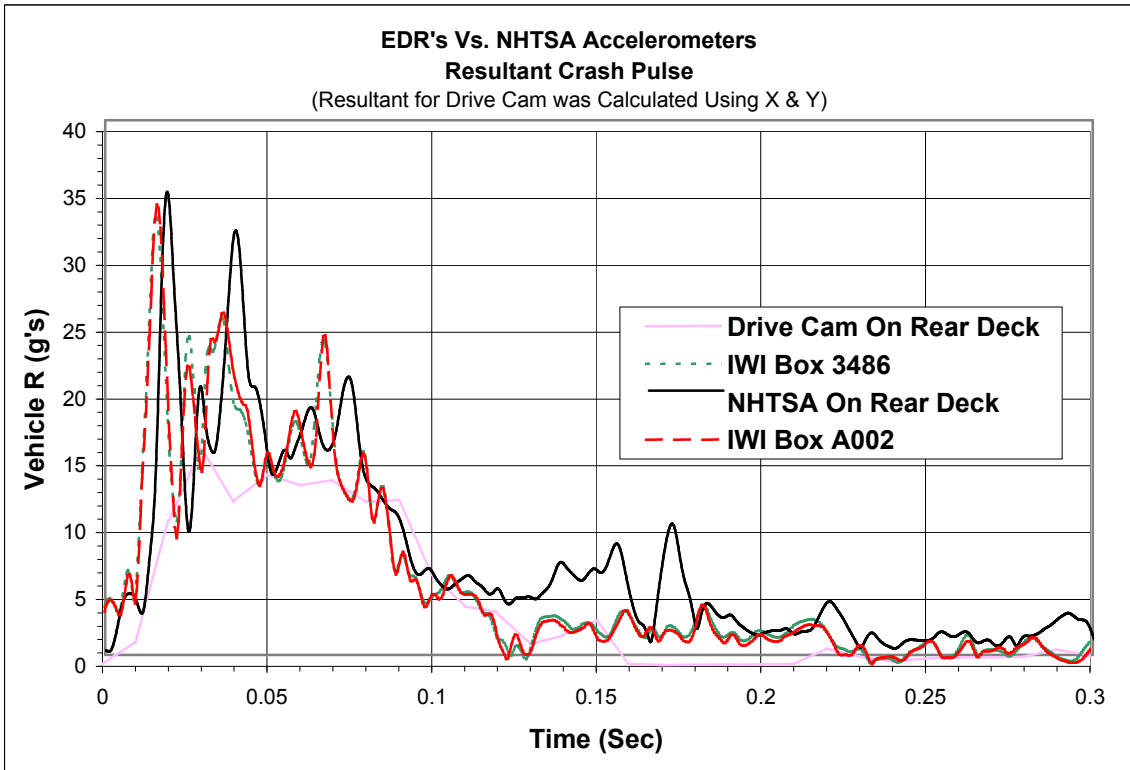
3.5 Comparison of all EDR's

A comparison of the output from the EDR's and accelerometers on the plate in the rear of the truck is presented in the following plots.

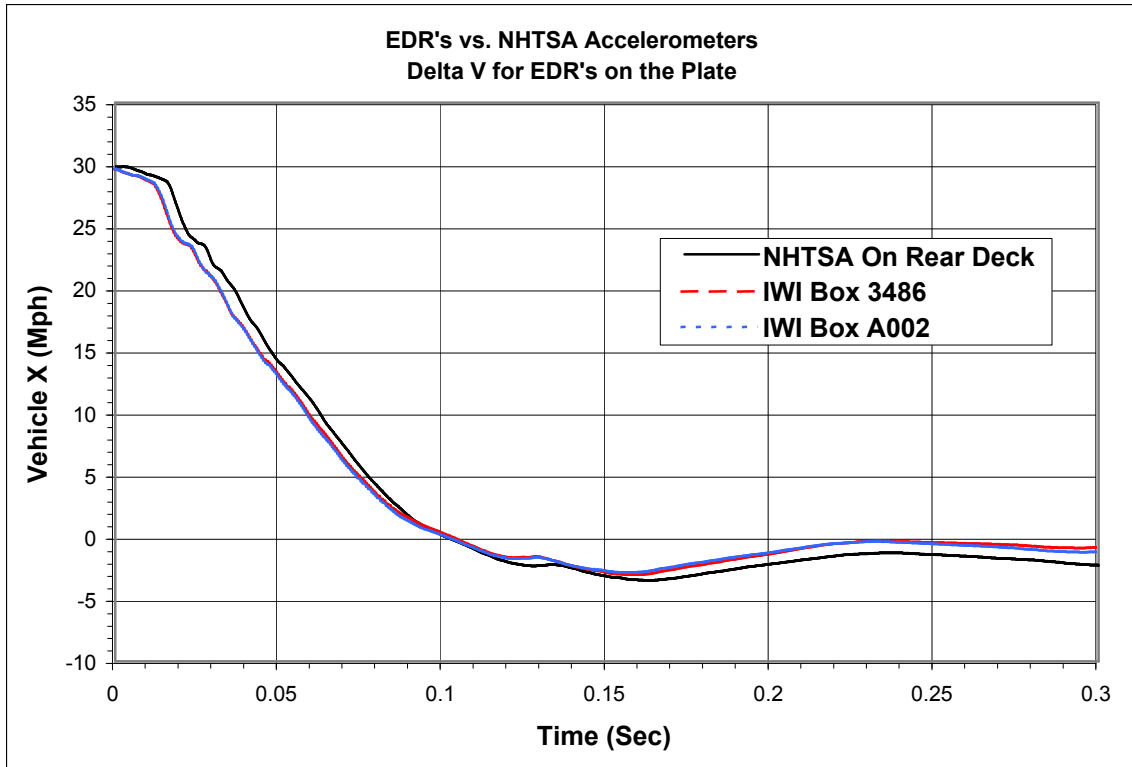
The delta-V from the EDR's on the plate is compared to those from accelerometers in the following plot. Selecting a cutoff time of 160 ms, the delta V values for NHTSA was 33.27 mph, and those from the IWI EDR's were 32.69 mph and 32.50 mph respectively. Again, the sampling rate of the DriveCam unit was considered to be too low to be able to produce comparable delta-V estimates.

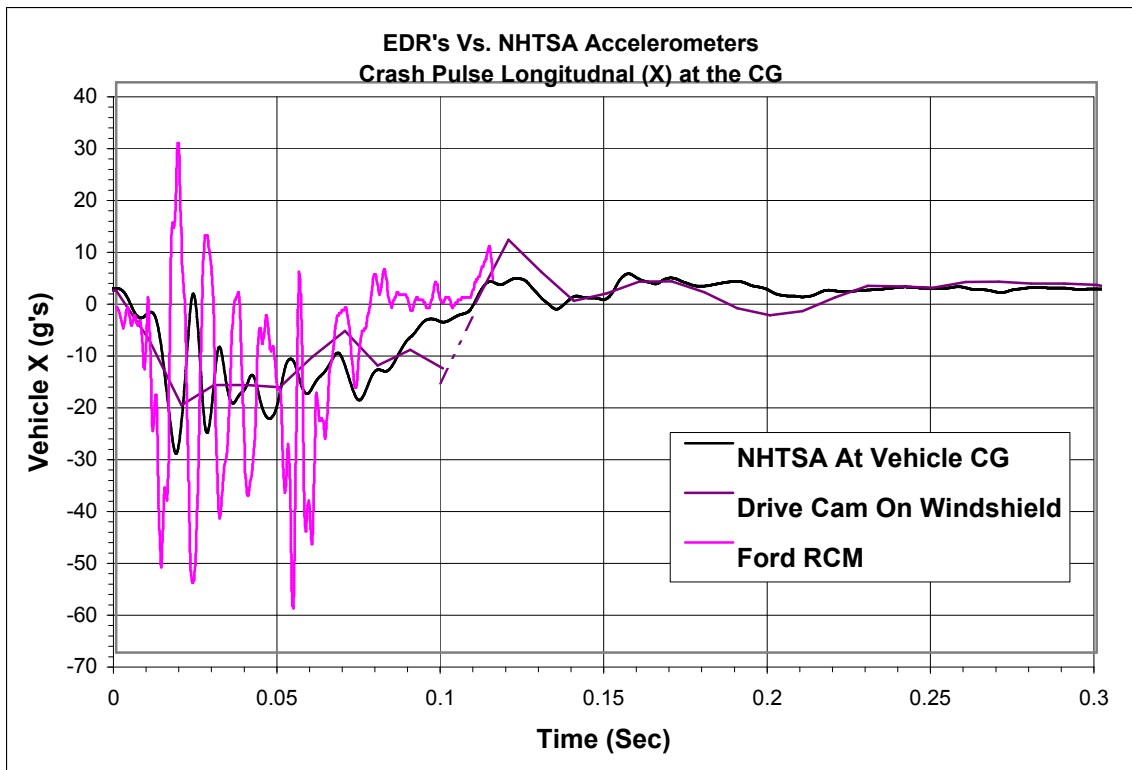
A comparison of the output from the accelerometers at the vehicle CG., DriveCam unit on the windshield, and Ford RCM module are shown for the longitudinal direction in the following plot.

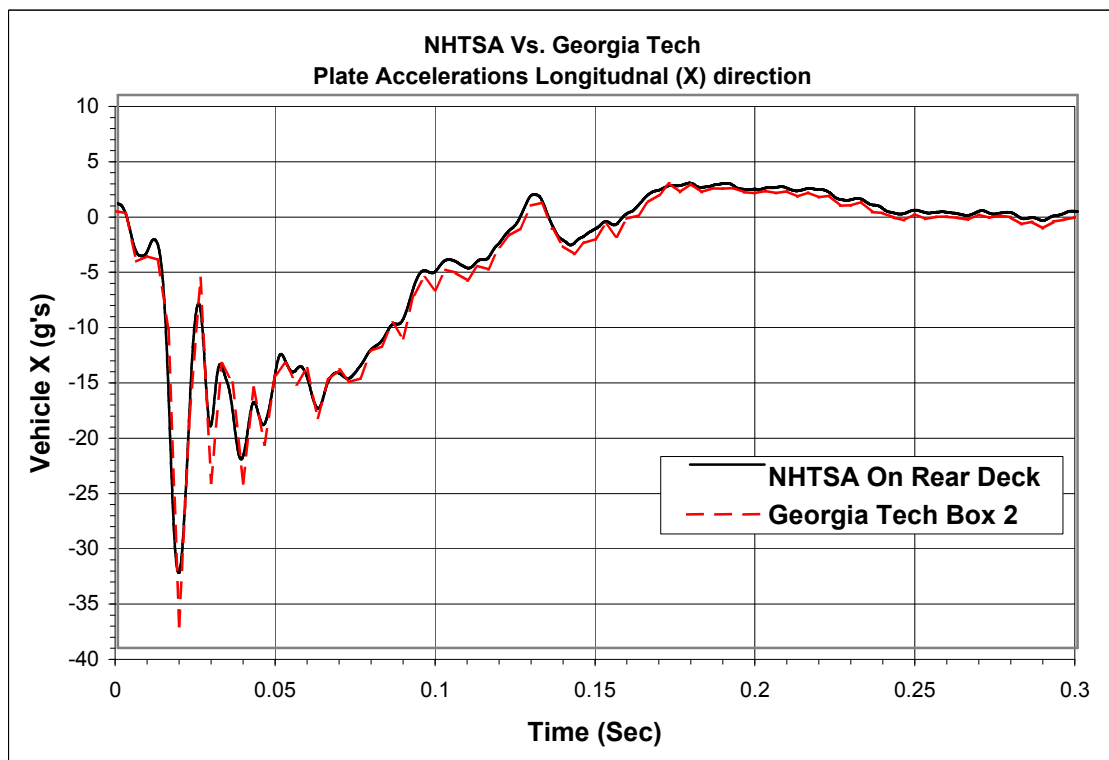
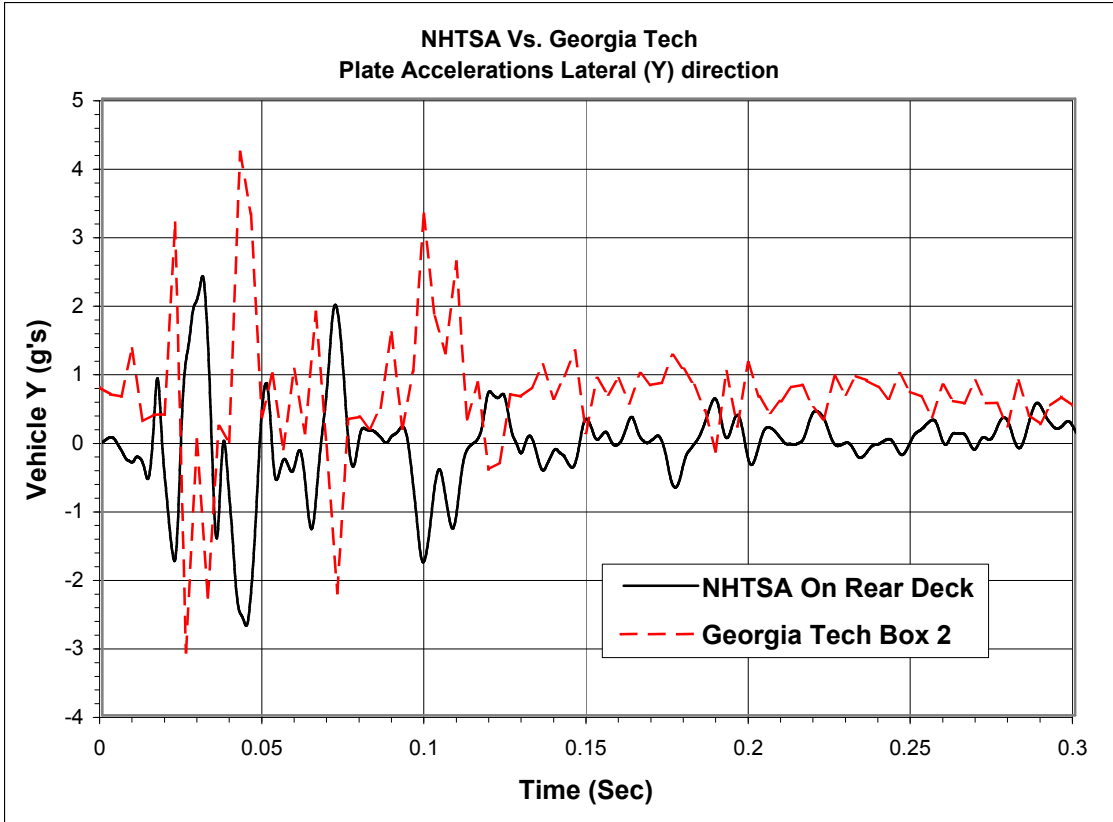
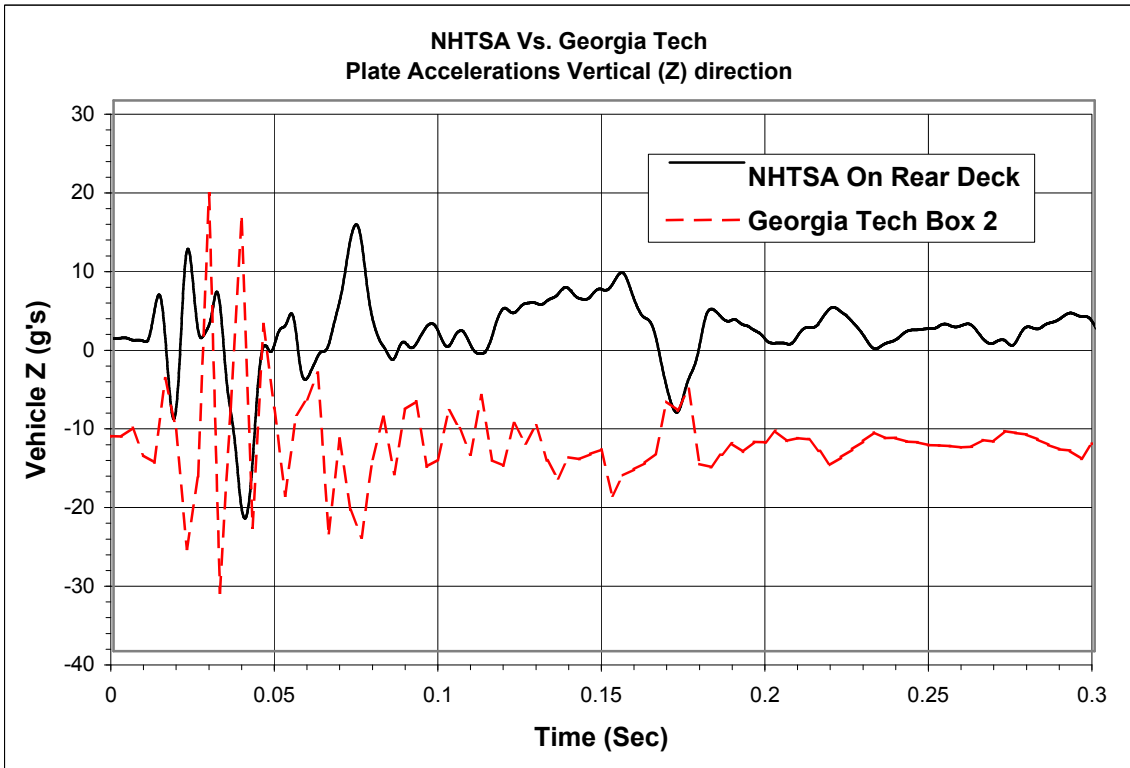
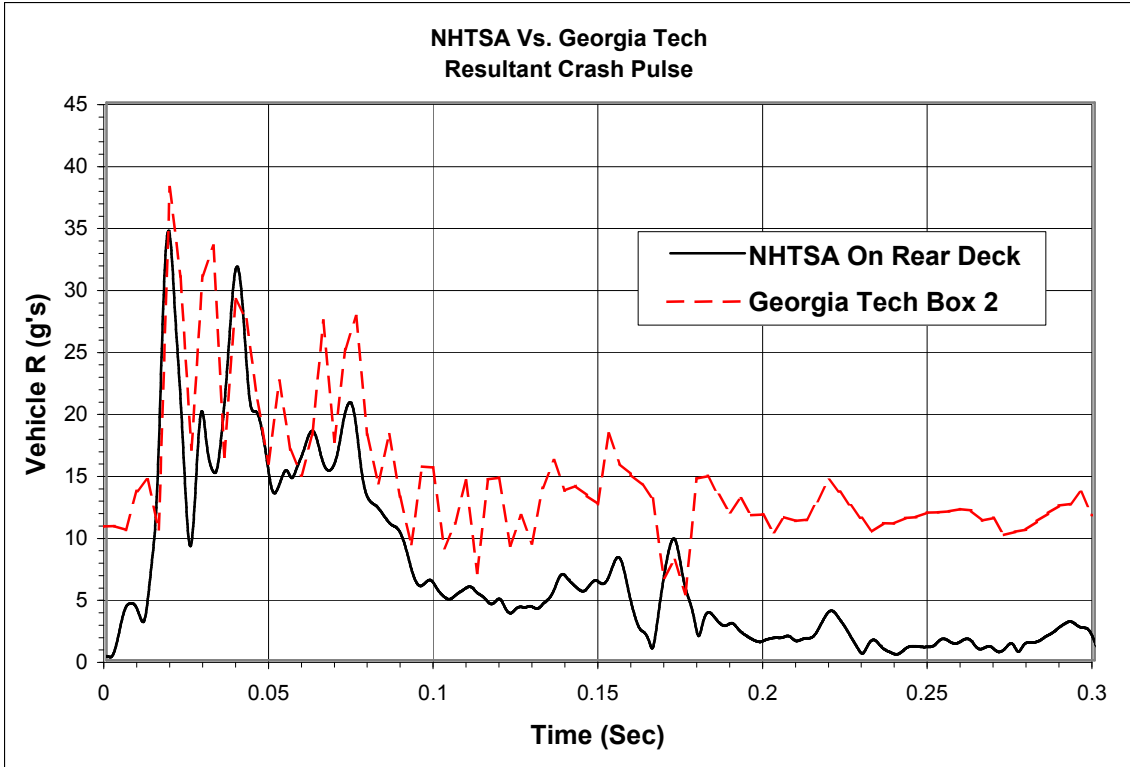
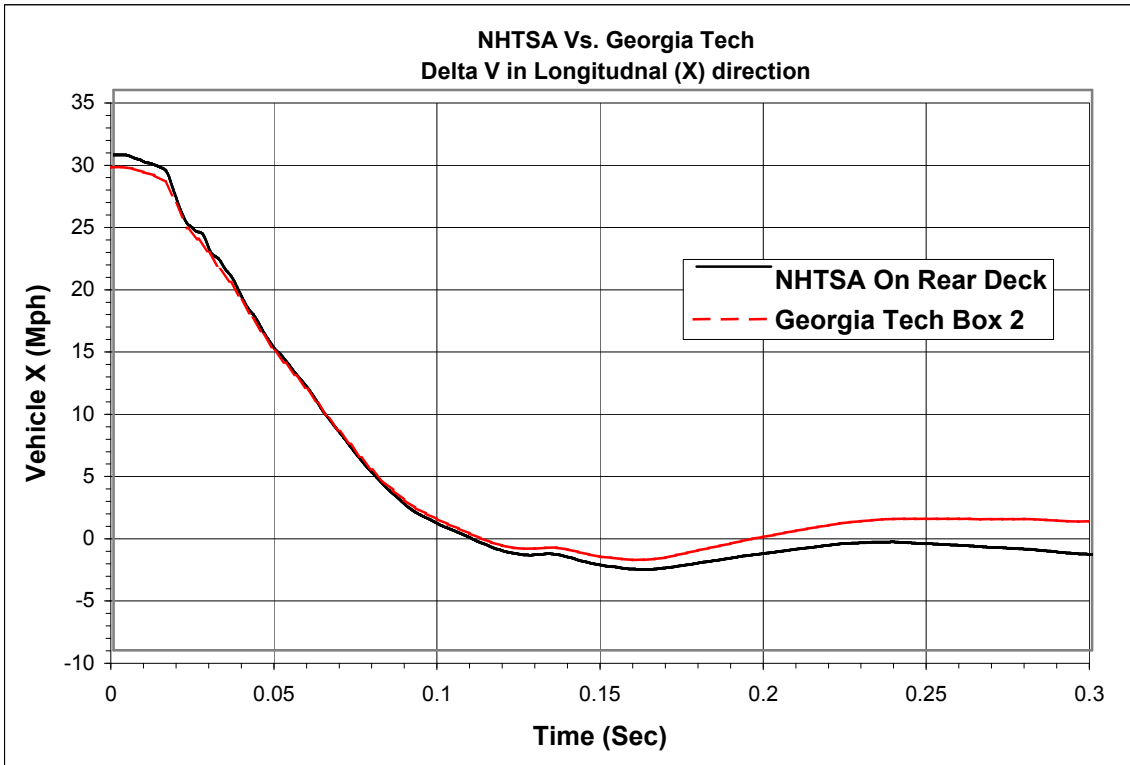
Appendix A Output from MACBOX

As of writing of this report, the data from G.Tech. EDR's (called Mobile Acceleration Crash Box or MACBOX) was not available as the development of the device was still in progress. Subsequently, some information was made available to the agency in February 2002. The output of the MACBOX, based on that information, is included in the plots below.

The data from MACBOX #1, which used automatic trigger to detect the crash event, was not considered to be representative of the crash event. Data from MACBOX #2, which was triggered manually to initiate data collection, was extracted and is shown here. The initial condition (time zero) for the data stream was determined by examining the data during post-processing.

An examination of results show that the product needs more development, especially in scaling, zero offsets and possibly polarity of the lateral and vertical (Y and Z) sensors.

As mentioned earlier in the report, the data from MACBOX EDR's were not made available to the Agency in any usable form in time for this report. Some information was provided subsequently, which allowed the data from one of the MACBOX'es (box #2, with manual trigger) to be extracted. That data is presented in Appendix A. The data from MACBOX #1, which used automatic trigger to detect the crash event, was not considered to be representative of the crash event. Both MACBOX units were still under development at the time of the crash test.
