CASE SUMMARY

PSU 79 CASE NO. 139A TYPE OF ACCIDENT car - ran off road

A. DESCRIPTION OF THE ACCIDENT SEQUENCE AND ACCIDENT PECULIARITIES

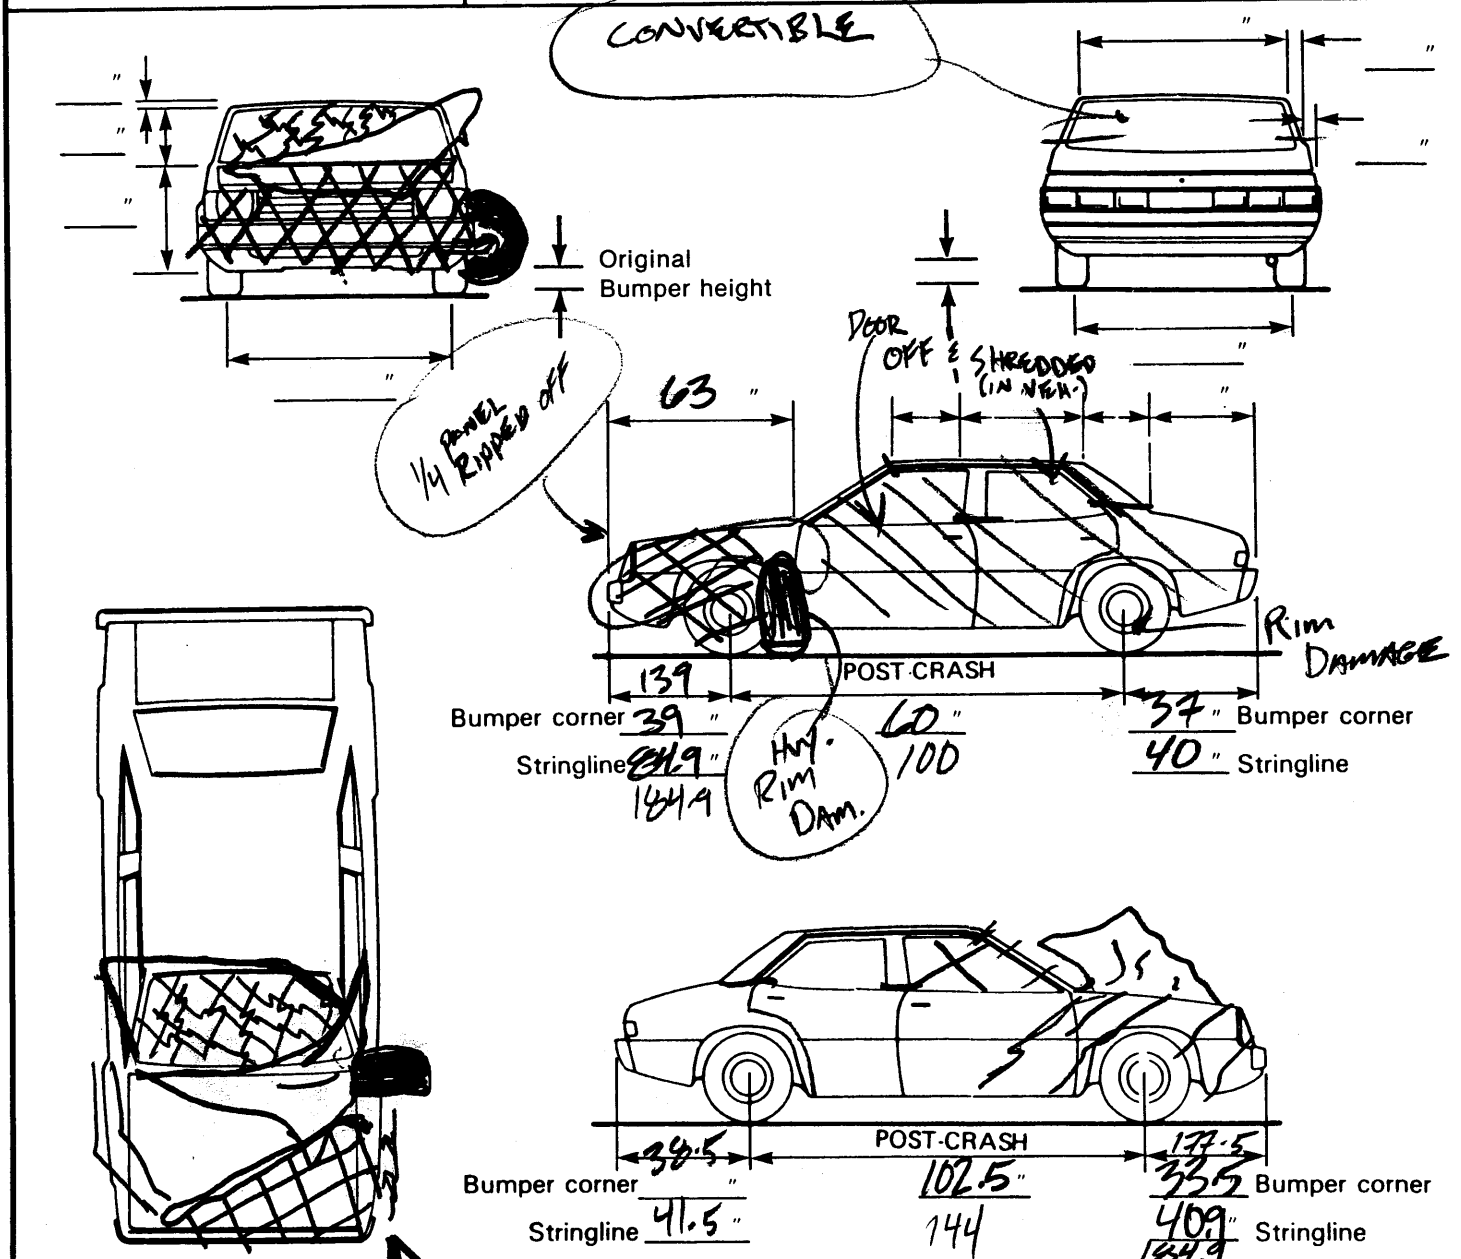
VEHICLE DAMAGE SKETCH

Specific Impact No.	Location of Direct Damage	Location of Field L
<u>5</u>	<u>ENTIRE FRONT PL CORNER INWARD</u>	
	<u>*STRONGLINE SQUARED ALONG REAR-LEFT & FRONTAL PLANES</u>

Specific Impact Number	Plane of C-Measurements	Direct Damage		Field L	C ₁	C ₂	C ₃	C ₄	C ₅	C ₆	±D
		Width (CDC)	Max Crush								
<u>5</u>	<u>Bumper</u>	<u>17.25</u>	<u>44.75</u>	<u>29.5</u>	<u>44.75</u>	<u>33.25</u>	<u>24</u>	<u>17.75</u>	<u>12</u>	<u>8</u>	
	<u>-F.S.</u>		<u>2</u>		<u>2</u>	<u>1</u>	<u>0</u>	<u>0</u>	<u>1</u>	<u>2</u>	
	<u>RESULT</u>		<u>42.75</u>		<u>42.75</u>	<u>32.25</u>	<u>24</u>	<u>17.75</u>	<u>11</u>	<u>6</u>	
	<u>-ADJ. for bumper</u>		<u>-.25</u>		<u>.25</u>	<u>.25</u>	<u>.25</u>	<u>.25</u>	<u>.25</u>	<u>.25</u>	
	<u>RESULT</u>		<u>42.50</u>		<u>42.50</u>	<u>32.00</u>	<u>23.75</u>	<u>17.50</u>	<u>10.75</u>	<u>5.75</u>	<u>0.25</u>
	<u>OVERLAPPING DAM.</u>										
	<u>MUL. IMPACTS</u>										
	<u>*IMPACTS 2-5+5 OVERLAP</u>

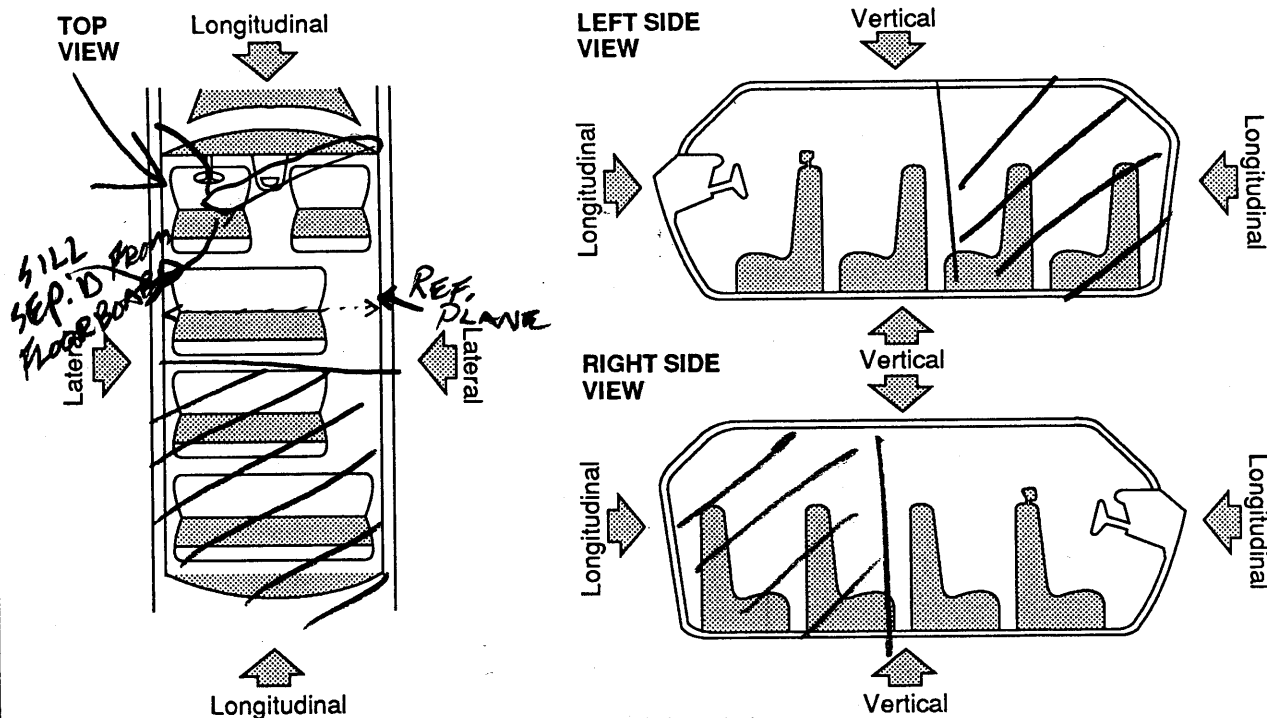
INTRUSION WORK SHEET

LOCATION OF INTRUSION	INTRUDED COMPONENT	COMPARISON VALUE	-	INTRUDED VALUE	=	INTRUSION	DOMINANT CRUSH DIRECTION
LF	L. DASH	0	-	24	=	24 ①	LONG.
	'A'	0	-	23	=	23 ④	"
	SILL		-	42	=	24 ②	LAT.
	F. OF 'A'		-	38	=	724 ③	"
	S. ASS.	50	-	70	=	20 ⑤	LONG.
CP	S. ASS.		-		=		LAT.
	DR. SEAT	24	-	27	=	3 ⑧	LAT.
	DASH	0	-	12	=	12 ⑥	LONG.
LF	W/S HEADER	0	-	8	=	8 ⑦	LONG
CP	"	0	-	4	=	4 ⑨	"
	XXXXXXXXXXXXXXXXXXXX		-		=		
			-		=		
			-		=		
			-		=		
			-		=

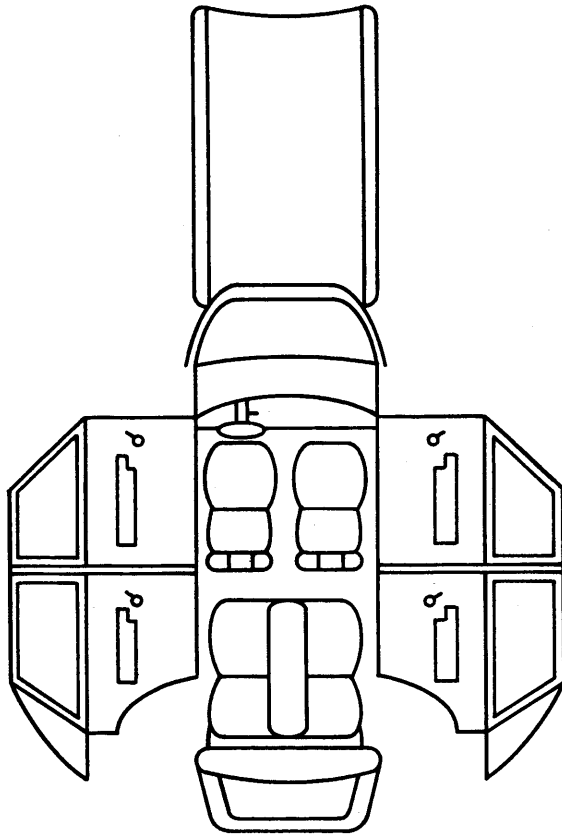
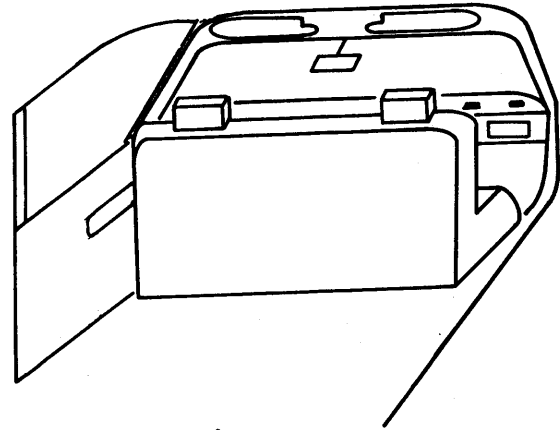
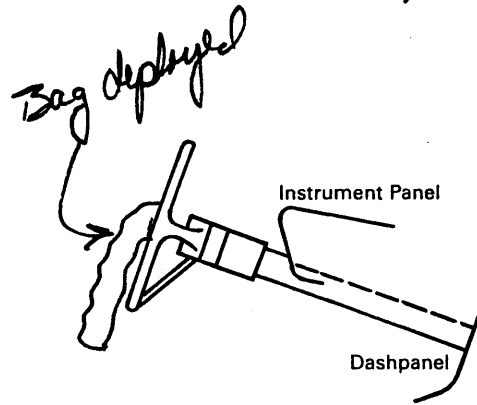
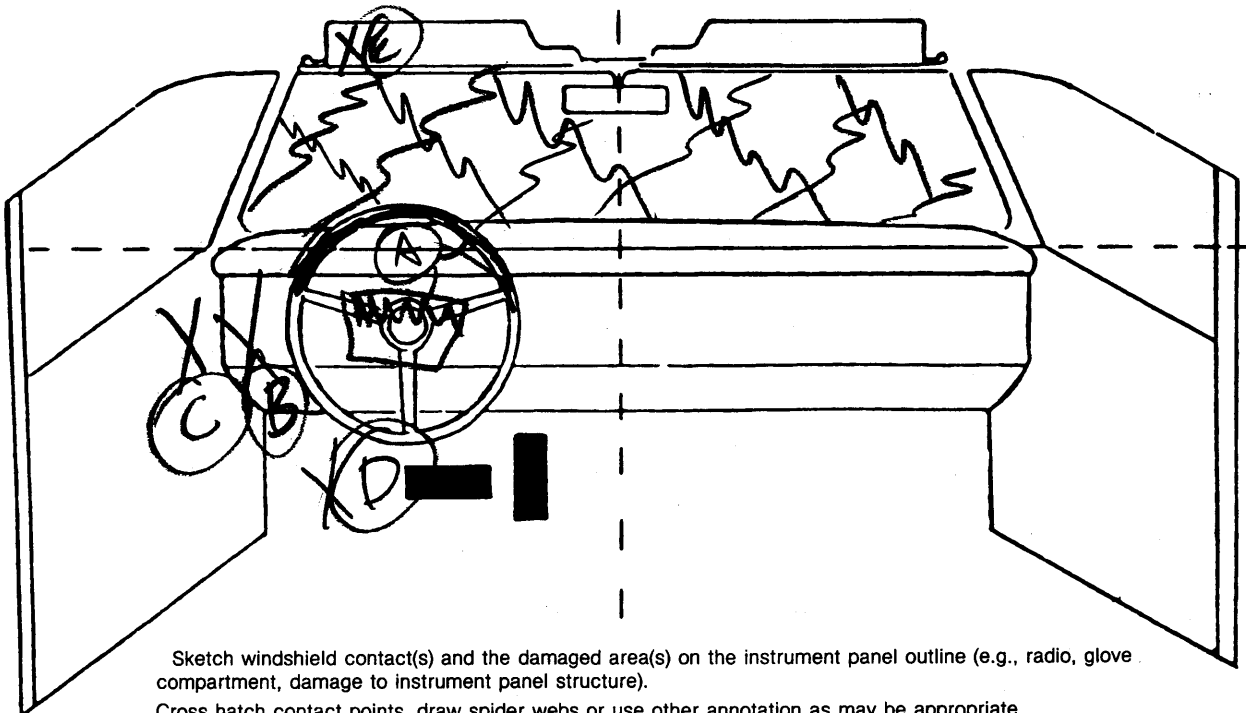
VEHICLE INTERIOR SKETCHES

Sketch windshield contact(s) and the damaged area(s) on the instrument panel outline (e.g., radio, glove compartment, damage to instrument panel structure).
Cross hatch contact points, draw spider webs or use other annotation as may be appropriate.
Annotate the contacted area with a letter (begin with A) and list on the Points of Occupant Contact page.

Contact	Interior Component Contacted	Occupant No. If Known	Body Region If Known	Supporting Physical Evidence	Confidence Level of Contact Point
A	S/W K/S	1	TORSO	DEMOLISHED BY IMP.	1
B	DR. DASH	1	KNIVES	RUSTED PLASTIC INT.	1
C	DR. DOOR	1	DR. SIDE	PADDED SIDE OF DOOR BENT	1
D	TOE PAN	1	LEG/FEET	SUSPECTED	2
E	SUN VISOR/S	1	HEAD	DENTED	2
F	<p>MASSIVE INTRUSIONS & WEATHER MASKS OCC. CONTACT POINTS</p>				
G					
H					
I					
J					
K					
L					
M					
N

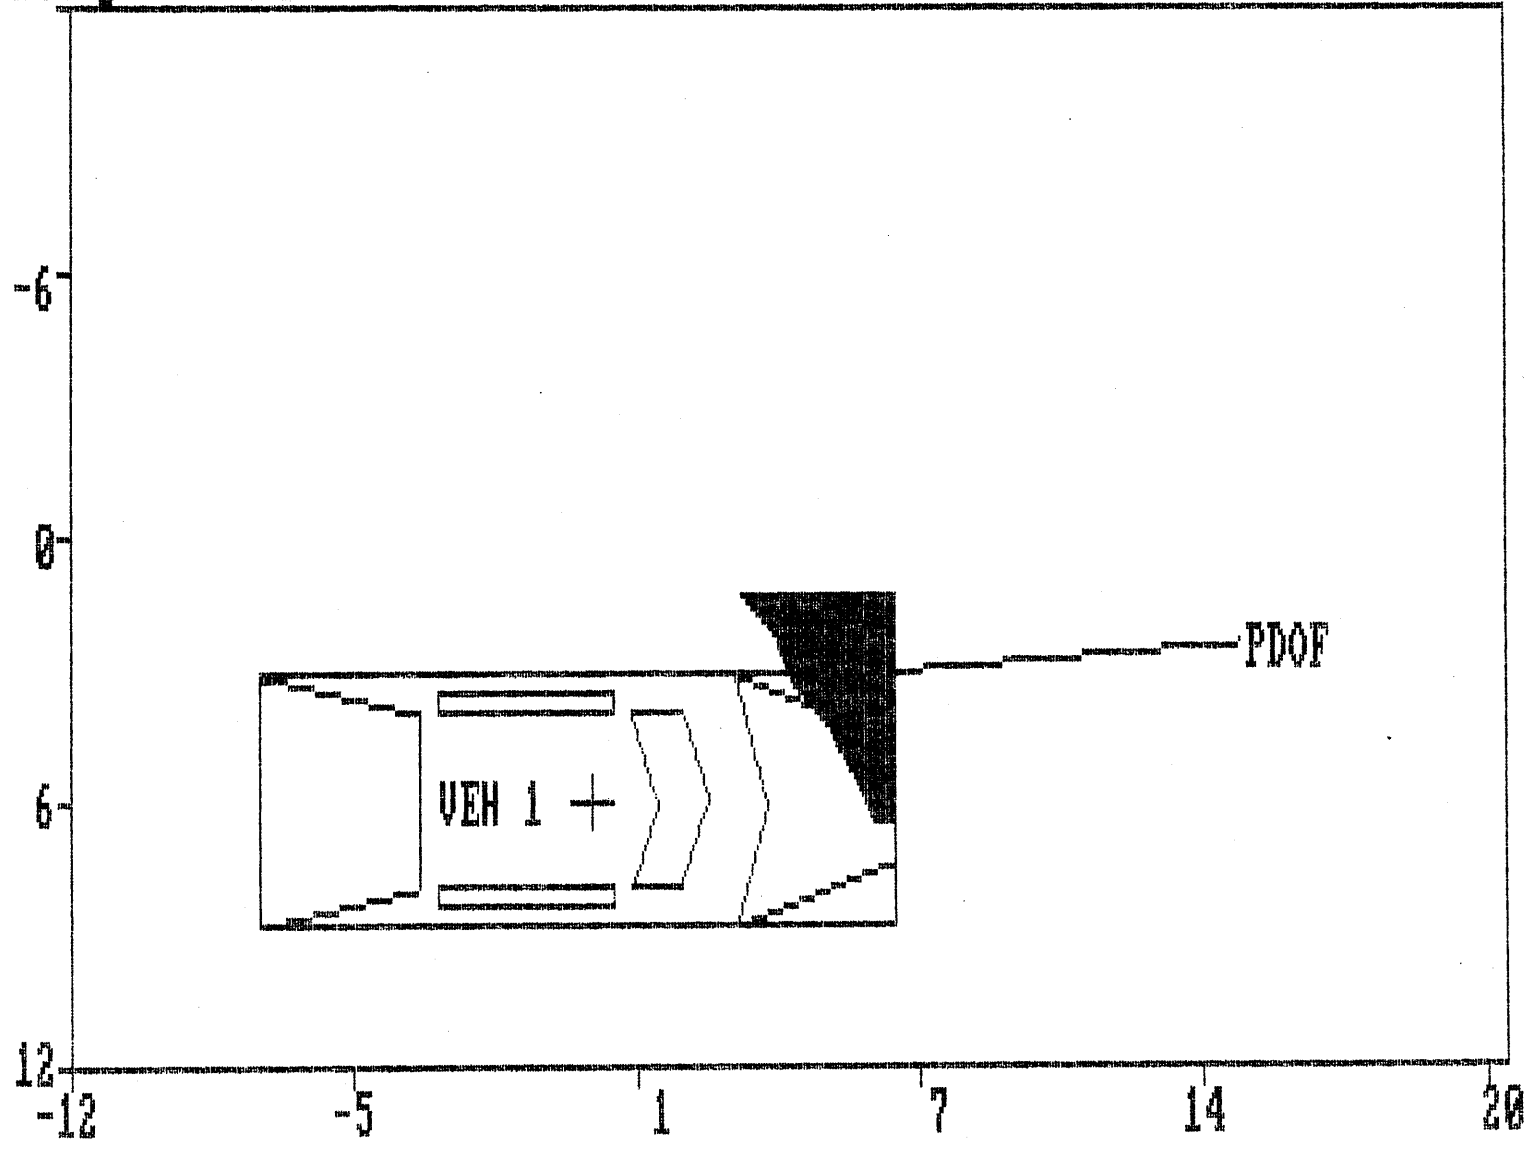
CRASH

SPEED CHANGE (DAMAGE)	VEH #1	TOTAL (MPH)	LONG. (MPH)	LAT. (MPH)	ANG. (DEG)
	VEH #1	29.6	-29.5	2.6	-5.0
	VEH #2	.0	.0	.0	.0

ENERGY DISSIPATED BY DAMAGE VEH#1:113766.6 FT-LB VEH#2: .0 FT-LB

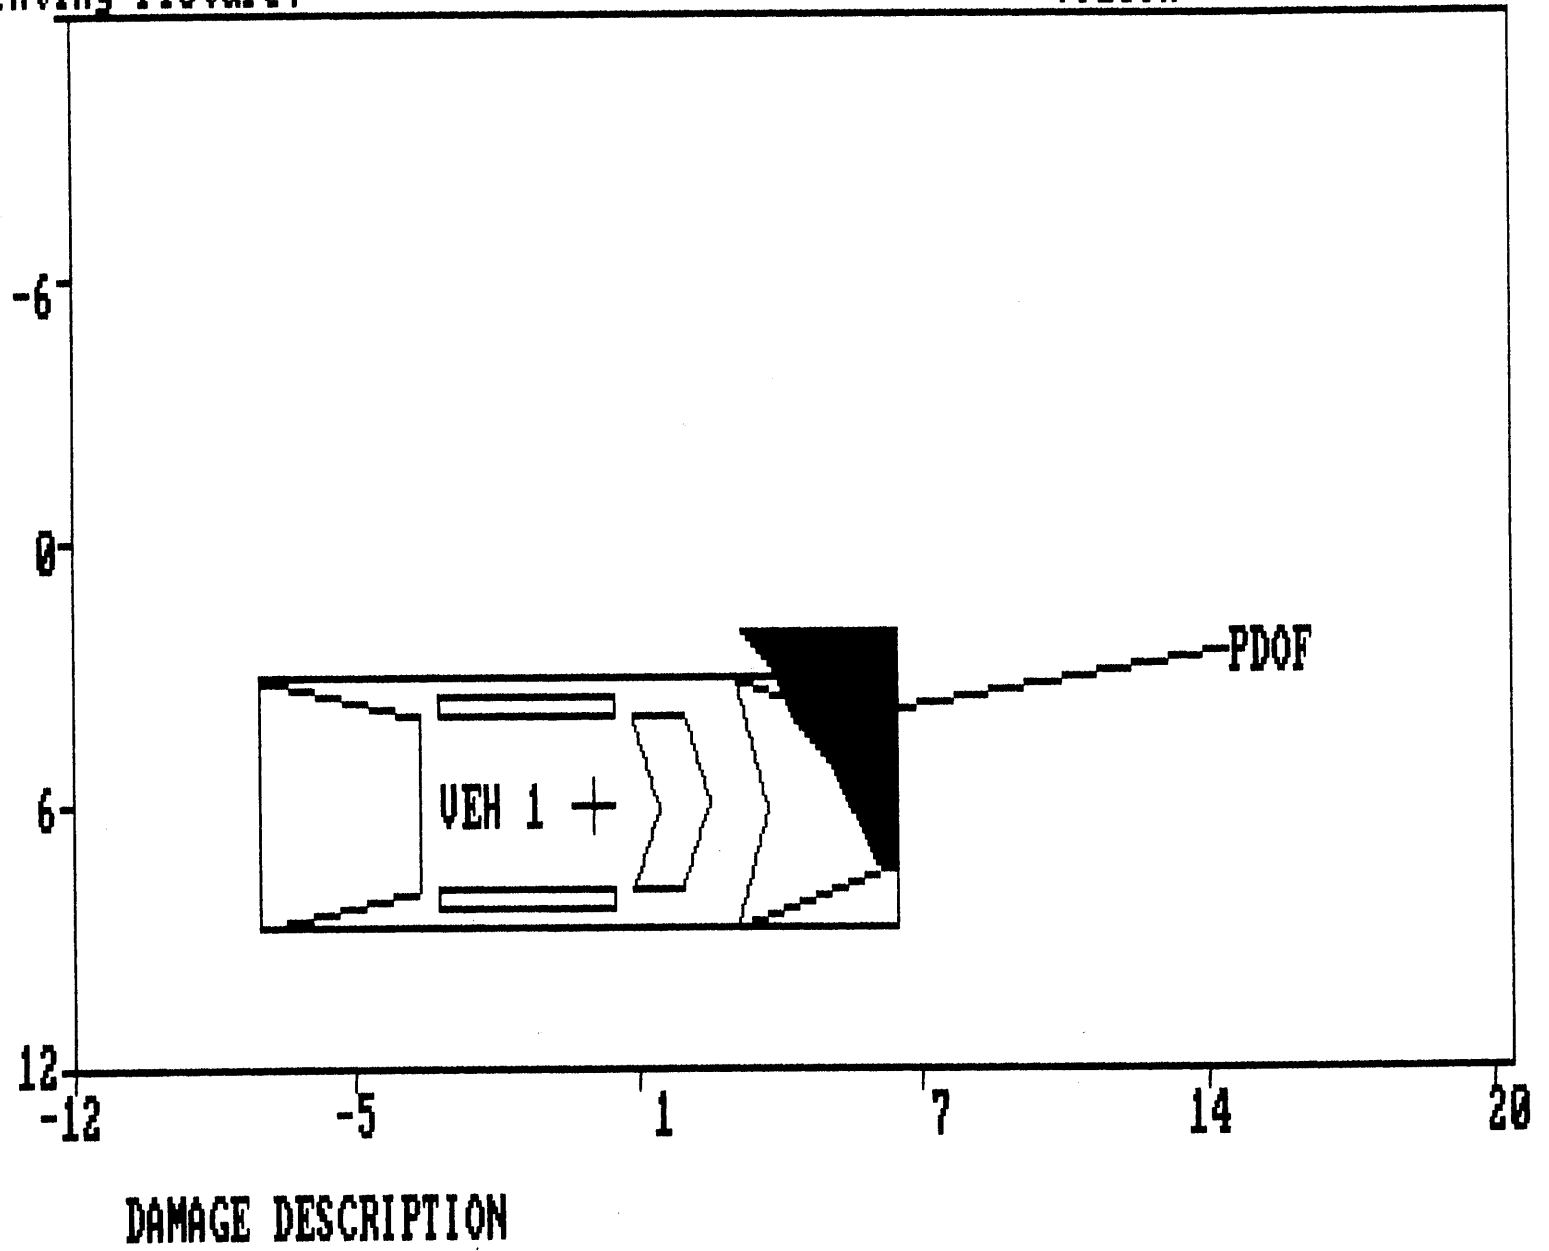
79139A

IMPACT SPEED (DAMAGE AND SPINOUT)		TOTAL (MPH)	LONG. (MPH),	LAT. (MPH)	
	VEH #1	47.2	47.2	.0	
	VEH #2	.0	.0	.0	
SPEED CHANGE (DAMAGE)		TOTAL (MPH)	LONG. (MPH)	LAT. (MPH)	ANG. (DEG)
	VEH #1	33.5	-33.0	5.8	-10.0
	VEH #2	.0	.0	.0	.0

ENERGY DISSIPATED BY DAMAGE VEH#1:116412.6 FT-LB VEH#2: .0 FT-LB
