SIMA SAN DIEGO USES ANTI-VIBRATION SANDERS TO PREVENT HAND ARM VIBRATION SYNDROME

Repair technicians in the Antenna Shop at the Shore Intermediate Maintenance Activity (SIMA), Naval Amphibious Base, Coronado, CA

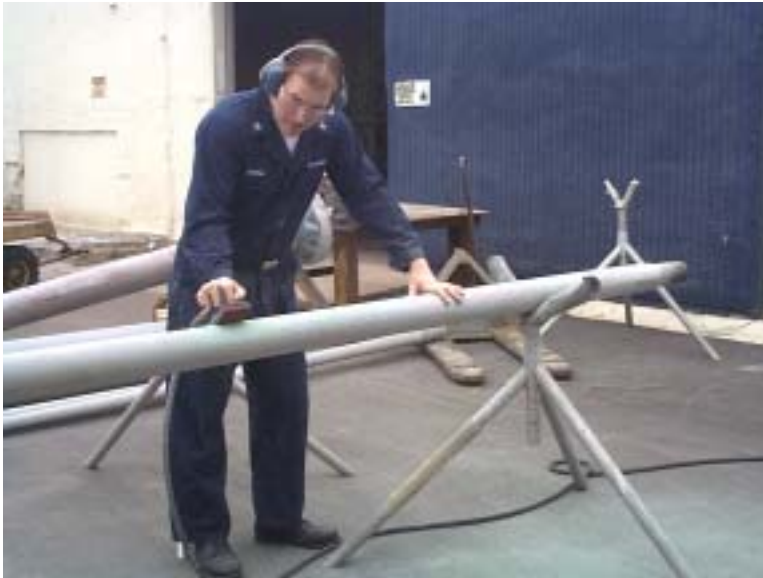
Antenna Shop personnel using a jitterbug sander that was not designed to be ergonomic or low in vibration to prepare an antenna for painting

Repair technicians use pneumatically-powered *jitterbug* sanders for the job. The *jitterbug* sander is a type of orbital sander that is

typically used with one hand. These sanders are designed to sand surfaces to a smooth, fine finish. The basic feature is a rectangular pad which is covered with abrasive paper. The abrasive paper is driven round in small orbits on the pad. When Antenna Shop technicians reported numbness and tingling in their hands and fingers after a few hours of using a *jitterbug* sander, Mr. Alec Wong, an Industrial Hygienist with the Naval Medical Center San Diego (NMCS) assigned to provide industrial hygiene services to SIMA, suspected that the workers were being overexposed to hand-arm vibration while using the *jitterbug* sanders.

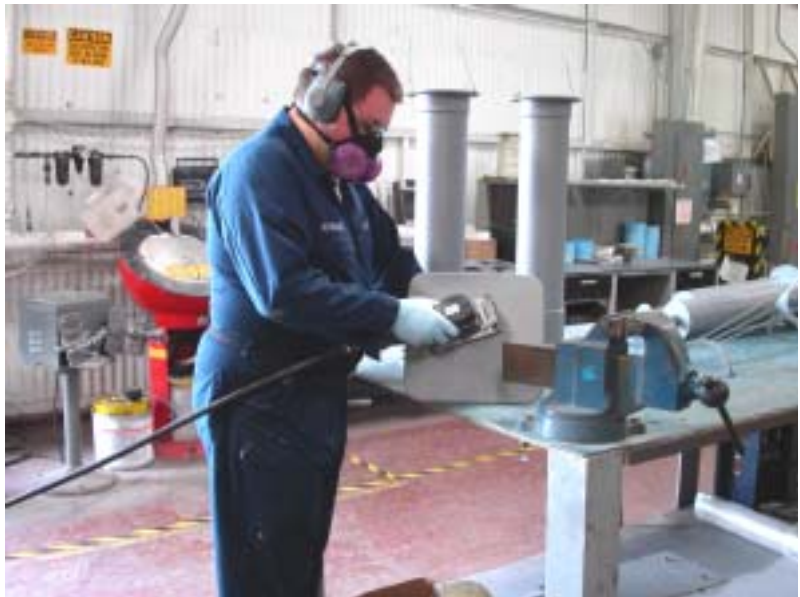
Worker uses the ergonomically designed jitterbug sander to prepare surface for painting.

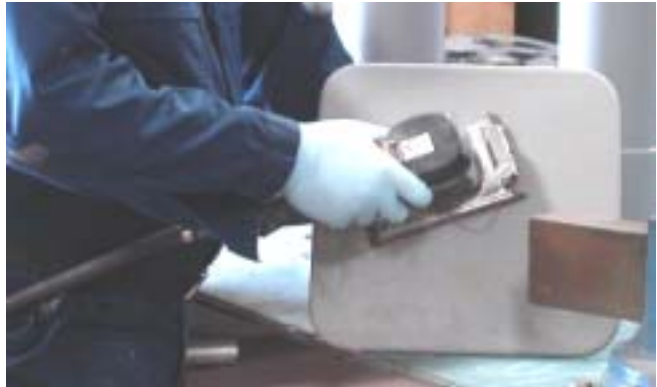
Anti-vibration jitterbug sander prevents HAVS and is most comfortable for SIMA's Antenna Shop.

Ms. Estrada and Mr. Wong were instrumental in acquiring and evaluating four *jitterbug* sanders equipped with vibration damping as well as other comfort and safety features. The Antenna Shop repair technicians evaluated the demonstration sanders to determine which they preferred. At the same time, the industrial hygienists measured the vibration exposure of each of the demonstration sanders. One of the four test sanders demonstrated the least transfer of vibration to the hands and arms of the repair technicians who tested them. The model that generated the lowest vibration levels was also the sander that the technicians had identified as the most comfortable to use. The industrial hygienists used the vibration measurement data and the workers' preferences to determine which sander to purchase as replacements for the *jitterbug* sanders with an unacceptable vibration level. The model of sander that had been shown to generate the least vibration was determined to be the best overall *anti-vibration jitterbug* sander for the shop; the Navy's Hazard Abatement Program funded ten new sanders for SIMA's Antenna Shop.

Since the new *anti-vibration jitterbug* sanders have been in use, Antenna Shop repair technicians have reported that they no longer experience numbness or tingling in their hands or fingers during or after sanding. As an added bonus, the shop supervisor reported that Antenna Shop productivity has improved due to the new sanders' larger sanding surfaces and the increased comfort of the technicians who use them.
