INDUSTRIAL HYGIENE TEAMS WITH PWC TO EXPEDITE RAILCAR RESTORATION AT NWS EARLE

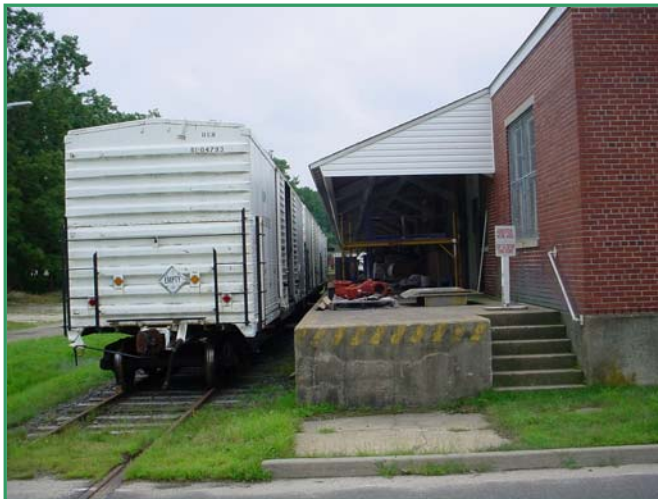
Railcars await repair outside PWC building, NWS Earle

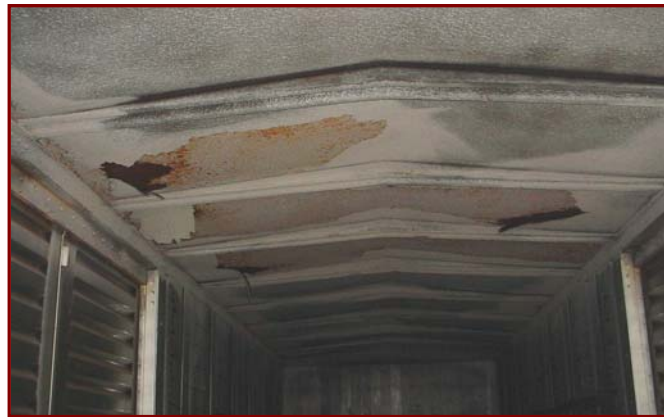
inspection due to deterioration of their ceilings. The ceilings had originally been covered with an adhesive tar material that, over time, had begun to crack and corrode. Since the work involved surface repair, Public Works recognized that before restoring those railcars, NWS Earle needed an industrial hygiene assessment to determine whether the ceiling materials contained asbestos, which could present a health hazard if disturbed. Industrial

Damaged ceiling tiles in railcar in need of repair

When the train cars pulled up at the building, the workers, wearing full-body protective clothing and respiratory protection, vacuum cleaned the cars with industrial vacuum cleaners fitted with special filters that prevent the release of asbestos fibers into the environment. After vacuuming, the workers placed protective plastic sheeting on the floor of the car and sprayed water onto the ceiling, soaking it thoroughly to saturate any

asbestos, minimizing the risk of releasing asbestos fibers into the air. Then, they scraped the damaged ceiling area clean. At the end of each work shift, the workers sealed the plastic sheeting and other materials and debris that could be contaminated with asbestos into thick-walled plastic bags that were labeled and disposed of as hazardous waste. The workers also wet-cleaned and vacuumed the entire railroad car to

railcars with an encapsulating paint, which would contain any remaining asbestos from flaking in the future.

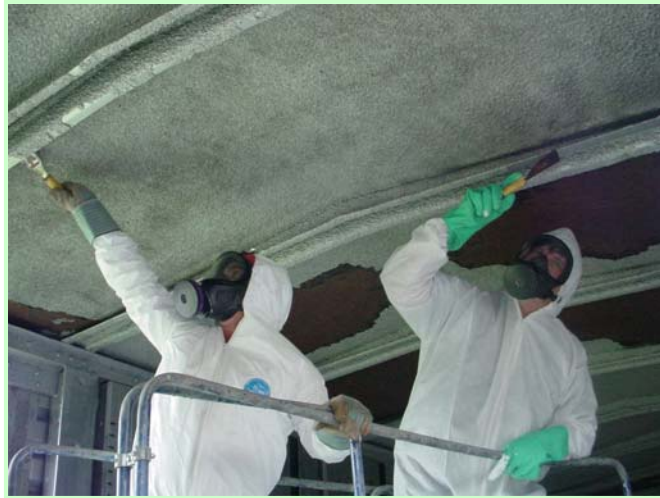
PWC clean up team members, wearing protective clothing, scrape railcar ceiling tiles in preparation for painting

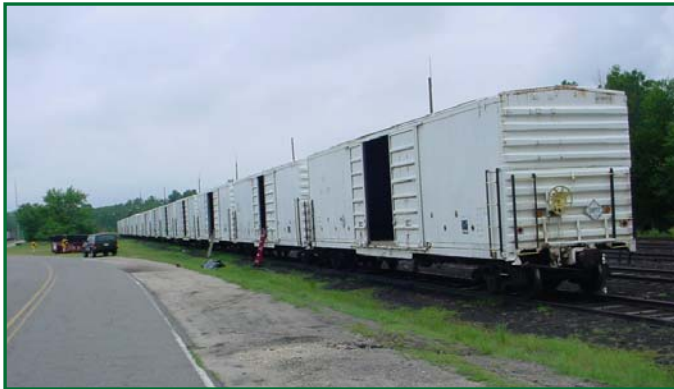
String of boxcars awaits asbestos removal before return to service
