NAVFAC INDUSTRIAL HYGIENIST ASSISTS IN THE CLEAN UP AND RESTORATION OF FLOODED NRC BALTIMORE

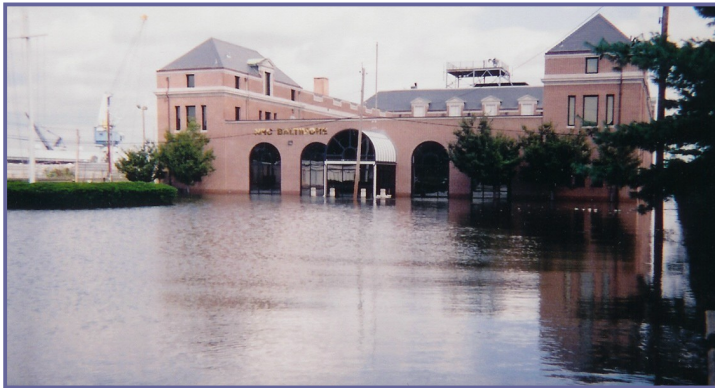
Naval Reserve Center Baltimore was flooded due to a storm surge during Hurricane Isabel

Baltimore, which is located on the Fort McHenry compound. The hurricane's storm surge sent water crashing through the NRC complex, swamping all of its buildings in two feet of murky seawater. The underground utility tunnels that connect the reserve center with the fort were also under water.

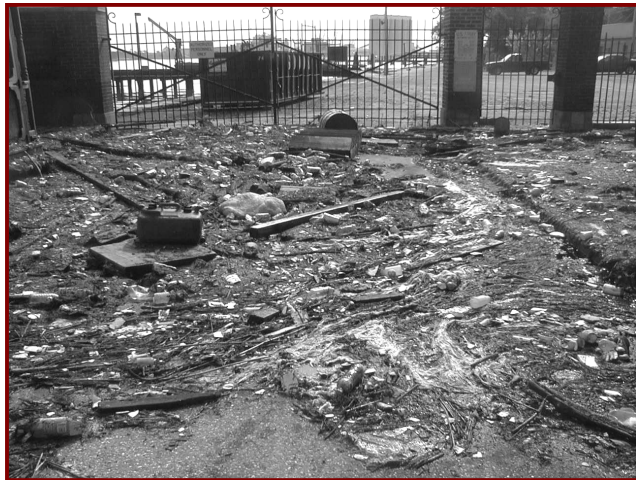
View of flood debris in front of NRC Baltimore following Hurricane Isabel

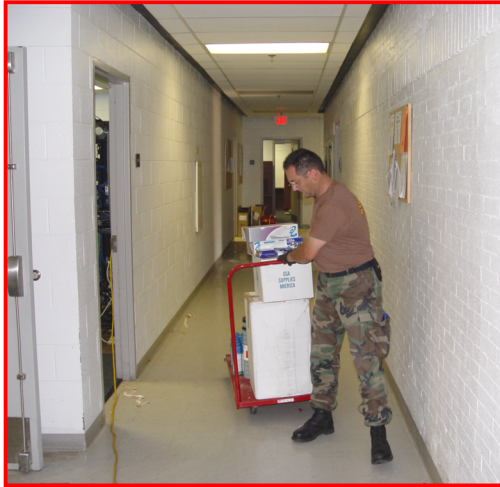
Flood-damaged documents were removed for salvaging by gas sterilization and freeze drying

Important NRC records and documents, such as building plans and military service records, were also waterlogged. Thanks to freeze-drying technology, they have been restored. Freeze-drying is a restoration process that was developed for museum curators and archivists to save priceless artwork and historical documents from moisture or water-damage. NRC's salvaged documents were also decontaminated, using gas sterilization, to eliminate the risk of disease from black water contaminants without risking further damage to the documents.

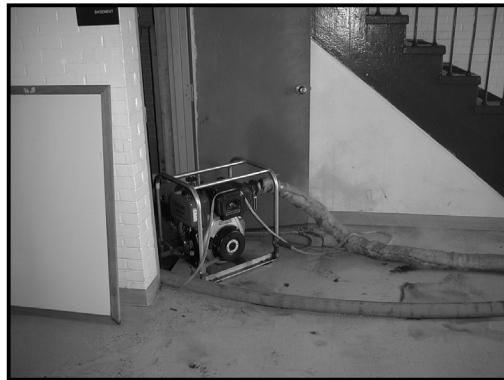
Discharge pump helped to remove floodwater from first floor of NRC Baltimore

The clean up crew disposed of all floor coverings and wallboard up to four feet from the floor. Insulation and other porous materials were discarded as unsalvageable. Nonporous surfaces were washed under high pressure with a disinfectant; heat, fans, and dehumidifiers were then used to dry those surfaces, eliminating any remaining mold. The waterlogged contents of the outdoor hazardous materials storage lockers were disposed of as hazardous waste; the lockers were then decontaminated, dried out, and reused.

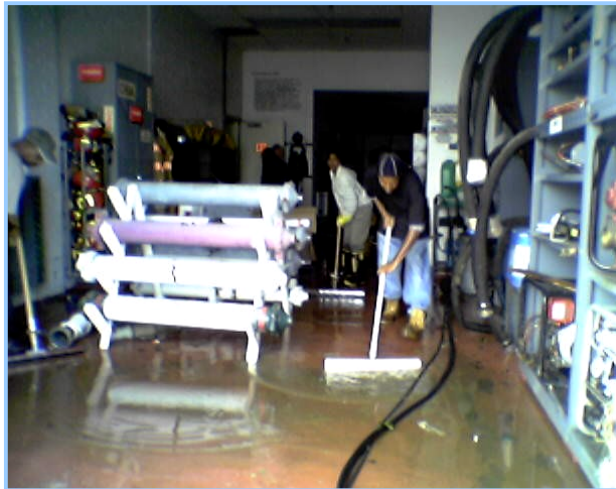
Naval Facilities Engineering Command's contract workers clearing out floodwaters at NRC Baltimore
