# Determination of Channel Change for Selected Streams, Maricopa County, Arizona

Water-Resources Investigations Report 01–4209

*Prepared in cooperation with the  
FLOOD CONTROL DISTRICT OF  
MARICOPA COUNTY*

*By* Joseph P. Capesius *and* Ted W. Lehman

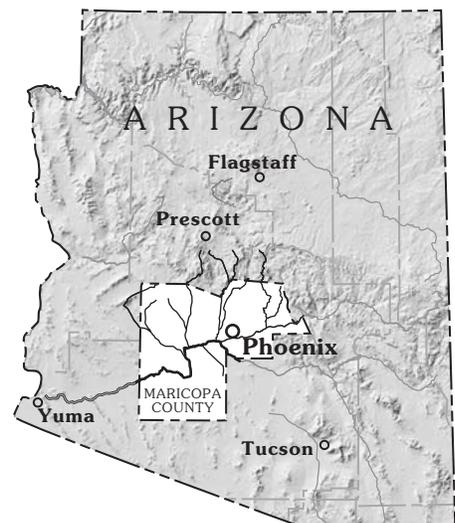
**Figure 1.** Location of study area and channel-change study sites, Maricopa County, Arizona. Study sites were at or near streamflow-gaging stations shown.

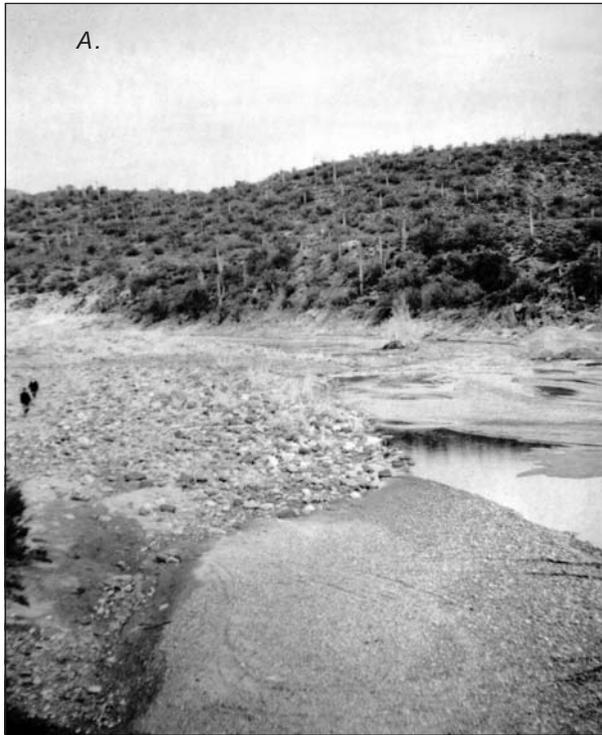
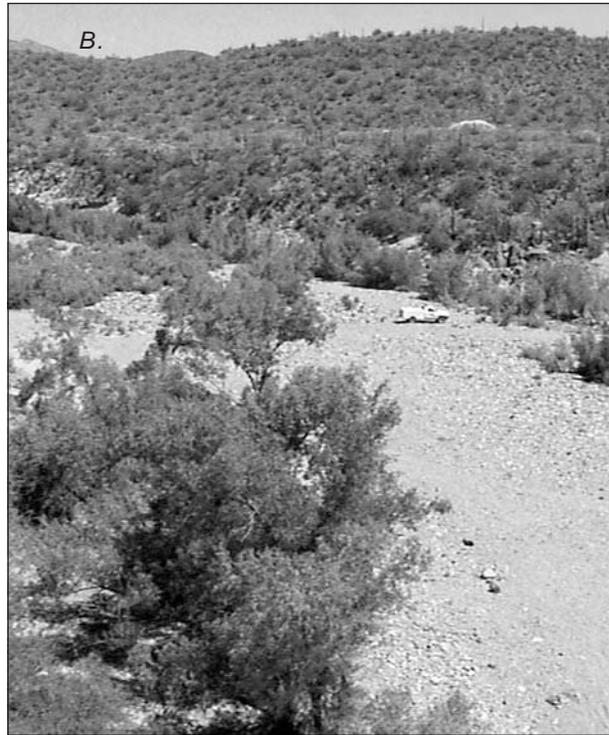
**Figure 7.** View downstream from cableway, Agua Fria River near Rock Springs, Arizona. *A*, January 1979 after the flood of December 18, 1978. *B*, June 18, 1998.

the channel is wide, flat, and sandy (fig. 7A). From the cross-section surveys of the reach, the channel had aggraded as a result of the flood. Figure 7B shows the channel on June 18, 1998, from about the same perspective. Note that figure 7B shows the reach several years after the large floods that occurred in 1993. The riparian vegetation to the right of the truck in figure 7B borders a narrow, well-defined low-flow channel.

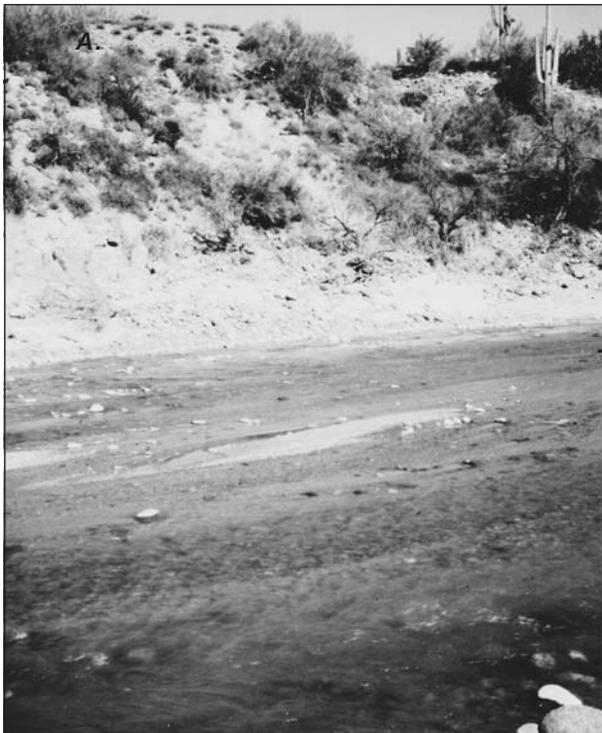
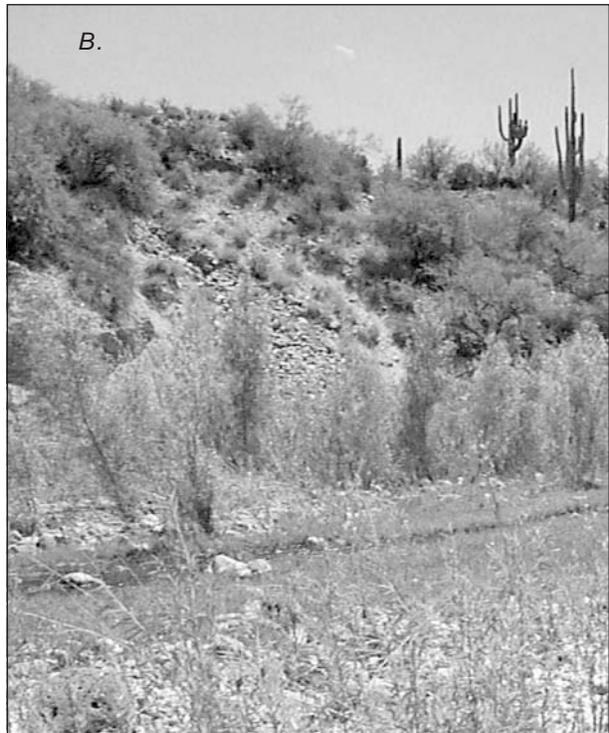
**Figure 8.** View of right bank near cross-section 3, Agua Fria River near Rock Springs, Arizona. *A*, January, 1979 after the flood of December 18, 1978. *B*, June 18, 1998. Flow is from right to left in photographs.

A view of the right bank of cross-section 3 is shown in figures 8A–B. Figure 8A shows a wide, flat, sandy channel in January 1979. Figure 8B shows about the same location and perspective on June 18, 1998. The growth of riparian trees along the low-flow channel obscures the view of the channel itself. The photograph, however, was taken from about the same elevation as that of figure 8A. The area with riparian tree growth indicates where several feet of channel incision has occurred since 1978.

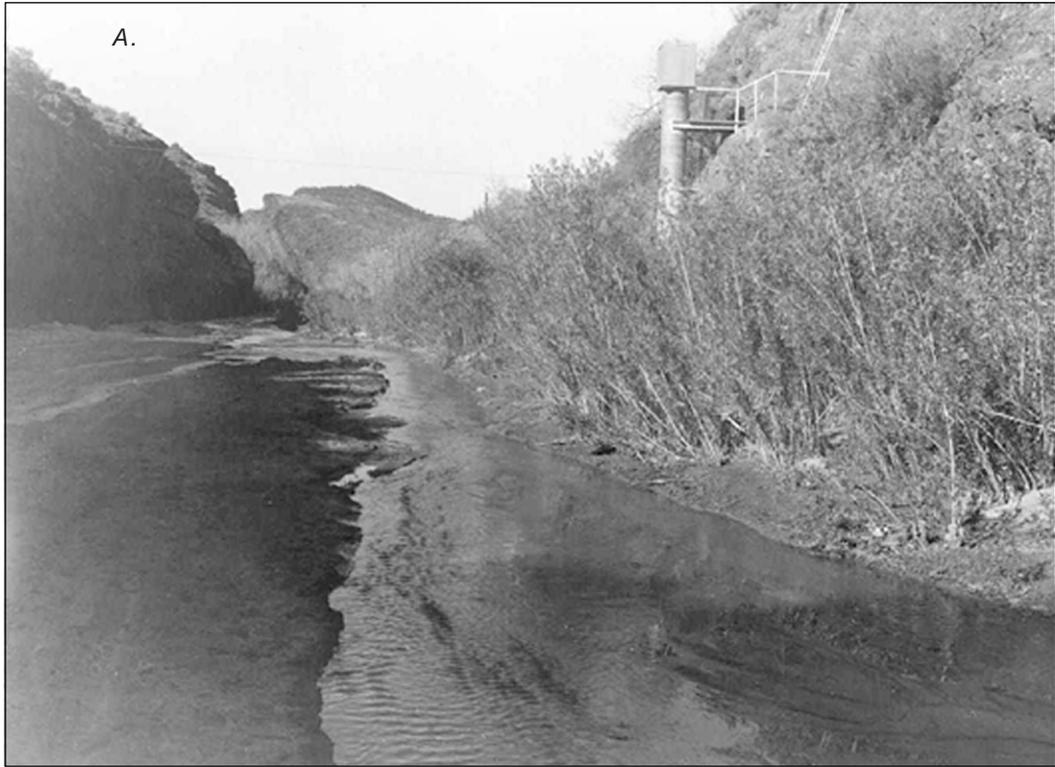
**Figure 14.** View downstream past stilling well, Hassayampa River at Box Canyon, near Wickenburg, Arizona. *A.* January 9, 1964. *B.* 1970, exact data unknown. *C.* After flood of September 5, 1970.

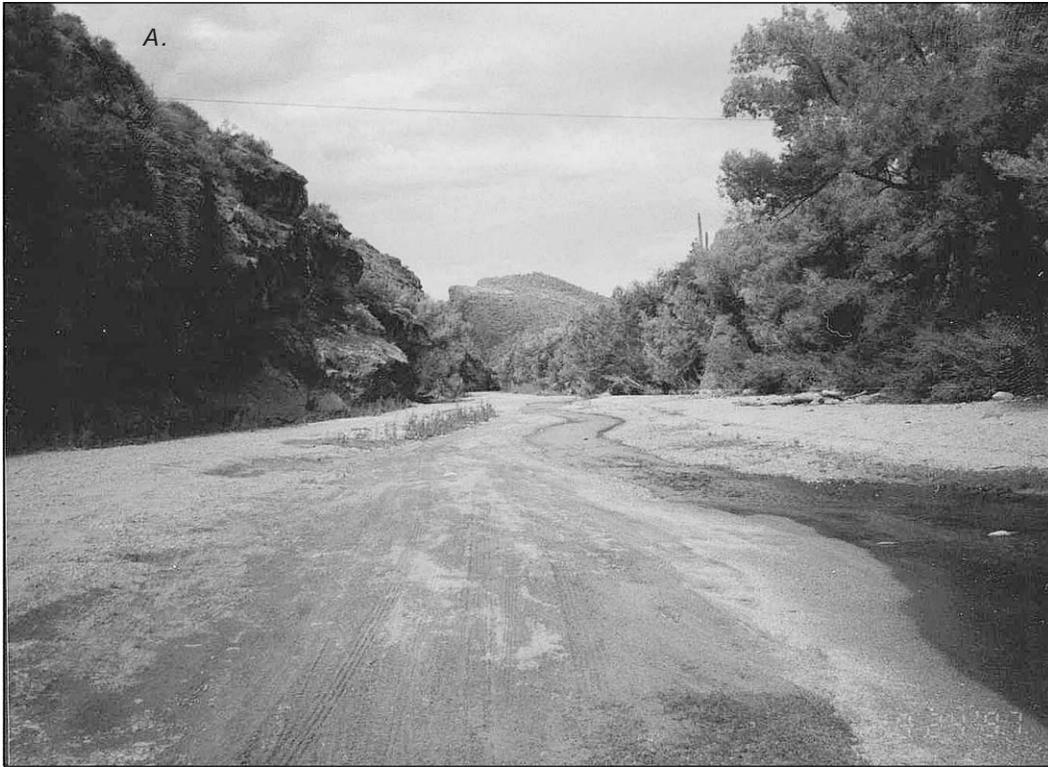
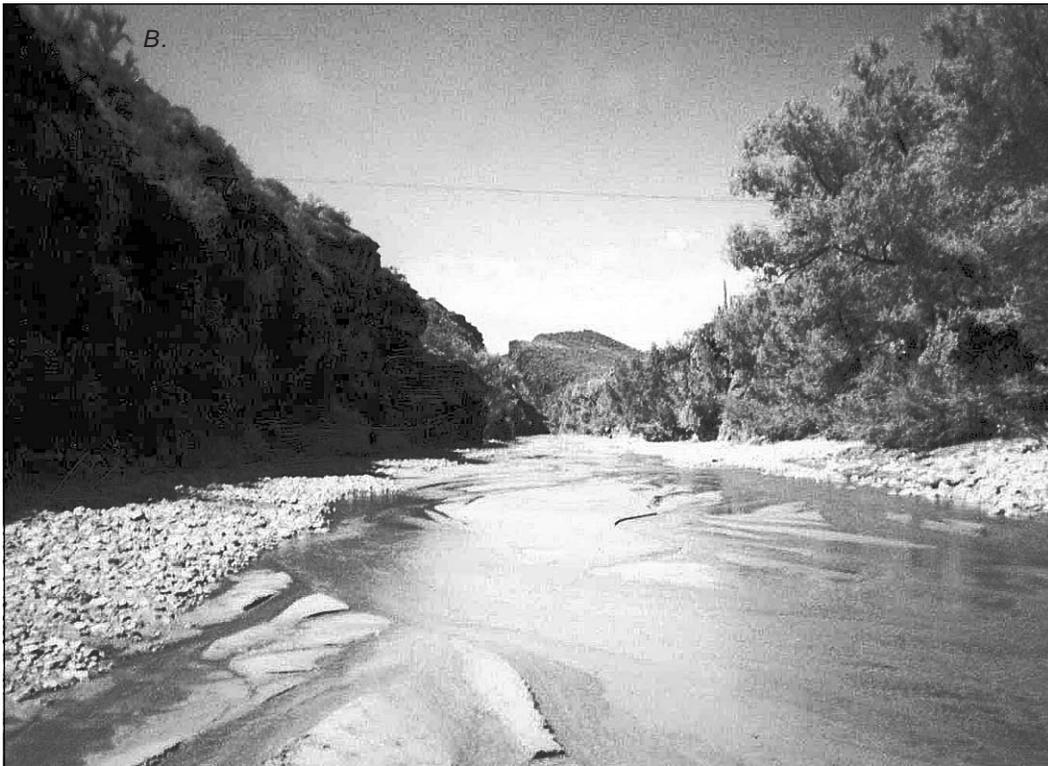
**Figure 15.** View downstream from gaging station. *A*, September 24, 1997. *B*, September 30, 1997.

The second set of repeat photographs were taken 2 days before and 4 days after the flood on September 26, 1997 (figs. 15A–15B). The photographs show the coarsening of the channel sediment immediately following prolonged flows, which occurred after the flood on September 26, 1997. This coarsening of channel sediment has been observed on several occasions at this site.
