Mars Exploration Rover Mission

**Spirit
and
Opportunity**

**Week in Review
May 22 - May 28**

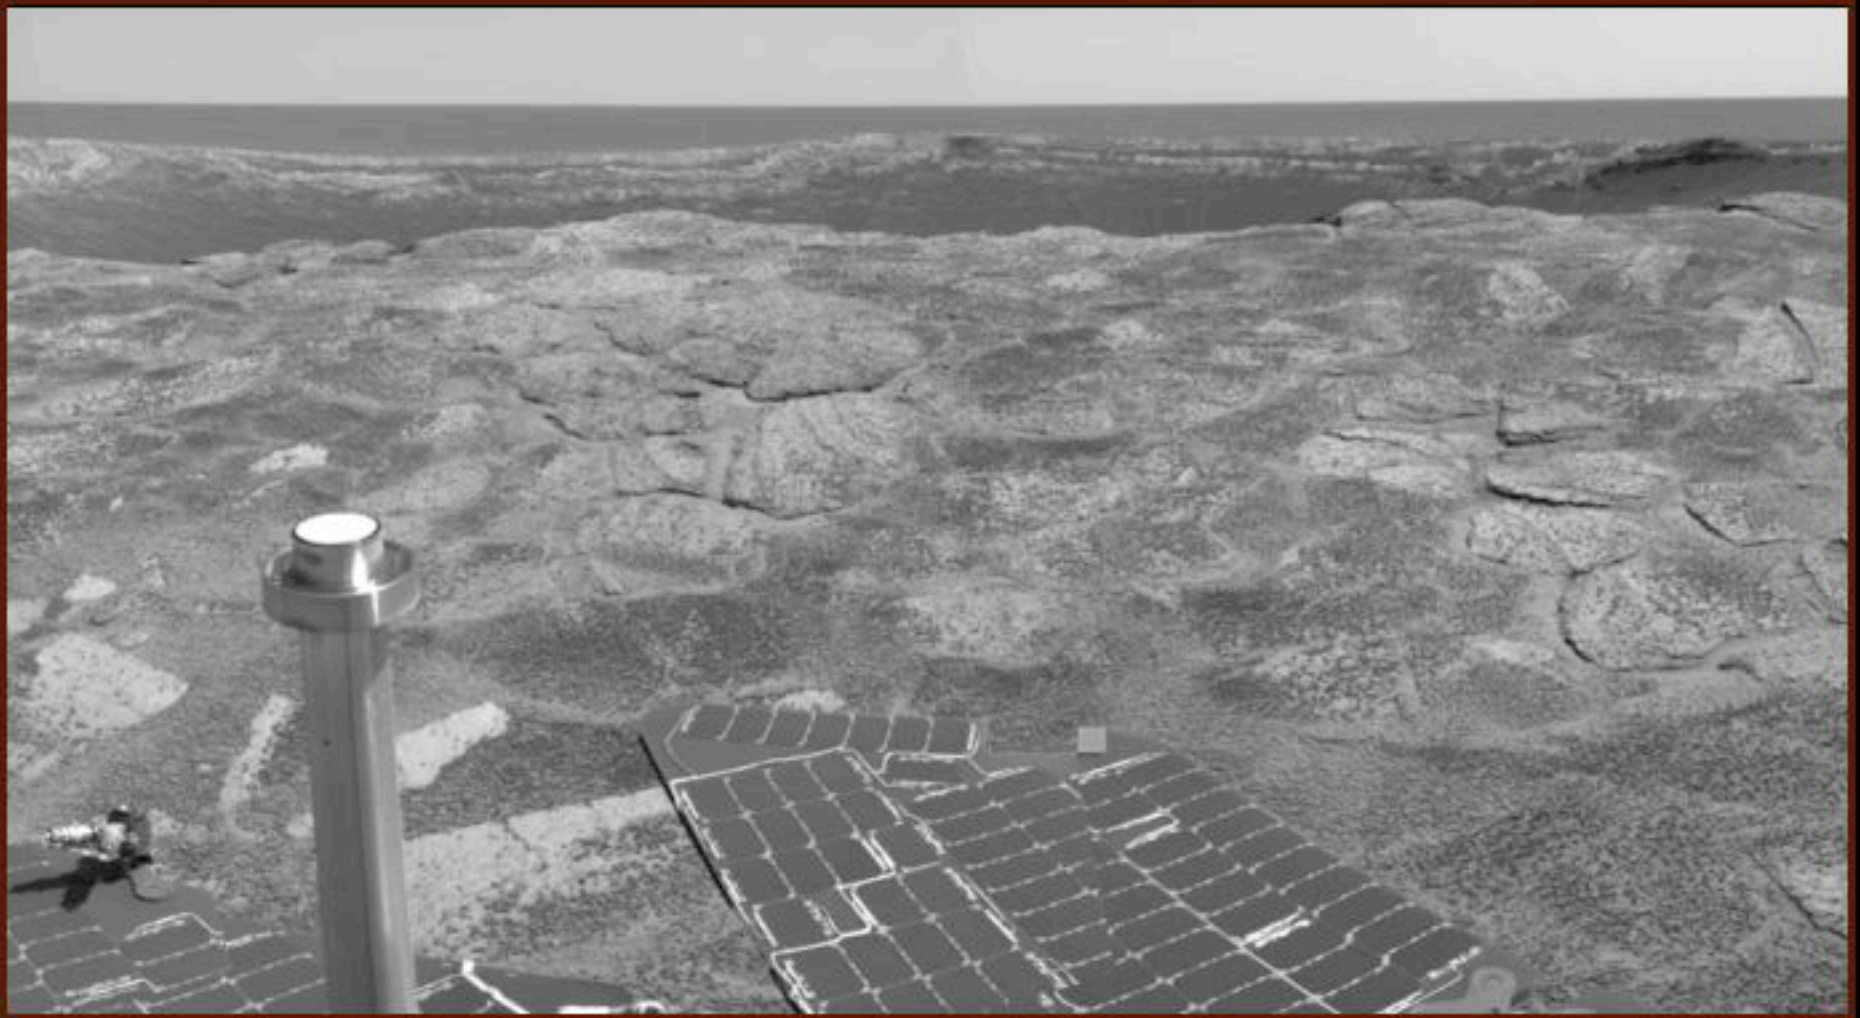
Navigation camera mosaic taken on May 21, 2004.

Opportunity continues to cruise around the rocky rim of Endurance Crater, which is about 430 feet (130 meters) in diameter.

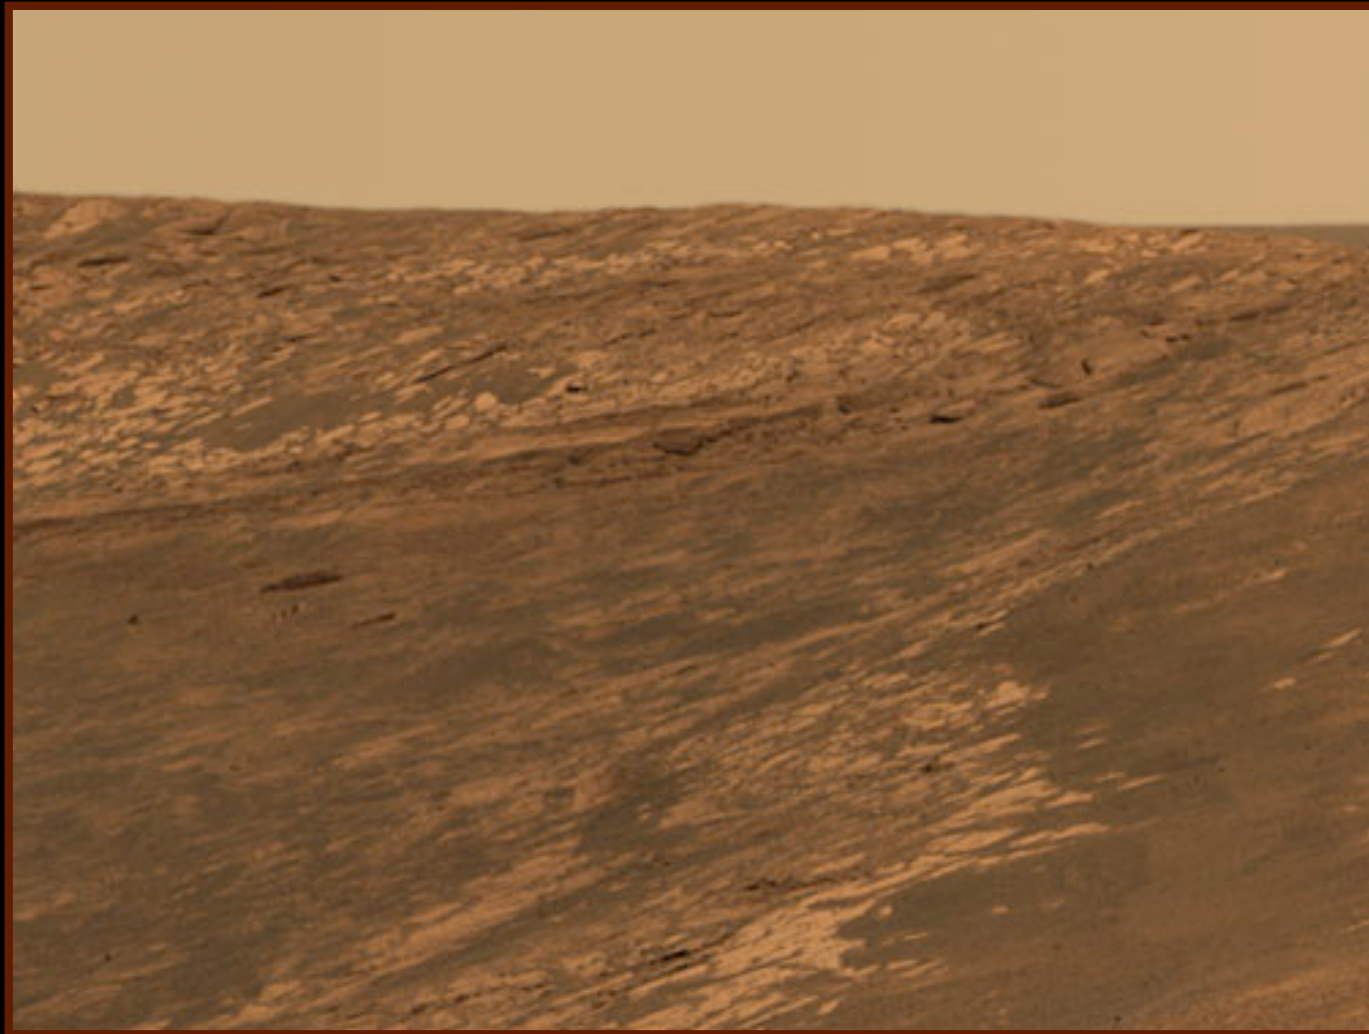
Possible area to enter Endurance Crater: Karatepe.

Scientists and engineers are trying to find a location with more stable rock than loose sand.

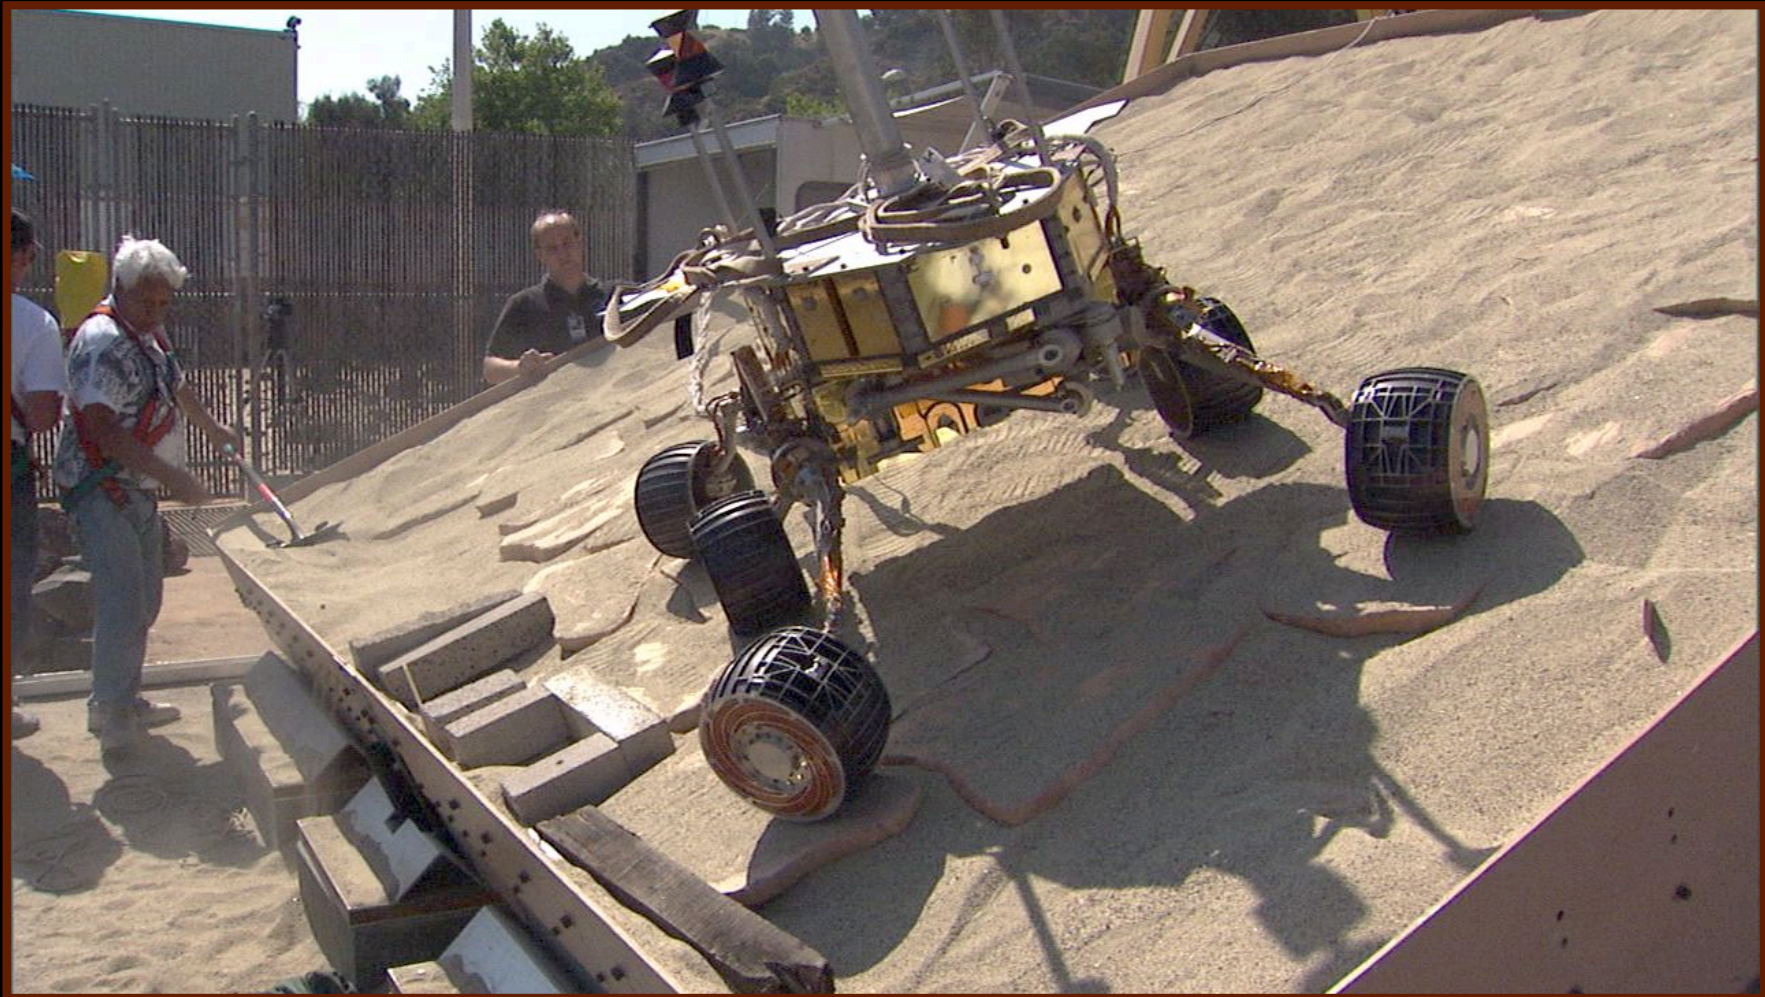
Engineering model of the rover during the sandbox test outside of the "Mars Yard" at Jet Propulsion Laboratory May 27, 2004.

Simultaneously, mobility experts, scientists, and engineers are testing the rover's slip limits on simulated martian soil and rock at a 25-degree tilt.

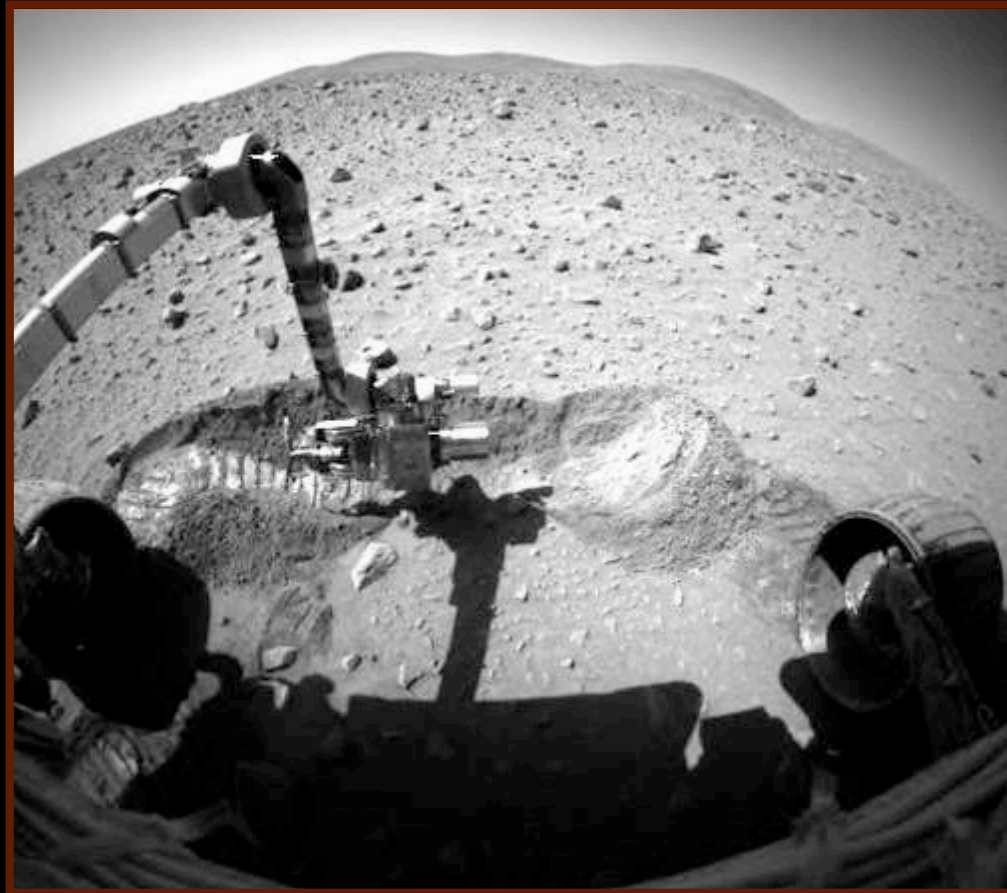
Front hazard avoidance camera image received on Earth May 26, 2004.

Spirit used its wheel to dig a trench, and then used its instruments to investigate the newly exposed surface.

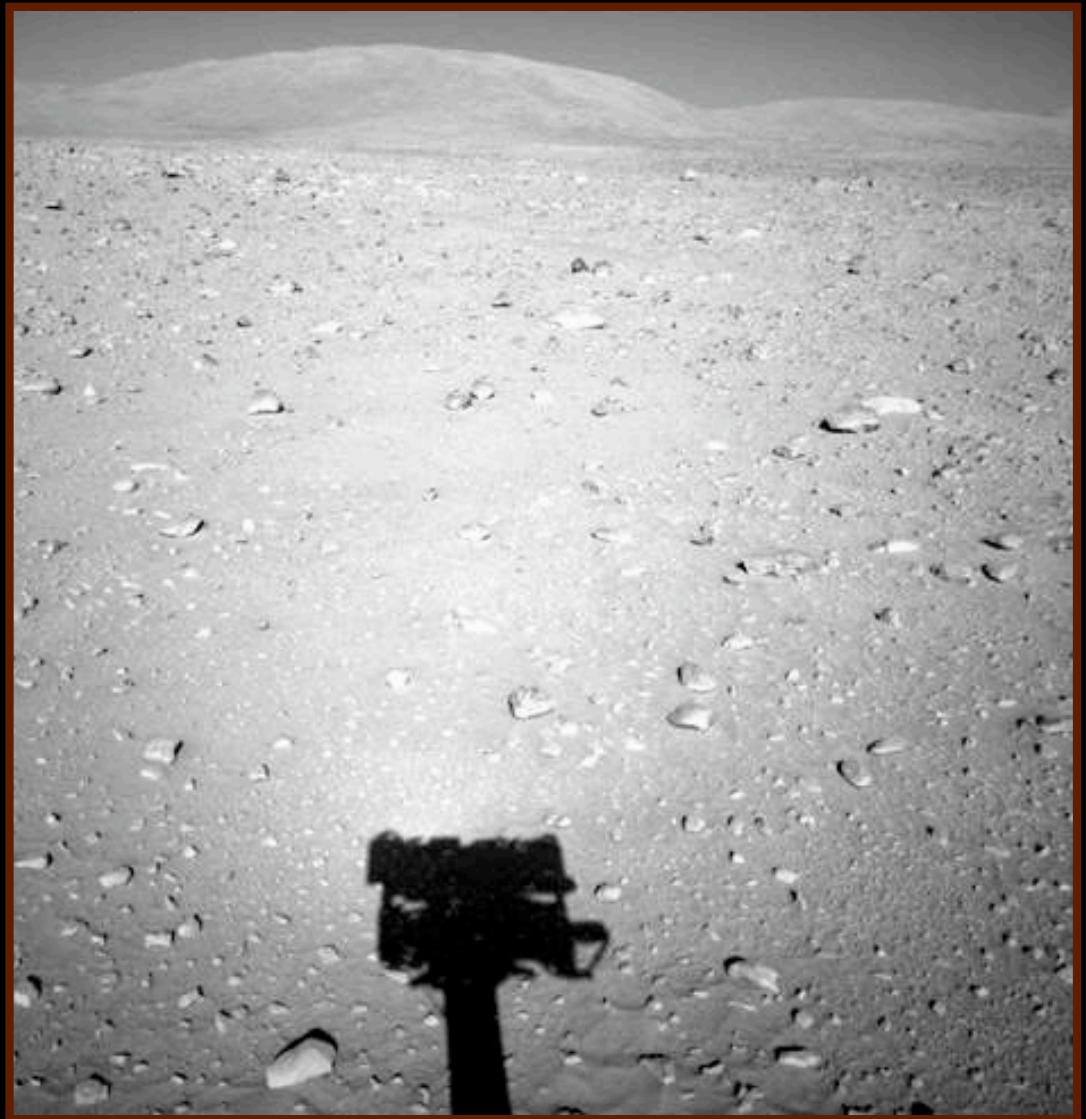
Navigation camera image taken on sol 135 at 3:33:58 p.m. Mars local solar time.
