Mars Exploration Rover Mission Spirit and **Opportunity Week in Review** June 5 - June 11

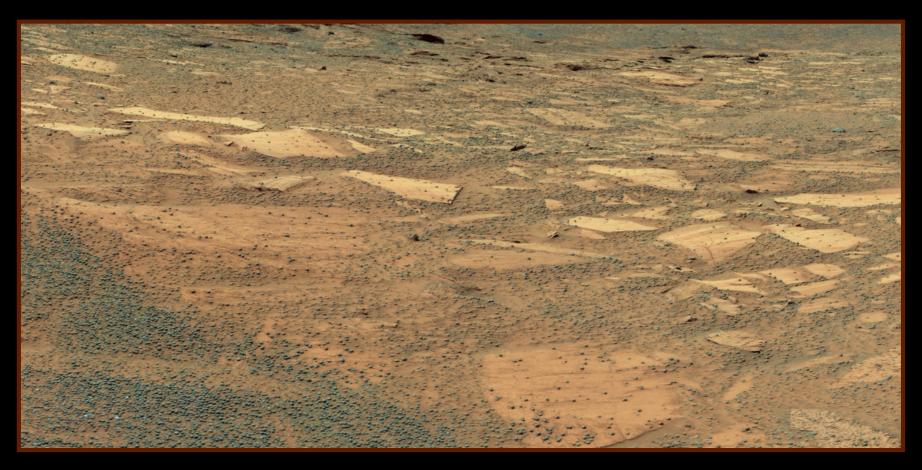
False-color panoramic camera mosaic taken on June 6, 2004.

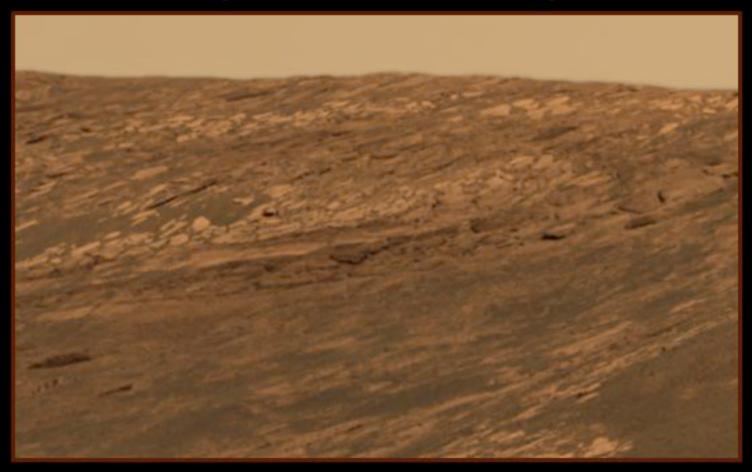
Panoramic camera mosaic of the Karatepe target area where Opportunity entered Endurance.

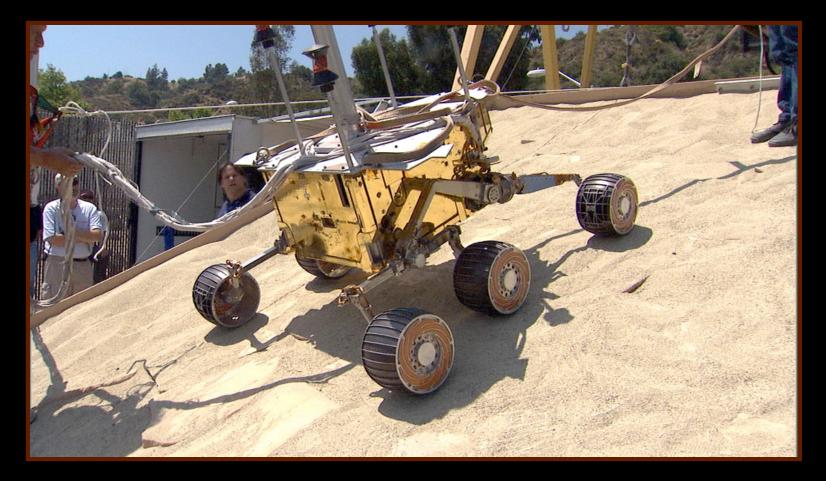
Rover mobility tests were done on simulated surface conditions of the Karatepe area, where Opportunity would enter Endurance Crater.

They indicated the rover could safely drive down and up a slope of 25 degrees.

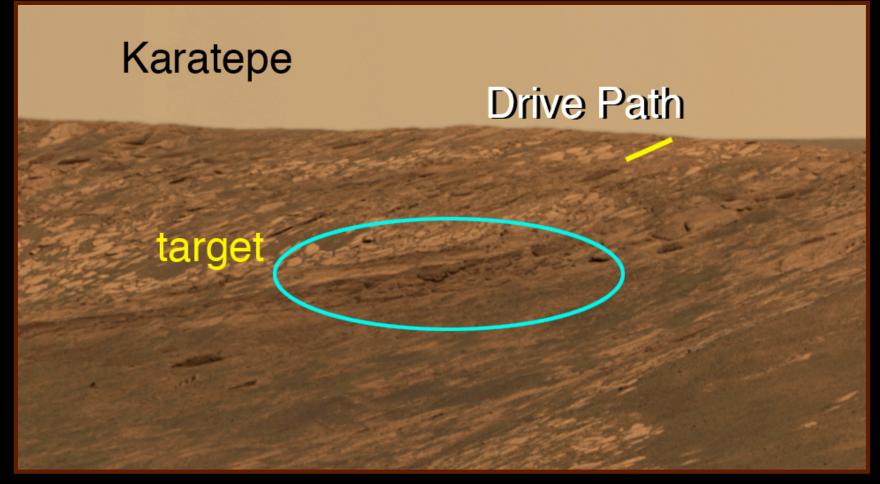
Panoramic camera mosaic of Karatepe area.

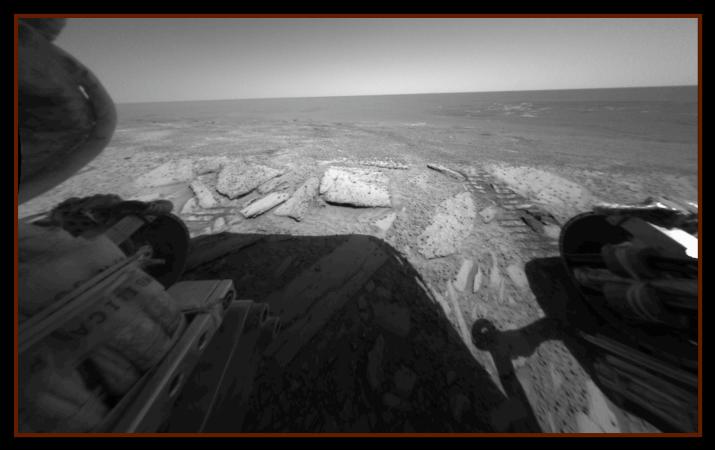
In this rear hazard-avoidance camera image taken June 8, 2004, Opportunity looks back at the plains from inside the crater rim.

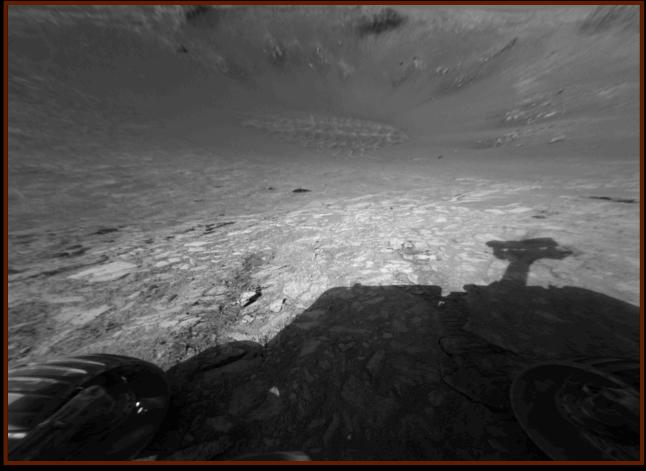
The rover looks down on the floor of Endurance Crater with its front hazard-avoidance cameras.

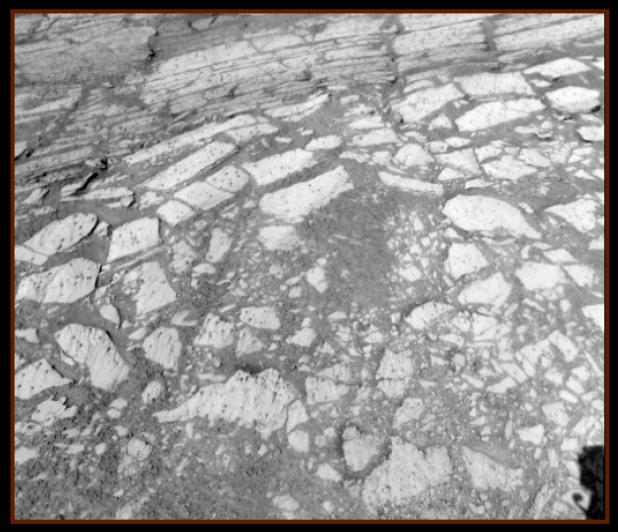
Navigation camera image looking down into the crater taken on June9, 2004.

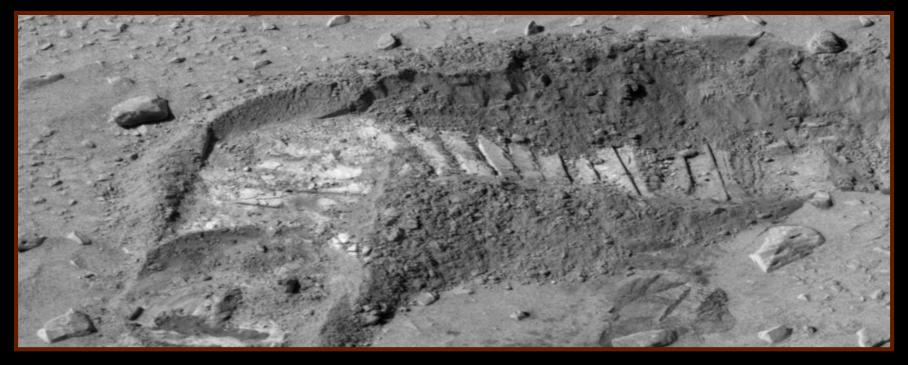
Panoramic camera image of the trench dug along the way toward the Columbia Hills.

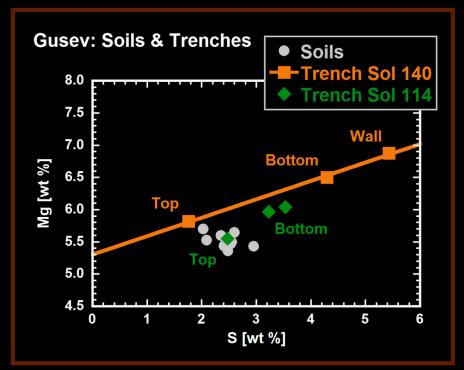
Because concentrations of magnesium and sulfur occur in the same ratio throughout the trench, scientists believe the soil there contains magnesium sulfate.

Alpha particle X-ray spectrometer data of soil composition. Image credit: NASA/JPL/Cornell/Max Planck Institute.

This finding is important because magnesium sulfate is often a salt left behind after water evaporates.

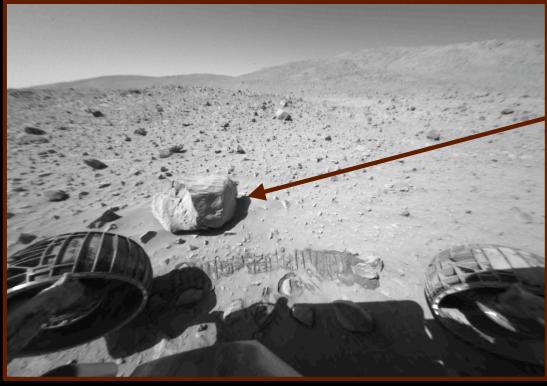
This larger rock didn't - make the cut, and Spirit passed on by, moving closer to new adventures on the hills.

Front hazard-avoidance camera image taken June 9, 2004.

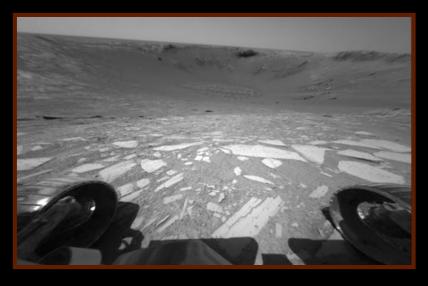
Front hazard-avoidance camera Image inside Endurance Crater. Opportunity is ready to use the instruments on its robotic arm, and will most likely stay inside Endurance Crater for 2-3 weeks of scientific study.
