Mars Exploration Rover Mission

**Spirit
and
Opportunity**

**Week in Review
June 26 - July 2**

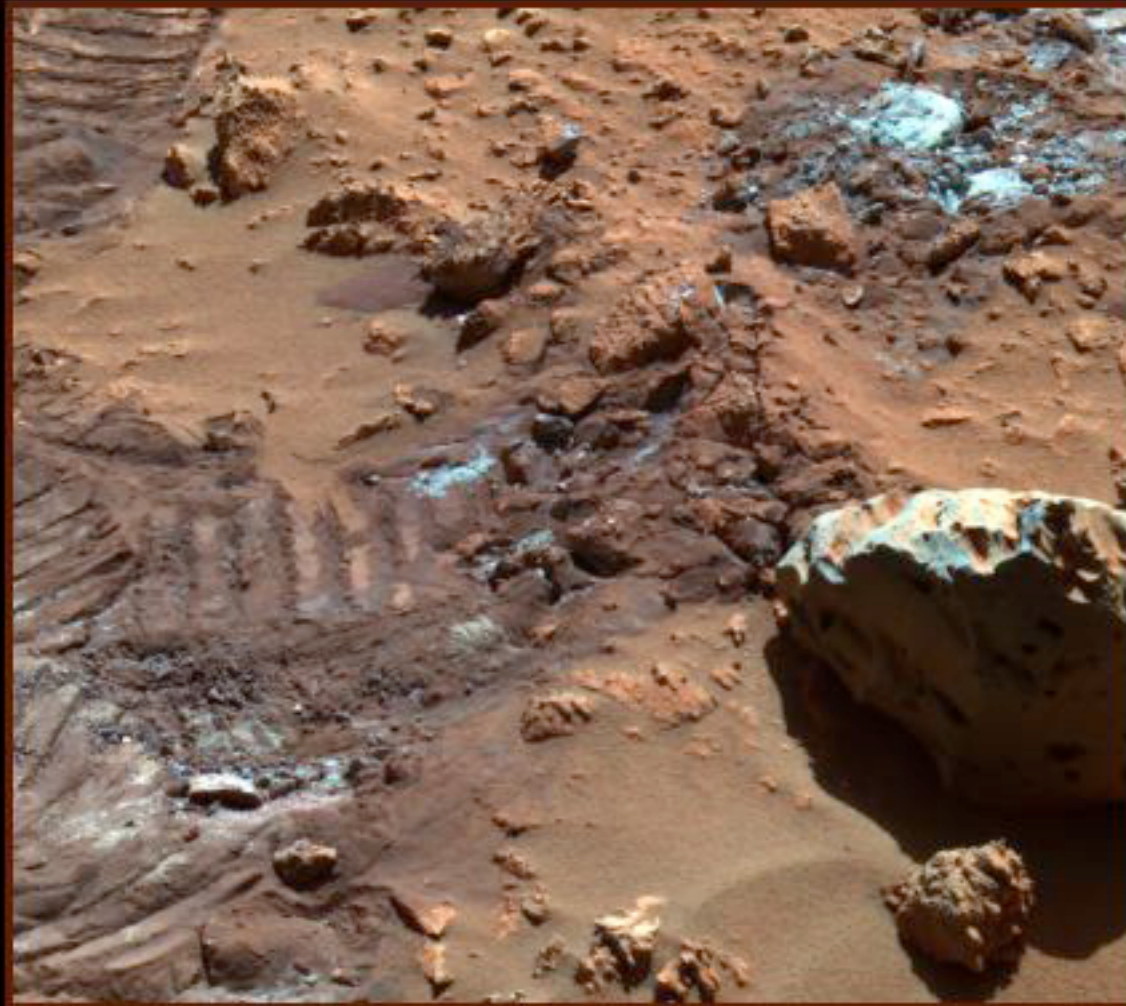
Spirit spent June 26 & 27, 2004 wrapping up studies of the mysterious and sparkly material in “Hank’s Hollow” near Columbia Hills.

False-color panoramic camera image of Hank's Hollow taken June 20, 2004.

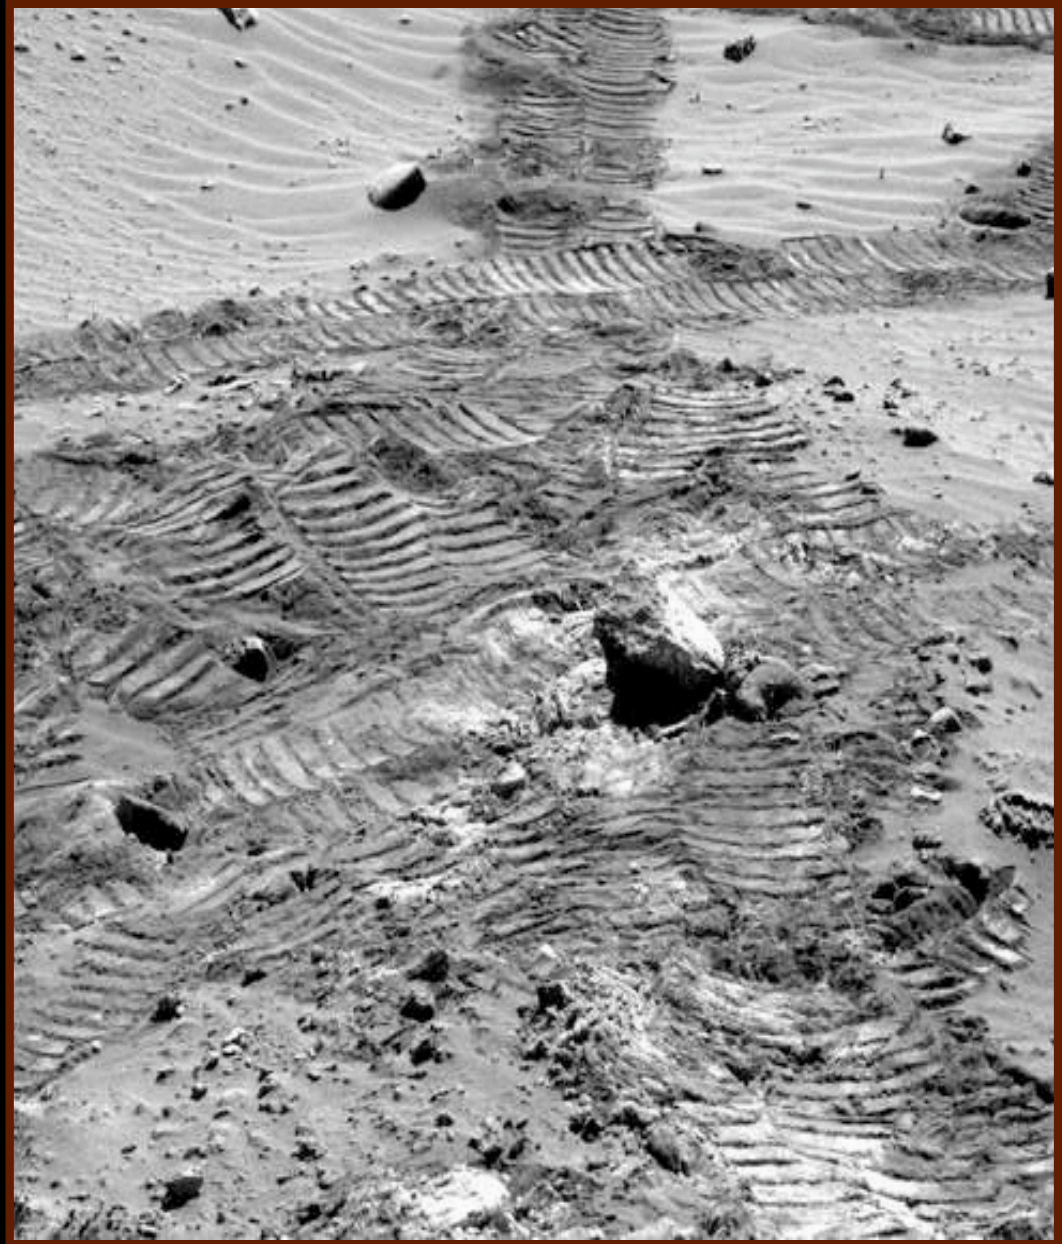
**On June 29,
Spirit turned
toward another area
with bright material,
freshly exposed
by the rover tracks.**

**Scientists are trying
to learn more about
what lies beneath
the surface of the soil
at the Columbia Hills.**

*Left panoramic camera image of "Bright Tracks"
taken at 11:41 Mars Local Solar Time on June 29, 2004.*

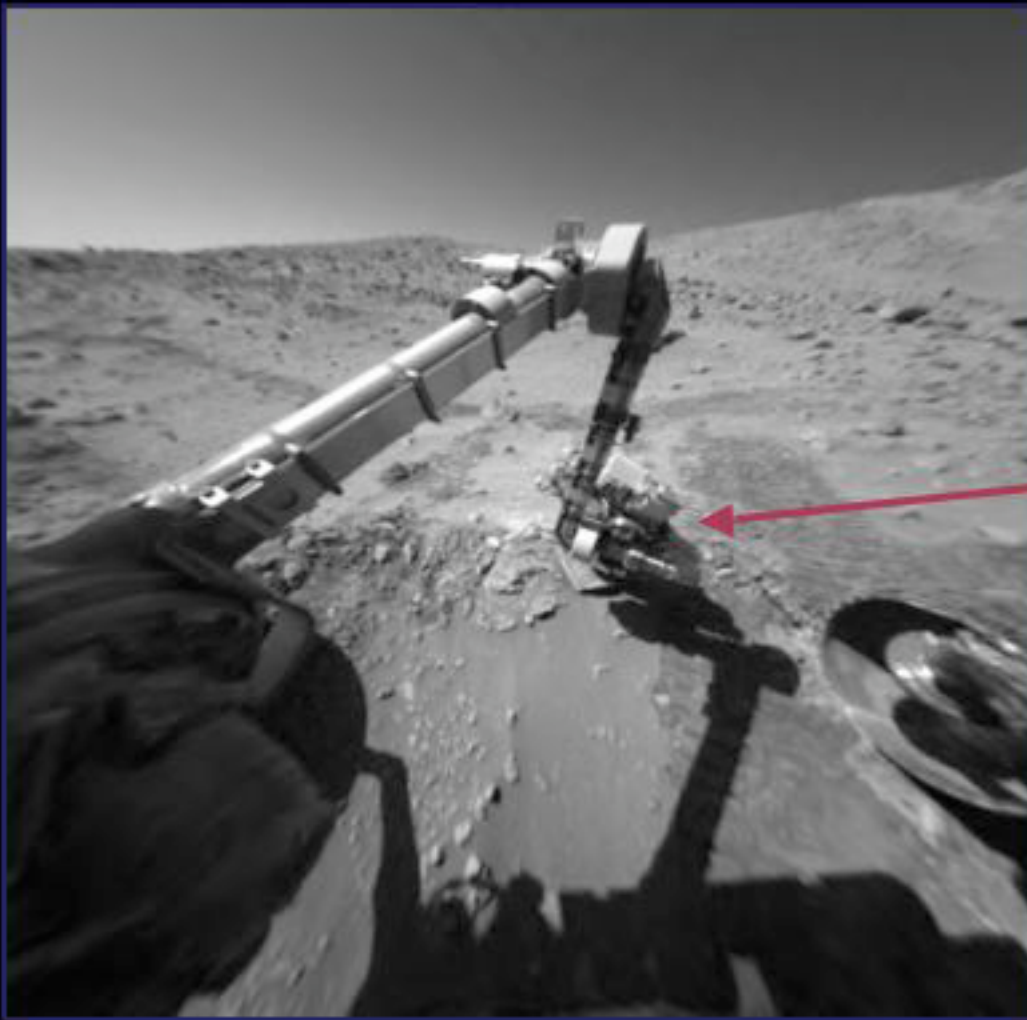
**Spirit did a bump backwards to the “Bread Basket” area,
where the microscopic imager got an up-close look.**

Front hazard-avoidance camera image taken on June 30, 2004.

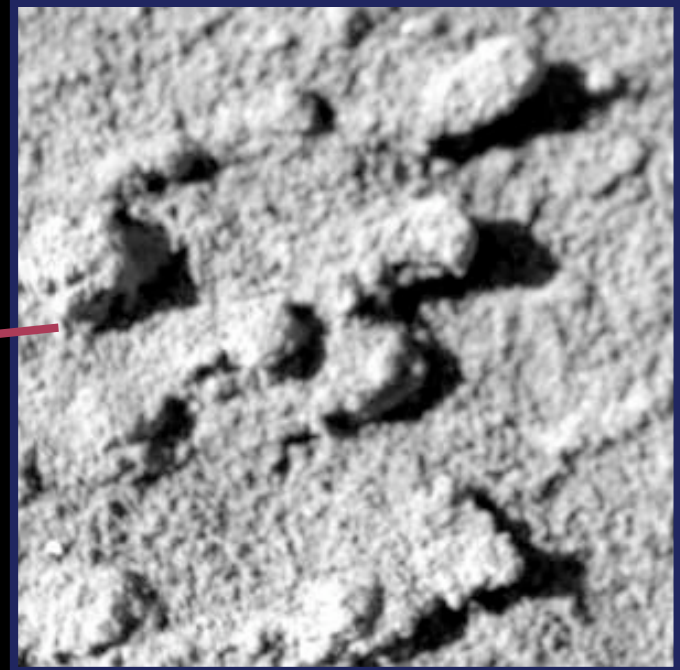
*Microscopic image of Bread Basket
taken at 11:29 Mars Local Solar Time
on June 30, 2004.*

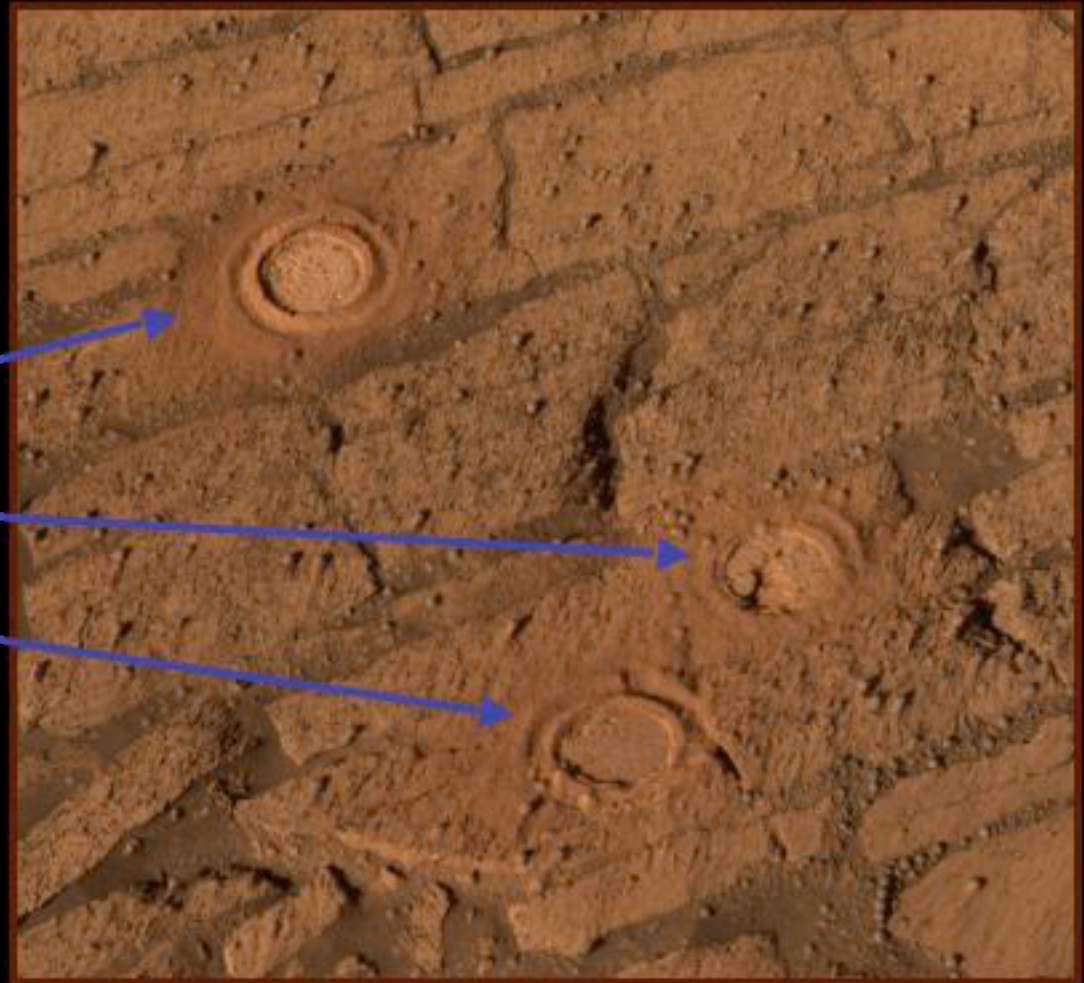
The rock abrasion tool created holes named:

- “London”
- “Virginia”
- “Cobble Hill”

Approximate true color rendering, panoramic camera image after rock abrasion tool grindings between June 18 and 23, 2004.

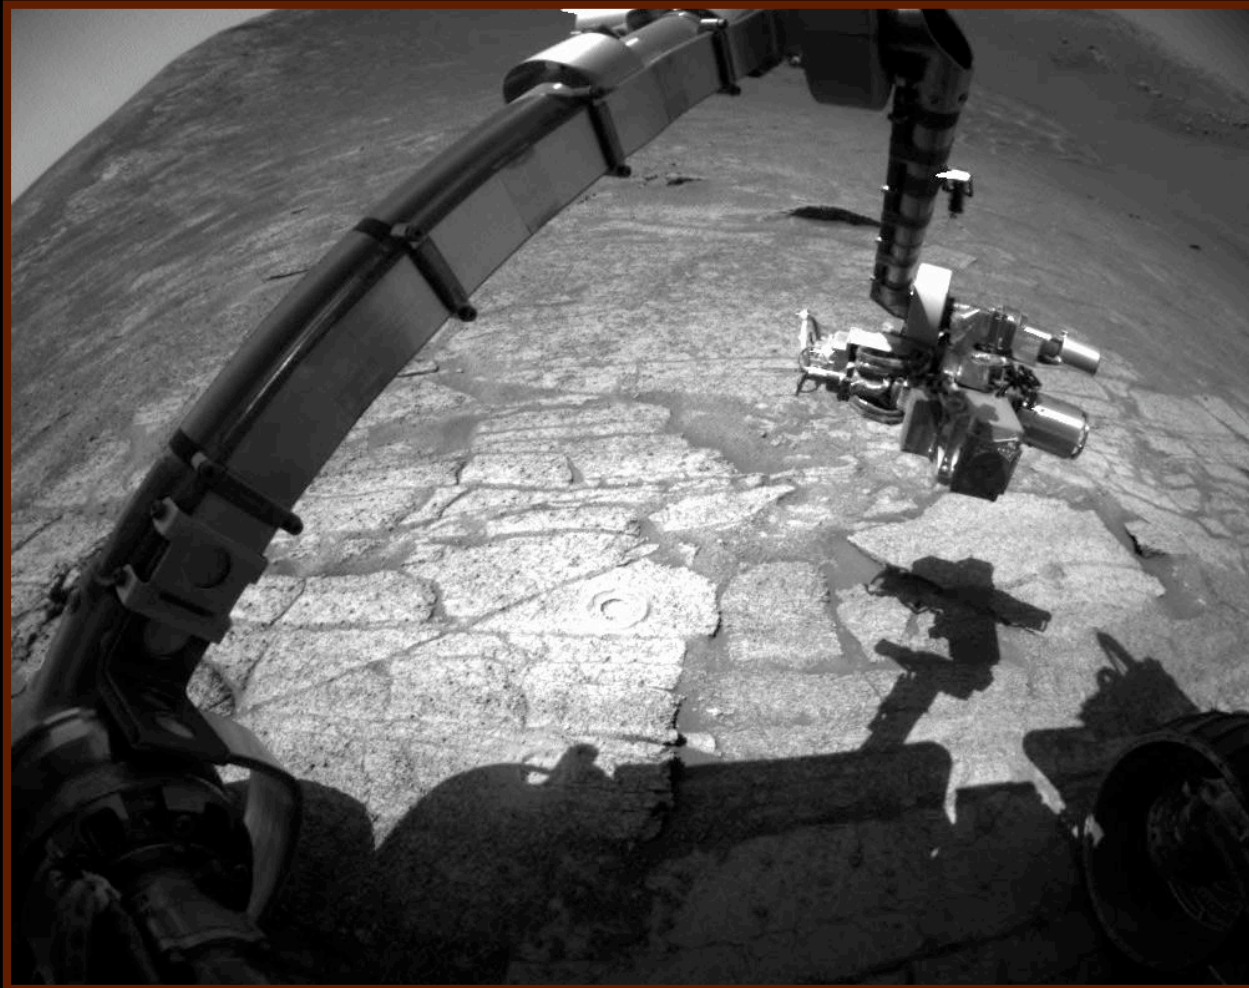
Opportunity's arm got a good workout this week, safely swinging its spectrometers into these holes to search for chemical clues about the history of water inside Endurance Crater.

Front hazard-avoidance camera image taken by Opportunity on June 30, 2004.

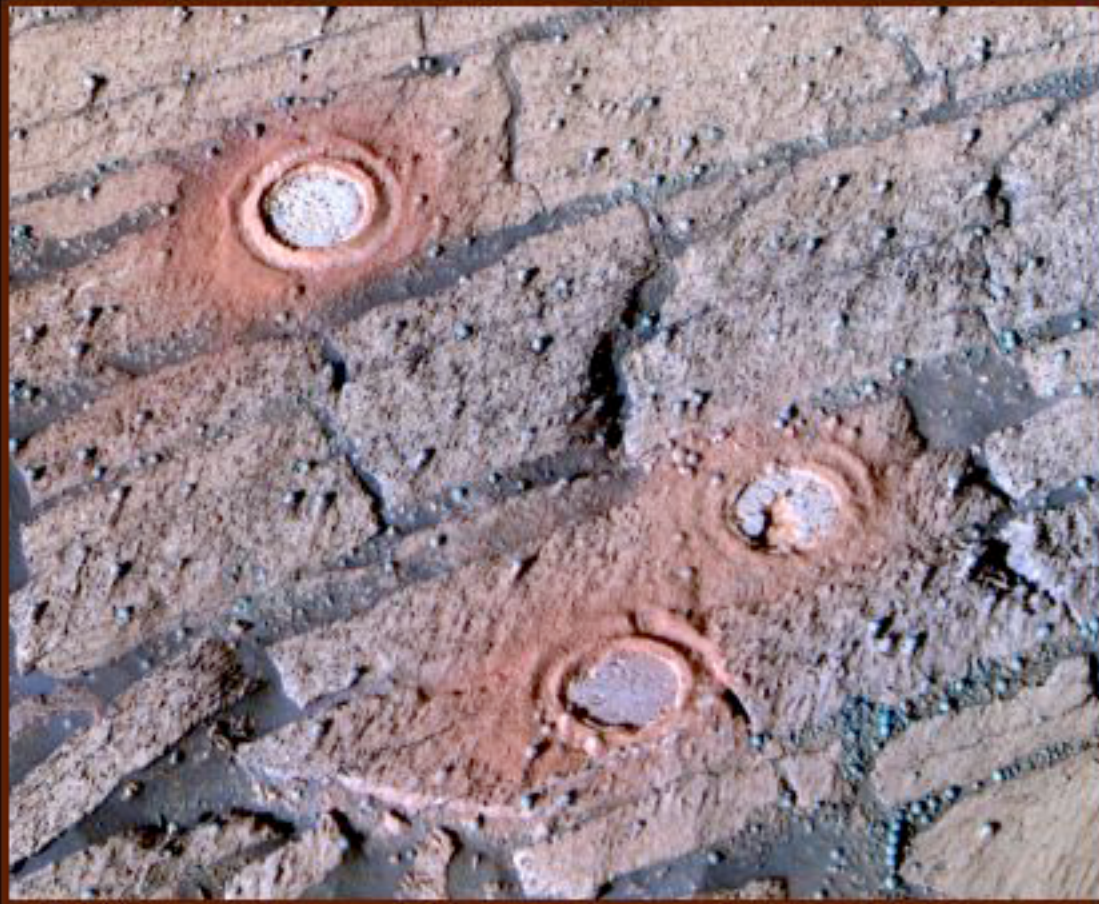
Scientists made color enhancements to this image in order to reveal variations that are too subtle to be seen without this kind of exaggeration.

These variations help them understand differences in the rocks' composition and texture.

Enhanced-color panoramic camera image from Opportunity inside Endurance Crater.

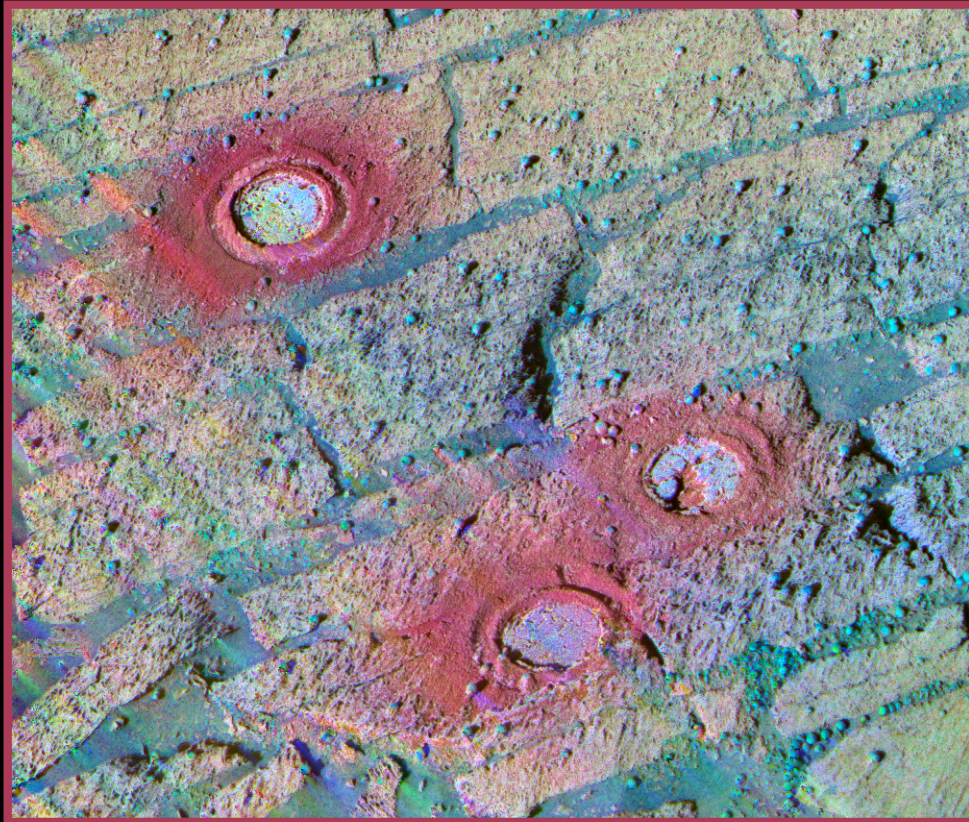
Exaggerating the colors even more, scientists noticed that the “powdery dust” left over from the grinding appears more red around London (top hole).

That’s because the rock abrasion tool sliced into two spherules within London containing the mineral hematite, which turns from gray to red when crumbled.

Processed panoramic camera image from Opportunity inside Endurance Crater.

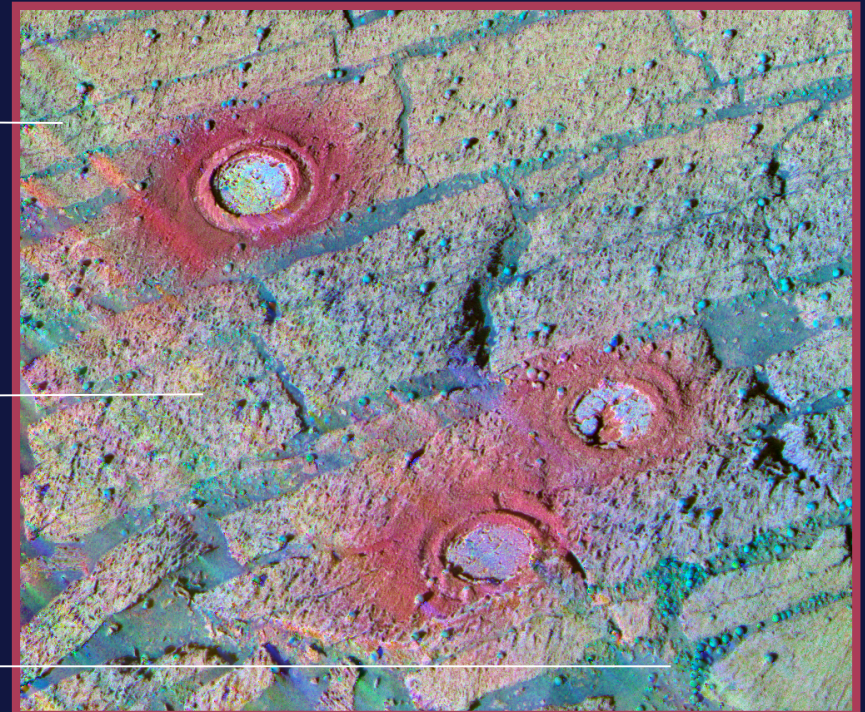
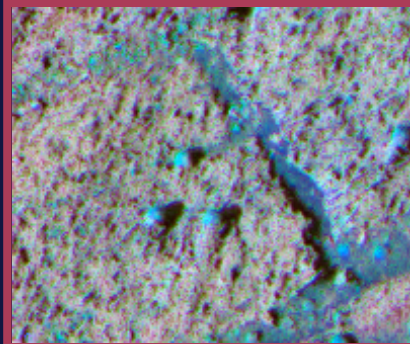
Rock layers with different chemical compositions show color variations as well:

Top layer:
Yellowish-red

Middle layer:
Yellowish-green

Lower layer:
Green

Decorrelation stretch panoramic camera images from Opportunity inside Endurance Crater.

Results on the chemical compositions of the layers are pending.

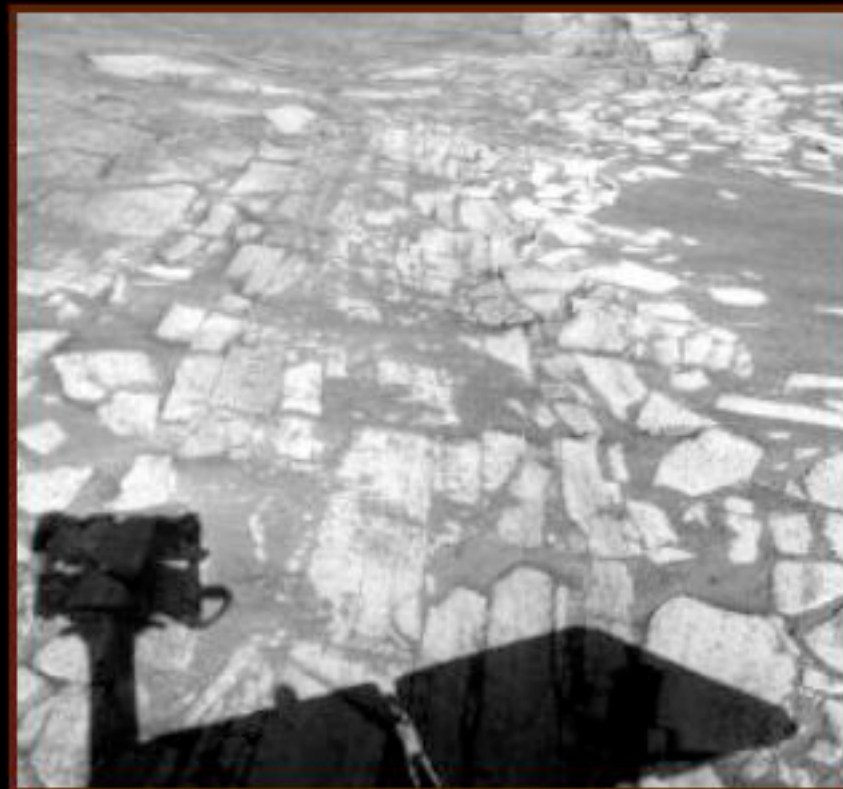
Over the next few weeks, Opportunity will continue to analyze the various layers of rock inside Endurance Crater.

Opportunity navigation camera image, June 30, 2004.

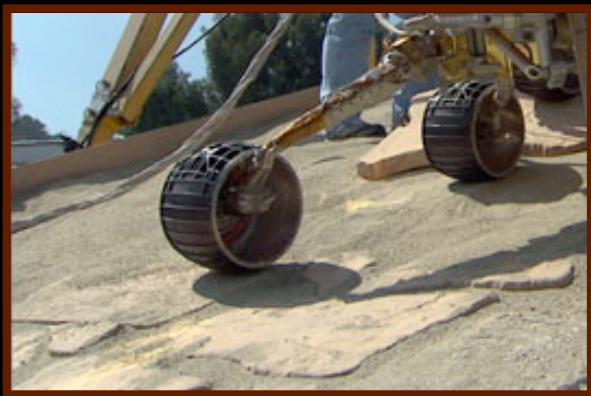
Test rover model at Jet Propulsion Laboratory.

Spirit will get a 3,000-meter tune up, including a hazard-avoidance camera adjustment and a right-front-wheel lubrication to prevent sticking and dragging of the wheel.
