Mars Exploration Rover Mission

**Spirit
and
Opportunity**

**Week in Review
July 24 - July 30**

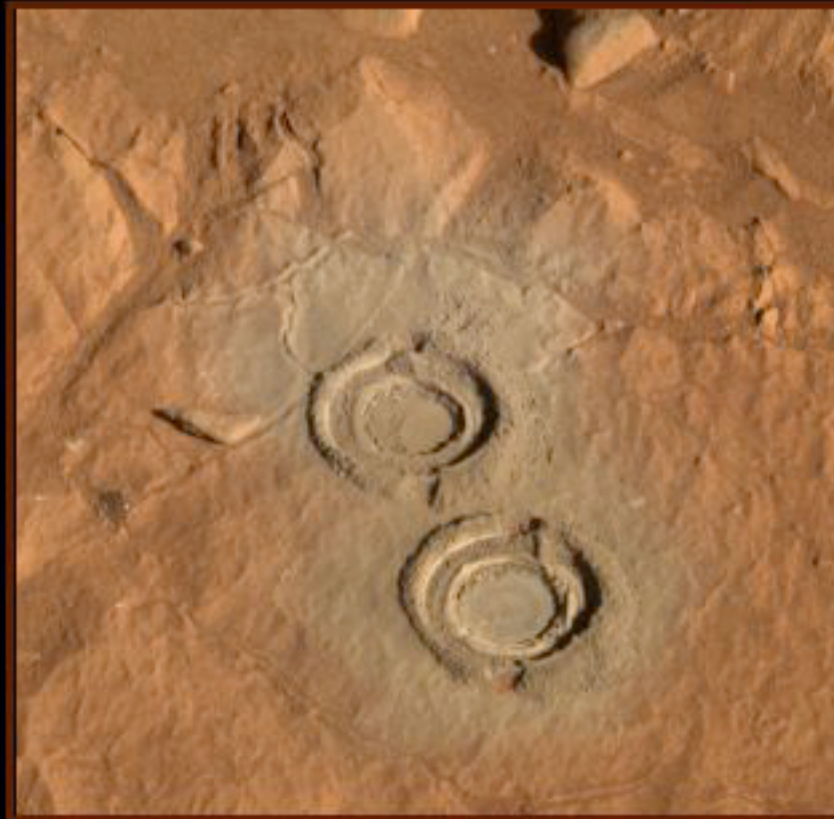
Approximate true-color panoramic camera image, July 25, 2004.

Small cracks in the surface outside the drill holes and one running through the upper hole may be the result of interactions with water-rich fluids.

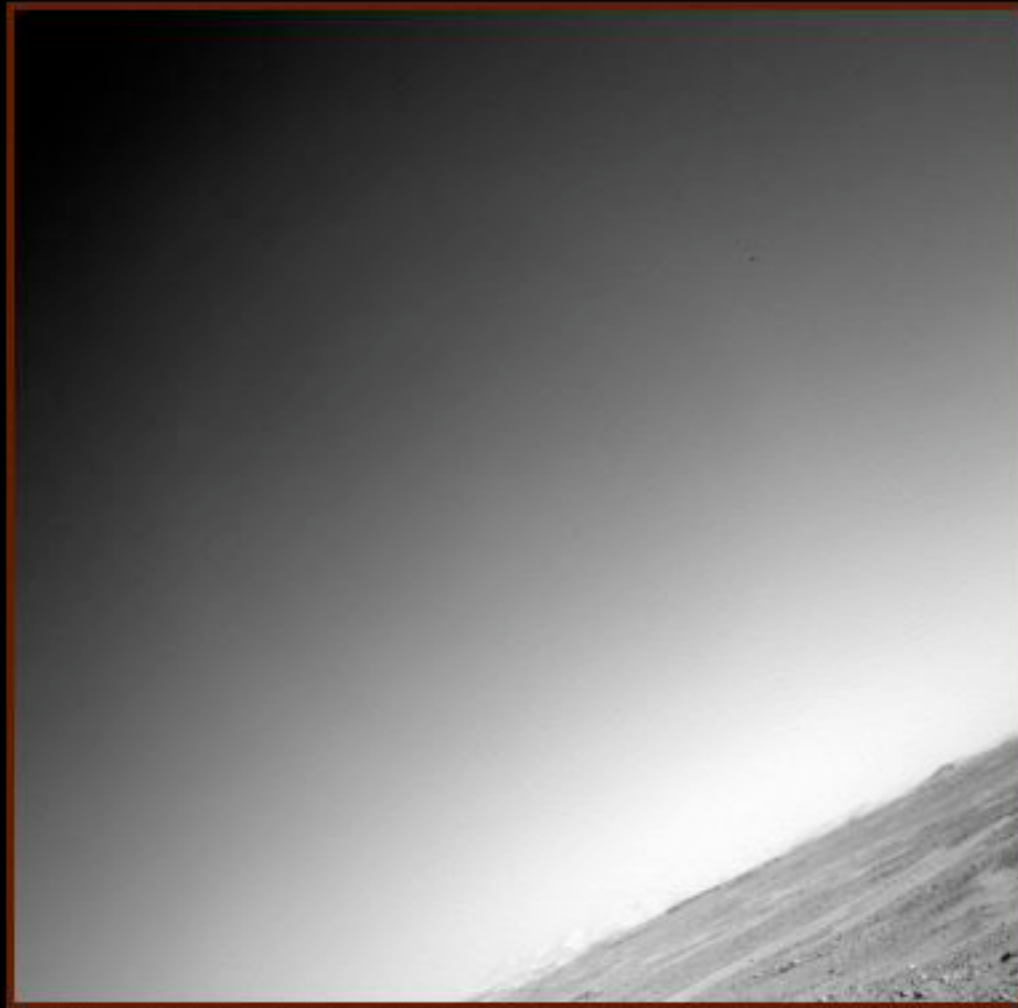
On July 27, Spirit was commanded to journey up the Columbia Hills, but the terrain was too steep for the maximum-tilt-angle limit, set at 25 degrees.

Navigation camera image, 3:10 p.m. Mars Local Solar Time, July 27, 2004.

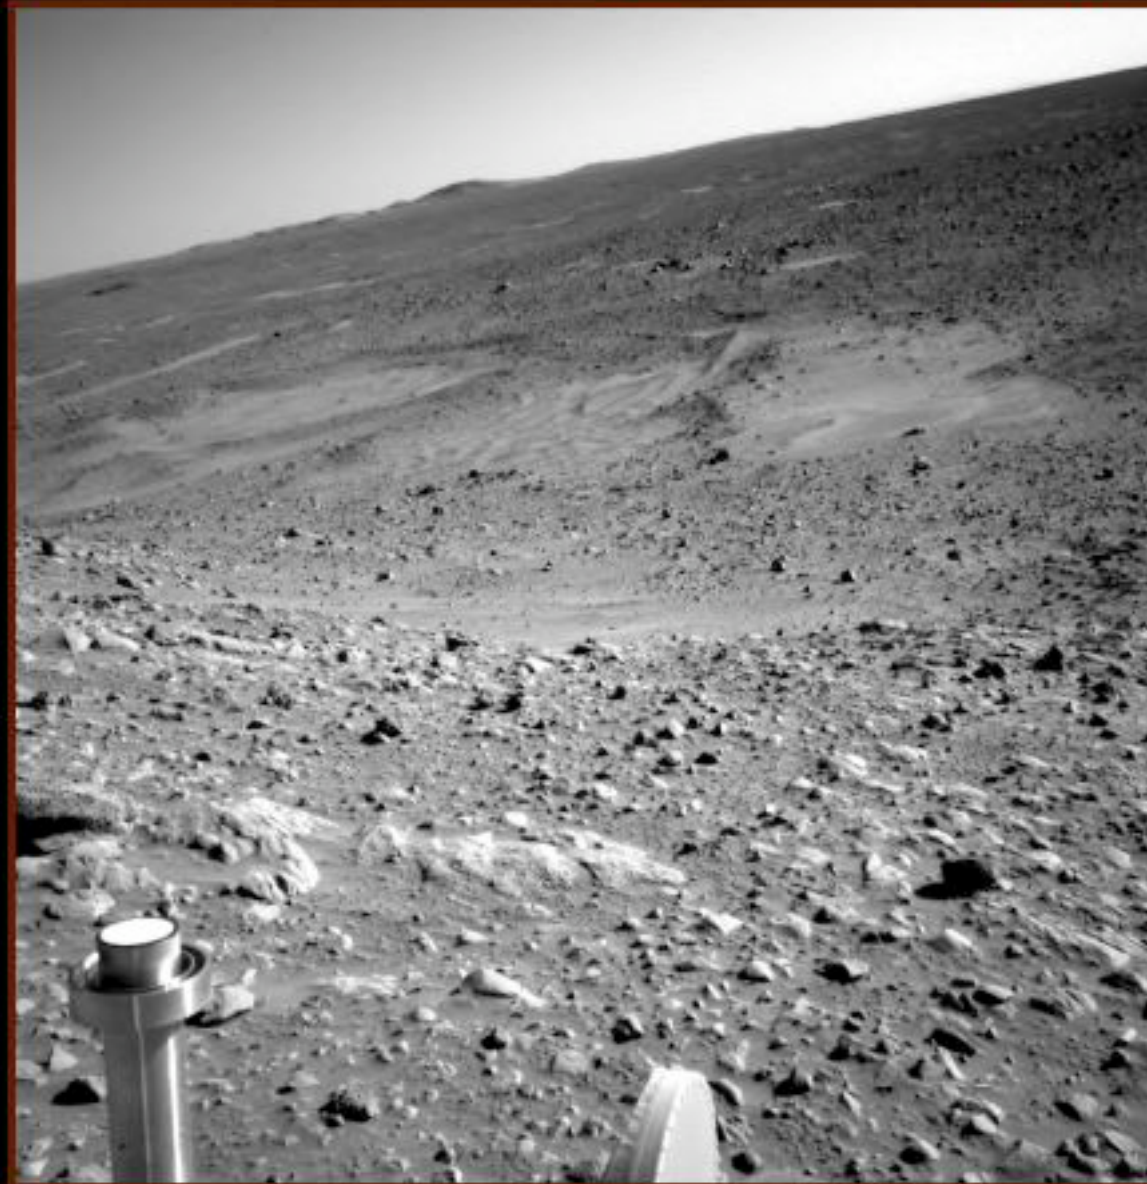
**On July 28, engineers set the max tilt angle to 32 degrees,
and Spirit made it 83.6 feet (25.5 meters) up the hill.**

Navigation camera image, 3:18 p.m. Mars Local Solar Time, July 28, 2004.
