Mars Exploration Rover Mission

**Spirit
and
Opportunity**

**Week in Review
August 7 - August 20**

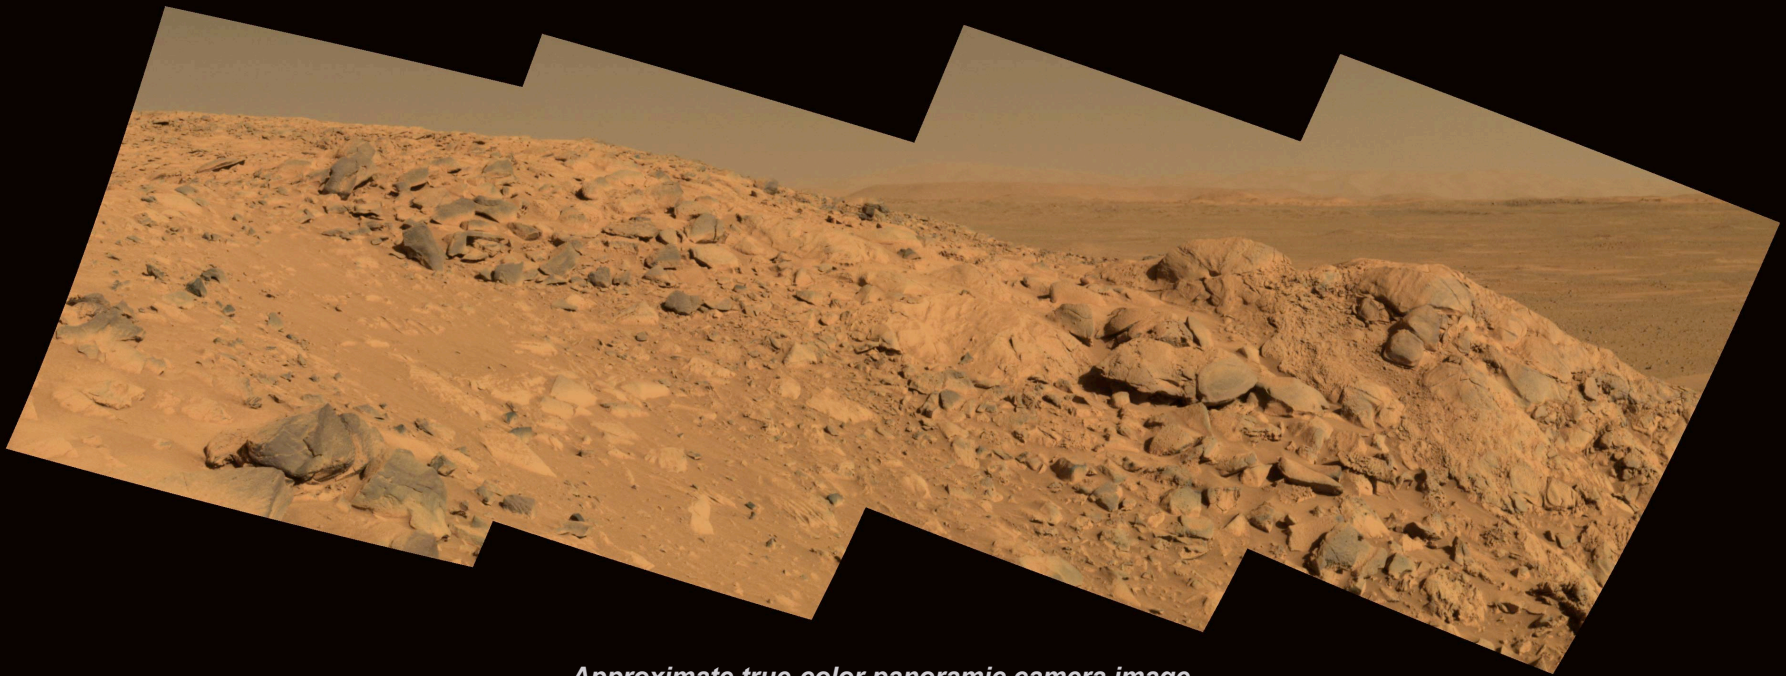
Approximate true-color panoramic camera image.

**This is a rock outcrop dubbed “Longhorn,”
and behind it are the sweeping plains of Gusev Crater.**

**The rim of the crater is on the horizon.
It is more visible now because the atmosphere
is less dusty than earlier in the mission.**

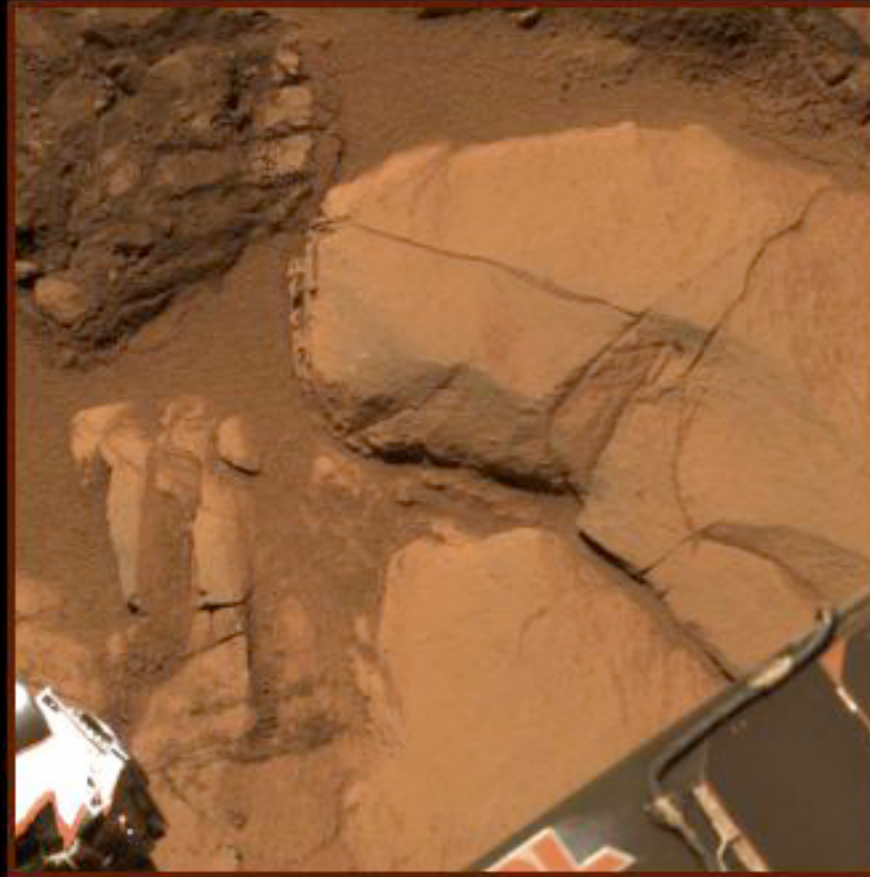
Approximate true-color panoramic camera image taken August 13, 2004.

After the rover easily ground a hole into Clovis, it became clear that this rock, like Woolly Patch, is much softer than the basalt lava rocks studied previously at Gusev.

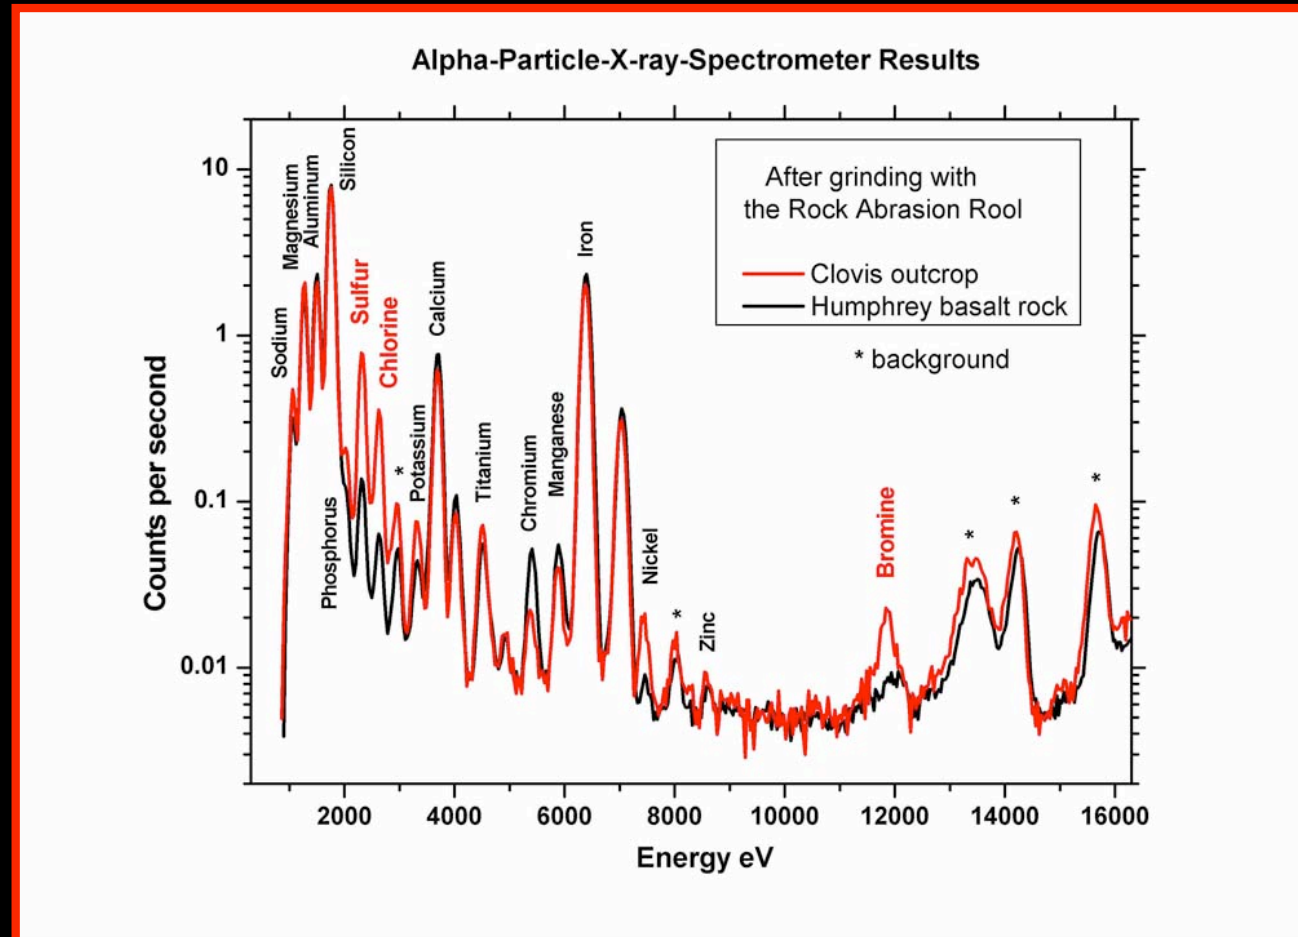
Clovis has higher concentrations of sulfur, bromine, and chlorine compared to volcanic rocks in the plains.

These higher concentrations of sulfur, bromine, and chlorine indicate that fluids probably once flowed through the rock, depositing minerals containing these elements.

*Data from Spirit's alpha particle X-ray spectrometer after the rover dug into Clovis with its rock abrasion tool.
Image credit: NASA/JPL/Cornell/Max Planck Institute*

Spirit's initial chemical analysis of the hole dug into Clovis suggests that water was likely active in Gusev.

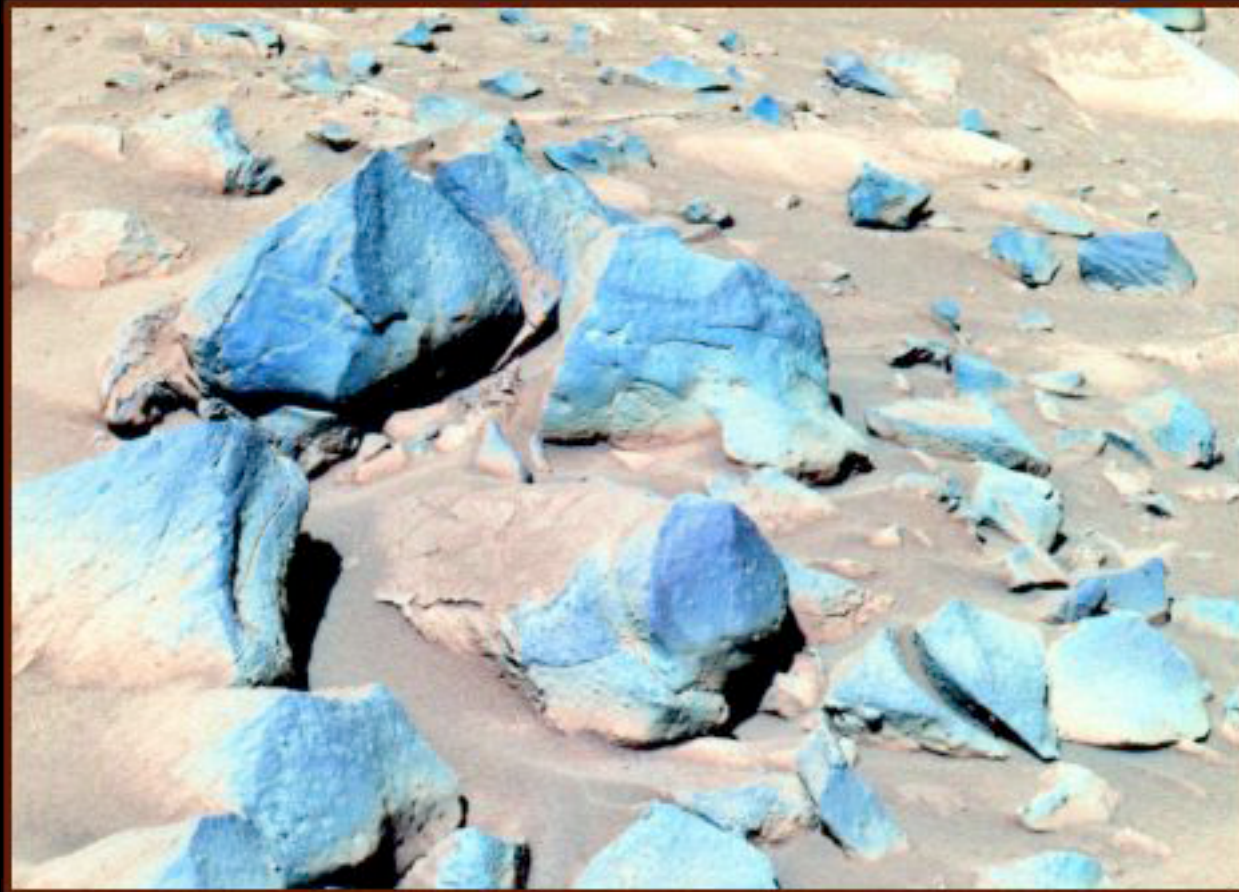
**A group of darker rocks dubbed “Toltecs”
are lying to the southeast of Spirit’s current position.**

False-color panoramic camera image taken on August 15, 2004.

**Scientists hope to use these presumably less altered
rocks as a standard for comparison to
strongly altered rocks like Clovis.**

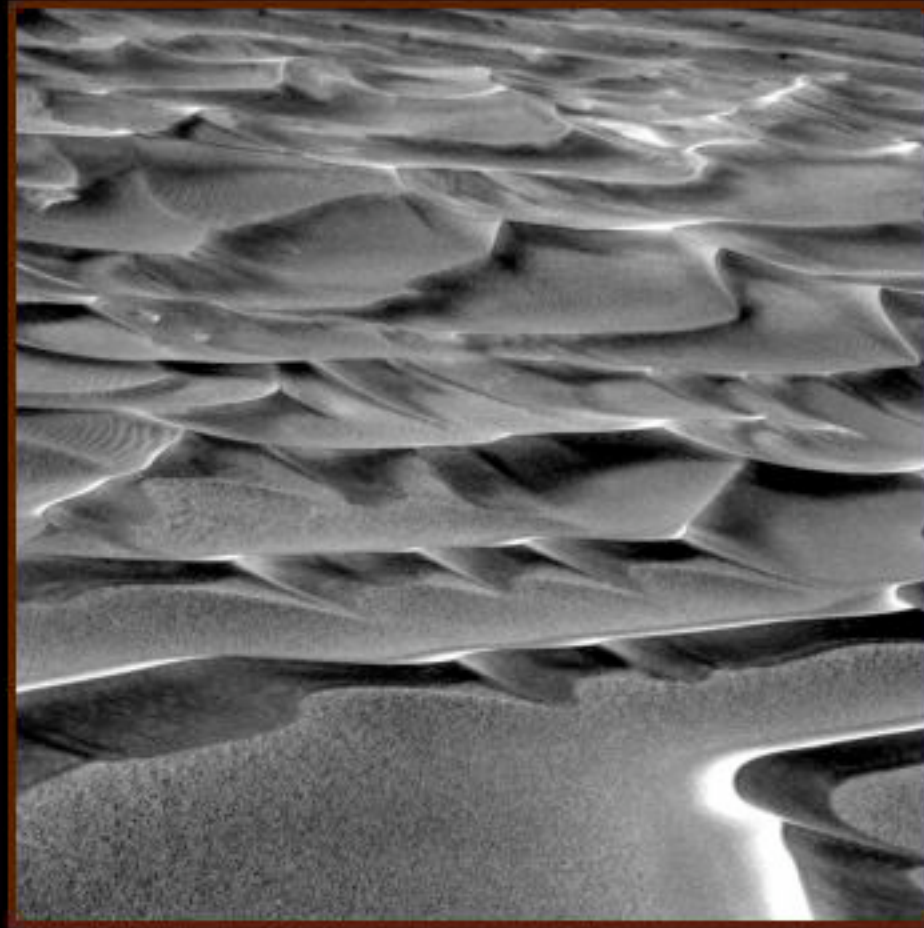
*Panoramic camera image
taken August 14, 2004.*

**The small scale ripples on top of larger dunes
suggest that wind has been moving these dunes
in geologically recent times.**

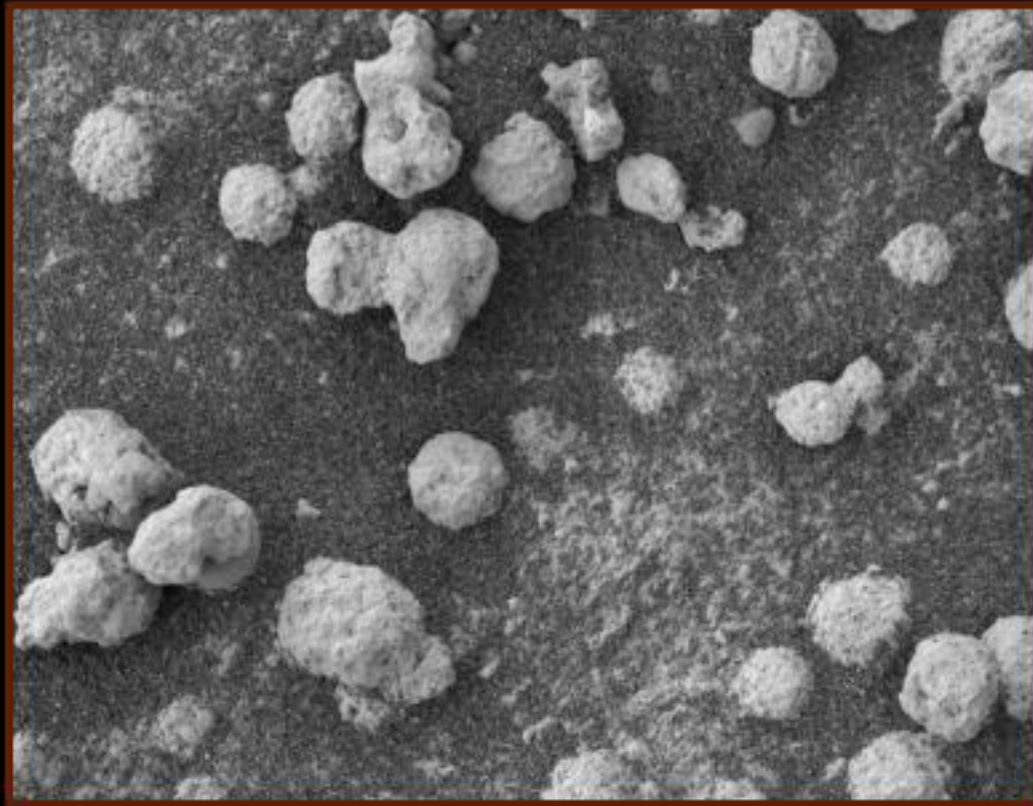
Opportunity found spherules on the surface of a rock dubbed “Bylot.” They are less round than the “blueberries” seen previously in Endurance Crater.

*Four-frame mosaic taken by the microscopic imager on August 15, 2004.
Image credit: NASA/JPL/Cornell/USGS*

Scientists are calling these light-colored, rough-textured spherules “popcorn.”

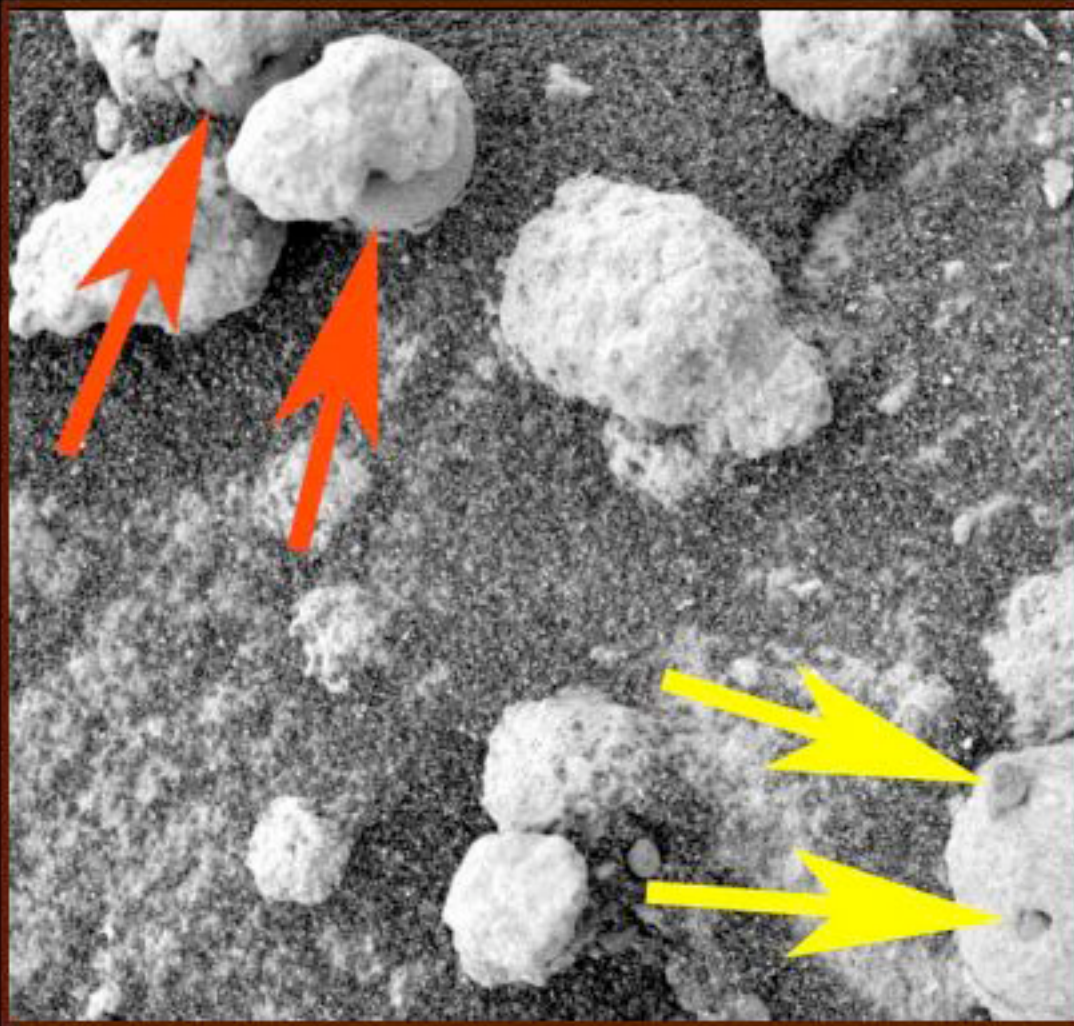
The red arrows point to blueberries partially covered with “popcorn” material.

Image taken by the microscopic imager on August 15, 2004.

The yellow arrows point to more puzzling objects, which may be blueberry fragments emerging from the popcorn material as the pebble weathers away.

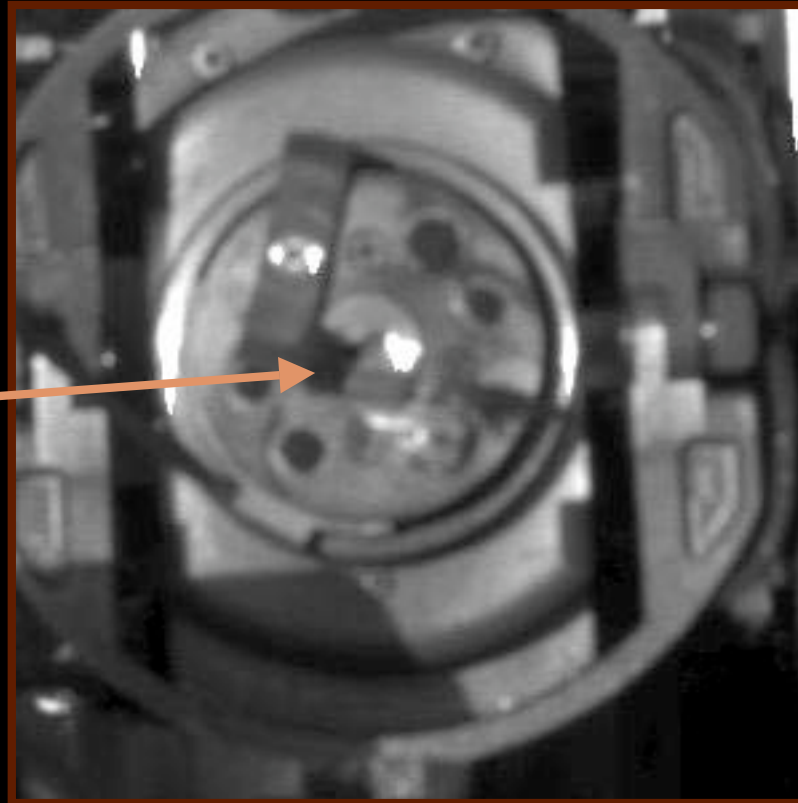
**Rogue
pebble?**

Opportunity's rock abrasion tool stopped working on August 15 most likely due to a pebble trapped between the cutting-blade and wire-brush rotors.

*Panoramic camera image of the rock abrasion tool taken on August 15, 2004.
The tool was closer than the camera could focus on sharply.*

Engineers are optimistic they can fix it by turning the rotors in reverse to release the pebble.

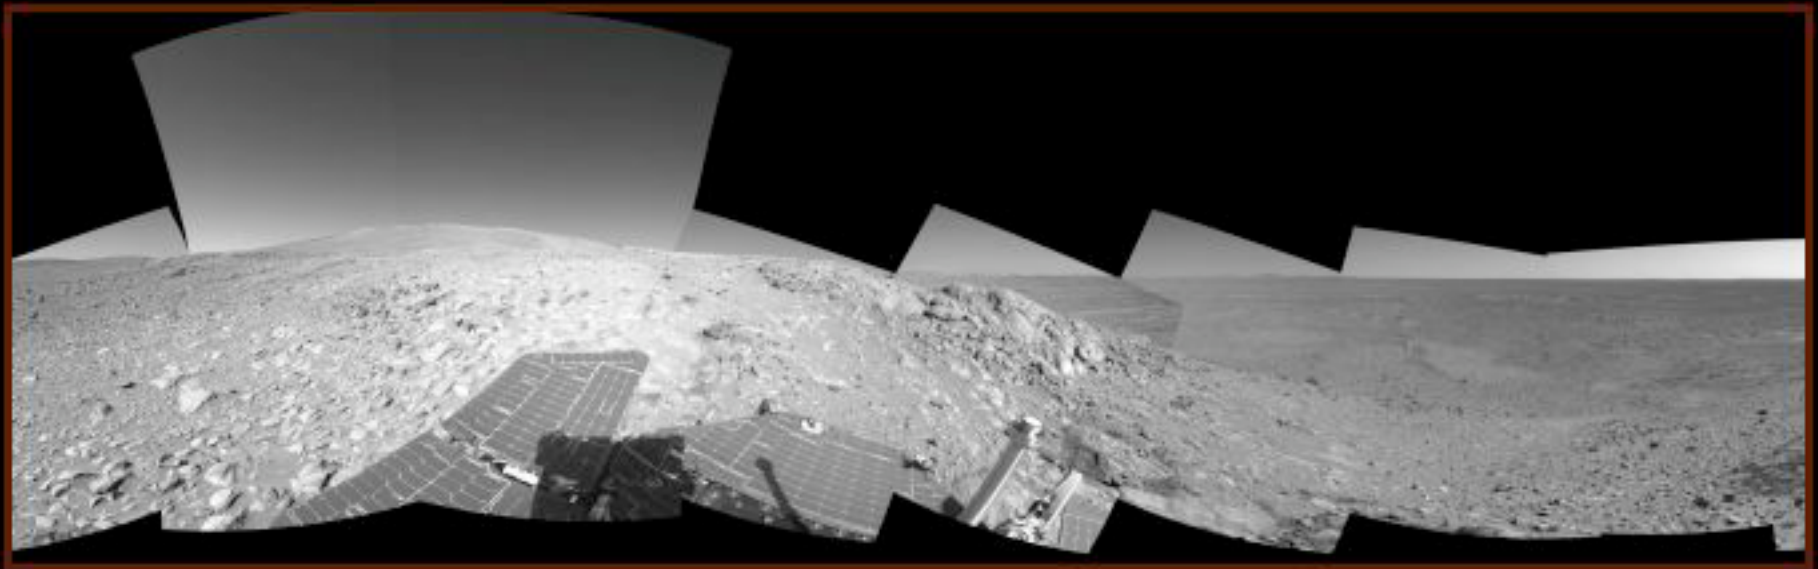
Spirit navigation camera mosaic taken between August 5 and August 8, 2004.

Spirit will continue studying the West Spur region of the Columbia Hills and take a color panoramic image from this location.
