# Geomechanics of Reinforced Cemented Backfill in an Underground Stope at the Lucky Friday Mine, Mullan, Idaho

**Report of Investigations 9655**

**Geomechanics of Reinforced Cemented Backfill  
in an Underhand Stope at the Lucky Friday Mine,  
Mullan, Idaho**

**T.J. Williams, D.K. Denton, M.K. Larson, R.L. Rains, J.B. Seymour, and  
D.R. Tesarik**

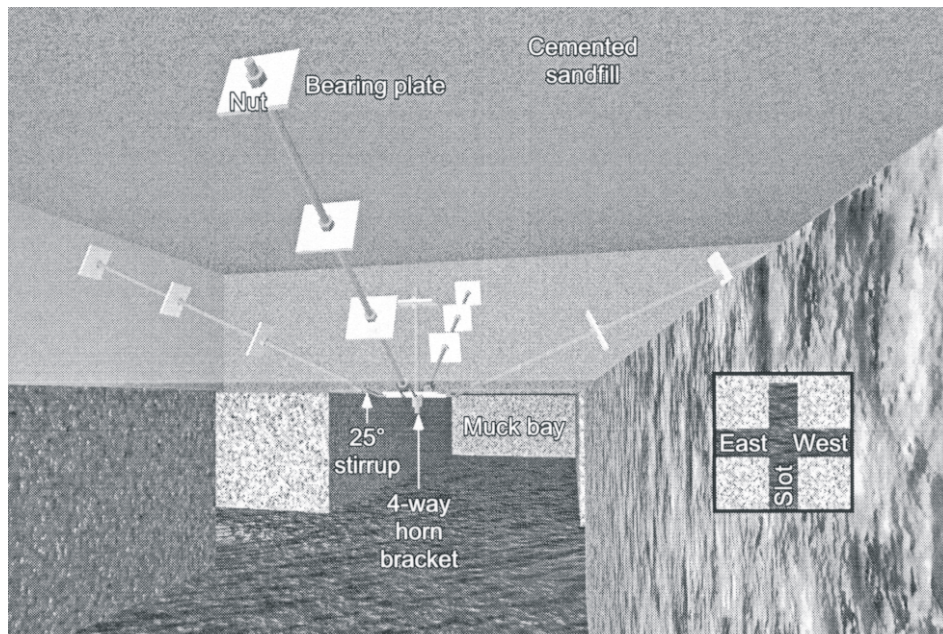
Figure 2.—Intersection truss system.

A four-way truss was installed at the center of the intersection in addition to the vertical rock bolts typically used as reinforcement. The truss was constructed using No. 7 Dywidag rock bolts having a minimum yield strength of 160 kN (36,000 lb). It consisted of one vertical rock bolt, four legs angled 15° to 20° from the horizontal, one four-way horn bracket, and four stirrup U-bolts bent upward at 25° from the horizontal. The horizontal legs consisted of two or three rock bolts joined together with couplings so that the ends of the legs lay outside the intersection into the east and west sides of the stope along the vein and into the slot and the muck bay (figure 2).

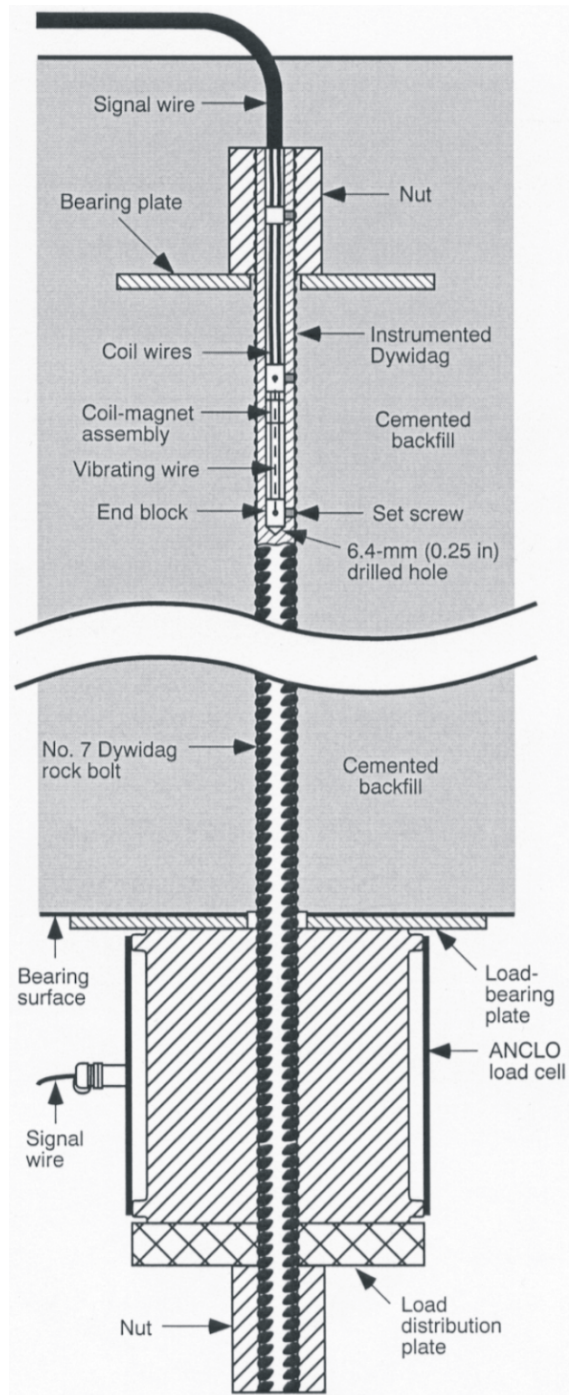
Figure 3.—Rock bolts instrumented with load cells.

Instrumented No. 7 Dywidag rock bolts were obtained from Roctest, Plattsburgh, NY, to measure induced load on the rock bolts used for backfill reinforcement. Roctest installed a vibrating-wire strain gauge and thermister in one end of each rock bolt. These instrumented rock bolts were placed at the ends of all the truss legs. They were also used to replace some of the vertical rock bolts throughout the stope. All instrumented

ALC10 rock bolt load cells were also obtained from Roctest to provide redundant readings on the vertical rock bolts and the truss. Load cells were the only instruments that could be used to obtain load readings at the junction of the stirrup and the horizontal legs at the truss bracket because blasting at this location would have destroyed the instrumented rock bolt wires. The load cells were installed on the lower end of instrumented rock bolts (figure 3) and on the truss legs after mining had passed. The load cells survived better than the instrumented rock bolts because the wires were not subjected to backfill deformation.

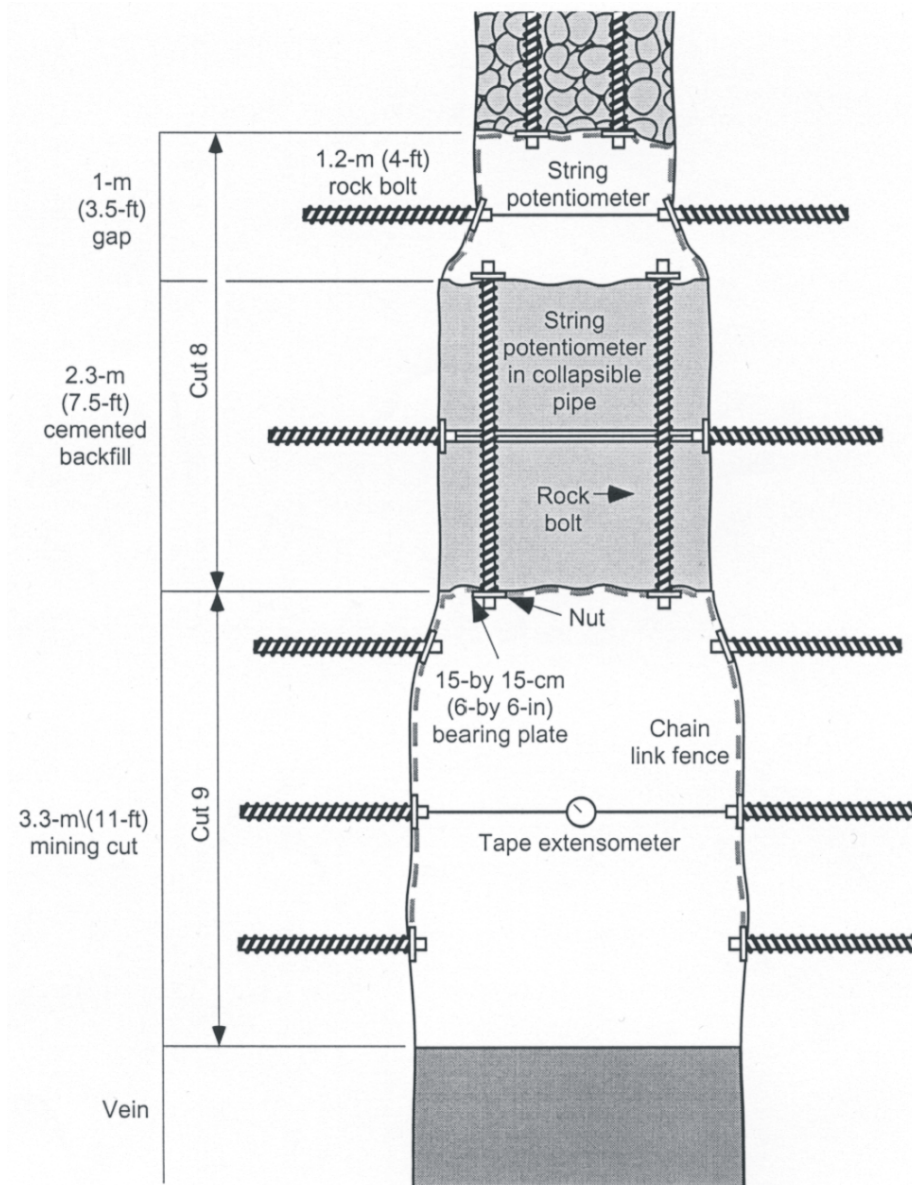
Figure 4.—Wall closure instrument locations.

At various locations, wall-to-wall closure was measured in three different vertical positions (figure 4). A closure plane in the 1-m (3-ft) gap above the backfill was measured with string potentiometers. Another closure plane across the backfill was measured with string potentiometers inside collapsible steel casings, and a closure plane in the new stope cut was measured with a tape extensometer. All closure readings were taken between 15- by 15-cm (6- by 6-in) bearing plates on 1.2-m- (4-ft-) long rock bolts to achieve as much accuracy as possible.

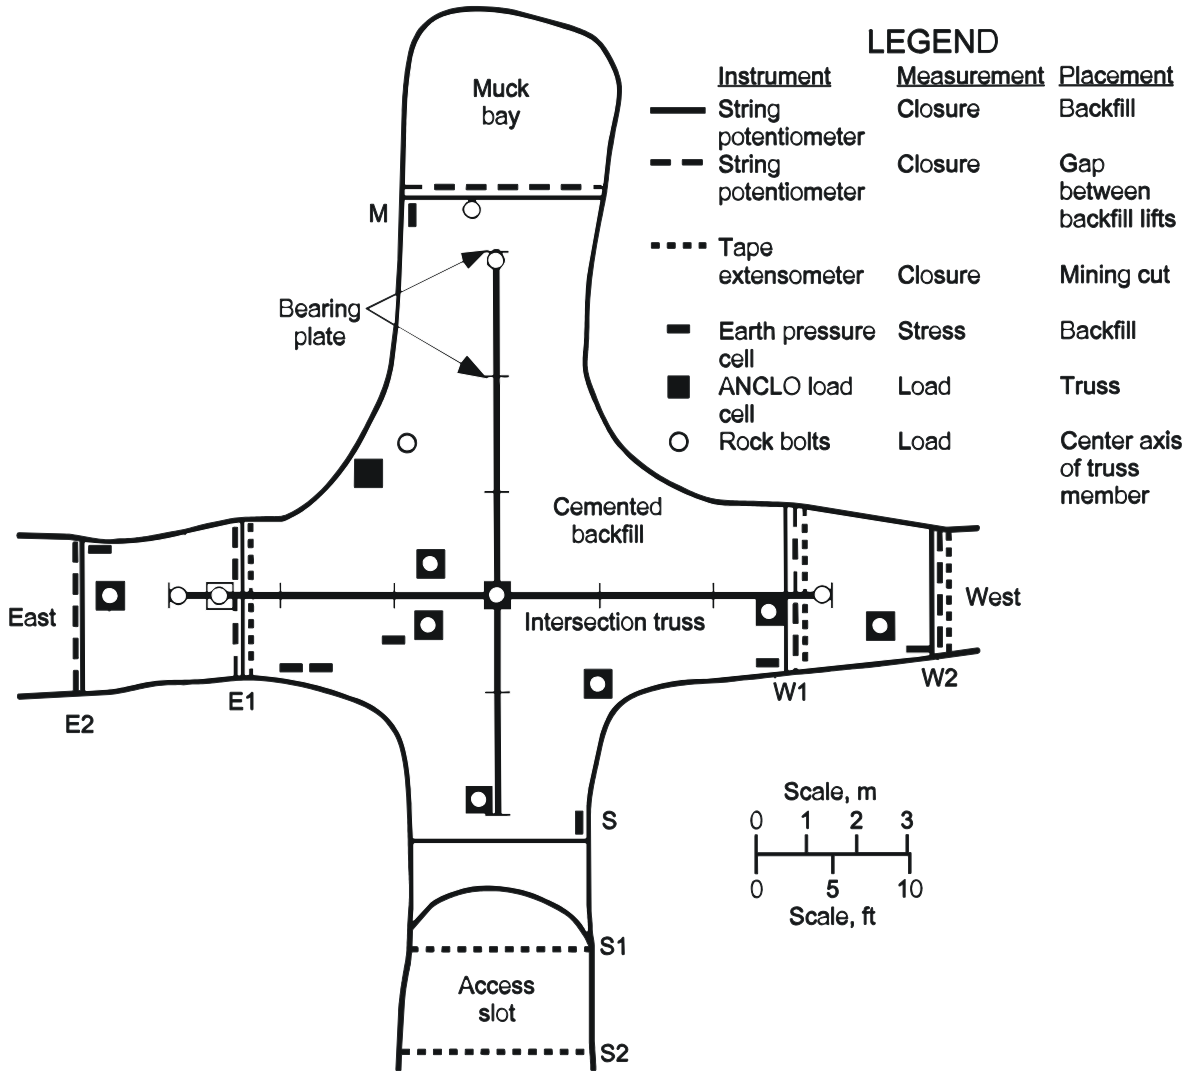
Figure 5.—Location of instruments in 5660-05-level intersection.

Figure 5 shows the location and types of instruments installed in the intersection.

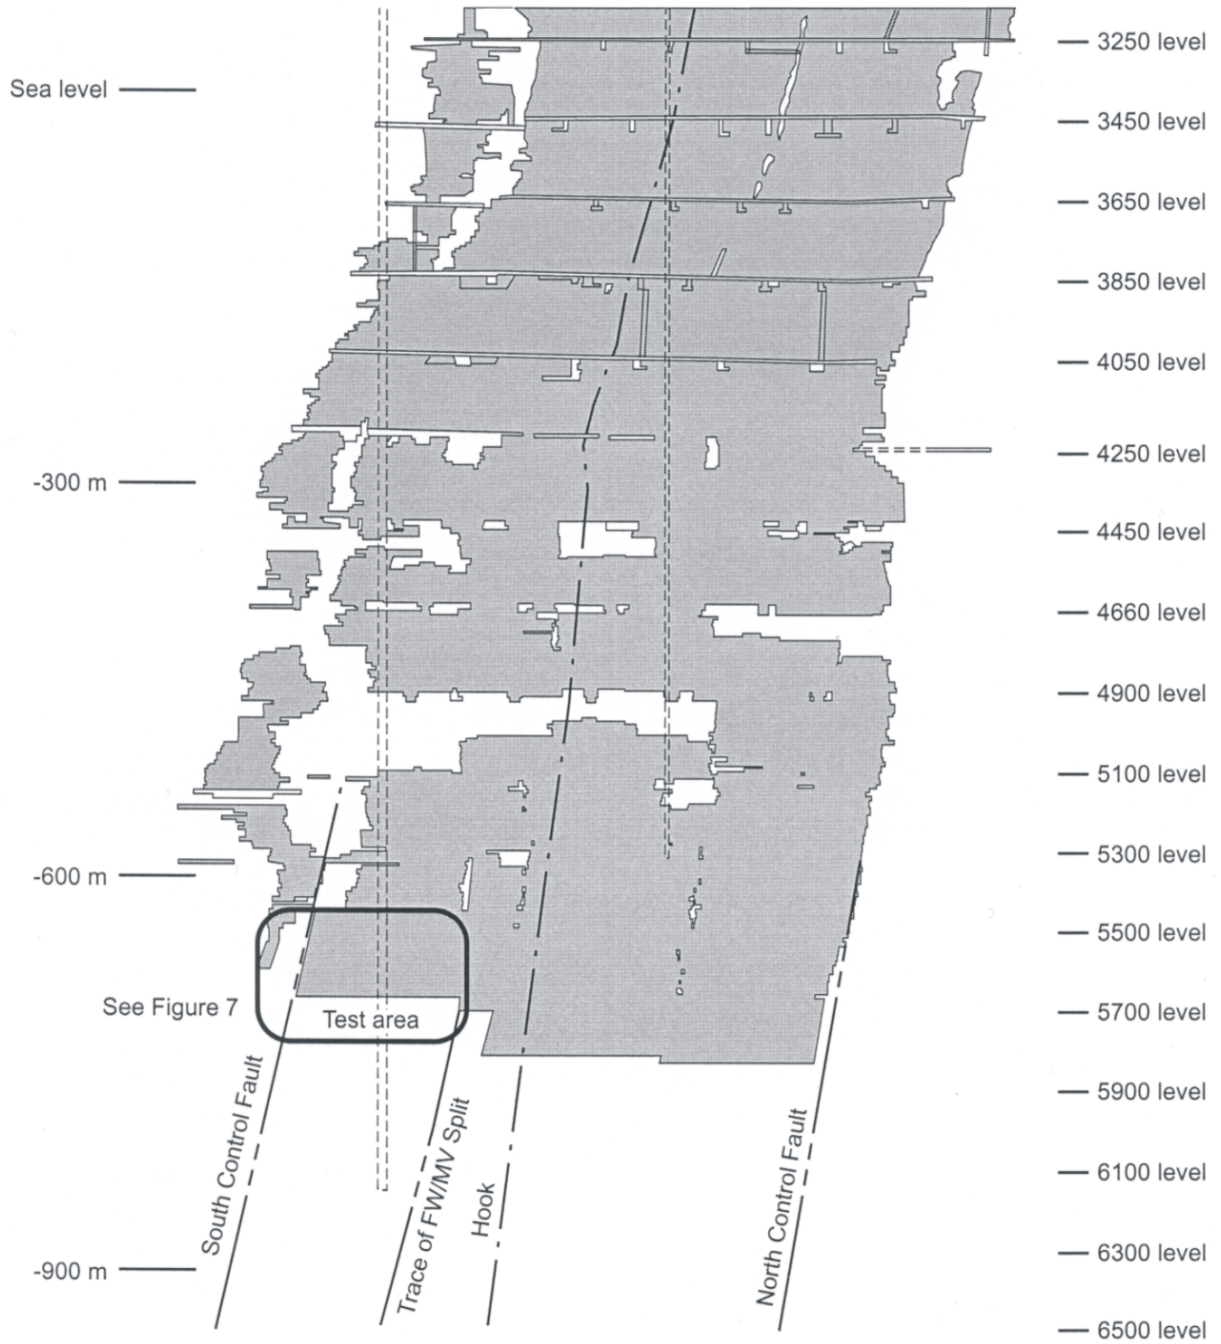
Figure 6.—Longitudinal projection of Lucky Friday Mine.

After the instruments were calibrated at SRL, they were installed in the mined-out cut 8 of the 5660-05 stope prior to placement of the backfill. Figure 6 is a longitudinal projection of the Lucky Friday Mine with the test stope location shown in the lower west corner. Figure 7 is an expanded view showing the cut sequence for the 5660 and 5750 sublevels and the location of the instrument site. On October 15, 1997, the intersection was backfilled with 2.3 m (7.5 ft) of cemented mill tailings so that the truss legs were completely covered. Because the stope was only filled for 2.3 m (7.5 ft) of its 3.3-m (11-ft) height, additional string potentiometers were installed wall-to-wall in the gap on October 16. The datalogger was then moved

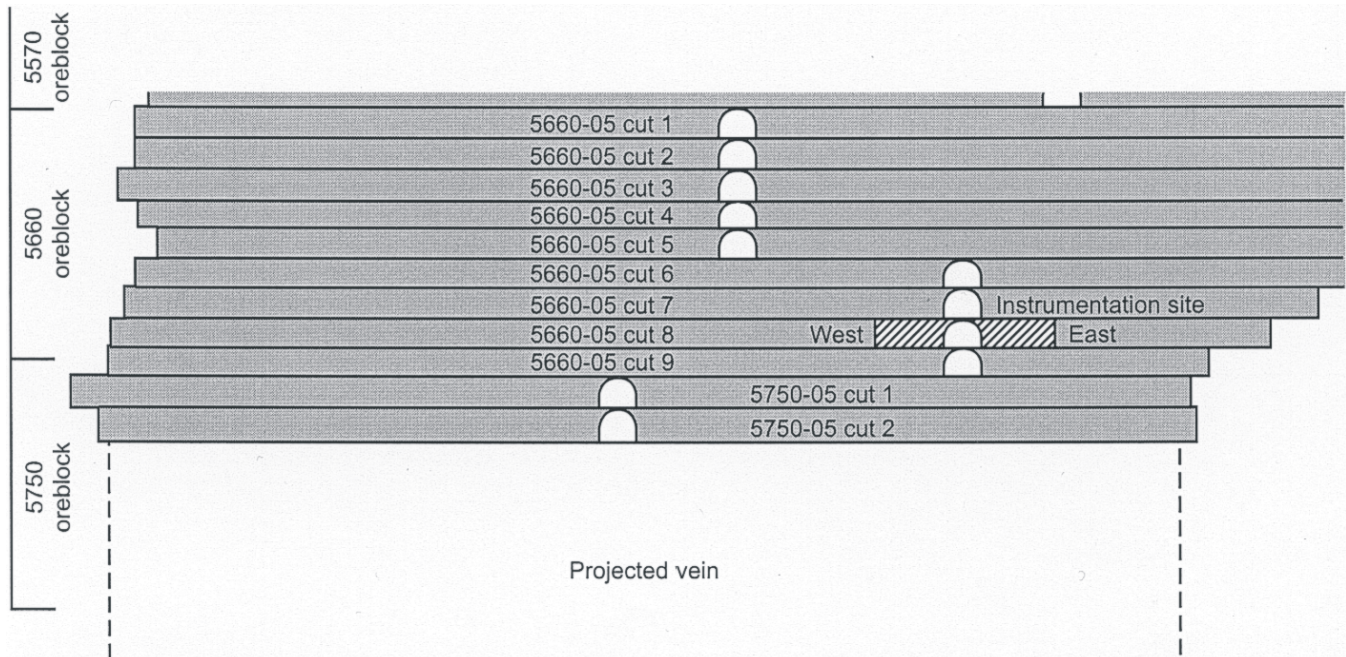
Figure 7.—Cut sequence for 5660 and 5750 sublevels showing location of instrumented intersection.

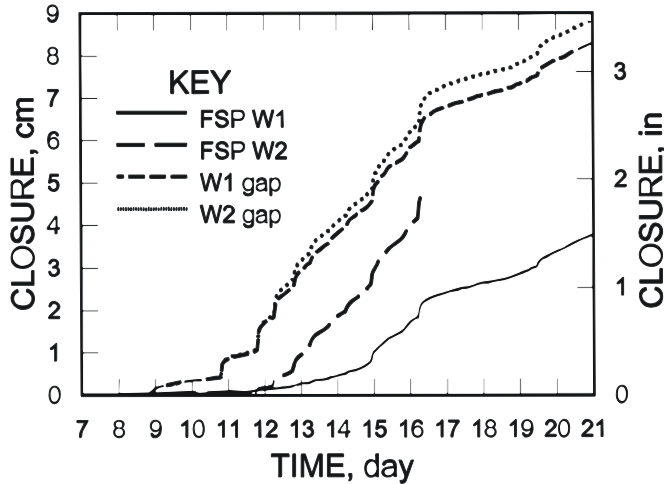
Figure 8.—Gap and backfill closure versus time.

String pots placed in the backfill showed the vein walls had converged an average of 7.9 cm (3.1 in) during mining of cut 9 on the 5660 level, 8.9 cm (3.5 in) during mining of cut 1 on the 5750 level, and 8.0 cm (3.2 in) during mining of cut 2 on the 5750 level. At the same time, vein closure measured by string pots in the gap area averaged 14.0 cm (5.5 in) for cut 9 on the 5660 level, 11.5 cm (4.5 in) for cut 1 on the 5750 level, and 9.7 cm (3.8 in) for cut 2 on the 5750 level. Increased amounts of closure across the gap were caused by a lack of support for the walls in this area. Gap closure also began 1 or more days

before closure in the backfill (figure 8), a further indication that the backfill was supplying wall support. The amount of overall wall closure would probably be the same, but the backfill supplied enough support so that fractures in the stope walls closed before the backfill started to yield. There were no borehole closure extensometers in the walls, so this hypothesis could not be confirmed.

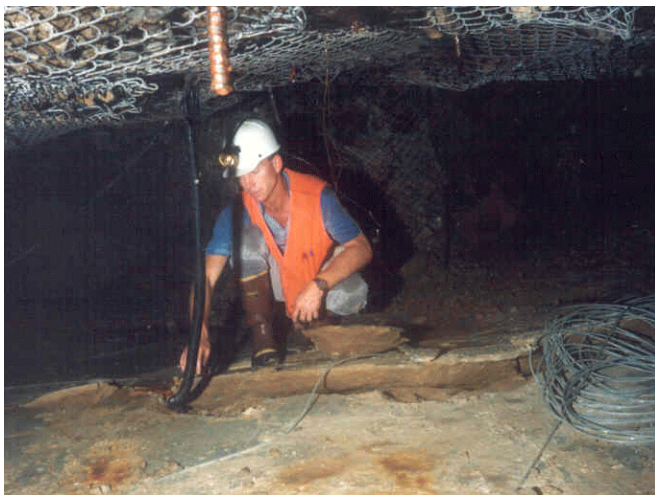
Figure 9.—Thrust-fault-type failure, November 4, 1997.

A thrust-fault-type of fracture (figure 9) was noticed at the top of the backfill while retrieving the CR10's data canister on November 4, 1997. The failure went across the intersection and into the east and west headings along the vein. Both 2- and 2.4-m- (6- and 8-ft-) long vertical rock bolts had been placed in

the area. Failure appeared to be above the 2-m (6-ft) rock bolts, but blocked by the 2.4-m (8-ft) rock bolts, the ends of which were just visible at the top of the fill.

This failure was caused by convergence of the vein walls on the backfill. At this time, there had been 2.5 to 7.6 cm (1 to 3 in) of horizontal closure across the vein in the backfill and 7.6 to 15 cm (3 to 6 in) in the gap above the instrumented backfill.

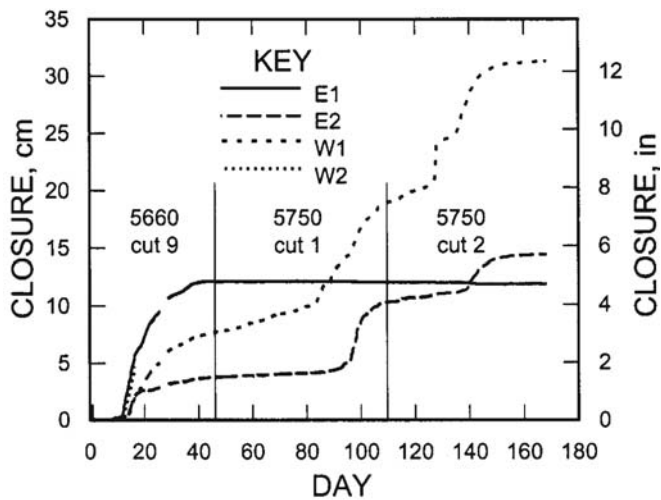
Figure 10.—Backfill closure as a function of time.

Fracturing of the backfill caused upward buckling that gradually reduced the gap between the backfills over time. Buckling continued until the initial 1-m (3.5-ft) vertical gap was reduced to less than 0.3 m (1 ft) before the backfill from cut 7 collapsed onto the instrumented cut 8 backfill. Table 1 is a summary of original stope widths, and table 2 shows closure readings for the three mining cuts. Figure 10 shows backfill closure as a function of time for three mining cuts. Total closure includes

some rapid closure as the cut was mined past the instruments and more gradual time-dependent closure resulting from all previous mining in the area.

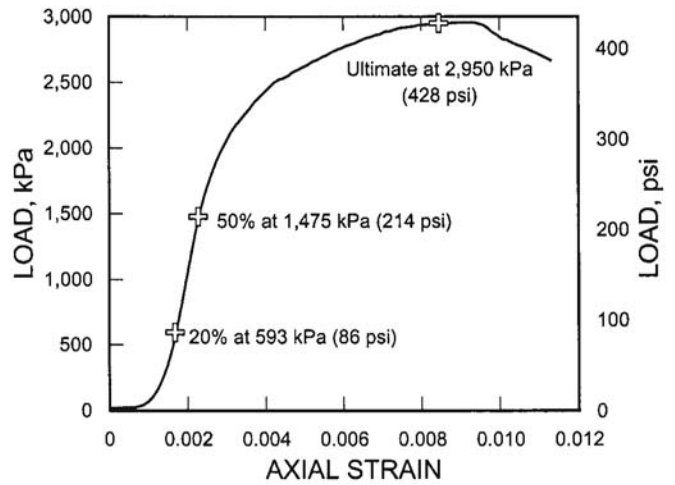
Figure 11.—Compressive test of cemented sandfill, stress/strain curve.

Movement of the platen head of the compression test machine was also recorded to determine an apparent modulus for the 7- and 28-day compressive tests. Figure 11 is an example of the stress-strain curve for the tests. The modulus for the samples is calculated between the 20% and 50% strength values because this is the straight line portion of the curve and most representative of the true response of the backfill. The equation used is —

$$\text{20-50 modulus} = \frac{(50\% \text{ strength} - 20\% \text{ strength})}{(50\% \text{ strain} - 20\% \text{ strain})}$$

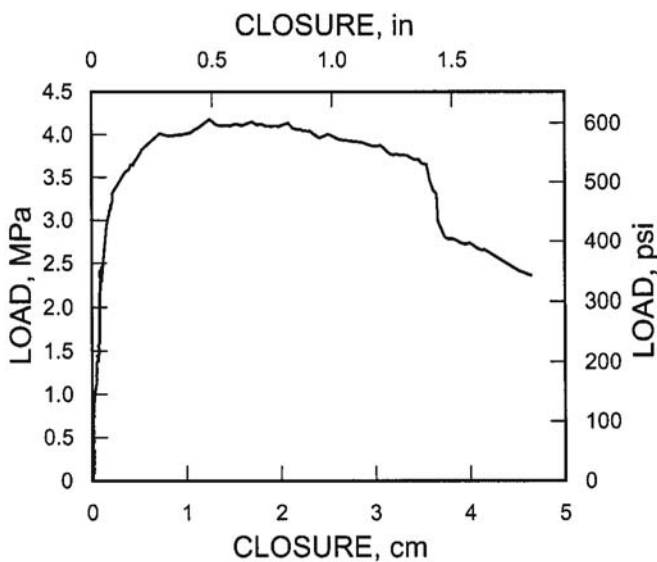
Figure 12.—Backfill closure versus backfill pressure, West 2.

Model 3500 earth pressure cells from Geokon, Inc., were placed in the cemented backfill to monitor pressure as the walls closed. The backfill pressure increased rapidly as wall closure commenced (figure 12). The readings peaked with mining of cut 9, after which backfill pressure dropped as each subsequent cut was completed. Peak pressures ranged from a low of 793 kPa (115 psi) in the intersection to 4178 kPa (606 psi) at West 2; the average across the vein was 2757 kPa (400 psi) at 15 days. The data collected in the mine were within the range of the data collected in the laboratory (7-day unconfined compressive strength of 2082 kPa [302 psi] and 28-day unconfined compressive of 3254 kPa [472 psi]).

The 20-50 moduli determined at locations E1, E2, W1, and W2 were 681, 1513, 2361, and 5095 MPa (98,760, 219,400, 342,400, and 738,800 psi), respectively, and averaged 2412 MPa (349,800 psi). Strain was determined by dividing measured wall closure by the original opening width. These modulus values were documented 8 to 12 days after the backfill had been poured and as mining of the following cut passed the instrument locations. These data show that the ultimate strength of the cemented backfill was surpassed by loading induced by the large amounts of wall closure experienced in the stope. Thus, rock bolt reinforcement is needed to maintain the integrity of the backfill so that it will be safe for miners to work under.

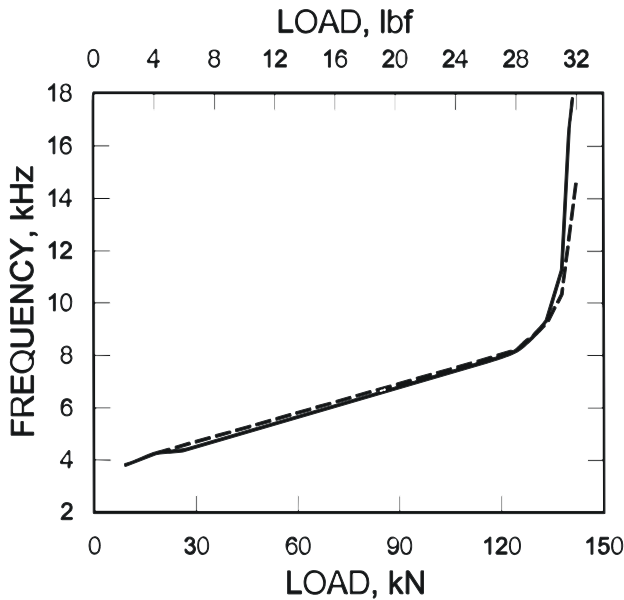
Figure 13.—Calibration curve showing relationship between frequency and load on instrumented rock bolts.

These tests showed that the hole drilled for the vibrating wire did not affect the yield strength of the bolt, but that it did reduce ultimate strength from 240 to 215 kN (54,000 to 48,450 lb). The slope of gauge response was linear between 8.9 and 124 kN (2000 and 28,000 lb) at 27 N/Hz (6 lb/Hz). Gauge response was then rapidly reduced to 2 N/Hz (0.45 lb/Hz). At 142 kN (32,000 lb), the gauges failed before the yield point of the rock bolts was reached. Figure 13 shows calibration load versus gauge response frequency for the bolts tested to failure. These tests showed that the vibrating-wire gauges installed in the end of the bolts were inadequate for this application and any future tests should use a gauge with a higher load range. The data were reanalyzed using this calibration curve.

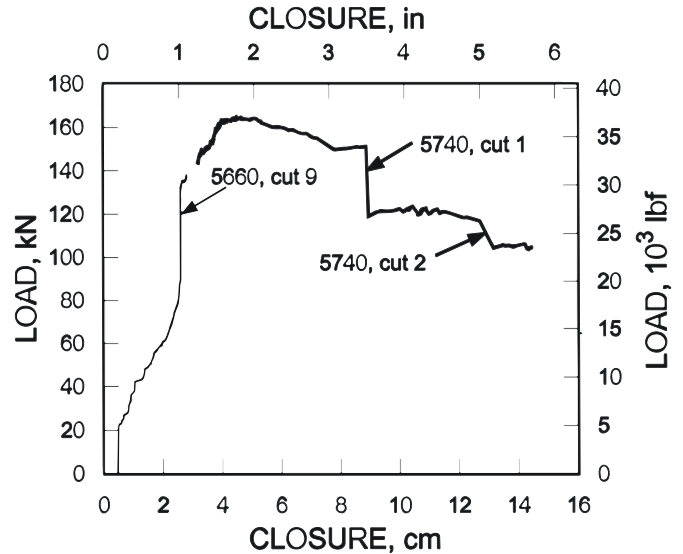
Figure 14.—Backfill closure versus rock bolt load, East 2.

Data from the rock bolt load cells indicated that the vertical rock bolts were under loads from 41 to 179 kN (9300 to 40,300 lb) after cut 9 was mined except in the muck bay, where loads ranged from 2.9 to 19.1 kN (660 to 4300 lb). Loads on the vertical rock bolts along the vein dropped as cuts were subsequently mined. This drop was probably a result of the continued breaking up of the backfill as the walls closed. Figure 14 shows the relationship of rock bolt load to backfill closure at East 2. The data indicate rock bolt load leveling off and

decreasing as closure continued following each mining cut. This drop was probably caused by backfill failure around the rock bolt bearing plates as the walls converged. Inspection of the bottom of the backfill revealed bags of broken backfill in the chain link fencing between the rock bolt plates. Visual observation of the top of the 2.4-m- (8-ft-) long vertical rock bolts also confirmed that the 15- by 15-cm (6- by 6-in) bearing plates resisted backfill deformation and transferred load to the rock bolt.

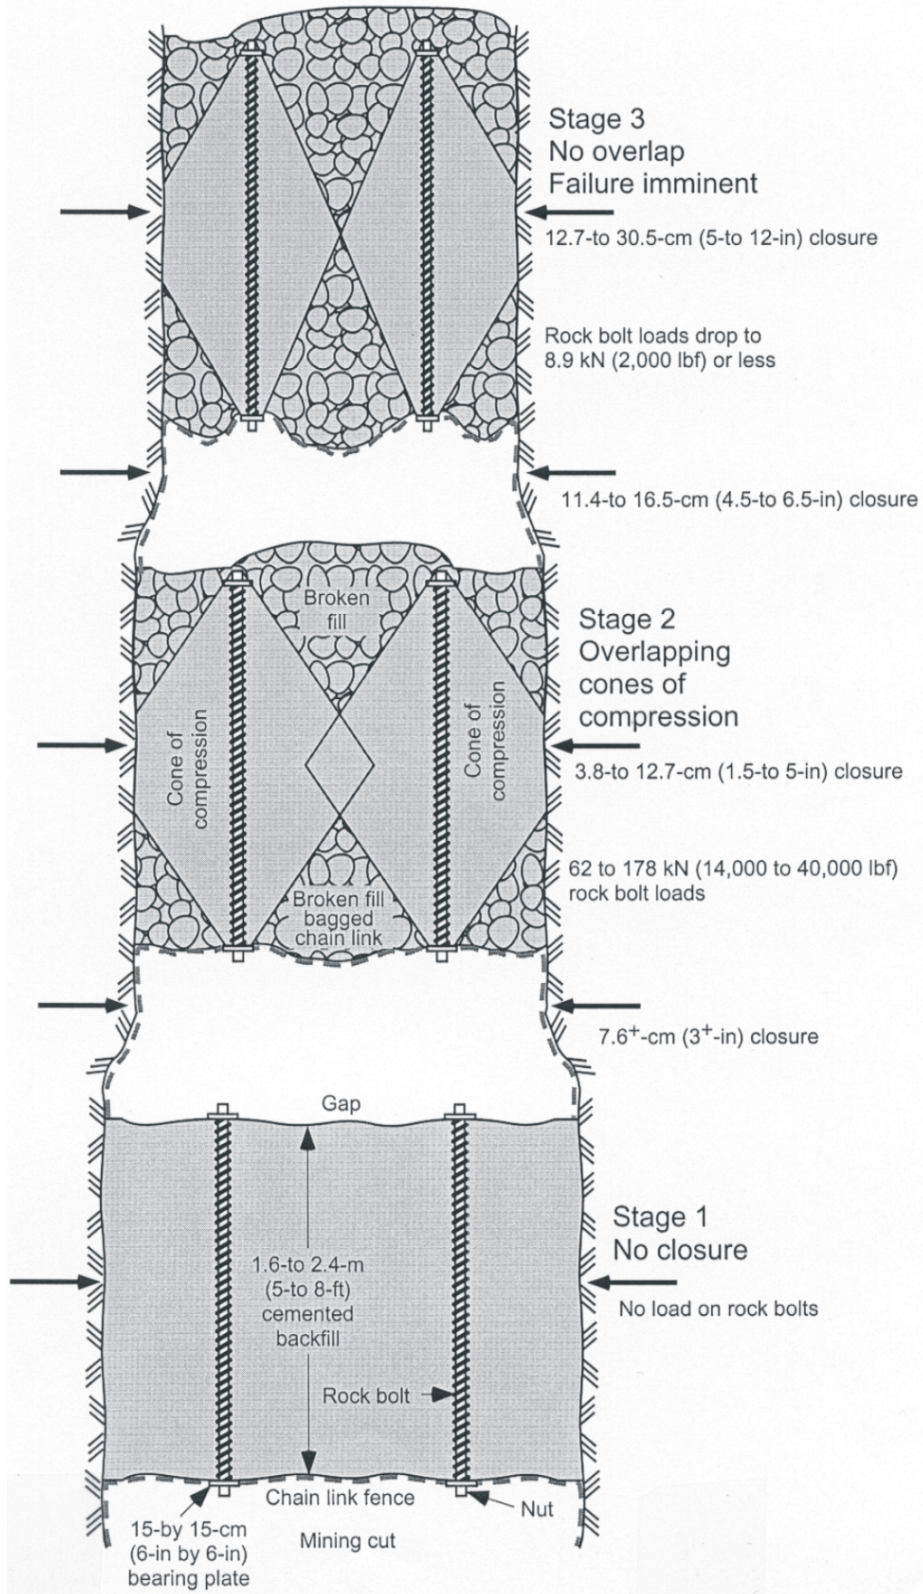
Figure 15.—Closure sequence in backfill.

Figure 15 is an idealized drawing of how the instrumented rock bolts interacted with the cemented backfill in the vein portion of the stope as mining progressed. This interpretation is based on conventional theories of rock bolt reinforcement that state that tensioned rock bolts create a self-supporting compressive arch across the opening (Lang 1961; Hoek and Brown 1980; Stillborg 1986; Brady and Brown 1993). The illustration is also based on visual observations, closure measurements, and load readings on the vertical rock bolts gathered during this project. Initially, in stage 1, there is no wall closure, pressure in the backfill, or load on the reinforcing rock bolts. Then forces in the backfill, created as the bearing plates resist backfill deformation caused by wall closure, form a cone of compression in the backfill (stage 2). The backfill is self-supporting until the backfill breakup progresses to the point where the overlap of the cones of compression between adjacent vertical rock bolts is eliminated (stage 3). The backfill then collapses because of gravity.

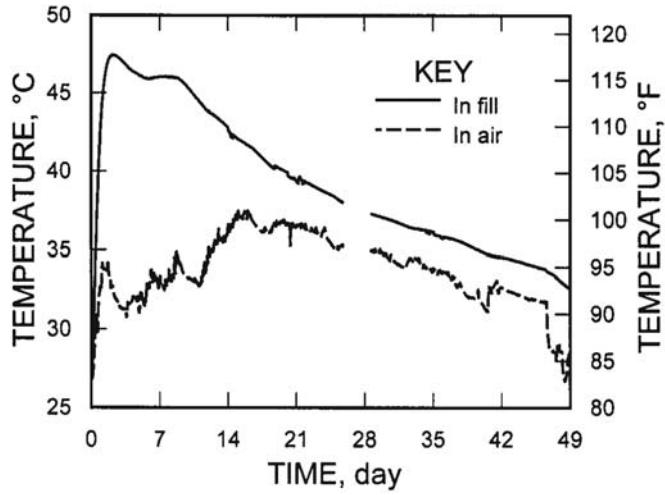
Figure 16.—Temperatures recorded on rock bolts in backfill and in mine atmosphere.

The instrumented bolts and two of the earth pressure cells had temperature sensors attached in case large temperature fluctuations required that calculations be made to compensate for these fluctuations. The sensors on the bolts were on the end of the bolt with the strain gauge, and the temperature readings reflected the position of the gauge with respect to the surface of the sandfill. The readings from the 2.4-m- (8-ft-) long rock bolts in the intersection were lower than the other readings because the ends of these bolts were exposed to the air. Figure 16 shows average temperatures for the bolts in the backfill and those in the intersection. The 47.2 °C (117 °F) in-fill temperature at day 2 was the highest temperature recorded in the backfill and stemmed from the heat of hydration of the cemented backfill. The 32.2 °C (90 °F) recorded on the IA, IB, and IC rock bolts was air temperature in the unventilated area above the backfill. The data show that no temperature compensation was required for the strain gauges because loads were significantly higher than the temperature compensation. The data also give an indication of the heat load to the ventilation system from the heat of hydration of the cemented backfill.

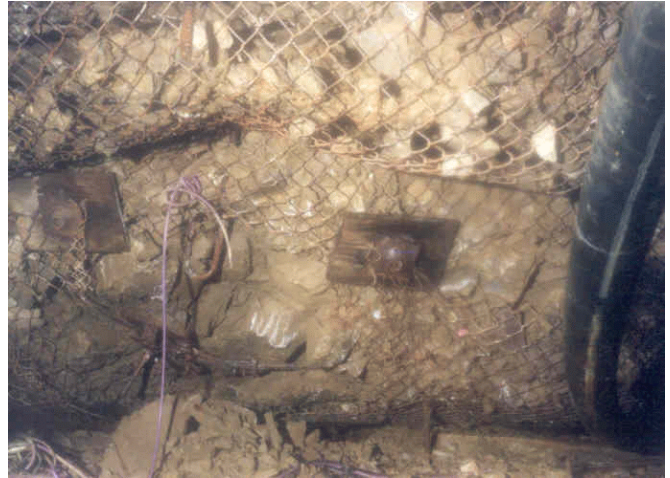
Figure 18.—Backfill failure at four-way bracket.

Visual inspection of the intersection on March 3 showed that the backfill in the northwest corner of the intersection had collapsed onto the backfill in cut 9, but that the truss was still above the backfill. It was not possible to determine how far the failure extended along the west side of the stope, but it is thought that, based on instrument response, failure was limited to the first 3 m (10 ft) of the west side. The 3-m- (10-ft-) long cap placed here probably stopped further collapse, but the area was not accessible to confirm this belief. The weight of the backfill from cut 7 on top of the instrumented backfill and continued wall closure from mining in cut 2 on the 5750-05 level caused the intersection to collapse. The collapse was not hazardous to miners because there were two intact backfilled cuts between the collapse and the active mining area.

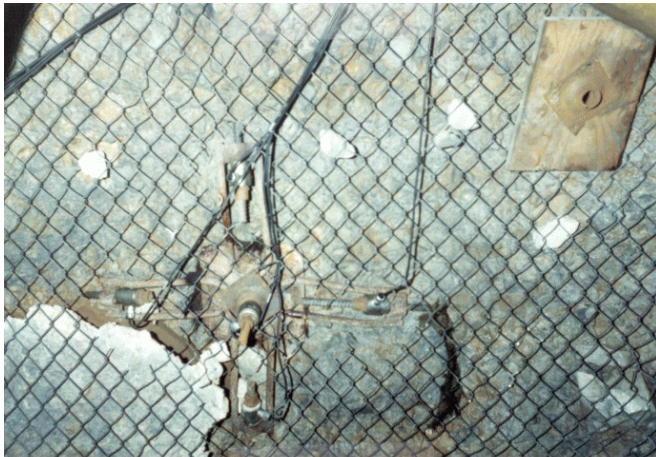
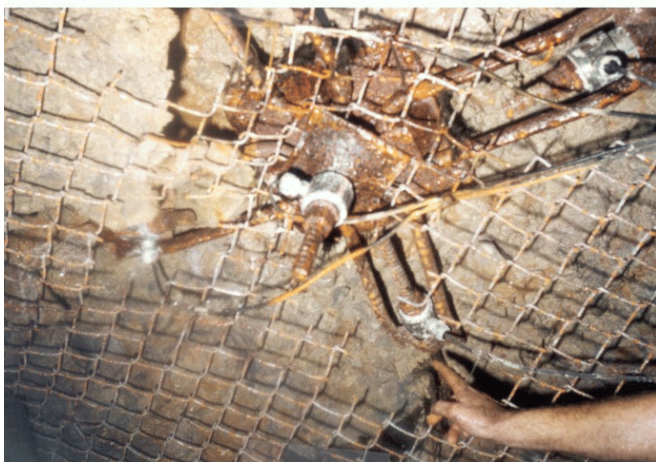
Figure 17.—Load cells at truss four-way bracket.

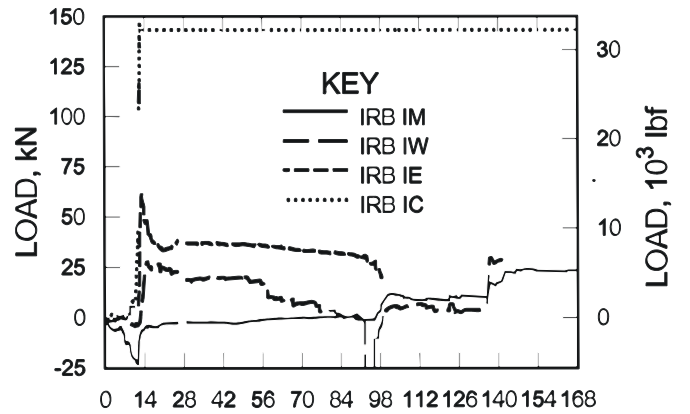
Figure 19.—Data from instrumented bolts in truss.

At day 136, the two remaining instrumented rock bolts on the muck bay leg and the west leg also recorded sudden increases in load similar to, but of a lower magnitude than, those of the load cells at the truss bracket. Readings from the instrumented rock bolt on the west truss leg stopped on day 142 after cut 2 from the 5750 level had mined under. Figure 19 is a graph of data for all three mining cuts.
