**DYNAMIC TEMPERATURE MEASUREMENT OF OVERHEATED
SHUTTLE CAR TRAILING CABLES IN UNDERGROUND COAL MINES**

**P. G. Kovalchik
L. W. Scott
T. H. Dubaniewicz
F. T. Duda**

**NIOSH
Pittsburgh, PA**

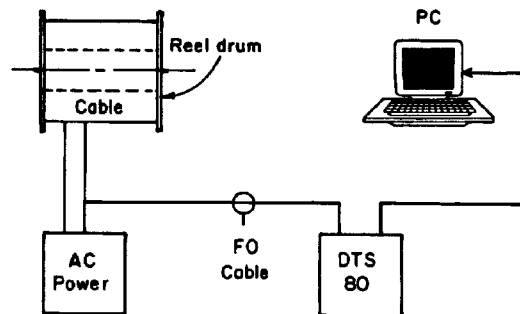
Figure 1. Test setup.

The test setup is shown in Figure 1. A trailing cable with an embedded optical fiber is reeled onto a shuttle car drum and connected to a 550-V, three-phase, ac power source. The shuttle car drum diameter is 25 cm. Connections to the optical fibers are made near the ac power source with fiber-optic jumper cables. The exposed conductors at the sensor breakout locations are reinsulated. The reinsulation procedure and the electrical isolation provided by the fiber-optic cables minimize risk of electrocution. The optical signal is processed by a York DTS 80 distributed temperature measuring system. Temperature and distance data are then downloaded via an ARC Net link to a personal computer for logging and visual display. With this setup, the shuttle car can move freely without interfering with the data acquisition process.

a single end connection, maximum performance requires connection of both ends to the instrument. For the shuttle car test setup, the "loop" was completed by installing a short fiber-optic jumper cable inside the drum. One of three separate loops embedded in the trailing cable is typically monitored during shuttle car tests. With this loop configuration, temperature resolution at each 1-m interval is 1 °C.

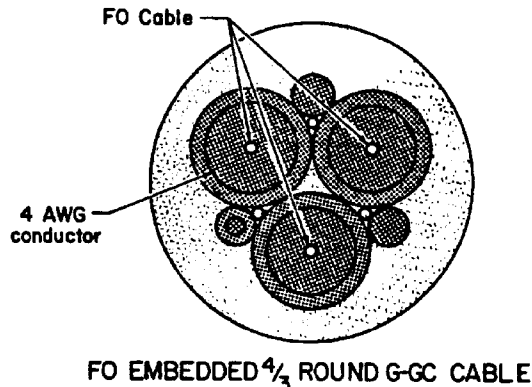
Figure 2. Cross section of fiber-optic embedded test cable.

The fiber-optic sensors must be protected in accordance with the intended application. In this case, the fiber-optic sensors were embedded within a Tiger Brand #4 AWG, 3-conductor, G-GC trailing cable during the manufacturing process. A fiber-optic cable containing two optical fibers replaced the center copper element of the #4 AWG conductors as shown in Figure 2. Outer copper elements were wrapped around the fiber-optic cable as it was pulled through the cabling machine. The cross-sectional areas of the copper elements were adjusted to maintain the equivalent cross-sectional area of a #4 AWG conductor. Insulation was extruded over the fiber-optic embedded #4 AWG conductor. The insulated conductor was then cut into thirds and extruded again to complete the final product. These manufacturing processes dictate that the sensor jacket must be abrasion resistant, able to tolerate high extrusion temperatures, and withstand stresses associated with pulling of the cable. To minimize special setup procedures, the overall diameter of the fiber sensor jacket should be compatible with standard cable manufacturing dimensions. Operating conditions such as the drum diameter, temperature, and number of test cycles the cable is expected to endure over a 6-month test period, must also be considered. Some of these fiber jacket design parameters are:

Optical fiber protection options were proposed by various vendors. One proposal consisted of two polyimide-coated, 50- μ m core optical fibers contained within a polyvinylidene fluoride (PVDF) loose tube buffer. A sample of this cable was incorporated into a production run of a #4 AWG conductor. An optical time domain reflectometer (OTDR) monitored the attenuation characteristics of one of the optical fibers as the sensor cable was pulled through the machine. The OTDR display showed intensity of back-scattered light as a function of fiber length (Figure 3). As the test run started, it soon became apparent the fiber was undergoing excessive stress as indicated by the signal attenuation between markers "A" and "B". The problem was caused by excessive pulling tension between the main capstan and a gear driven take-up reel. Although a clutch adjustment to the take-up reel eliminated further problems, this experience suggested more substantial protection was needed. An alternative design including stress-bearing kevlar strands was subsequently chosen. In this configuration, an inner tefzel loose tube isolates two polyimide-coated, 50- μ m core optical fibers from the kevlar. An outer tefzel tube protects the kevlar strands from abrasion.

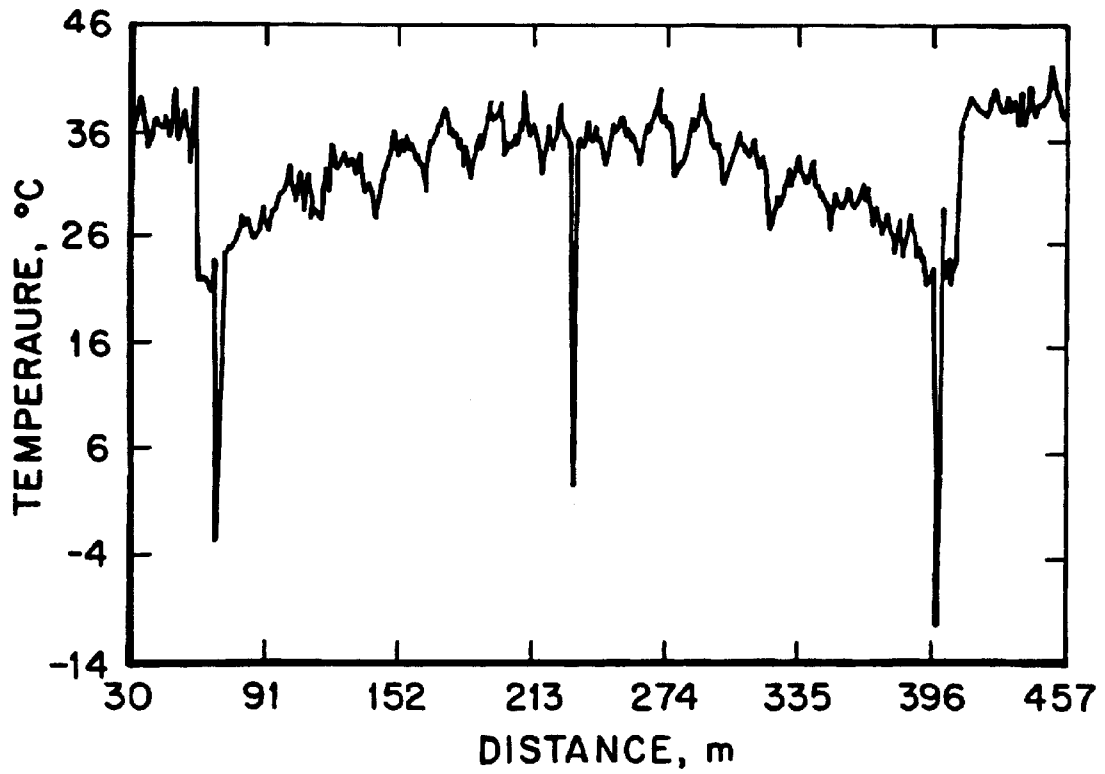
Figure 4. DTS 80 display which shows 7 layers of cable.

Researchers also conducted preliminary shuttle car tests with the fiber-optic-embedded trailing cable. The shuttle car was loaded with coal and operated in a manner similar to a room-and-pillar scenario. A typical DTS 80 display shows temperature readings as a function of distance from the instrument (Figure 4). The drum-terminated end of the trailing cable corresponds with the sharp downward peak in the center of the figure. This downward peak is caused by jumper cable connector reflections in the center of the drum and should not be misinterpreted as actual temperature. Reflections effectively blind the DTS 80 over short distances, commonly referred to as dead zones. Dead zones can be eliminated by replacing connector interfaces with splices. However, space limitations inside the drum make reliable splice installation difficult. Dead zones are an example of concepts that need to be understood when interpreting DTS 80 generated data.

The symmetrical side lobes around the central dead zone in Figure 4 represent temperature readings from two fiber-optic sensors. These jumper-connected fiber-optic sensors form one sensor loop. The periodic downward peaks indicating lower temperature are consistent with sections of cable closest to the outside of the reel. These sections of cable are most susceptible to convective cooling effects from the surrounding atmosphere. Further testing is required to make quantitative assessments of
