**RI 9553**

## **Detection and Control of Spontaneous Heating in Coal Mine Pillars—A Case Study**

**By Robert J. Timko and R. Lincoln Derick**

**UNITED STATES DEPARTMENT OF THE INTERIOR**

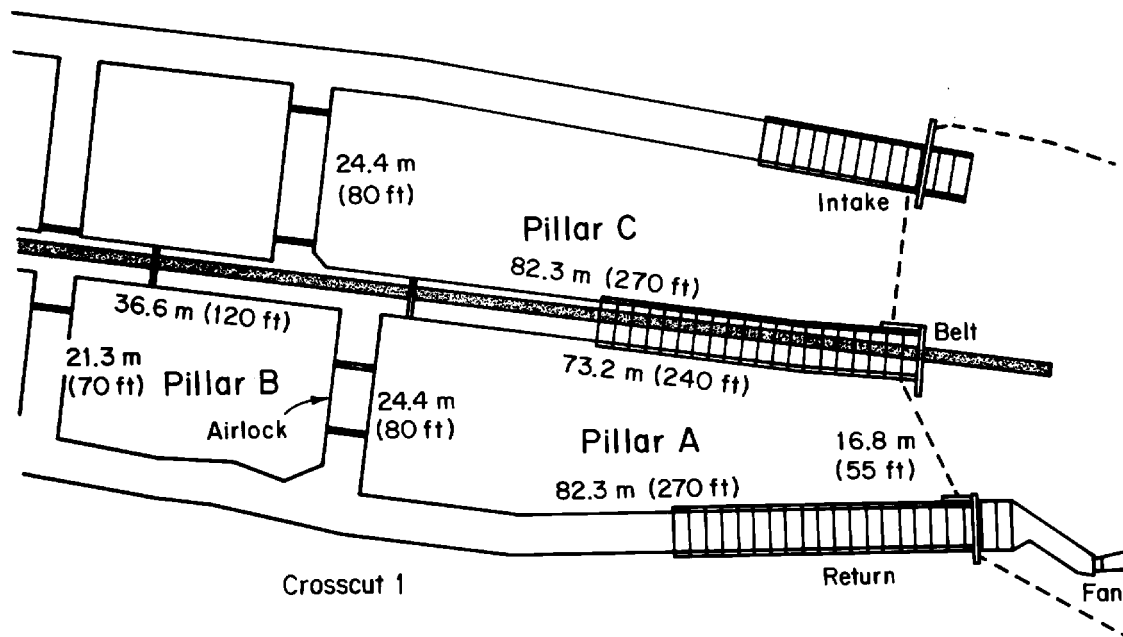
**Figure 1**

The three pillars examined in this study and their associated dimensions are seen in figure 1. Two pillars, A and B, were located between the belt and the return entries and were subjected to differential pressures of 175 Pa ( $0.7 \text{ in H}_2\text{O}$ ) across them. Pillar C was separated by intake and belt entries and, since both entries were on intake air, had no measurable differential pressure across it.

**Plan view of the three pillars evaluated.**

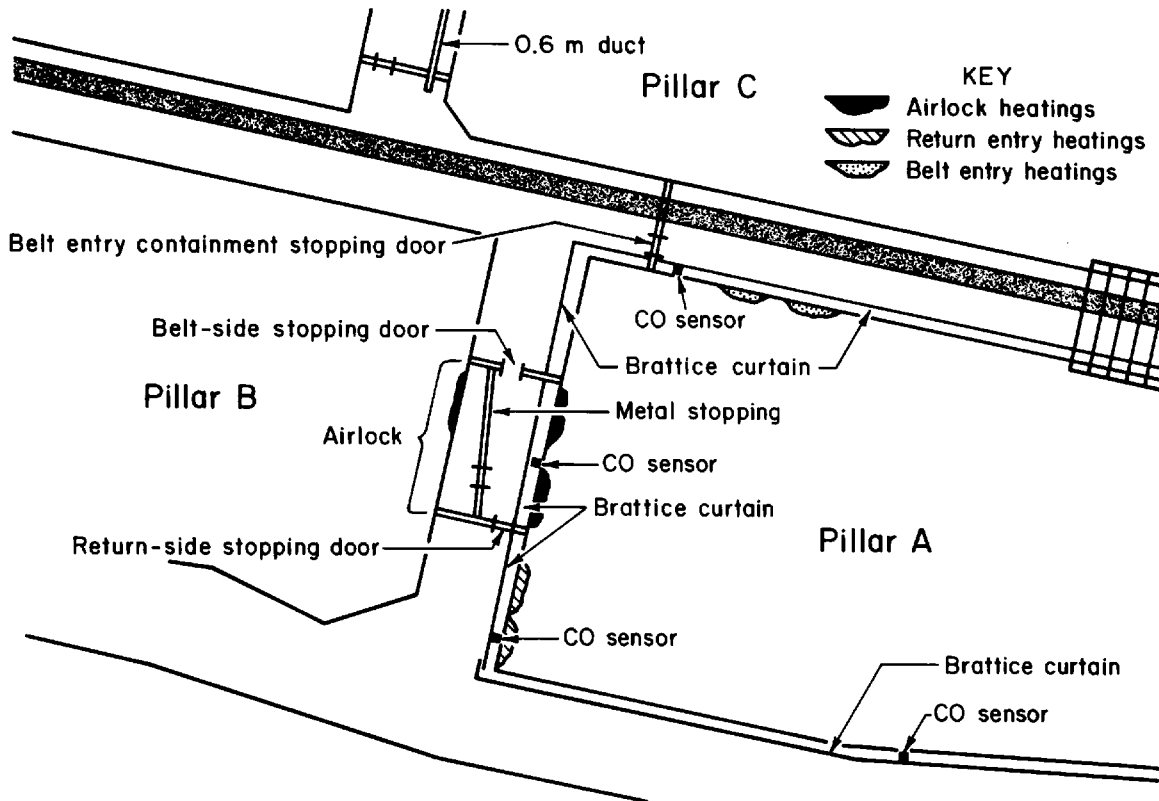
Figure 2

During a routine survey with the infrared camera, elevated surface temperatures were discovered along the pillar A rib in the crosscut 1 airlock (figure 2). Further investigations found heatings within the airlock along pillars A and B. A Magnehelic-type device found that pressure fell 175 Pa (0.7 in H<sub>2</sub>O) from the belt side to the return side of the crosscut 1 airlock. Since air was flowing through the pillar and then into the airlock, the pillar A heating could have occurred anywhere along a line roughly paralleling the coal cleat between the belt-entry pillar rib and the crosscut 1 rib. Conversely, the heating along the pillar B rib had to be near the surface because air was flowing into the pillar at that location.

***Detection of spontaneous heating episodes and resulting control measures implemented.***

A CO sensor was positioned inside the airlock on the pillar A rib and connected to the minewide monitor. A brattice curtain was hung within the airlock along the pillar A rib to isolate the CO sensor from the remainder of the airlock volume. This curtain was located about 1 m (3.3 ft) away from and parallel to the pillar A rib, effectively isolating the rib. CO levels in the airlock behind the curtain stabilized at about 26 ppm.

An attempt was made to reduce airflow through pillar A. The doors in the airlock belt-side stopping and the belt-entry containment stopping were opened to provide a low-resistance flow path between the belt and the airlock return-side stopping. A 0.6-m (2-ft) diameter duct was opened in crosscut 1 between the belt and the intake entries, which effectively balanced ventilation pressure between the belt and the intake entries. The belt-to-return pressure differential was now across the crosscut 1 airlock return-side stopping. These changes increased the flow path distance, raised the resistance, and

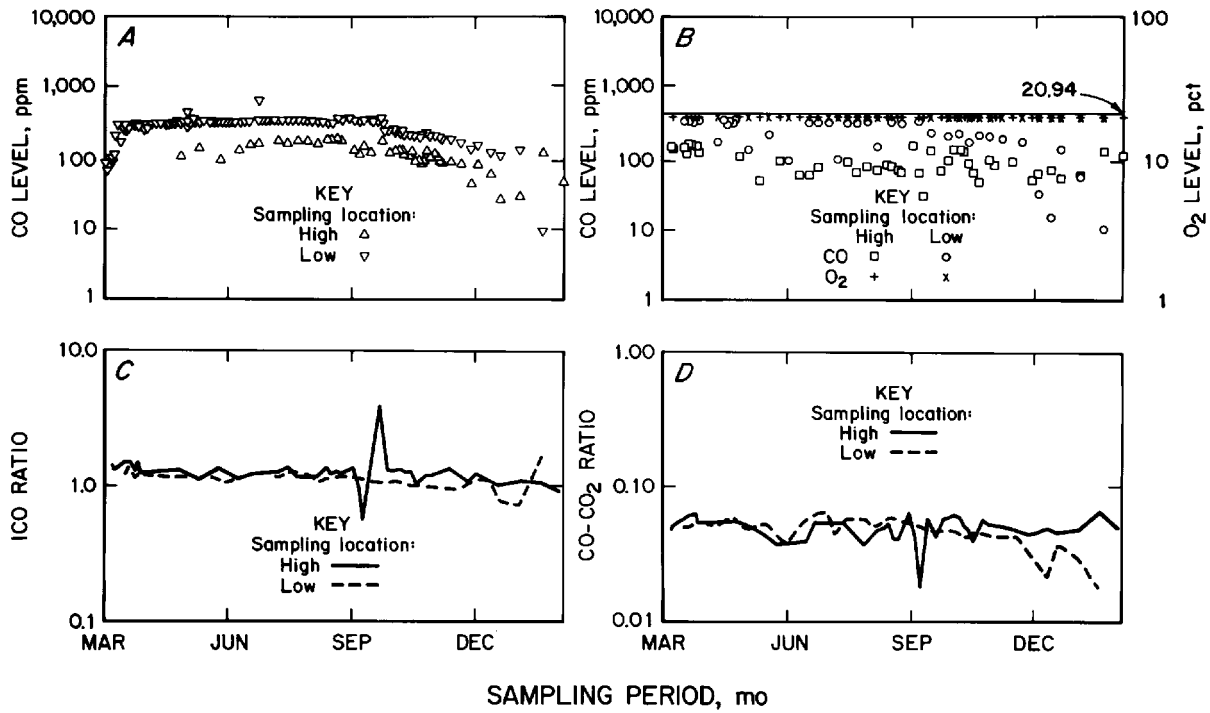
Figure 3

Handheld CO values are shown in figure 3A. Even though these results remained relatively stable throughout the evaluation, the presence of CO in the atmosphere indicated that some level of oxidation was taking place within pillar A and was being vented to the atmosphere in the airlock.

Gas chromatographic analyses of airlock samples (figure 3B) found CO in conjunction with below-ambient oxygen concentrations (less than 20.94 pct O<sub>2</sub>), indicating that oxygen was being consumed by the oxidation reaction. ICO and CO-CO<sub>2</sub> results at both the high and low sampling locations (figures 3C and 3D) remained stable with the exception of the large fluctuations in September.

Crosscut 1 airlock. A, Handheld results; B, gas chromatography data; C, ICO; and D, CO-CO<sub>2</sub> ratio.

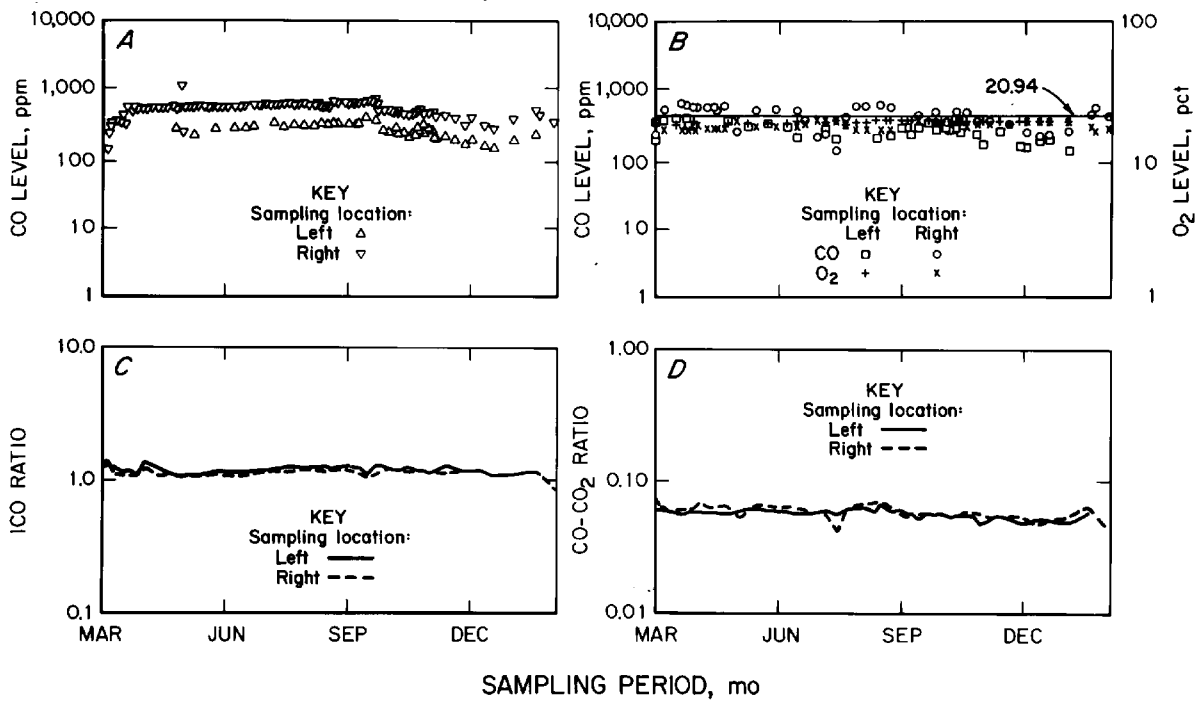
Figure 4

Handheld results (figure 4A) showed that CO values at the right location were consistently higher. Chromatographic results (figure 4B) paralleled those CO values found with the handheld instruments. Depleted oxygen levels reinforced the

Crosscut 1 return. A, Handheld results; B, gas chromatography data; C, ICO; and D, CO-CO<sub>2</sub> ratio.

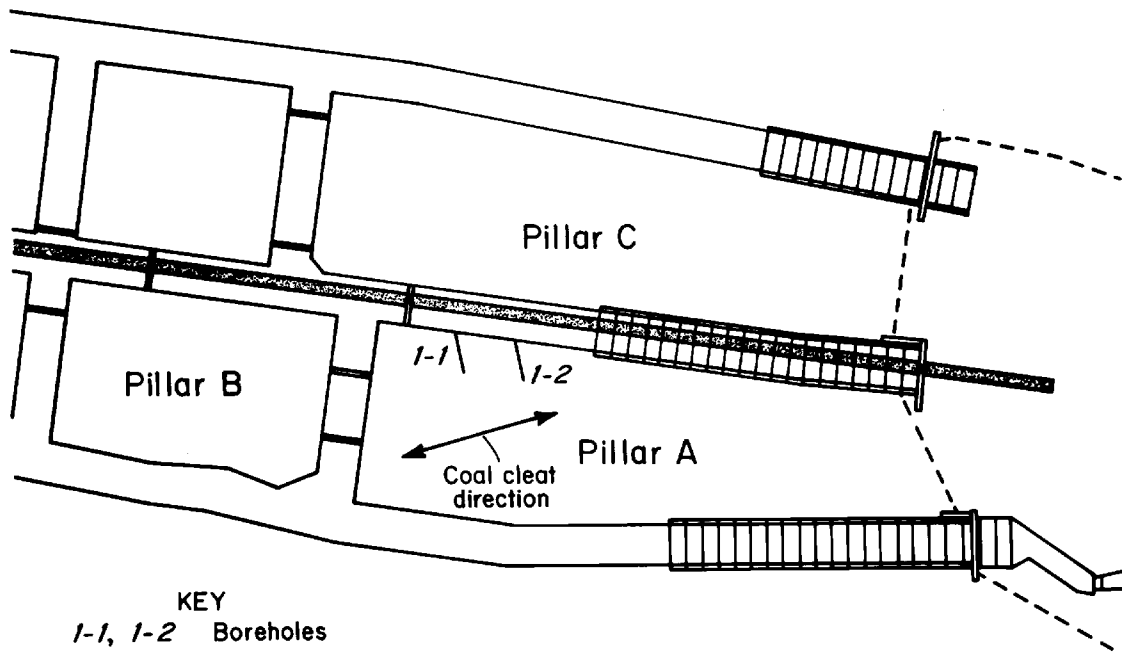
Figure 5

Locations of prototype 3.7-m boreholes.

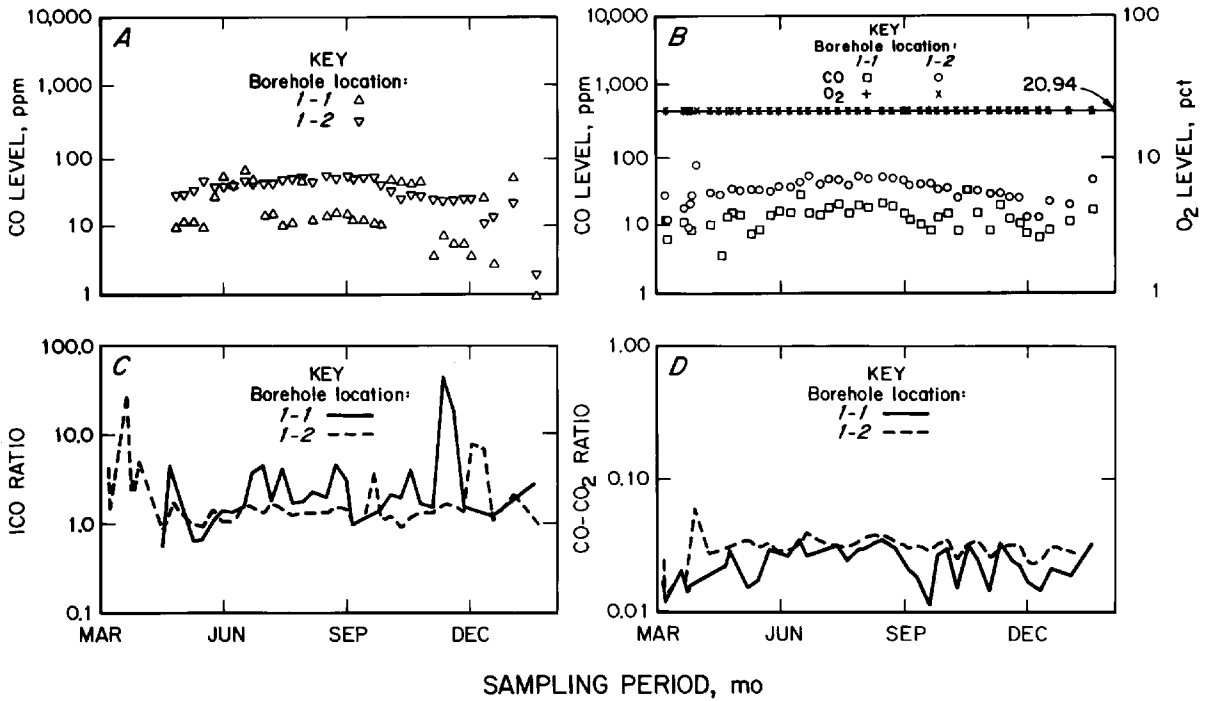
Figure 6

The ICO and CO-CO<sub>2</sub> ratios at both boreholes (figures 6C and 6D) fluctuated wildly. Had the ICO been the only sampling method used to monitor for spontaneous heating, the fluctuations would probably have kept officials on constant alert throughout the study. The CO-CO<sub>2</sub> ratio was less than the atmospheric samples taken at the airlock or return locations and was indicative of a stable atmosphere.

3.7-m boreholes. A, Handheld results; B, gas chromatography data; C, ICO; and D, CO-CO<sub>2</sub> ratio.

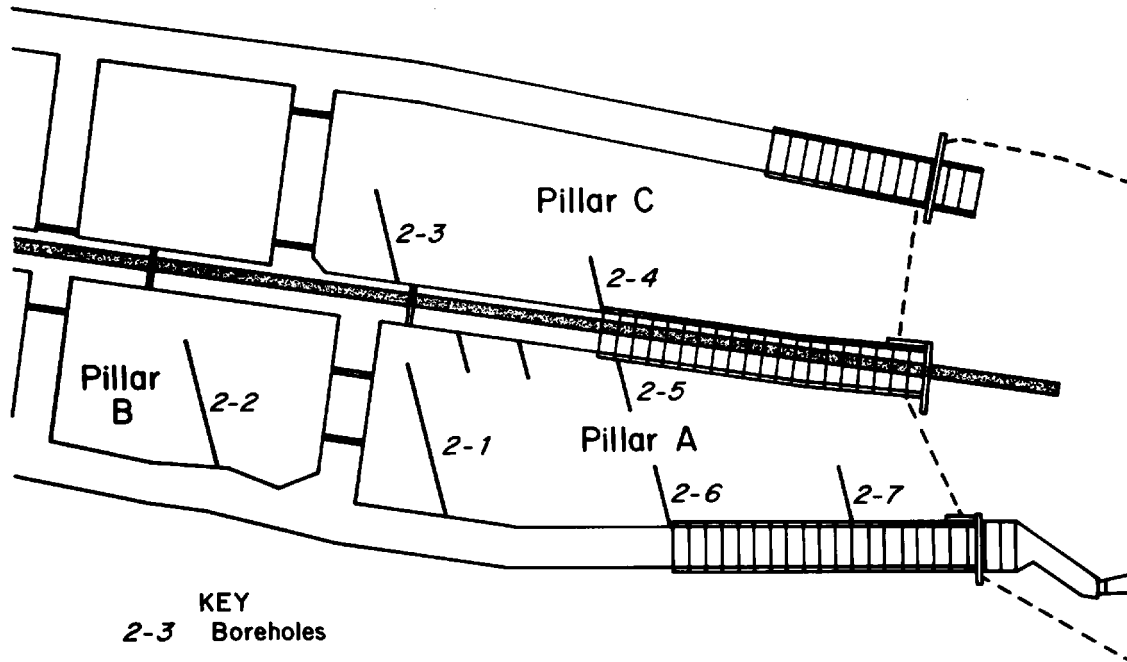
Figure 7

Locations of pillar boreholes.

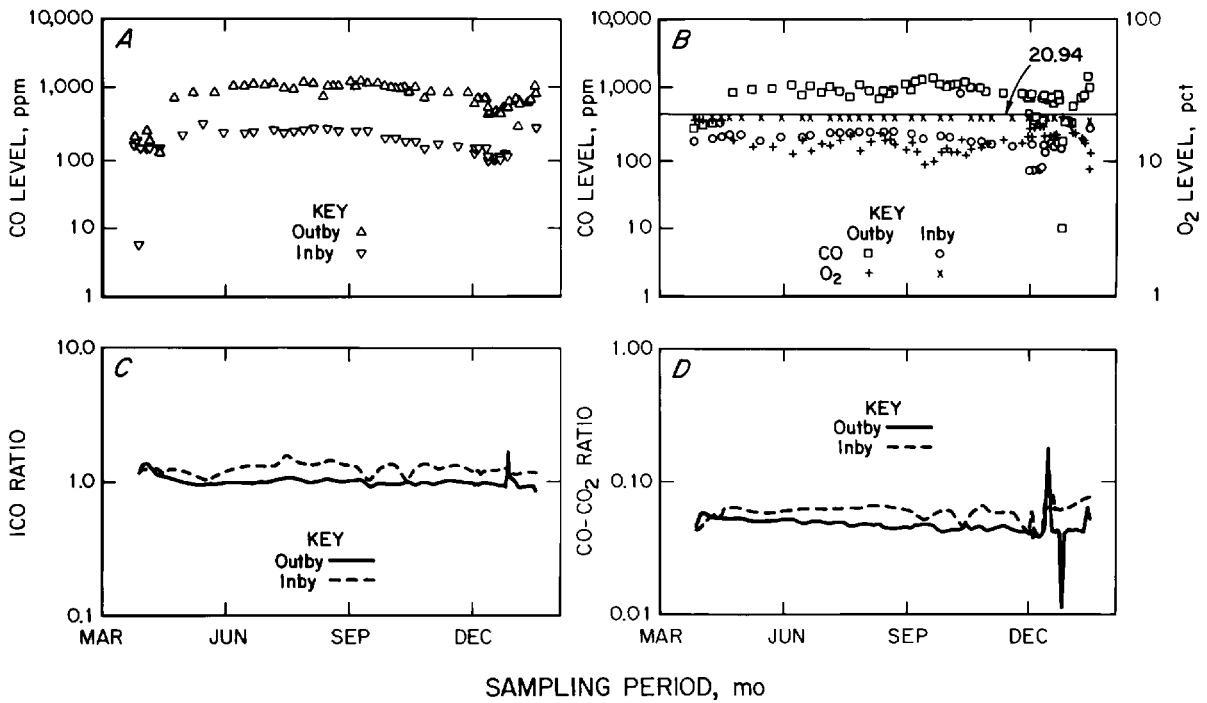
Figure 8

Borehole 2-1. A, Handheld results; B, gas chromatography data; C, ICO; and D, CO-CO<sub>2</sub> ratio.

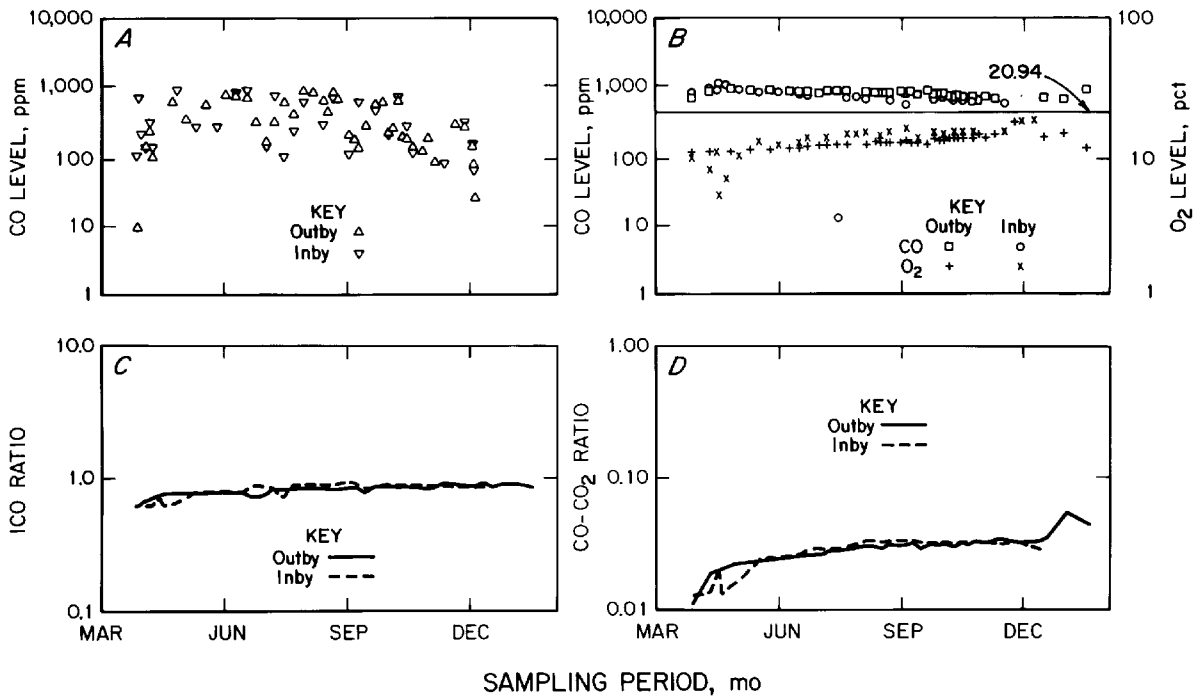
**Figure 9**

**Borehole 2-2. A, Handheld results; B, gas chromatography data; C, ICO; and D, CO-CO<sub>2</sub> ratio.**

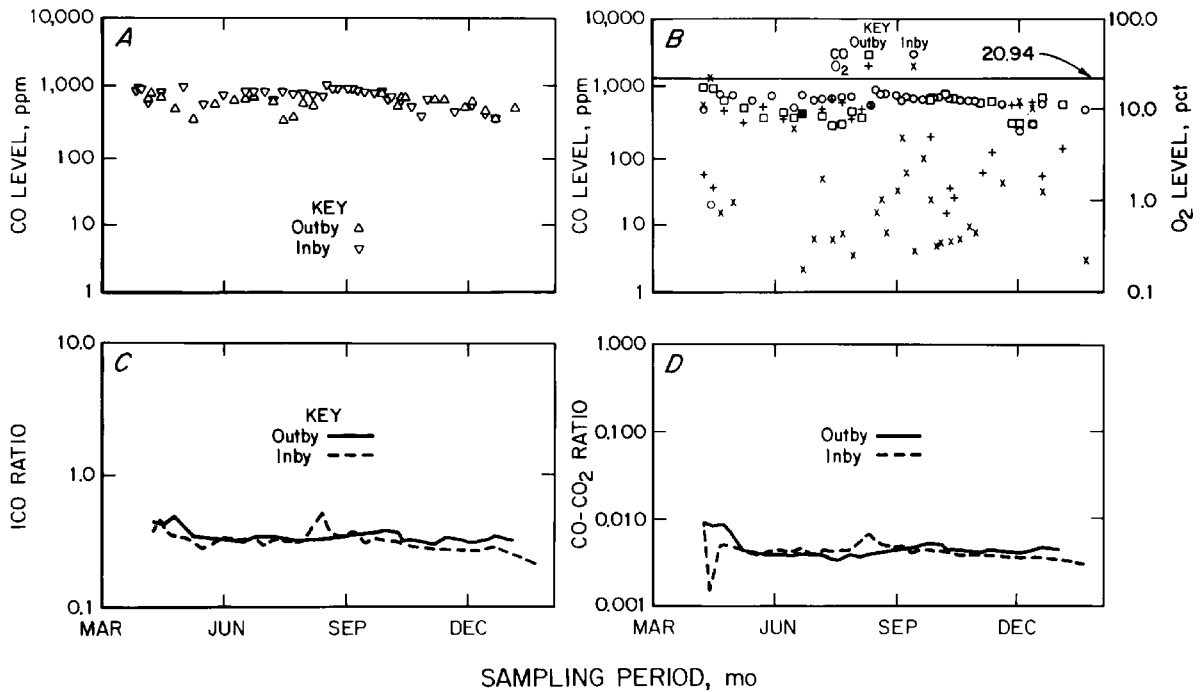
**Figure 10**

Handheld results (figure 10A) showed that CO levels remained elevated and stable throughout the evaluation, with both inby and outby locations having similar results. Gas chromatographic data (figure 10B) found that inby and outby CO values paralleled the handheld results. Levels of O<sub>2</sub> remained below ambient; there was no explanation for the fluctuations.

ICO and CO-CO<sub>2</sub> results (figures 10C and 10D) remained stable and below values found at the other test hole locations. These results were believed to be a signature of normal oxidation within coal pillars having no differential pressure, and thus no appreciable airflow, through them.

**Borehole 2-3. A, Handheld results; B, gas chromatography data; C, ICO; and D, CO-CO<sub>2</sub> ratio.**

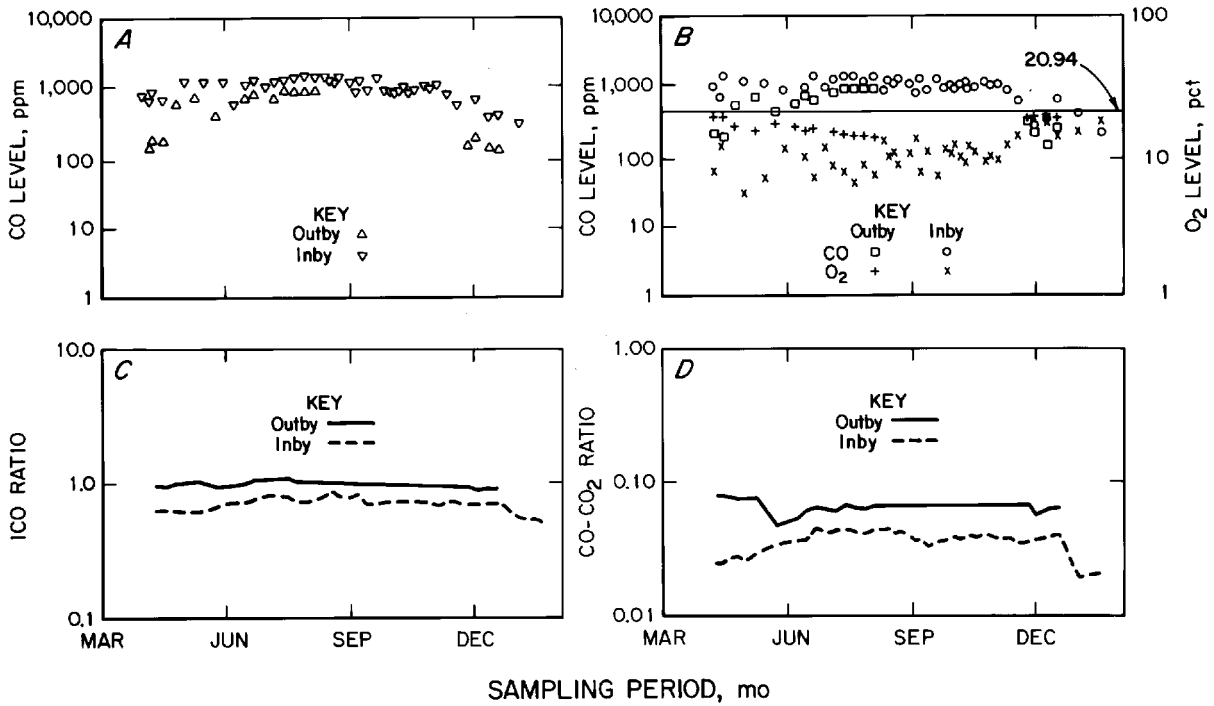
**Figure 11**

A second borehole, designated test hole 2-4, was drilled into pillar C. This borehole was 9.1 m (30 ft) deep. Handheld CO values (figure 11A) and gas chromatographic results (figure 11B) from both the inby and outby sampling positions correlated well with each other and with those values found at test hole 2-3. Based on comparative results between boreholes 2-3 and 2-4, internal pillar CO values near 1,000 ppm as well as O<sub>2</sub> levels of about 10 pct were considered indicative of the oxidation rate in the D seam.

ICO and CO-CO<sub>2</sub> results from test hole 2-4 (figures 11C and 11D) were more similar to borehole 2-1 data than to borehole 2-3. This apparent inconsistency was probably caused by the proximity of test hole 2-4 to the coal burn line.

**Borehole 2-4. A, Handheld results; B, gas chromatography data; C, ICO; and D, CO-CO<sub>2</sub> ratio.**

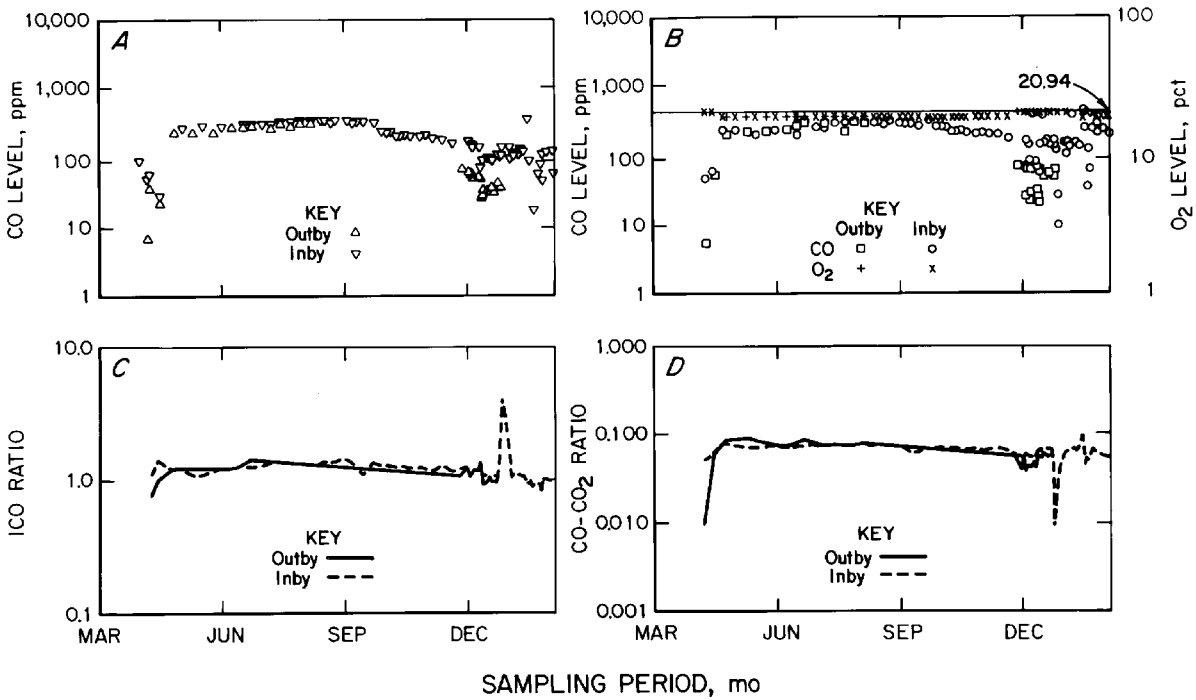
**Figure 12**

Chromatographic CO values (figure 12B) closely paralleled handheld concentrations. The O<sub>2</sub> levels at both the inby and outby positions remained close to ambient. ICO and CO-CO<sub>2</sub> results (figures 12C and 12D) were unchanged until the fire. The only indication of fire at borehole 2-5 was a slight increase in the ICO and a corresponding decrease in CO-CO<sub>2</sub>. The fluctuations that followed the initial changes were believed

**Borehole 2-5. A, Handheld results; B, gas chromatography data; C, ICO; and D, CO-CO<sub>2</sub> ratio.**

to be caused by efforts to control the fire, rather than being indicative of the fire itself.

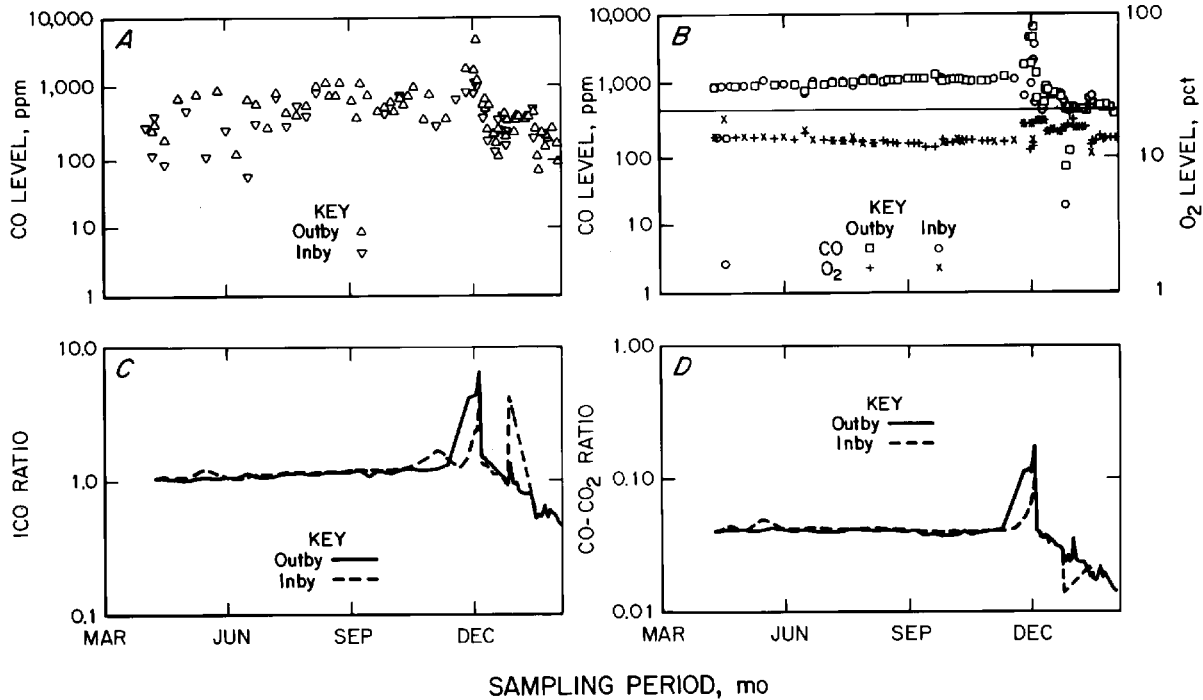
**Figure 13**

As the trend began to change, a thorough investigation of pillar A was performed with the infrared camera. An area of glowing coal was discovered behind the tunnel liner in the pillar A rib, upstream of borehole 2-6 and between the borehole and the mine portal. The burn zone extended into the pillar rib about 0.3 m (1 ft). It was extinguished by extracting the burning coal and saturating it and the remaining in situ pillar coal with water.

**Borehole 2-6. A, Handheld results; B, gas chromatography data; C, ICO; and D, CO-CO<sub>2</sub> ratio.**

The following day, more smoke and glowing coal were discovered in the belt entry behind the tunnel liner, just outby the previous event. This fire was also extinguished by removing the burning material and flooding the area with water.

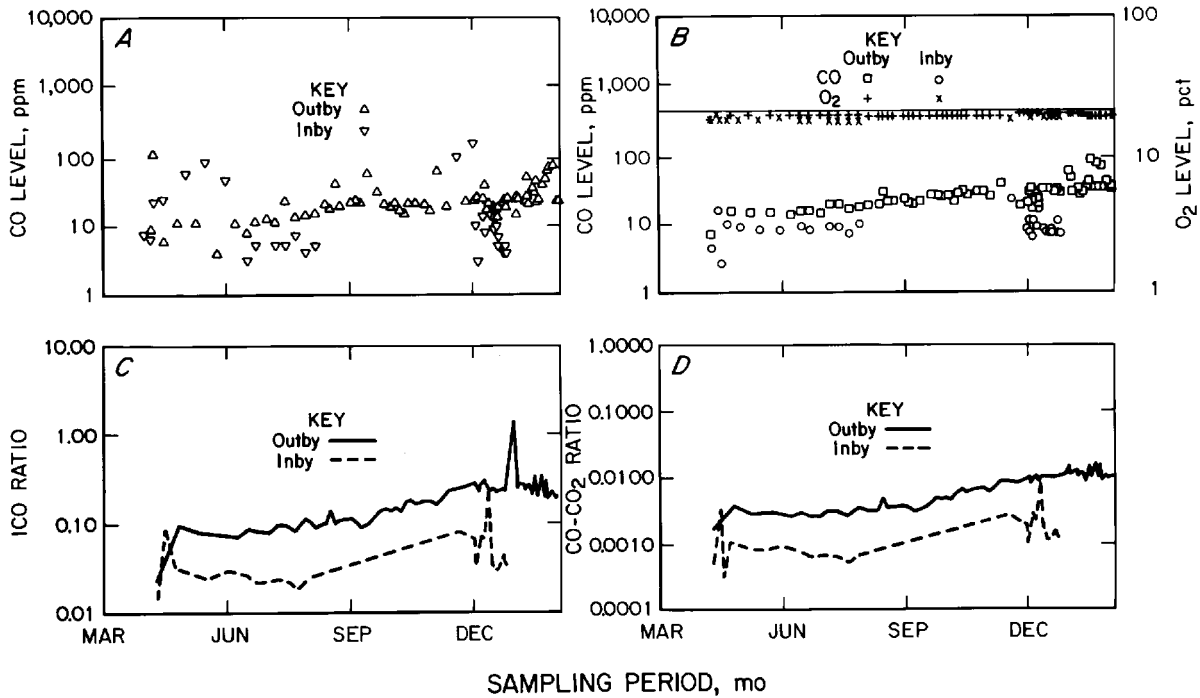
**Figure 14**

Borehole 2-7 was 9.1 m (30 ft) deep. Inby and outby values of handheld CO (figure 14A) were less than those levels found at the other holes. Chromatographic CO samples (figure 14B), while exhibiting a very gradual increase over time, were below the values found at all other locations. The O<sub>2</sub> values were unchanged but slightly below ambient throughout the study.

ICO and CO-CO<sub>2</sub> results exhibited a continual increase (figures 14C and 14D) even though they were below values found at other locations. If an increasing trend alone was regarded as a predictor of spontaneous heating, looking at this data could lead one to infer that a heating was taking place upstream of borehole 2-7 in pillar A even though no heating was ever located. These indications could have been from the pillar A belt-entry fire or from residual heating in the coked material outby the borehole.

**Borehole 2-7. A, Handheld results; B, gas chromatography data; C, ICO; and D, CO-CO<sub>2</sub> ratio.**

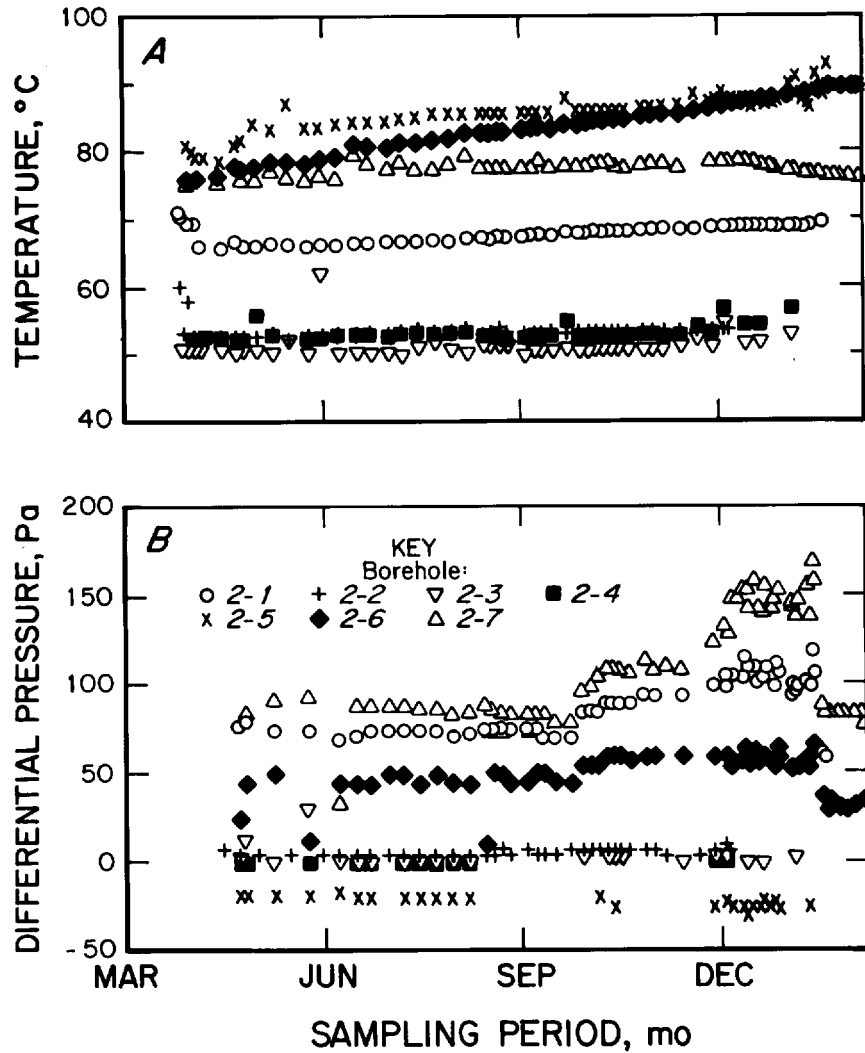
Figure 15

A correlation existed between borehole pressure and temperature. If a pressure differential existed within the hole, that borehole also had elevated and increasing temperatures. Temperature and pressure data reinforced the premise that some level of spontaneous heating was constantly occurring in pillar A.

Borehole measurements. A, Temperatures; B, pressures.

To immediately control spontaneous heating in Pillar A, a solution of magnesium chloride and water was injected into the boreholes. This solution was designed to flow into the numerous fractures within the pillar. As the liquid evaporated, the salt that remained tended to seal many of those fractures.
