PNEUMATIC GRINDER PREVENTS WORKPLACE INJURIES IN SIMA NAVAL AMPHIBIOUS BASE CORONADO'S SMALL BOAT REPAIR DEPARTMENT

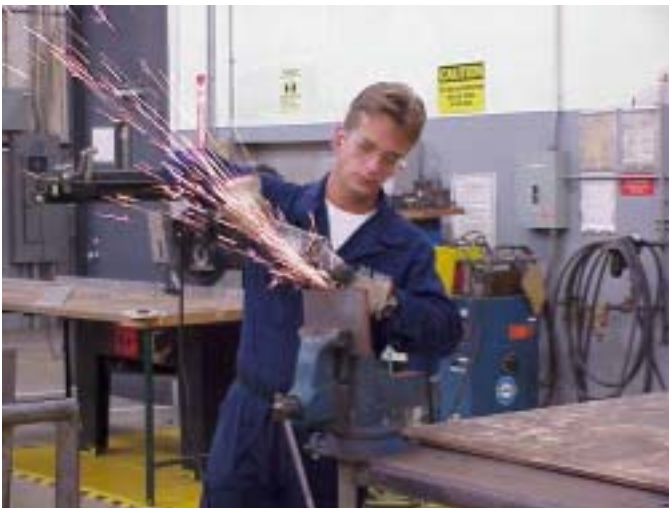
Ship repair technicians reported hand and arm pain when using conventional grinders

Small Boat Repair Shop employees who used the conventional grinder reported hand and arm pain, even after as little as 30 minutes of grinding. The industrial hygienist servicing the command suspected that the repair technicians reporting discomfort after using the conventional grinder were being exposed to hand/arm vibration. This type of vibration exposure is caused by the regular use of vibrating pneumatic,

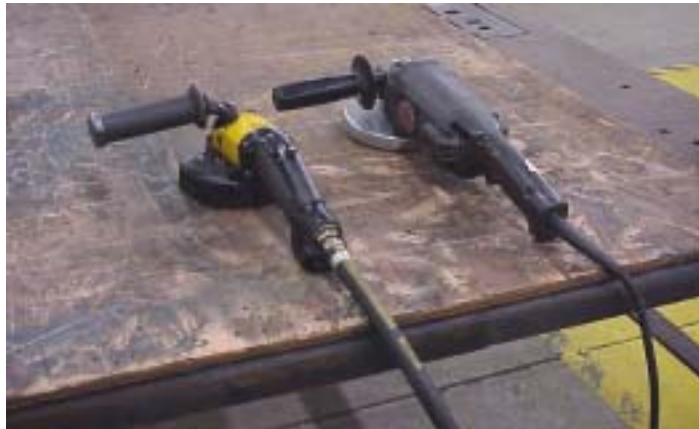
Lightweight, *pneumatic* grinder on left produces far less vibration than heavy, conventional grinder on right

monitoring on SIMA Small Boat Repair Shop technicians. Accelerometers were attached to grinder handles while employees used the conventional tools. The accelerometer measured the amount of vibration produced by the grinders. The vibration data collected at the Small Boat Repair Shop indicated that employees were exposed to several times the American Conference of Government Industrial Hygienists (ACGIH) guidelines for exposure to hand/arm vibration, which allows an employee to be exposed to vibration levels of 12 meters per second squared (m/s^2) for less than one hour per day. The vibration measurements also showed the industrial hygienists that the conventional grinder produced high vibration levels because of uneven wear on the grinding wheel that resulted in an unbalanced rotation.

The Industrial Hygiene Department's research into grinding tools concluded that a *pneumatic grinder* was the best choice for SIMA's Small Boat Repair Shop, because its auto-balance feature results in far less vibration than conventional grinders. The *pneumatic grinder* has an automatic balancing design that uses ball bearings to compensate for imbalances as they develop in the grinding wheel. Such imbalances would otherwise result in vibration and vibration-related disorders. The automatic balancing technology keeps vibration levels below 5 m/s², allowing boat repair workers to use the grinders for up to six hours a day while minimizing the risk of overexposure to hand and arm vibration. An additional ergonomic advantage is that the *pneumatic grinder* is about half the size and weight of the conventional nine-pound electric grinder, making it much easier to handle and use. The time needed to complete repair projects can now be reduced as much as 25% by using the *pneumatic grinder*.

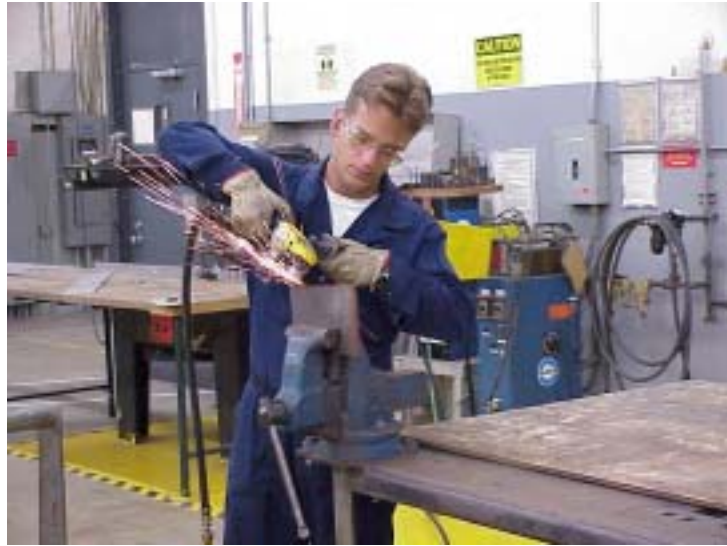
Repair technicians no longer report hand and arm pain when using ergonomically designed *pneumatic grinder*.

Overall, SIMA boat repair technicians are very pleased with the *pneumatic grinder* and report no discomfort when using it. Productivity in the Small Boat Repair Shop has increased for workers using the new tool, and since use of the *pneumatic grinder* was implemented there have
