SUCCESSFUL ERGONOMIC AND INDUSTRIAL HYGIENE INTERVENTIONS

DENTAL PROSTHETICS LABORATORY

U. S. NAVAL STATION ROTA SPAIN

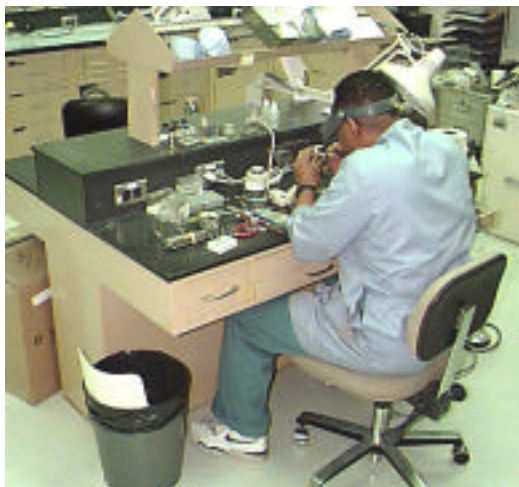
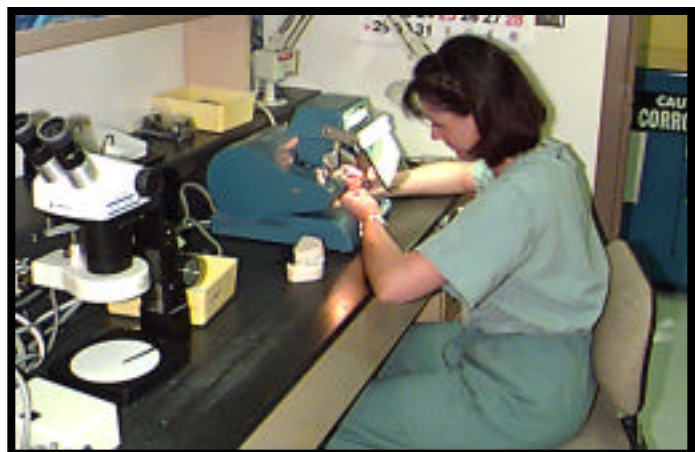
- ◆ Configuration of workstations brought about the posture shown at left and below when technicians worked on dental prostheses. This awkward posture led to discomfort and fatigue in the neck, upper back, and shoulders.

- ◆ Pressure on technicians' forearms led to discomfort and accelerated fatigue from leaning forward for extended periods of time with forearms pressed against the edge of the bench top.
- ◆ Absence of task lighting led to eyestrain and intensified fatigue.

Acquisition of ergonomically designed workbenches relieved ergonomic risk factors as shown below. The technician is seated in a neutral posture with arms supported by built-in arm rests. The improved workstations also enhanced worker productivity, efficiency, and morale. Specific ergonomic design features include:

- ◆ Placement of prosthetic pieces away from and directly in front of the technician facilitating a neutral back, shoulder, and neck alignment that relieves stress and discomfort.
- ◆ Wide, padded forearm rests support the weight of technician's forearms, eliminating discomfort due to contact with the sharp edges.
- ◆ Specially designed overhead task lighting and magnifying lens attachment minimize eyestrain and prevent fatigue.
