Turkey - Sea of Marmara - 17 August 1999

Vanuatu - 26 November 1999

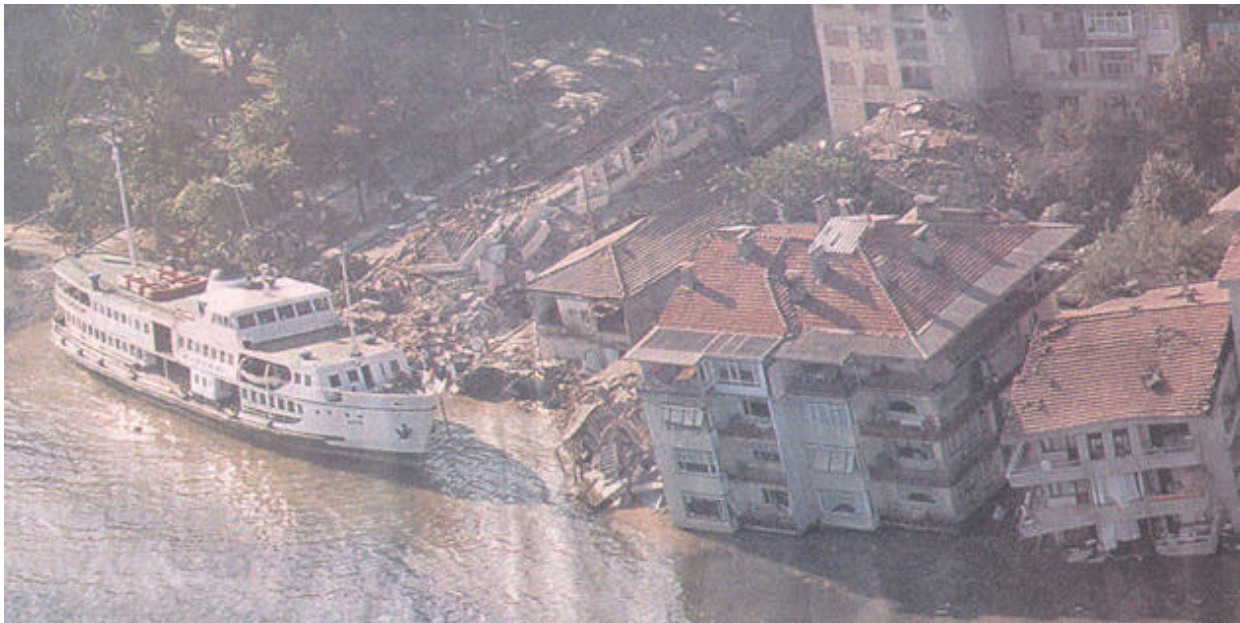
Subsidence and permanent flooding at Degirmendere, Turkey.

Also large coastal portions of the town of Degirmendere remained flooded as a result of subsidence with sea level reaching the second floors of apartment buildings. Similar permanent flooding, but to a lesser extent, occurred also at Karamursel. The tsunami waves from this earthquake had an extremely short period of less than a minute which indicates that the source for this tsunami was the localized subsidence of coastal areas and underwater slumping, rather than larger scale tectonic movements.
