**National Highway
Traffic Safety
Administration**

CASE SUMMARY

PSU 08 CASE NO. 133A TYPE OF ACCIDENT Single car impact with tree-fatal

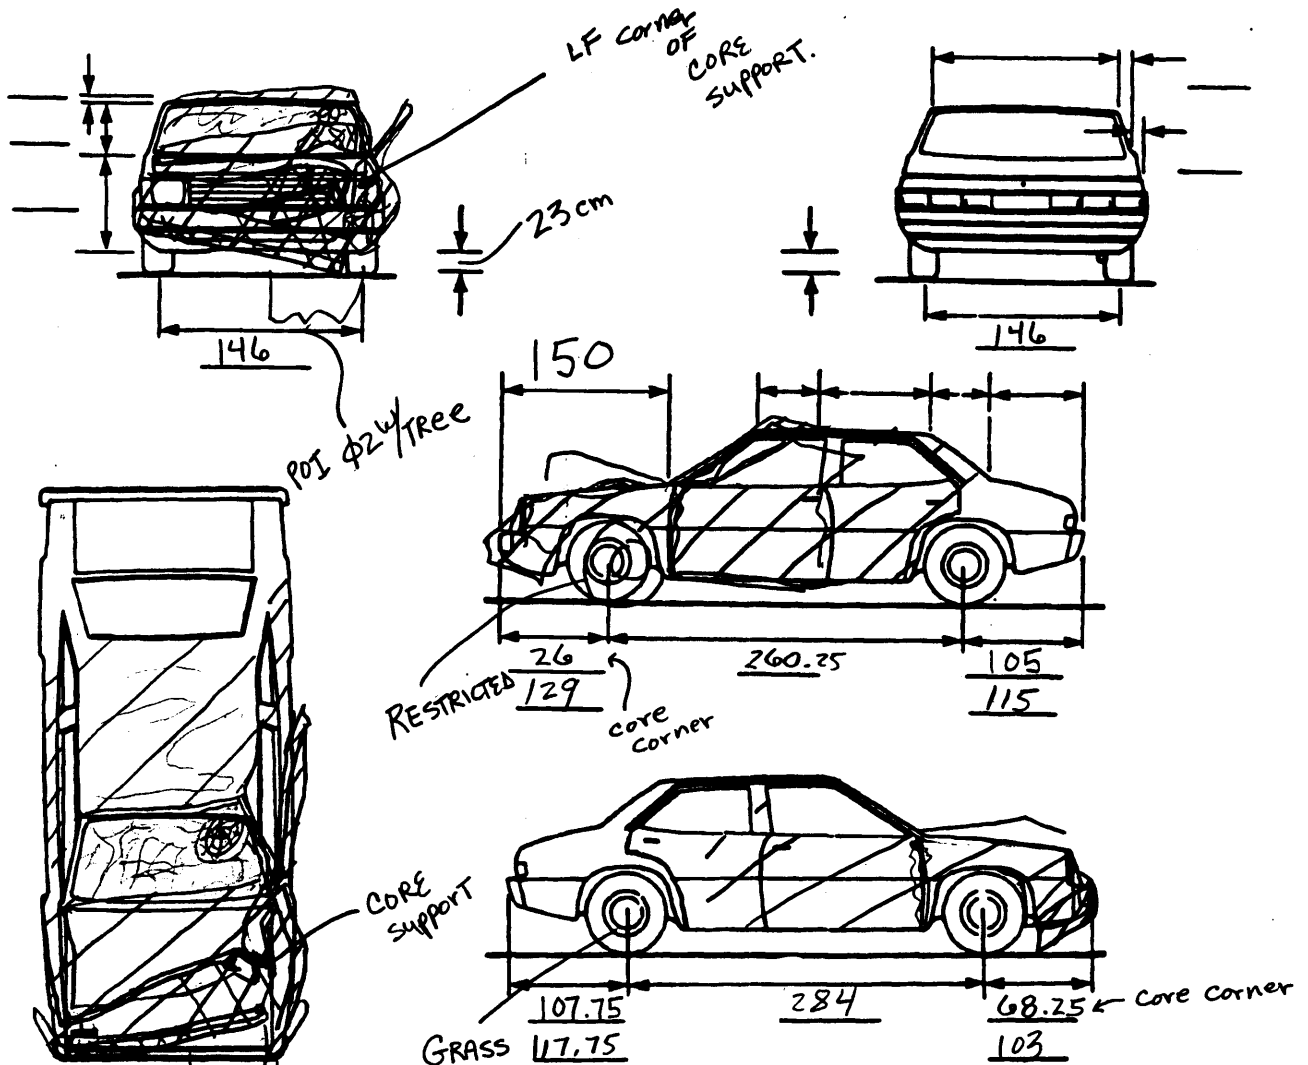
VEHICLE DAMAGE SKETCH

NOTES: Identify the plane at which the C-measurements are taken (e.g., at bumper, above bumper, at sill, above sill, etc.) and label adjustments (e.g., free space).
 • MEAS. TO FRONT CORE SUPPORT DUE TO SEPARATED CONDITION OF FRONT BUMPER
 Measure and document on the vehicle diagram the location of maximum crush.

Specific Impact Number	Plane of Impact C-Measurements	Direct Damage		Field L	C ₁	C ₂	C ₃	C ₄	C ₅	C ₆	$\pm D$
		Width (CDC)	Max Crush								
$\phi 2$	Front Core Support	63*	109.5	134	103	102.5	75.5	53.1	40	34.75	-37.5 cm
	FS		33		33	33	33	33	33	33	
	Resultant		76.5		70	69.5	42.5	20.1	7	1.75	
$\phi 1$	Front Bumper	153		134							ϕ
		\downarrow MEAS. OFF BUMPER									
		Entire Front Bumper was contacted by shrub.									
		* Pocket of Damage

MEASUREMENTS IN CENTIMETERS

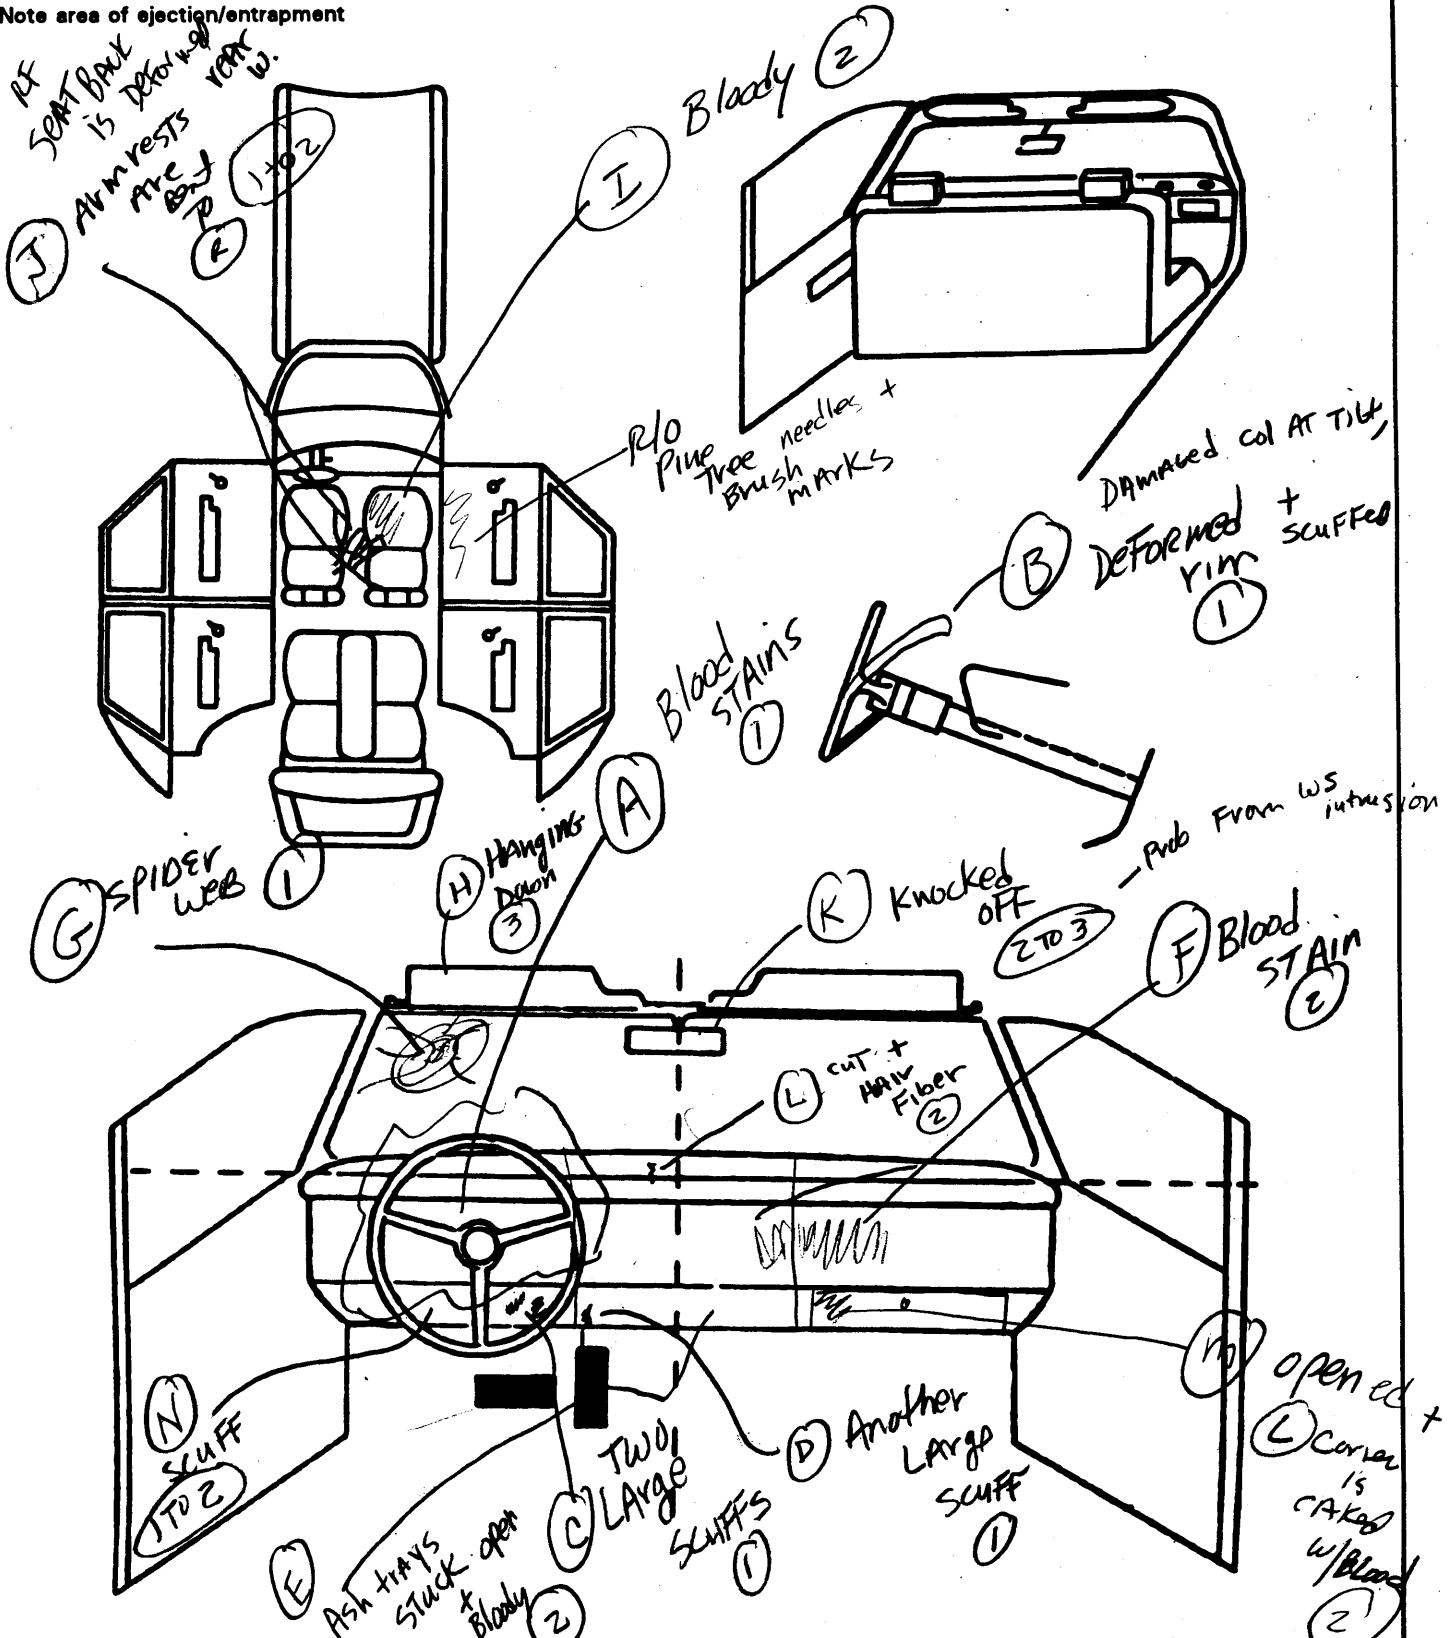
RF SEAT BACK is deformed
Arm rests are bent
Rear W.

Contact	Interior Component Contacted	Occupant No. If Known	Body Region If Known	Supporting Physical Evidence	Confidence Level of Contact Point
A	45	Φ1	CHEST, FACE	BLOOD STAINS, DEPLOYED	1
B	Φ6	Φ1	CHEST, FACE	SCUFFED + DEFORMED RIM, COL. DAMAGED AT TILT JOINT	1
C	13	Φ1	(R) Knee	TWO LARGE SCUFFS to lower (R) Portion	1
D	1Φ	Φ1	(R) Knee	Another Large SCUFF	1
E	1Φ	Φ1	(R) KNEE, THIGH	Ash TRAYS STUCK OPEN + BLOODY	2
F	10/11	Φ1	Upper Body	Blood stain - LARGE	2
G	Φ1	Φ1	HEAD	SPIDER WEB	1
H	Φ3	Φ1	HEAD	LF VISOR IS HANGING Down	3
I	4Φ	Φ1	Upper Body	RF SEAT CUSHION IS BLOOD SATURATED	2
J	4Φ	Φ1	(R) Hip, Shoulder	RF SEATBACK IS DEFORMED. CTR ARMRESTS REAR W. ARE BENT TO (R)	1 TO 2
K	Φ2	Φ1	(R) ARM, FACE	Knocked OFF	2 to 3
L	1Φ	Φ1	FACE, (R) ARM	PANEL MATERIAL IS CUT AND HAS A HAIR FIBER ATTACHED	2
M	12	Φ1	Upper Body	OPENED, AND (L) corner is CAKED w/ Blood	2
N	13	Φ1	(L) Knee	SCUFF to Lower (L) Portion	1 to 2
