**Federal Building and Fire Safety Investigation
of the World Trade Center Disaster**

**Project 6 – Structural Fire Response and
Collapse Analysis**

October 19, 2004

**Building and Fire Research Laboratory
National Institute of Standards and Technology
U.S. Department of Commerce**

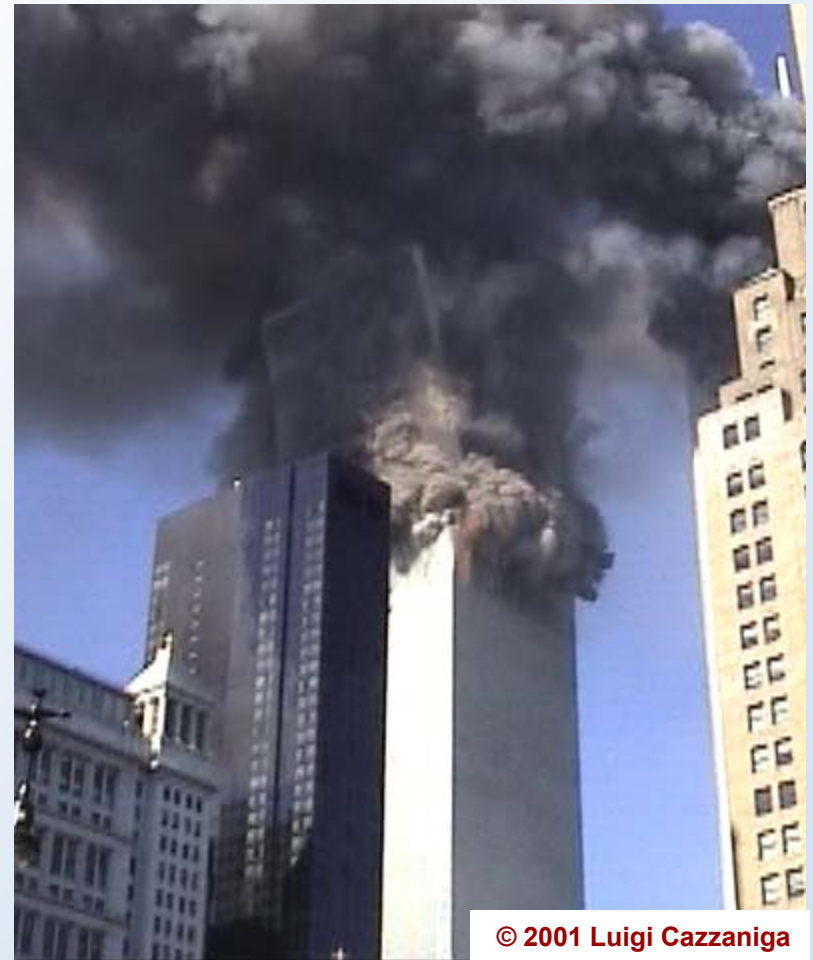
WTC 2 Collapse

WTC 2 tilted to the east and south and twisted in a counterclockwise motion in this view from the northeast.

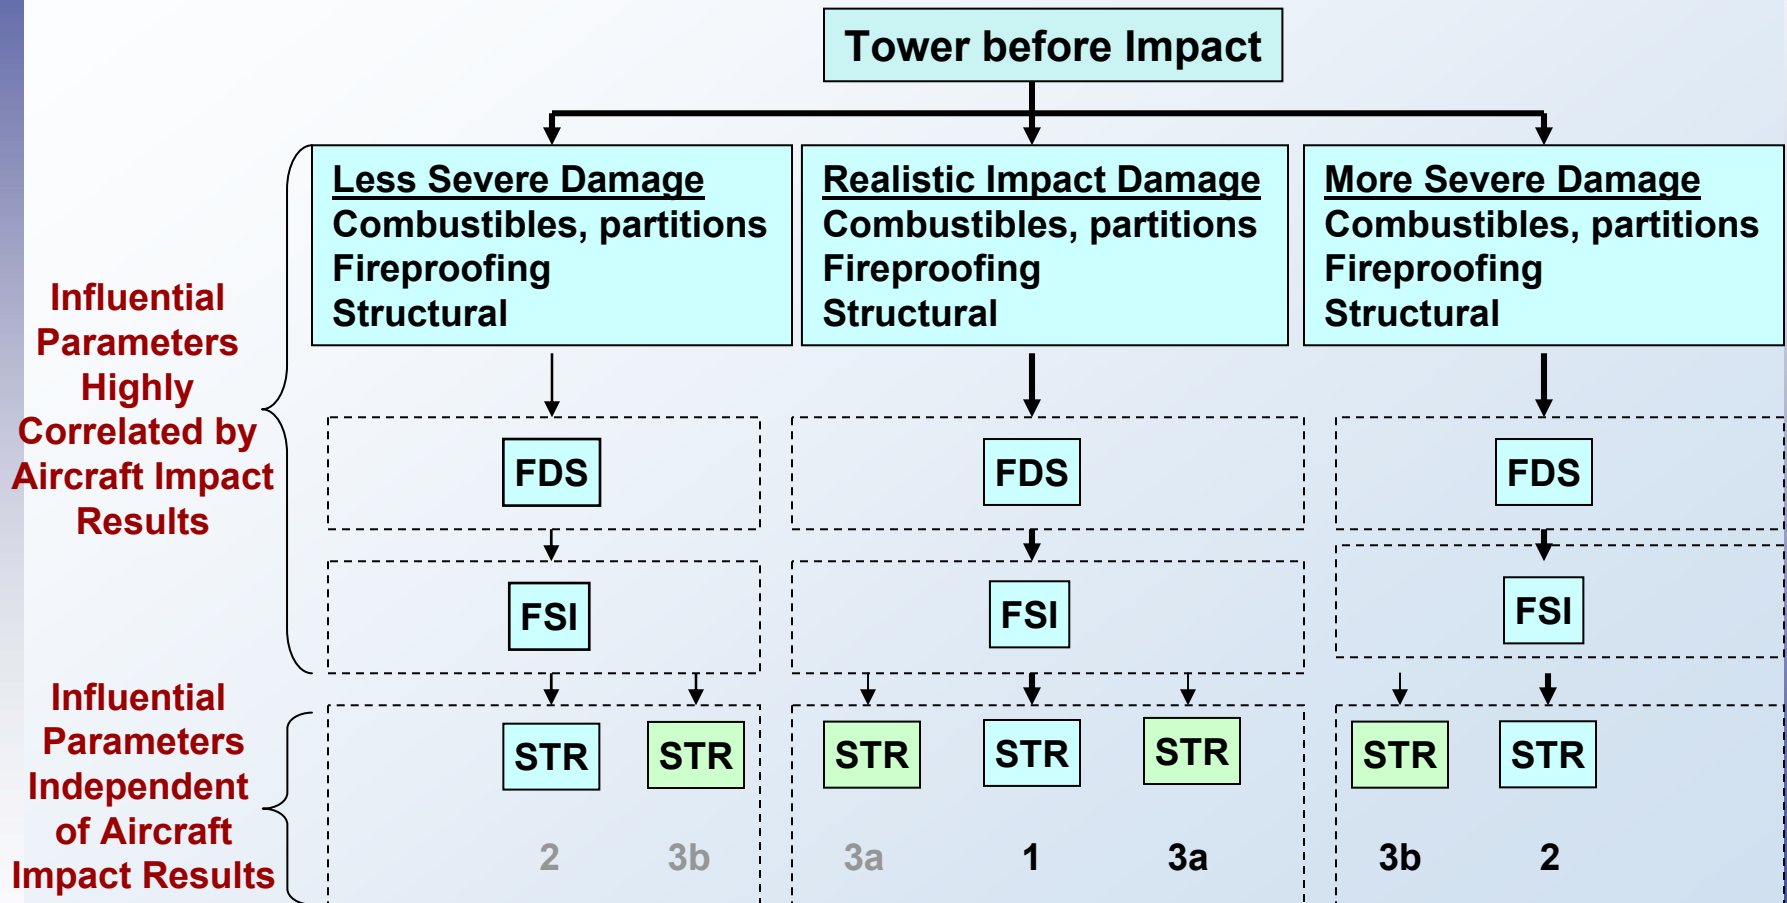
Pruned Analysis Tree for Influential Parameter Effects

Bounding computational analyses of subsystems and global systems, for specific response behaviors that were required to be captured in the final analyses, provided valuable insight into the collapse sequence.

These insights along with the sensitivity studies enabled significant reduction of the number of scenarios to be analyzed from the full analysis tree.

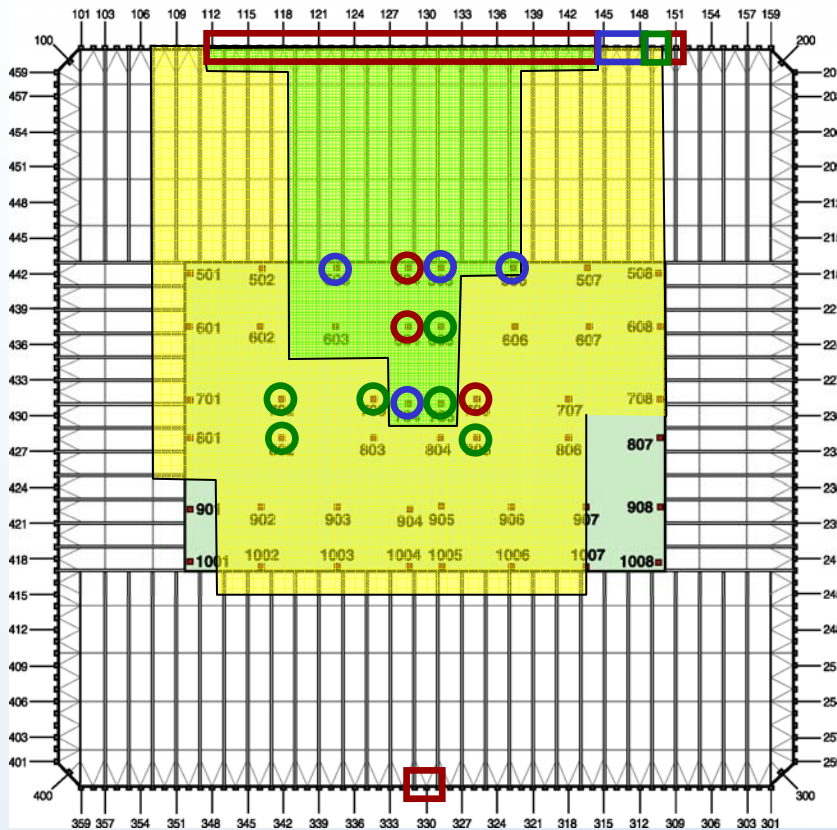
Aircraft Impact Damage to WTC 1

Floor and Wall Damage

Column Damage

Realistic

More Severe

- ❑ WTC 1 had 39 perimeter and 3 to 6 severed core columns - N side, center
- ❑ WTC 1 damage was primarily centered through the north face and floor area, the core, and into the south floor area
- ❑ WTC 2 had 29 perimeter and 5 to 10 severed core columns - SE side
- ❑ WTC 2 damage occurred primarily on the east side of the core and floor area

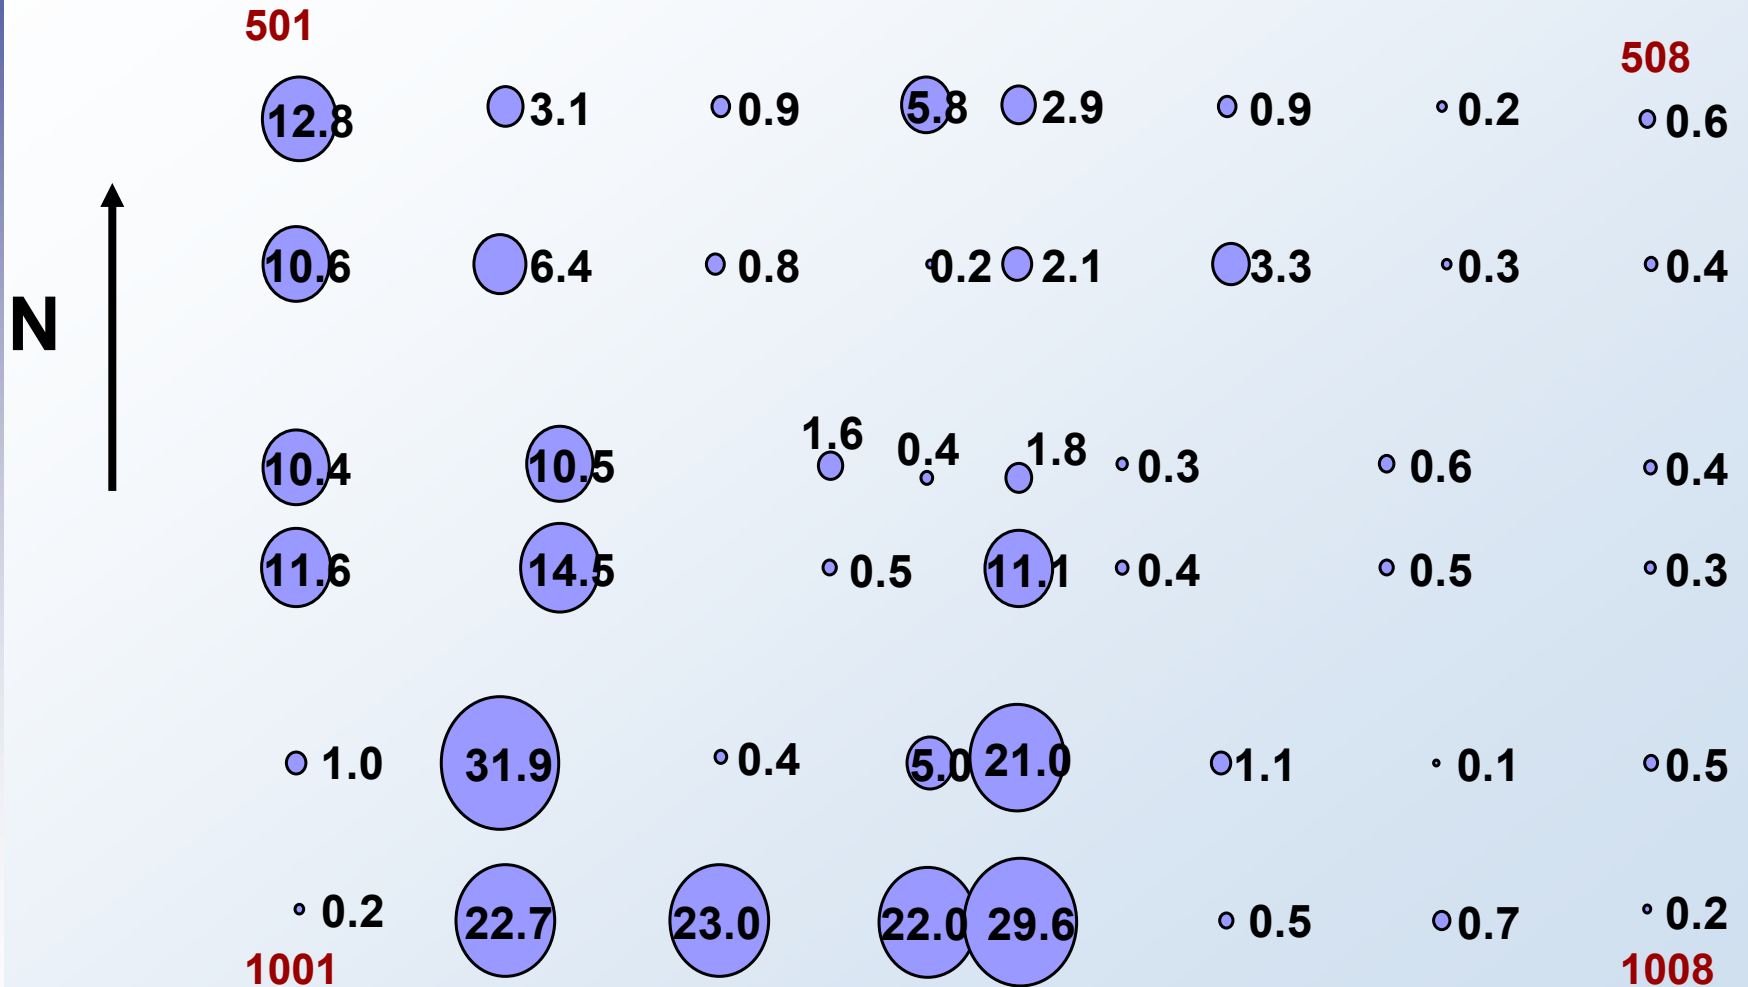
Column Shortening in WTC 1 Measured by Ratio of Plastic-to-Elastic Strain (Ductility) at 6000 s

Creep and nonlinear buckling will increase core shortening

At 500 °C to 700 °C, columns softened and shortened, through yielding or buckling, sufficiently to redistribute their loads to adjacent core columns and perimeter columns primarily through the floors.

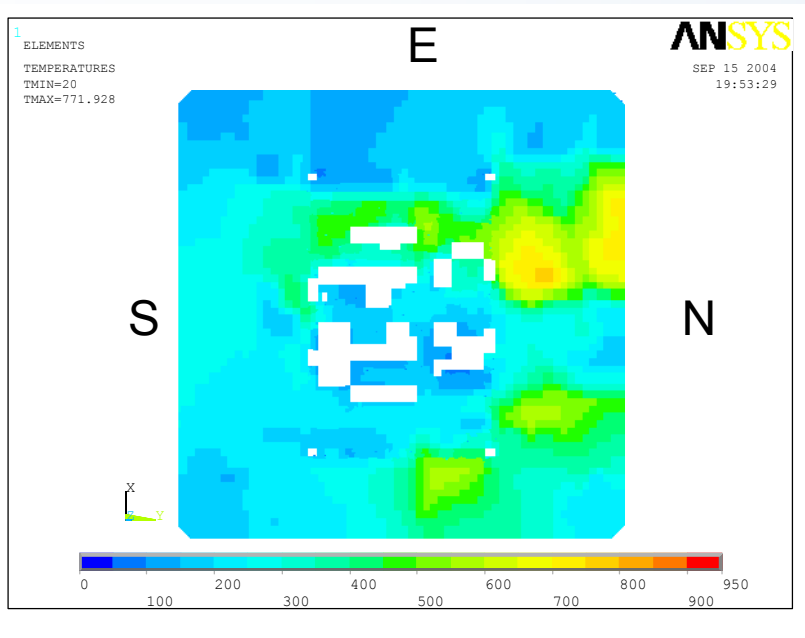
Temperature Distributions for Bottom of Slab of WTC 1 Floor 96 for More Severe Fires

600 s

6000 s

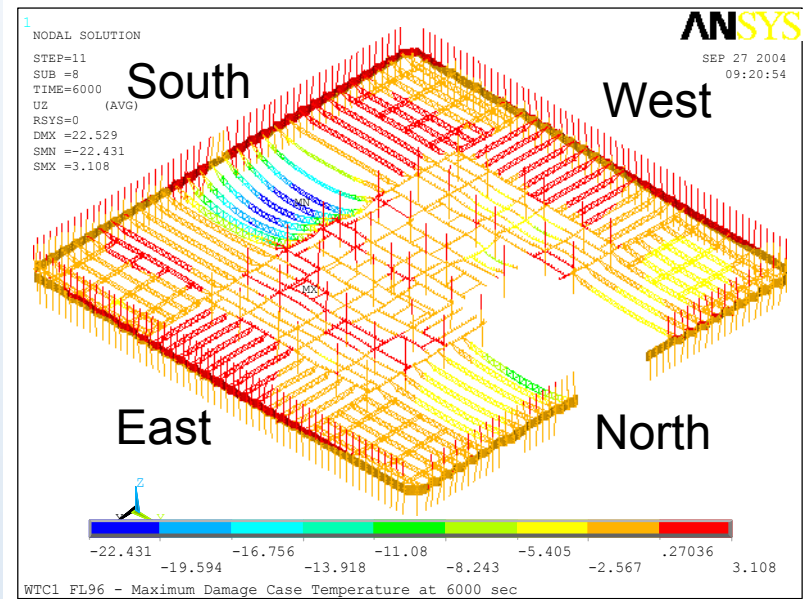
Vertical Displacement for WTC 1 Floor 96 for More Severe Fires

Maximum vertical displacement = 28.6 in.

Maximum vertical displacement = 22.4 in.

- ❑ Damage to truss fireproofing was extensive near the impact area. For the realistic fires, the maximum floor deflection was 23 in and for the more severe fires the maximum floor deflection was 29 in.
- ❑ Damage to truss fireproofing on the south side was less extensive. For the realistic fires, the maximum floor deflection was 6 in and for the more severe fires the maximum floor deflection was 23 in.
- ❑ As slab temperatures rose for both fire cases, the slab expanded on the order of 2 to 4 in., and pushed outward on the perimeter columns.
