Electrical Near Misses Continue to Occur

The purpose of this report is to describe commonly made electrical safety errors and identify lessons learned and specific actions that should be taken to prevent similar occurrences.

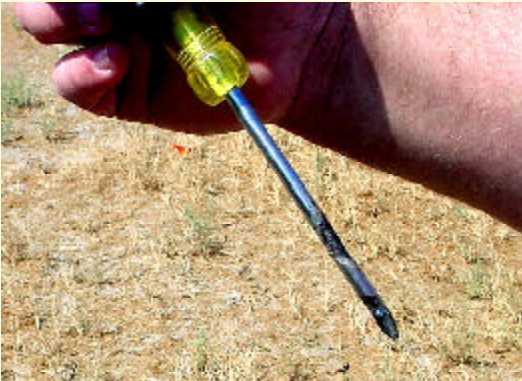
A journeyman electrician was replacing a 20-amp circuit breaker with a 60-amp breaker in an energized 480-volt, 1,600-amp distribution panel when an electric arc flash occurred. He received minor flash burns on his forearm and neck. In violation of procedures, the electrician tried to minimize downtime to the facility by mounting the replacement breaker without de-energizing the panel. He then planned to isolate the panel with a lockout/tagout before attaching the breaker to the bus bar and load side connectors. However, as he was attaching a mounting screw, his screwdriver slipped, made contact between a breaker lug and a grounded mounting plate, and created the arc flash.

Damaged screwdriver

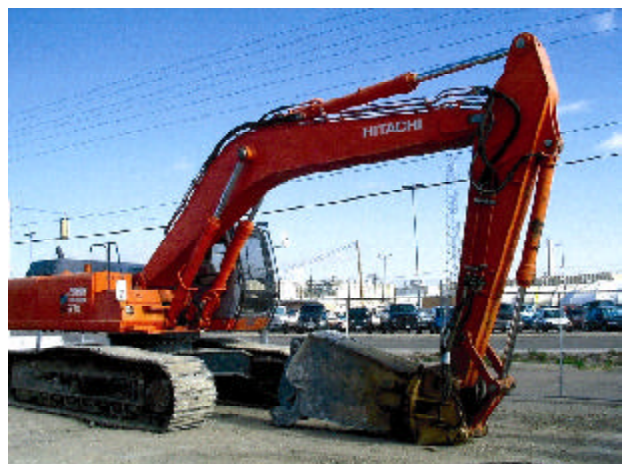
In 2002, excavator boom contacted 13.8 kv overhead power line

- Job hazard analyses for tasks involving vehicles need to include all work areas and travel routes to identify overhead electrical hazards and to address appropriate requirements for vehicle clearances and an adequate number of spotters.
- Job hazard analyses should also consider the possibility of changed vehicle profiles

and load configurations, such as raised truck beds, the shifting of masts and booms, and the increased heights of vehicles after unloading.

- Spotters assigned to transports need to be dedicated for the whole job, including exiting.
- Drivers must be trained to stay in communication with spotters and to be aware of the effect of changed vehicle and load configurations on clearances.
- Guy wires, utility poles and overhead lines need to be marked if not clearly visible to drivers and spotters.
