# A Review of Electrical Intrusion Events at the Department of Energy: 2000-2001

Office of Performance Assessment and Analysis

June 2002

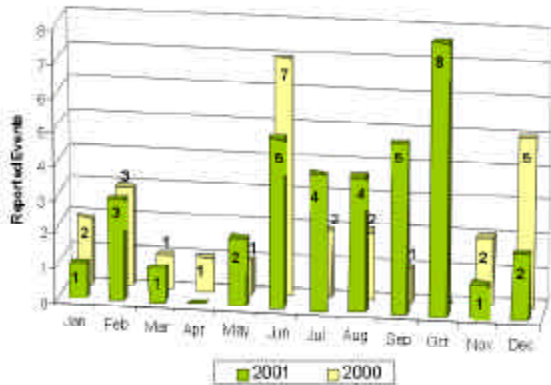
The frequency of electrical intrusion events across the DOE complex doubled beginning in June 2001, as shown in Figure 1. More than four events per month were reported during the June - December 2001 period, compared to only two per month between January 2000 and May 2001.

Figure 1. Electrical intrusion events doubled beginning in the summer of 2001

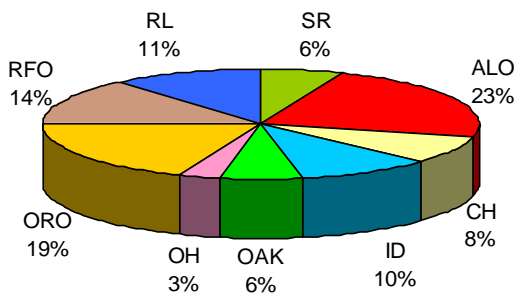
This increase led the EH Office of Performance Assessment and Analysis to examine all 63 electrical intrusion events reported in ORPS during calendar years 2000 and 2001. During 2000, 26 electrical intrusion events occurred, compared to 37 in 2001. These events occurred at nine Field Offices, as shown in Figure 2. Oak Ridge had a dramatic increase in the number of events that occurred in 2001 (10 compared to 2 in 2000). Albuquerque had the highest total number of events (14) during 2000-2001, but had no significant year-to-year change.

Figure 2. Data for 2000-2001 events by Field Office show they occurred complex-wide

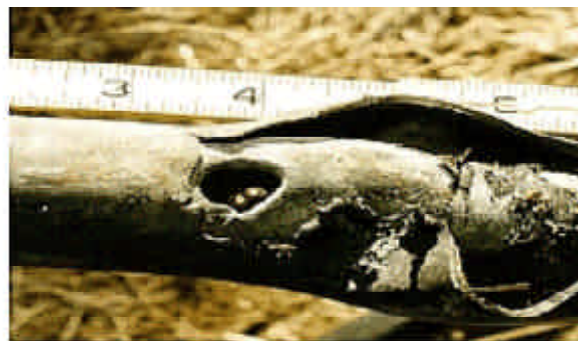
The most serious electrical intrusion injury within DOE in the past 10 years occurred on January 17, 1996 at the Los Alamos National Laboratory. A laborer was burned and rendered unconscious when his jackhammer hit a buried 13,200-volt electrical power cable (Figure 3). This event triggered a DOE Type A investigation.

Figure 3. Penetrated 13,200-volt cable during construction

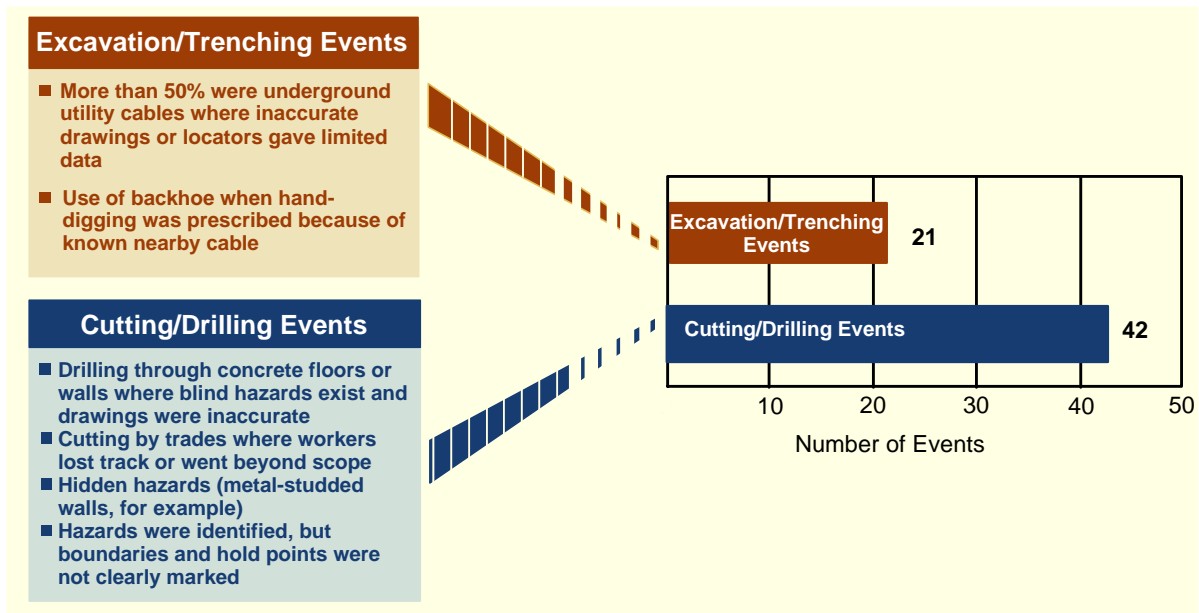
Figure 4. Cutting and drilling events and excavation/trenching events each contributed significantly to event totals, and each have multiple causes

Twenty cutting and drilling events and 13 excavation and trenching events occurred during construction. This work primarily involved routing new services within a facility and installing utilities or piping systems.

Similarly, 13 cutting and drilling events and 2 excavation and trenching events occurred during decommissioning. Decommissioning activities involved the removal of electrical conduit from facilities undergoing closeout and demolition. In many cases, some electrical systems may need to remain energized (such as lighting circuits) while other conduit and electrical systems are being removed. Figure 4 summarizes these events.

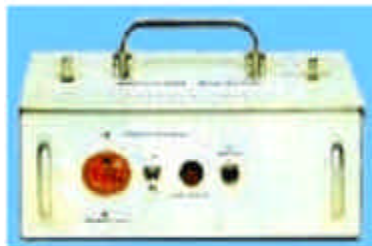
Figure 5. Example drill stop box

- Use double-insulated electrical tools that have insulated handles.
- Use drill-stop equipment when core drilling (stops drill when grounded metal is contacted), an example of which is shown in Figure 5.
- Use ground fault circuit interrupters with power tools.
- Use fiberglass-insulated shovels and picks when excavating by hand.
- Use rubber mats.
- Wear eye protection and electrically-rated protective gloves and footwear.

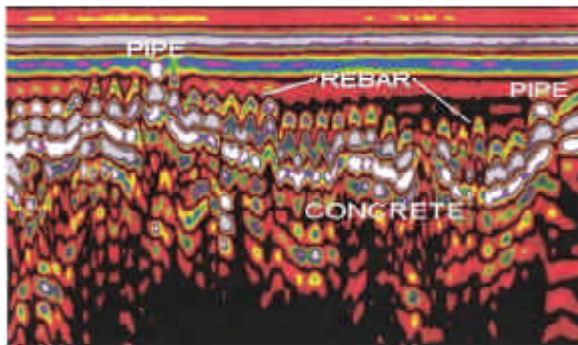
There are many types of utility and near-surface structure or hazard detection equipment available to DOE. These locating and survey instruments include ferroskan for locating rebar, electromagnetic and radio frequency for locating cables, metal piping, and power lines, and ground-penetrating radar (GPR) (Figure 6) that can locate plastic, ceramic, metallic objects, and even voids in the ground and structures. Ground-penetrating radar refers to the use of radio waves to detect embedded or buried objects. Radio waves penetrate the surface and are reflected back when an object or a change in composition is encountered.

Figure 6. Example GPR scan

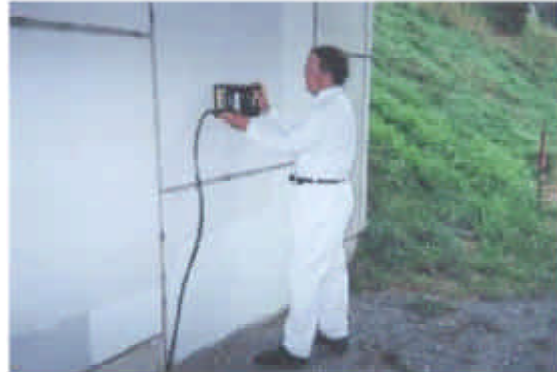
Figure 7. Using GPR to survey a structure

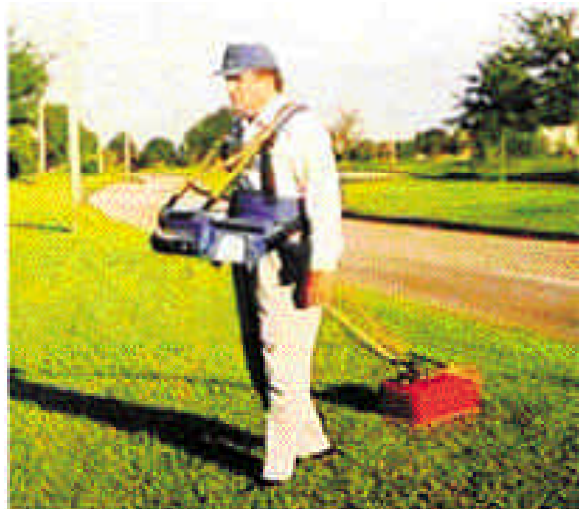
Figure 8. Using GPR on a ground survey
