## MARINE CASUALTY REPORT

FISHING VESSEL FISH-N-FOOL, D.N. 293888

CAPSIZING AND SINKING ON 5 FEBRUARY 1987  
IN THE PACIFIC OCEAN APPROXIMATELY 2.6  
MILES SOUTH OF ISLA DE SAN MARTIN,  
MEXICO WITH MULTIPLE LOSS OF LIFE AND  
INJURIES TO PASSENGERS

Marine Board of Investigation Report  
and  
Commandant's Action

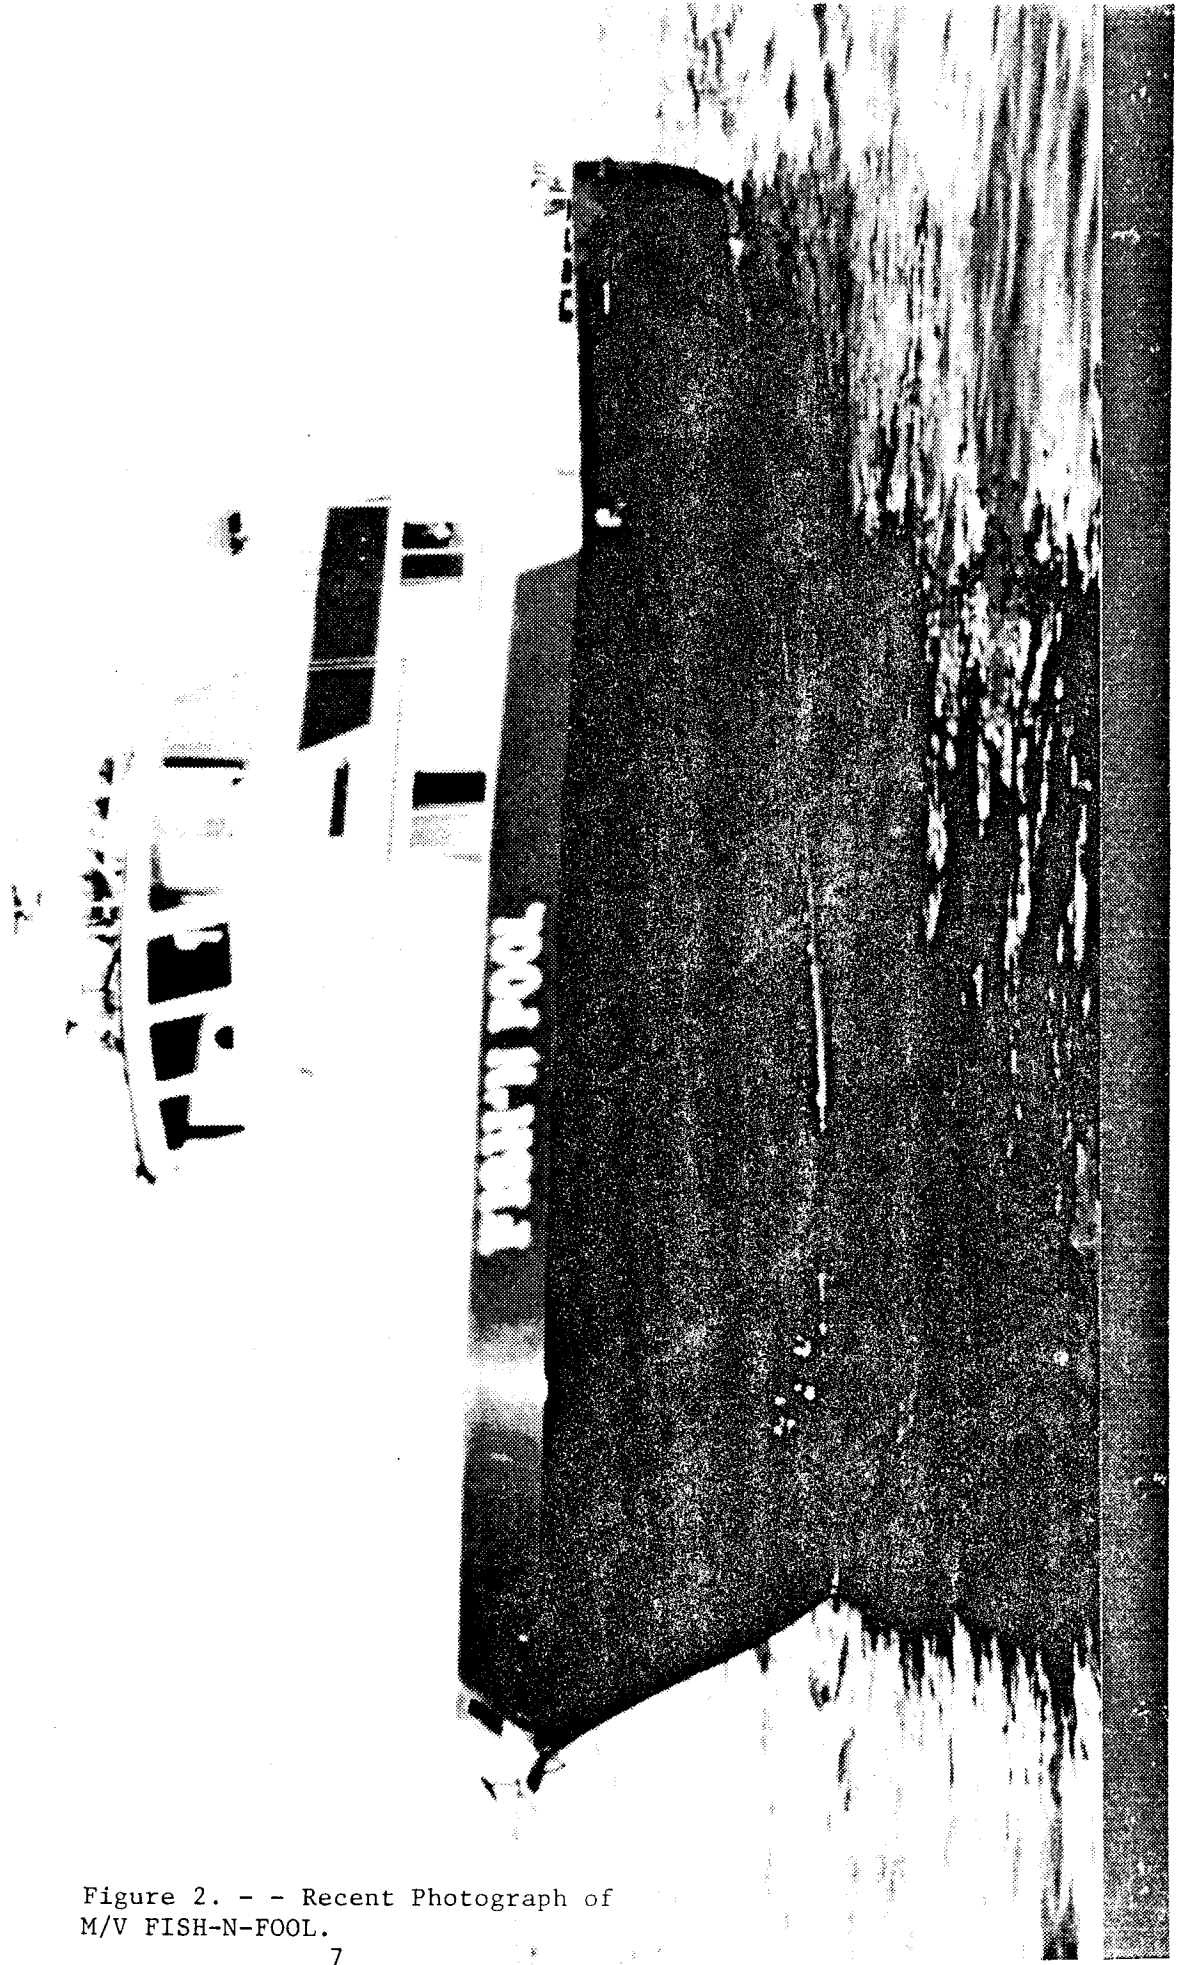
Figure 2. - - Recent Photograph of  
M/V FISH-N-FOOL.

propulsive power. Electronics included three VHF marine radios, one Single Side Band radio, a Benmar 21SK autopilot, a Furuno FE-600 depth finder, a Sitex 24 mile radar and an American Pioneer Model 101 Fishscope. Below deck berthing accommodated 32 passengers, with two crew bunks available in the forward area and one in the pilothouse. The vessel was reported to be in good condition and fit for the intended service.

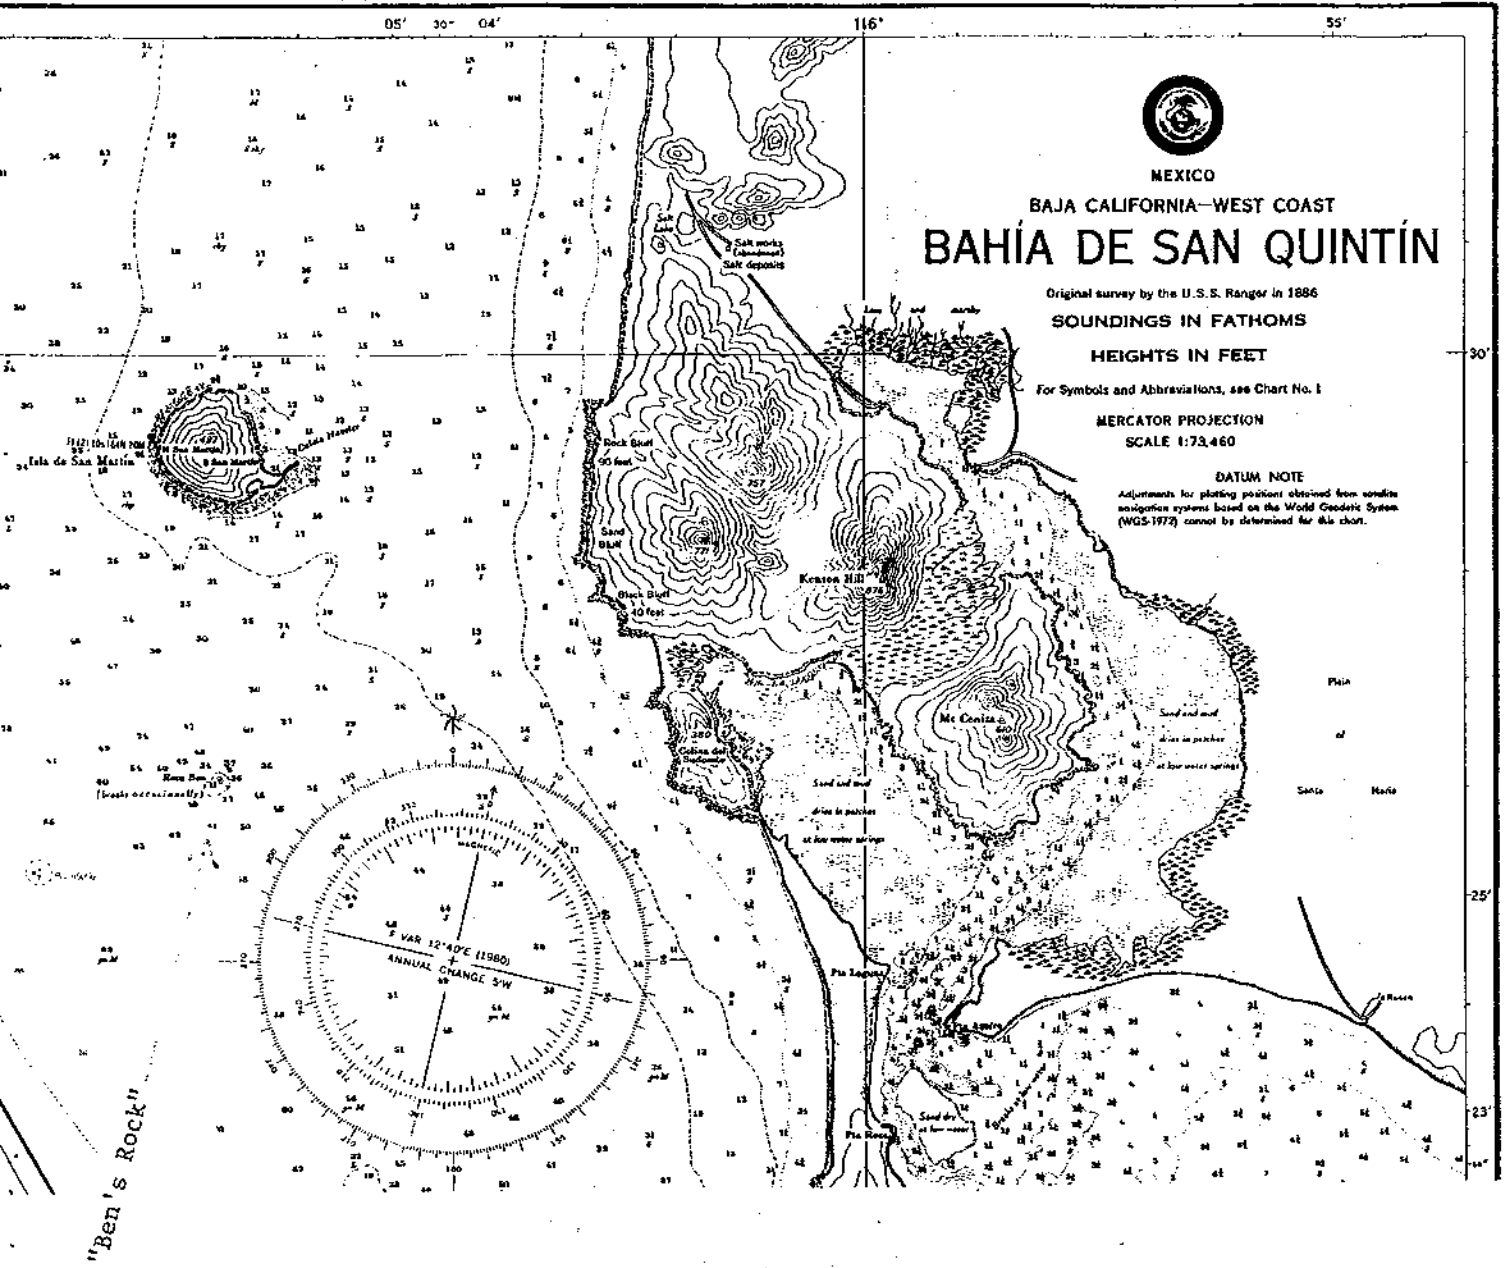
Figure 3. - - Excerpt from DMA Chart No. 21061, detailing "Ben's Rock", Isla de San Martin and the San Quintin coastline.

The cause of the casualty was the operator's positioning of the vessel in close proximity to, and down the swell line from, Ben's Rock (charted as a navigational hazard) to engage in fishing operations. The chart is annotated to indicate that occasional breakers occur in this area. A large swell subsequently broke over Ben's Rock and struck the vessel broadside, causing it to heel beyond its range of stability and capsize.

1. The proximate cause of the vessel casualty was operator Gary LaMont's positioning of M/V FISH-N-FOOL in close proximity to, and down swell of, Ben's Rock to engage in fishing operations. This action placed the vessel in such a position that a large swell, breaking over Ben's Rock, struck the vessel nearly broadside and imparted sufficient heeling energy to overcome the inherent dynamic stability of the vessel, causing the vessel to heel beyond its range of stability and capsize.
