May 1996

Investigating the F/A-18

LCDR Tom Ganse Code 136
(804) 444-3520, Ext. 7239 (DSN 564)
Fax (804) 444-7049

Naval Safety Center
375 A Street
Norfolk, VA 23511-4349

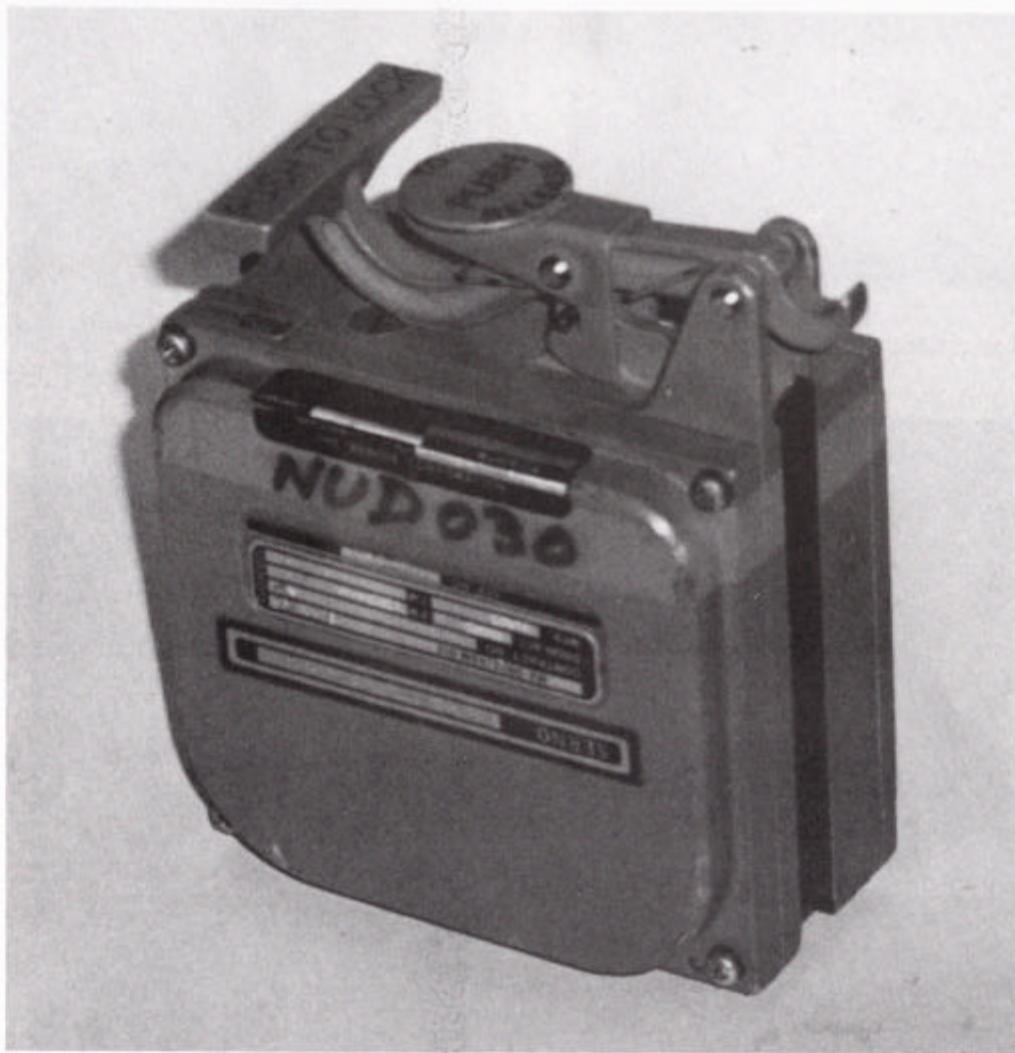
Figure 7. MSDRS Cassette

Maintenance Signal Data Recording System (MSDRS). This removable cassette, pictured in Figure 7, is used by Lot 9 and earlier aircraft (BUNO 161353 - 163175). The gray metal case measures approximately 3" X 3" X 1.5" and has a yellow stripe painted around it. It is not crash hardened, and does not contain all of the information the DSU does. Figure 8 shows the MSDRS installed behind Door 14R. Figure 9 shows recorded parameters. An undamaged MSDRS tape can be read locally.

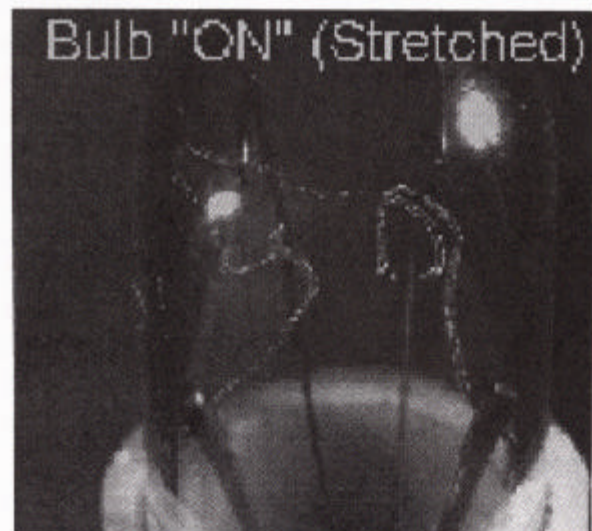
Figure 23. Light Bulb Filament Analysis

Lights. Incandescent light bulbs produce light by heating a thin metal filament until it glows white hot. A filament in this condition exhibits ductile failure characteristics, therefore, if it is illuminated at impact, it will stretch and distort instead of breaking. The time it takes for filaments to change from ductile to brittle is measured in hundredths of a second. Because of this, analyzing light bulbs may provide answers to questions like: Did the aircraft have electrical power? Which busses were powered? Was a fire light on? Any other warnings, cautions, or advisories lit? Was the Master Caution light on? Be careful with this last one since a caution may exist but the master caution light may have been deselected. Master Caution light on is a good indication that a caution existed, but master caution off tells you very little. The illustrations in Figure 23 provide examples of filament analysis, which can even be accomplished at the crash site with larger bulbs.

Stretched and distorted filament
indicating light ON impact

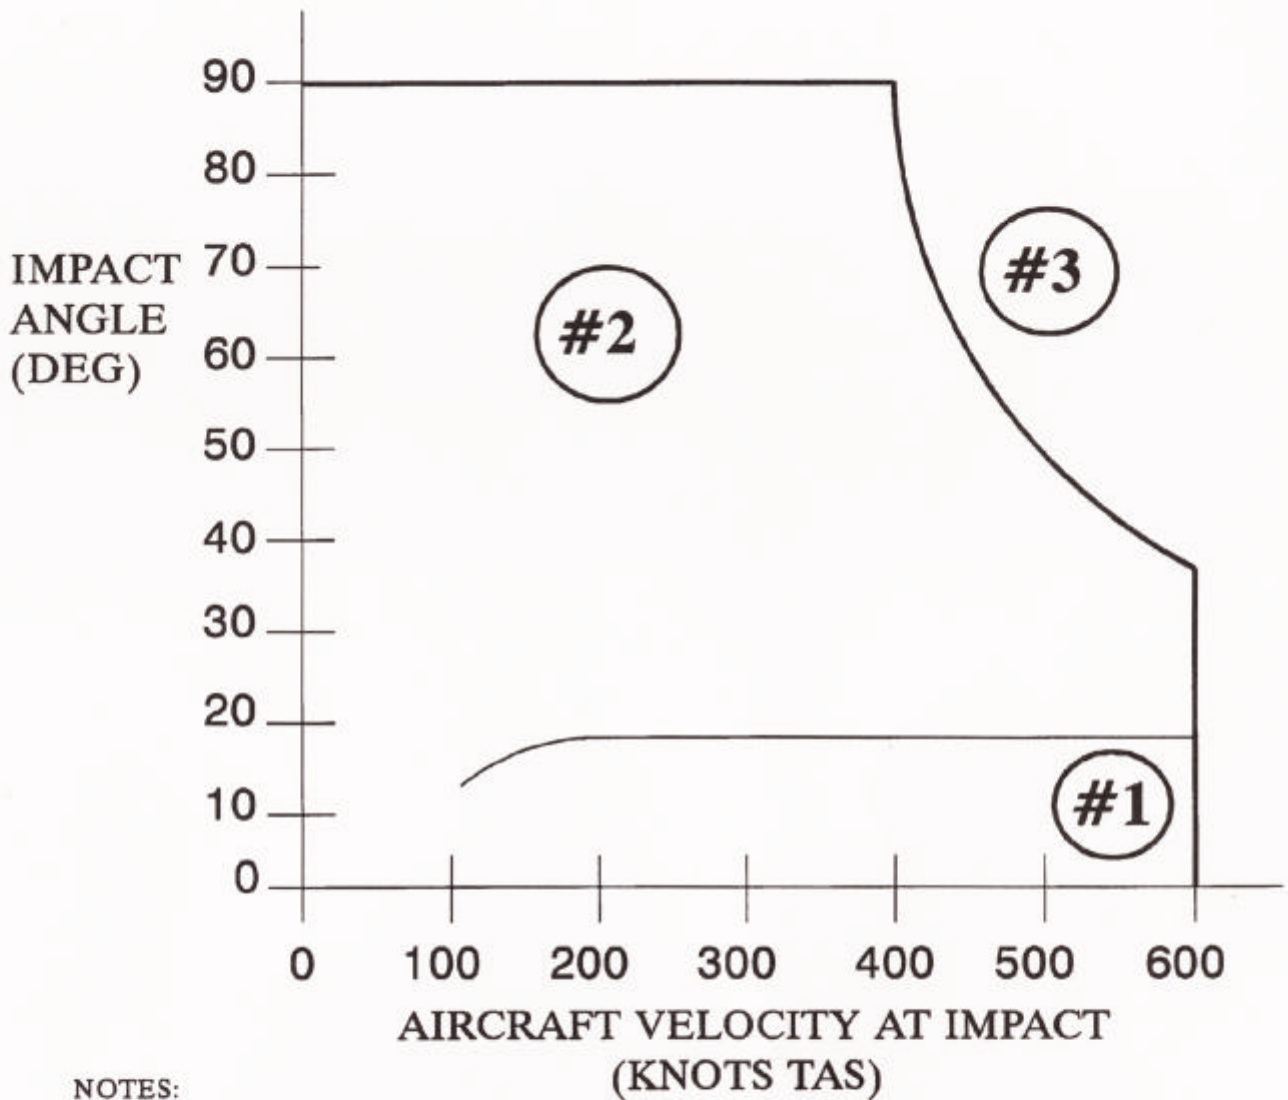
DFIRS Deployment Envelope

1. Projected deployment areas depicted as follows:
 - #1 DFIRS likely to be deployed and recovered.
 - #2 DFIRS likely to be deployed, may not be recovered.
 - #3 DFIRS may not be deployed.
2. Deployment area definition based on:
 - a. Aircraft upright, nose down, wings level.
 - b. Flat, planar impact surface.
 - c. Aircraft velocity vector coincident with longitudinal axis.
3. Impact angle is defined as the angle between the aircraft longitudinal axis and impact surface.

The DFIRS deploys upon ejection or impact exceeding 20 Gs. The expected deployment envelope is provided in Appendix B. DFIRS maintains the most complete record of aircraft event history, including all critical parameters recorded by ECAMS. Unfortunately, it is limited to the last 30 minutes of electrical power. The Naval Safety Center can produce a hardcopy printout and a computer generated video display from this data if the memory module can be retrieved undamaged. DFIRS is currently installed in later Lot 15 aircraft and all Lot 16 and subsequent aircraft (BUNO 164725+). The ongoing retrofit into Lot 14 and 15 aircraft (BUNO 164627 - 164724) should be complete by the end of 1996.
