Mech

The Naval Safety Center's Aviation Maintenance Magazine

Vol. 2, No. 6, Apr – Jun '99

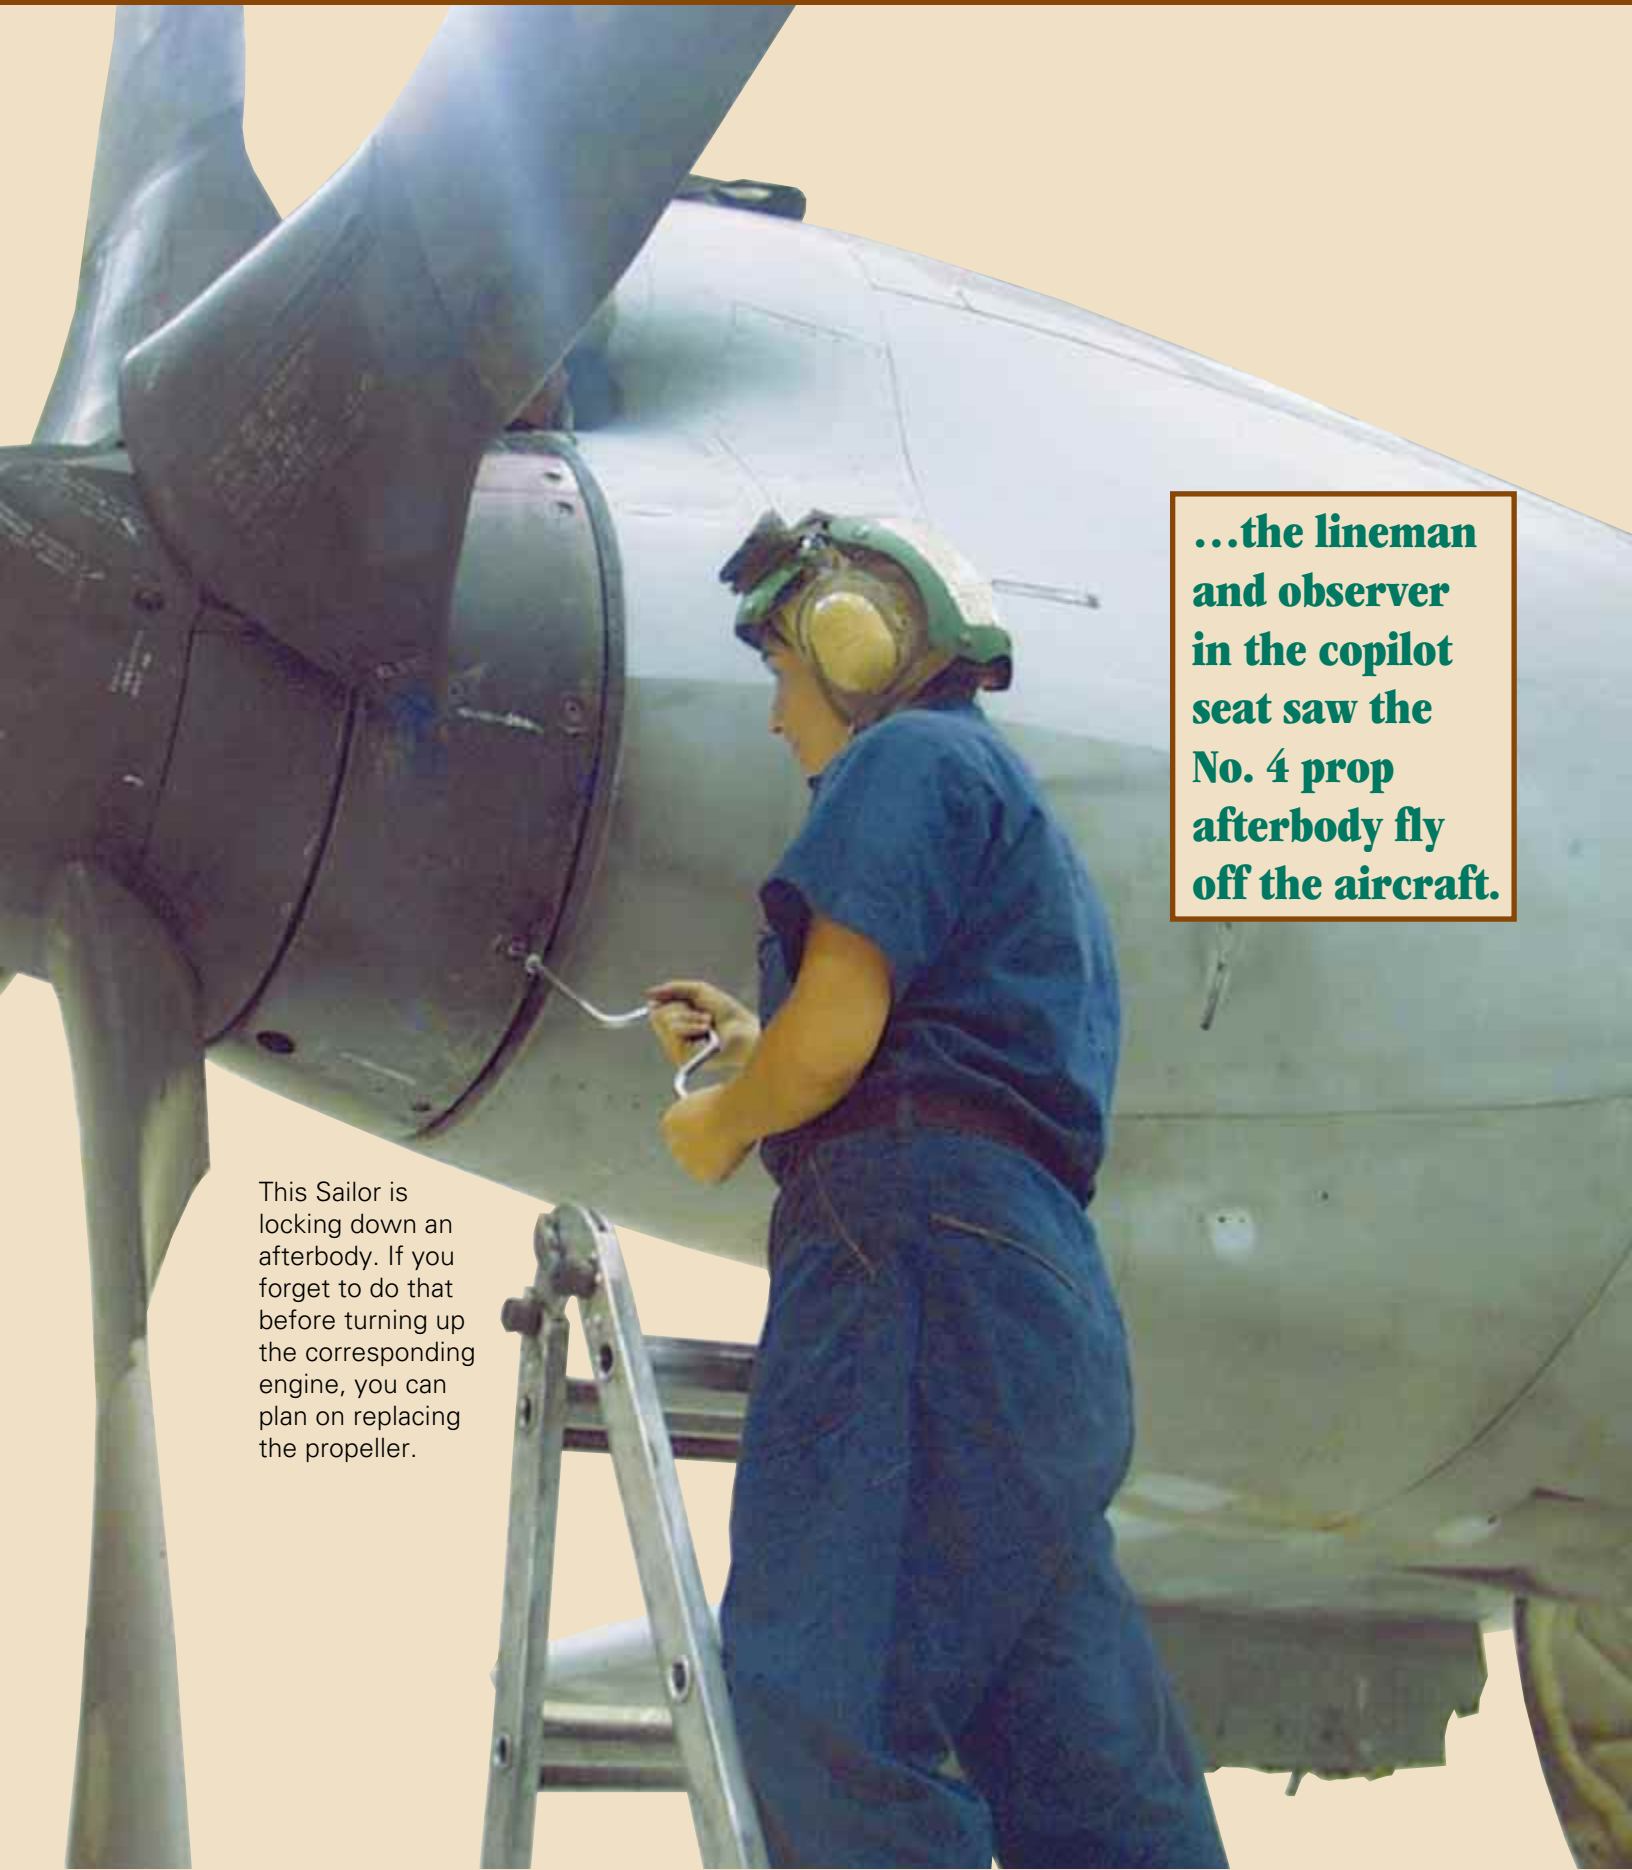
...the lineman and observer in the copilot seat saw the No. 4 prop afterbody fly off the aircraft.

This Sailor is locking down an afterbody. If you forget to do that before turning up the corresponding engine, you can plan on replacing the propeller.

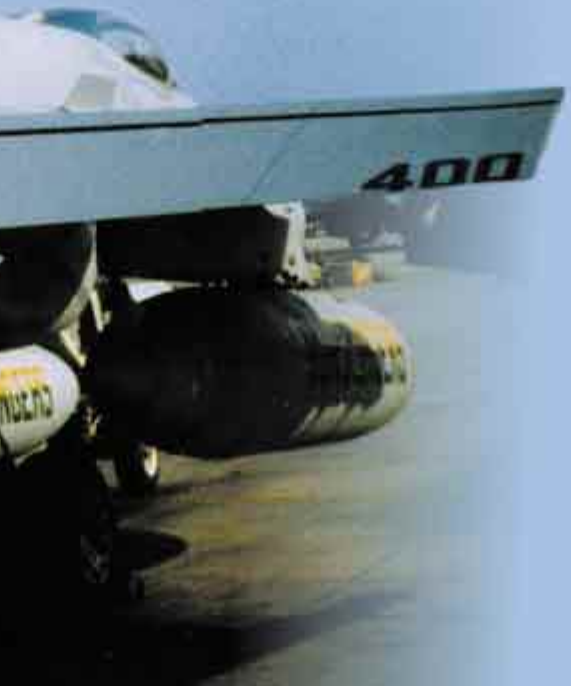
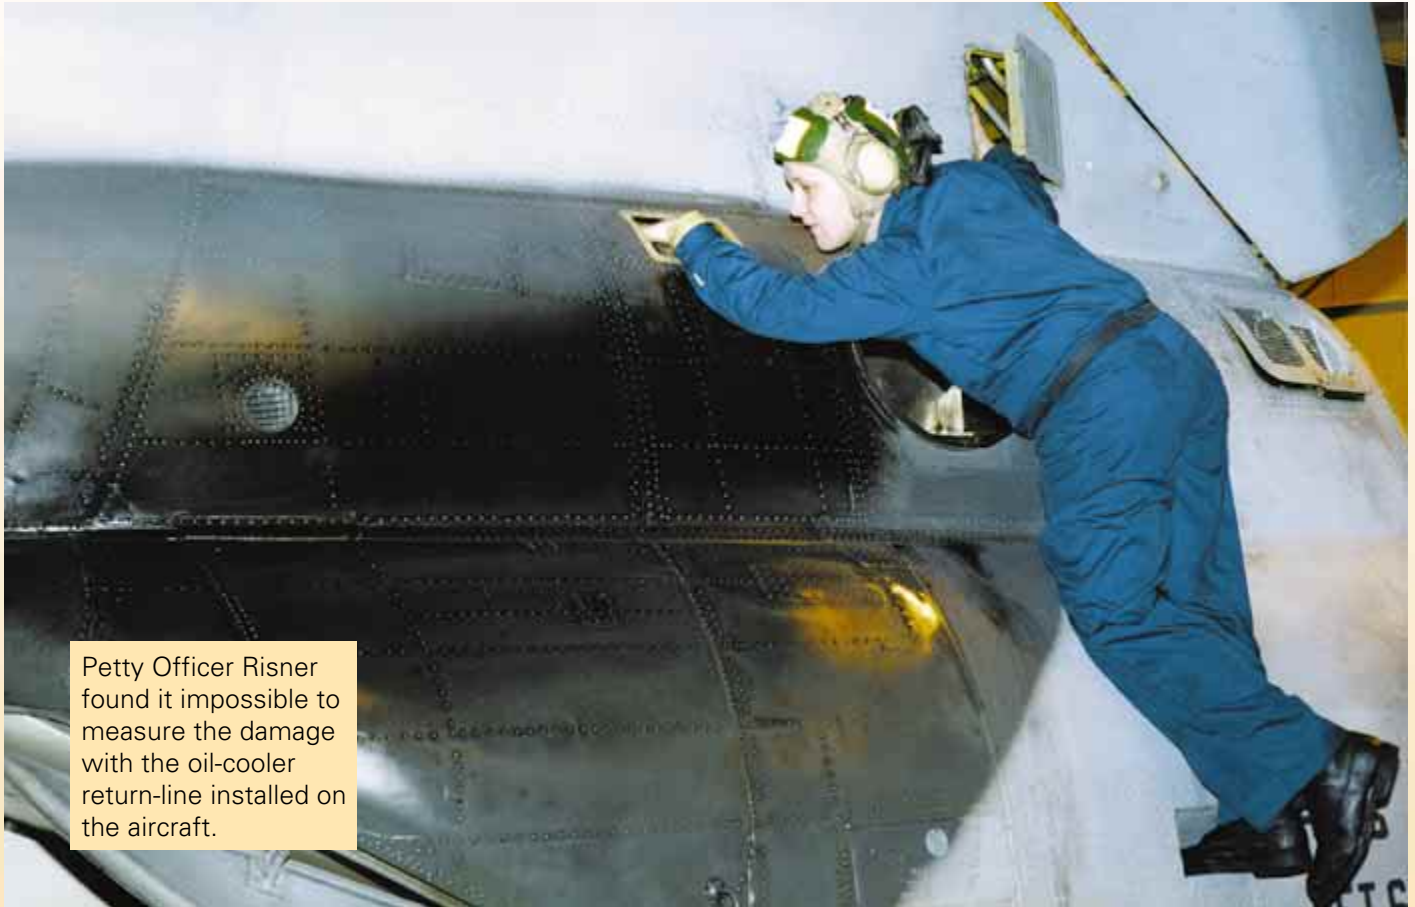
Petty Officer Risner found it impossible to measure the damage with the oil-cooler return-line installed on the aircraft.

It was impossible to measure the damage with the line installed on the aircraft. After several unsuccessful tries, we removed the line to get an accurate measurement, which was .032 inches. We checked our findings against table 9-1 in the NA OI-1A-20, which showed the chafing limit for the line to be .006 inches. This damage was not just beyond the designated limit; it was way beyond it.

Once we removed the line from the aircraft, we could see several damaged layers of steel laminate that hadn't been visible while the line was installed in the airframe. The transmission-oil line that the hydraulic line had been chafing against was also severely worn; we wrote a discrepancy against both. When we

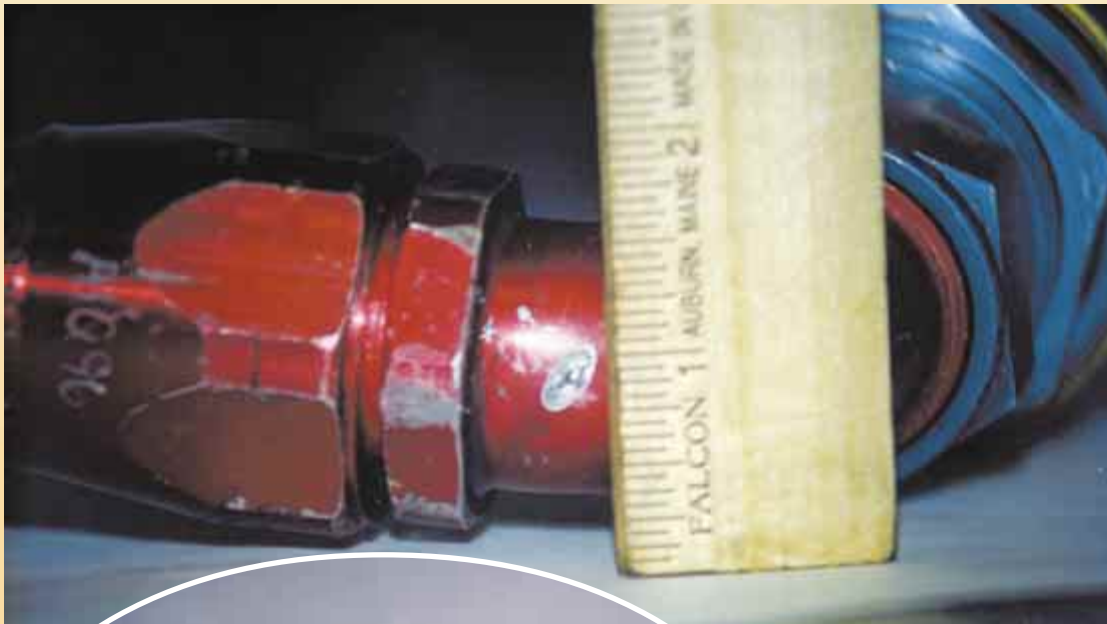
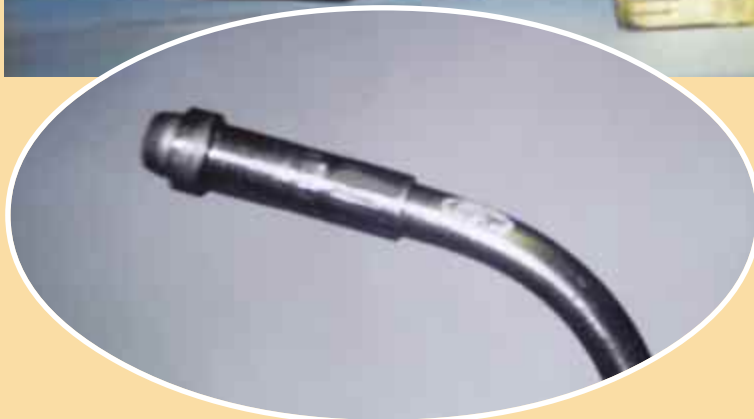
How long would it take for these lines to wear through from vibration and cause the transmission to fail or the hydraulic pump to cavitate?

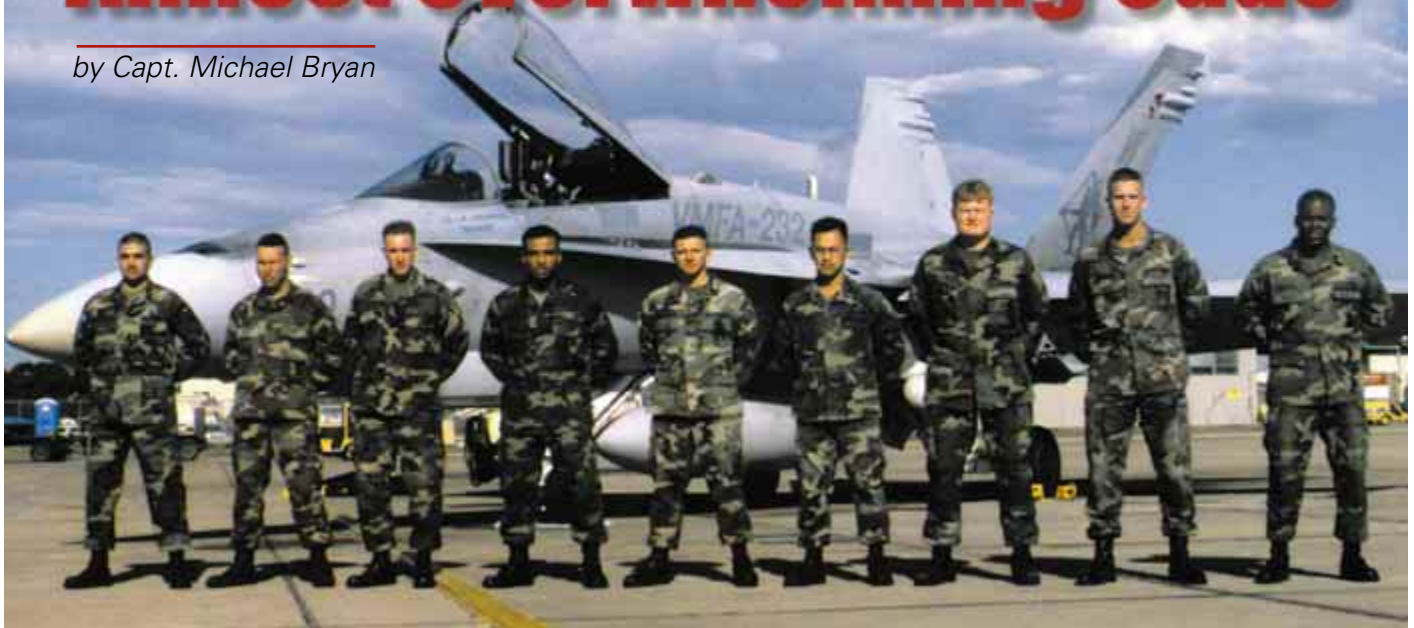
These Marines wrestled a 20-by-75-foot section of fibreglass parking ramp to a standstill in high winds to protect their squadron's Hornets.

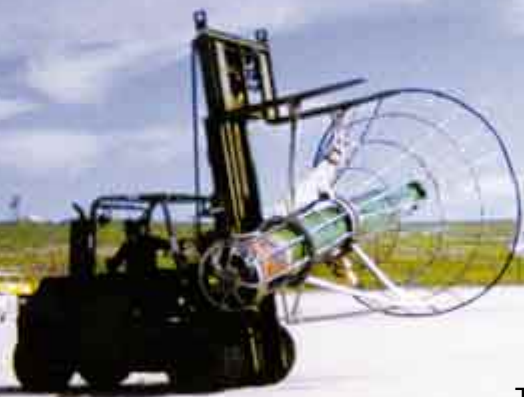
The Mk-2 (helicopter weapon-recovery system) and training shape are transported by forklift, which will react violently to even the smallest bump.

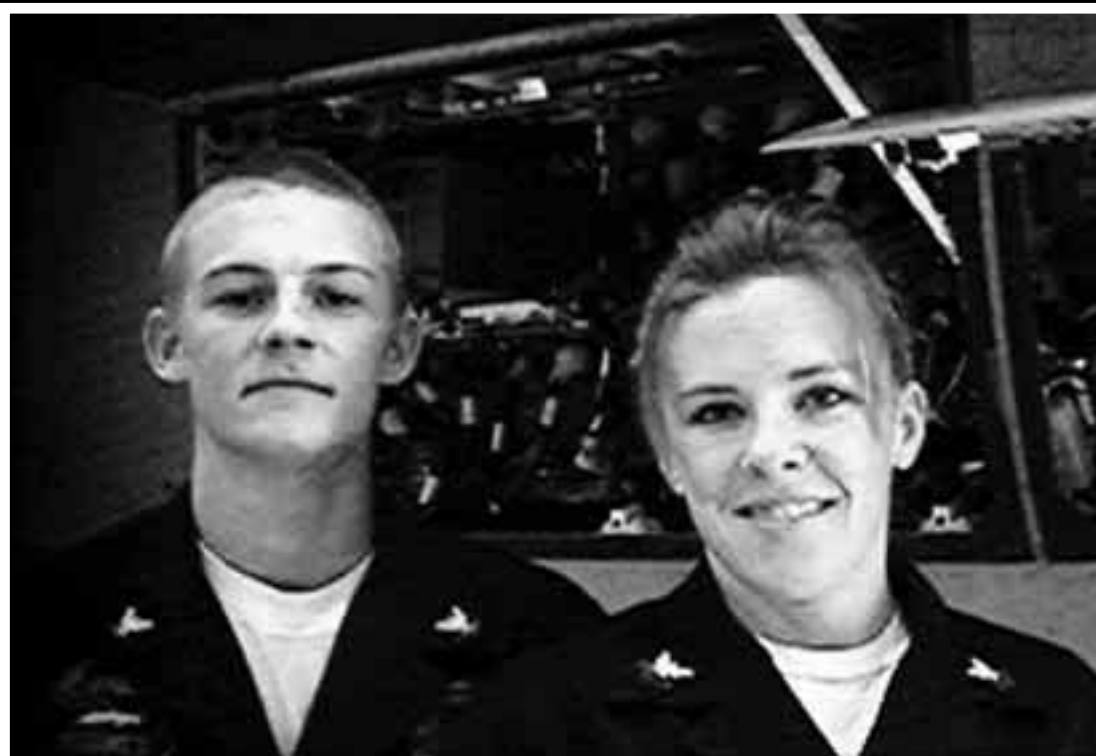
AE3 Scott Mason and AMS2 Jeanette Moore found the cause of intermittent binding of flight controls.

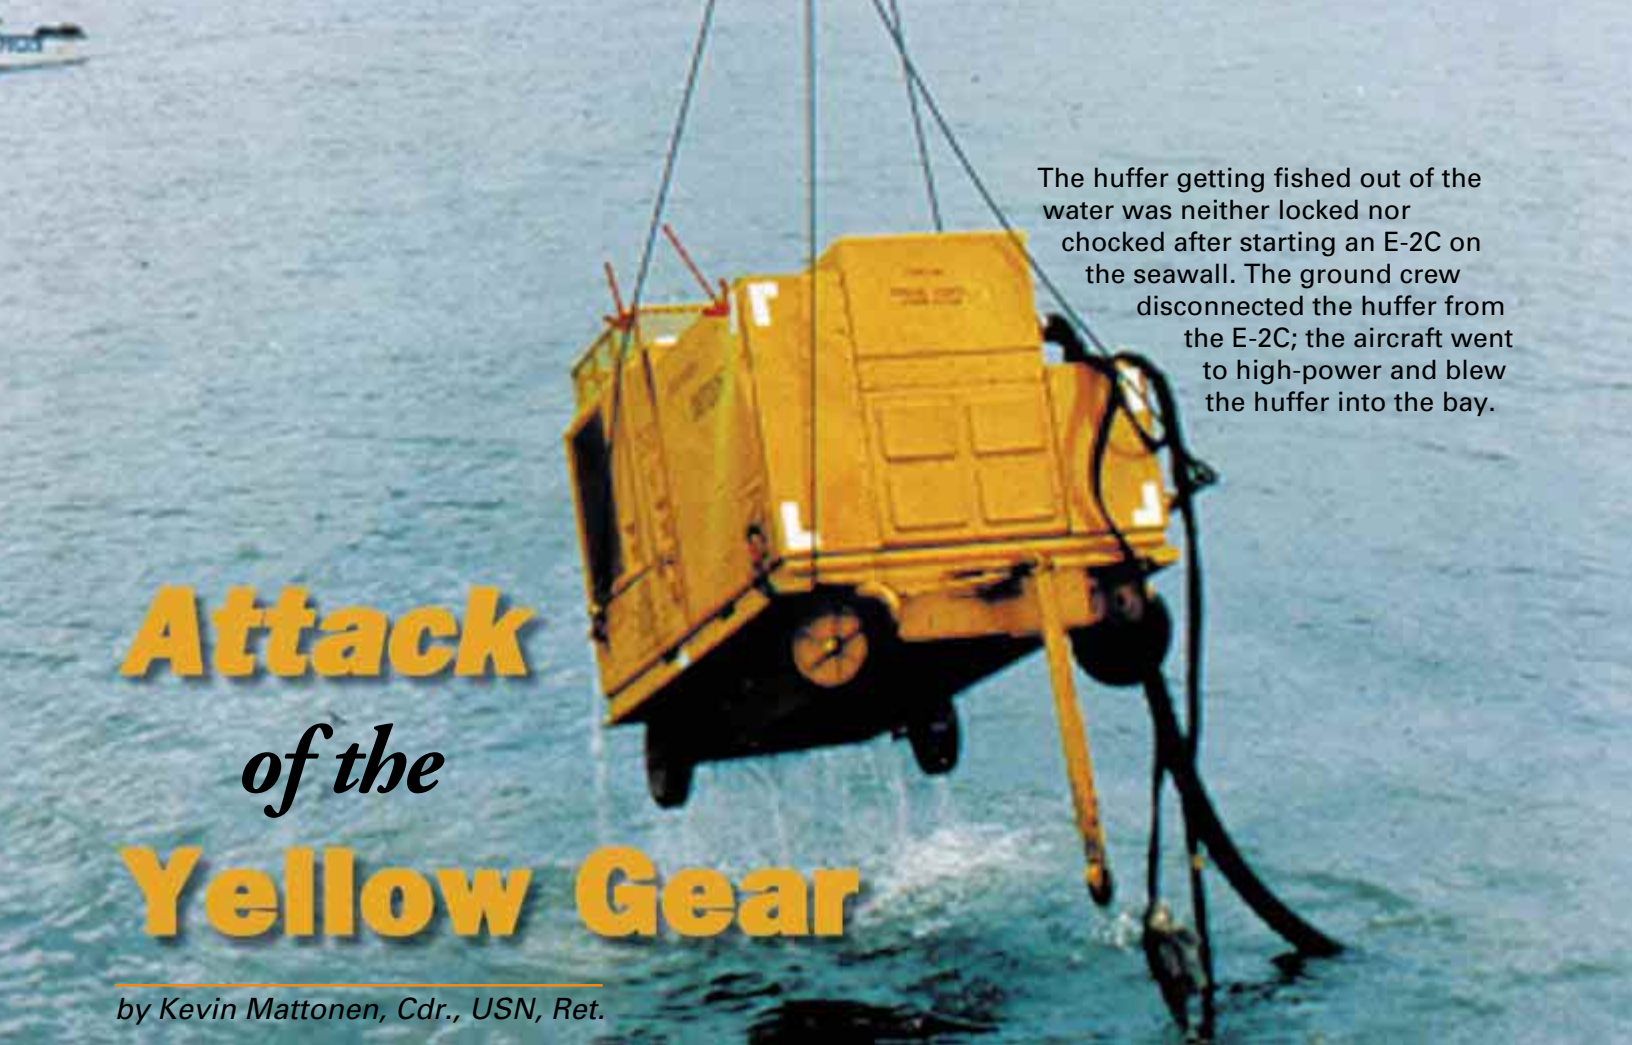
The huffer getting fished out of the water was neither locked nor chocked after starting an E-2C on the seawall. The ground crew disconnected the huffer from the E-2C; the aircraft went to high-power and blew the huffer into the bay.

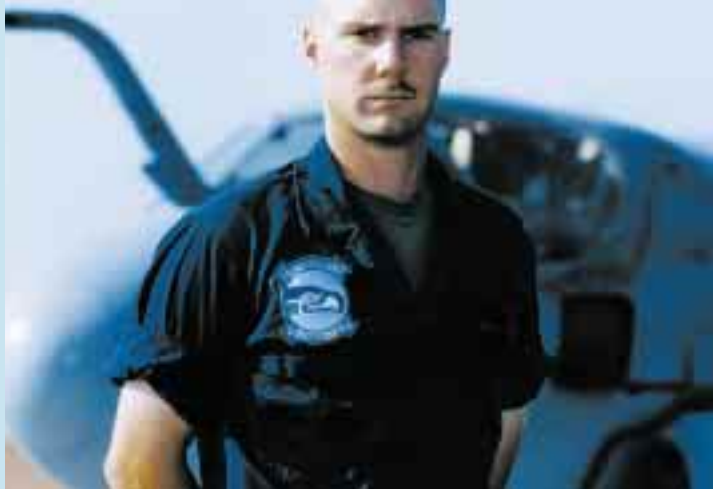
Sgt. C.L. Anderson
VMAQ-4

Sgt. Anderson (a power plants and line supervisor) and his crew were removing an engine from an EA-6B and lowering it with two HLU-288 bomb hoists. He heard an unusual noise, stopped work and inspected the forward bomb hoist cable and attaching points. Two strands of the cable had severed 4 inches below the engine mount, and the remaining cable was about to break.

Had the cable broken, the engine would have fallen 4 feet, been damaged and might have injured the maintenance crew.

Sgt. Anderson cleared everyone away and told a Marine to put a weapons loader under the engine until they could replace the bomb hoist.

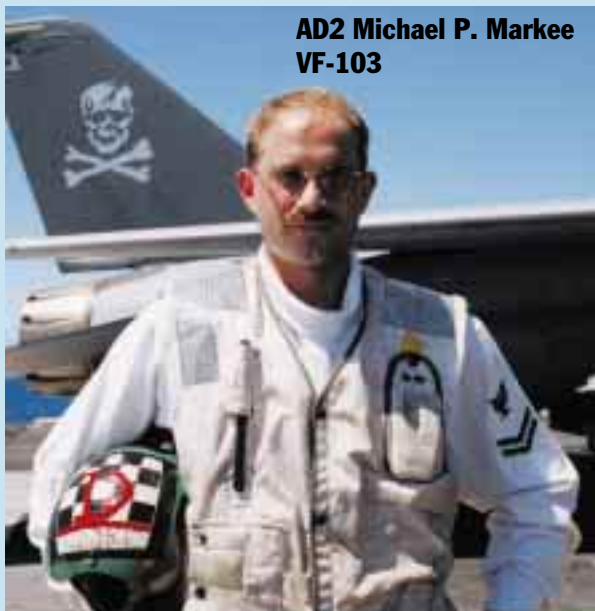
AD2 Michael P. Markee
VF-103

AD2 Markee, a final checker aboard USS *Dwight D. Eisenhower* (CVN 69), noted a small amount of hydraulic fluid coming from the port nozzle of Victory 116 as the Tomcat went into tension for launch. He immediately suspended the launch and downed the aircraft. Troubleshooting further, he found a crack in the port rudder-actuator assembly.

Had AD2 Markee not stopped the launch, the aircraft would have had an airborne emergency. Given the location of the crack and how close it was to the flight-hydraulic system, it could have caused a complete hydraulic failure.
