Helicopter Logging

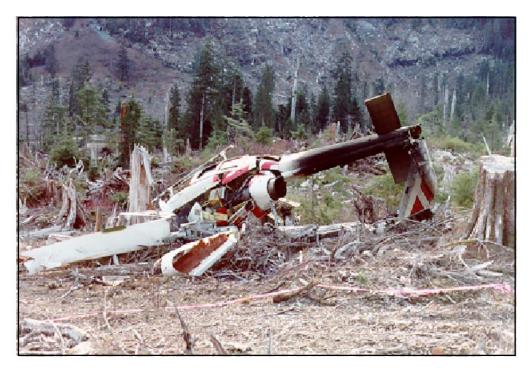
Photo 5: A helicopter crash at Dora Bay, Alaska

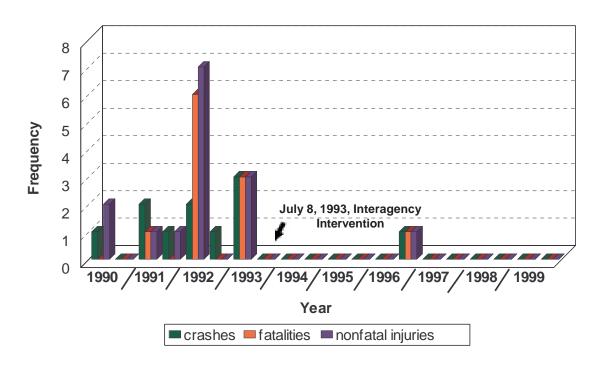
Figure 8: Crashes, Fatalities, and Nonfatal Injuries in Alaska Helicopter Logging Operations, 1990-1999 (By 6-Month Intervals)

By late July 1993, all helicopter logging sites and ramps in the state had been visited by the jurisdictional agencies, with a number of these operations being curtailed or entirely shut down for irregularities. Since that intervention and the implementation of the Working Group's recommendations during July 1993, there were no additional helicopter logging crashes or fatalities in Alaska until July 1996, when a single crash occured, with one fatality. (See Figure 8.) There have been no more since (through December 2001), despite continuation of large-scale helicopter logging in Alaska.
