Memphis, Tennessee  
15-Passenger Day Care Van  
Run-Off-Road Accident

April 4, 2002

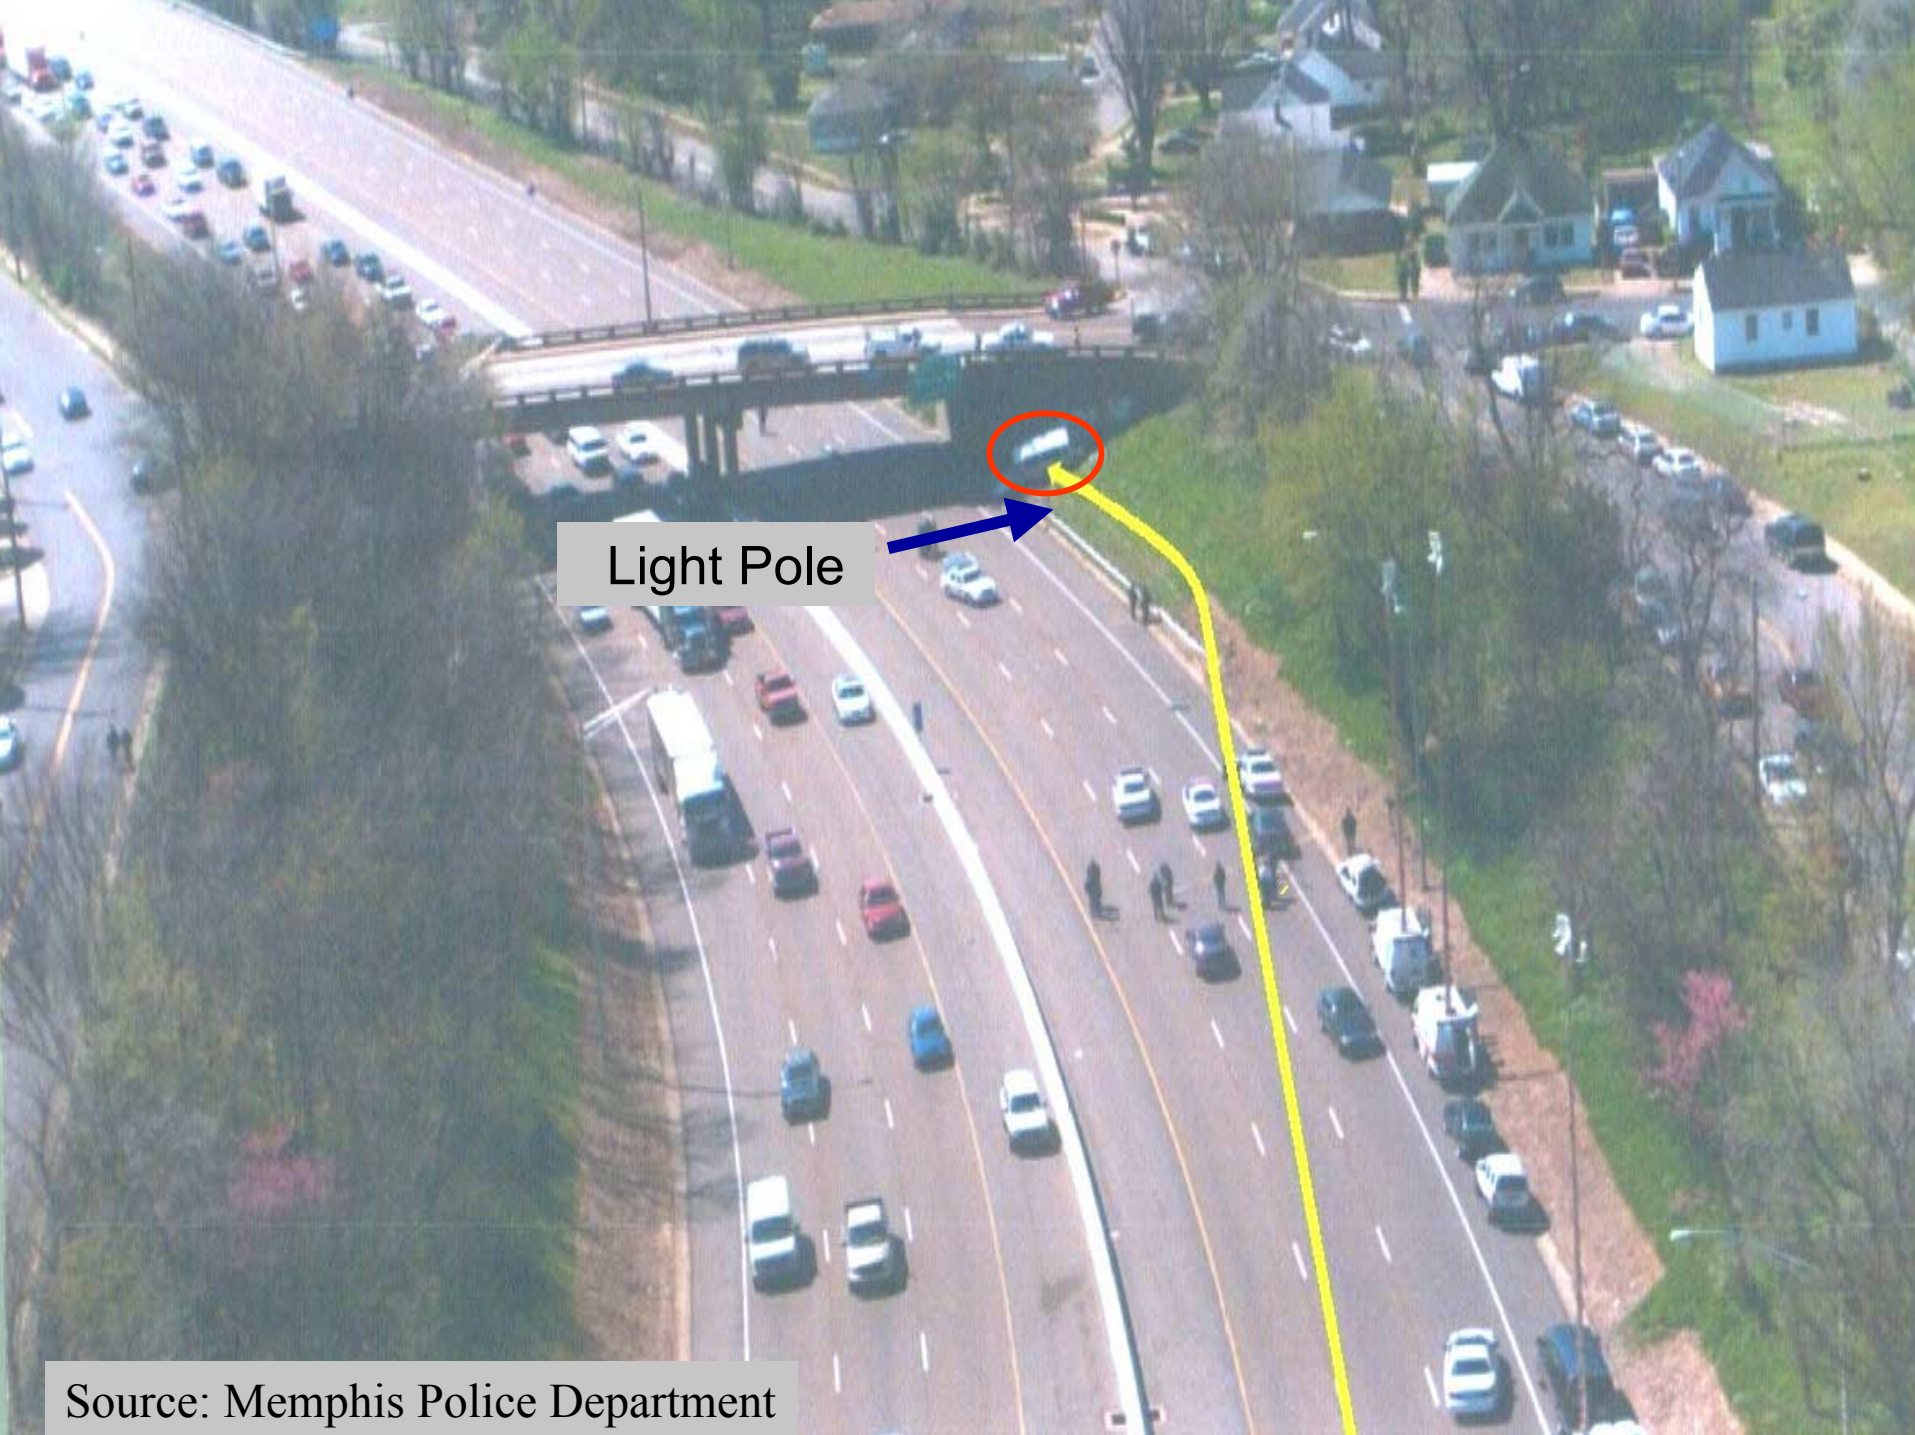
- Southbound Interstate 240
- Van departed roadway
- Overrode guardrail
- Struck light pole
- Rotated counterclockwise
- Struck bridge abutment

Light Pole

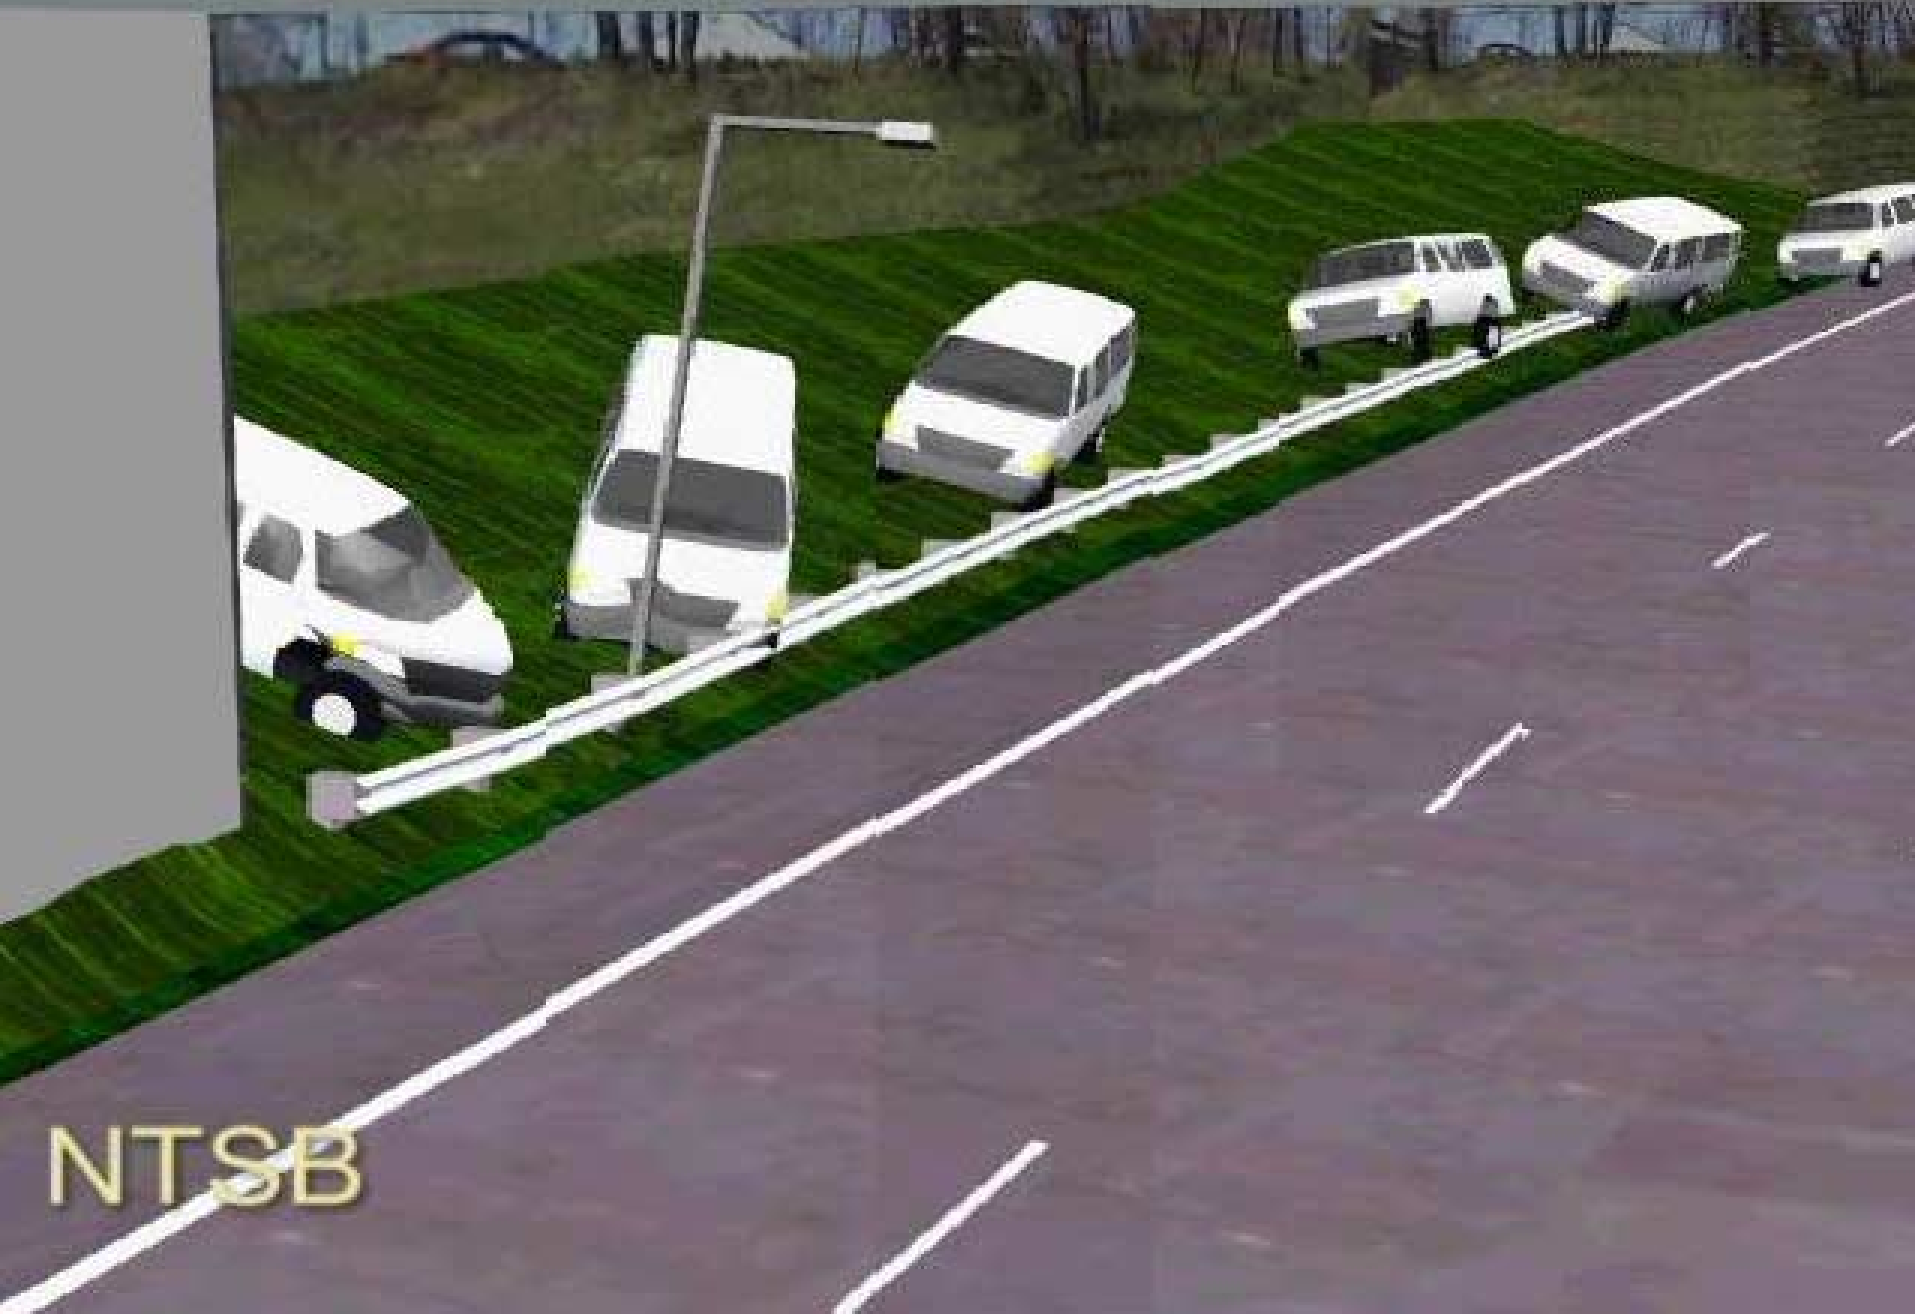
# Vehicle Simulation

- Developed based on physical evidence and vehicle deformation
  - Tire marks
  - Vehicle damage patterns
  - Damage to guardrail, light pole, bridge abutment
  - Final rest locations
- Characterizes best fit to physical evidence
- Representative of accident sequence but may not show actual accident

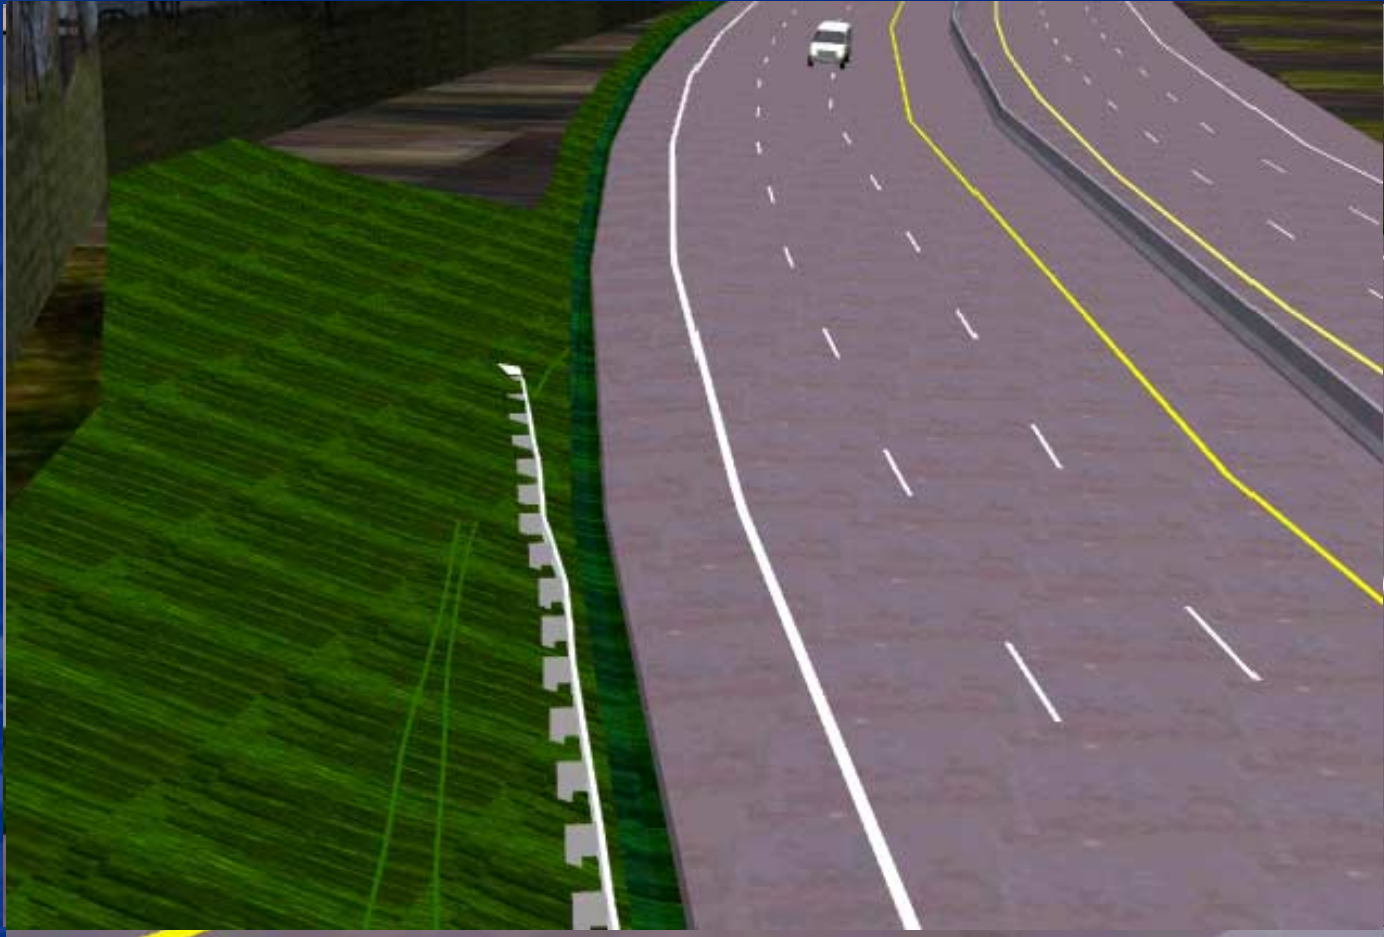
# Simulation Videos

- Van drifted from left lane
  - No applied steering
  - Duration of more than 3 seconds
- Van speed at roadway departure approximately 63 mph
- Peak van accelerations:
  - 12 g during impact with light pole and guardrail posts
  - 31 g during impact with bridge abutment
- Significant intrusion resulted

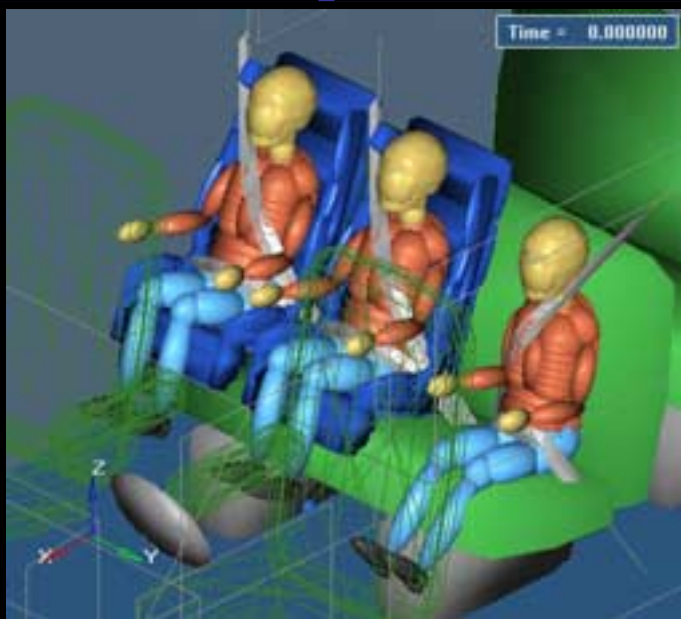
Time = 0.000000

## Actual Restraint

- Belt impinges on neck
- 2<sup>nd</sup> row occupant traveling forward and laterally into driver's region

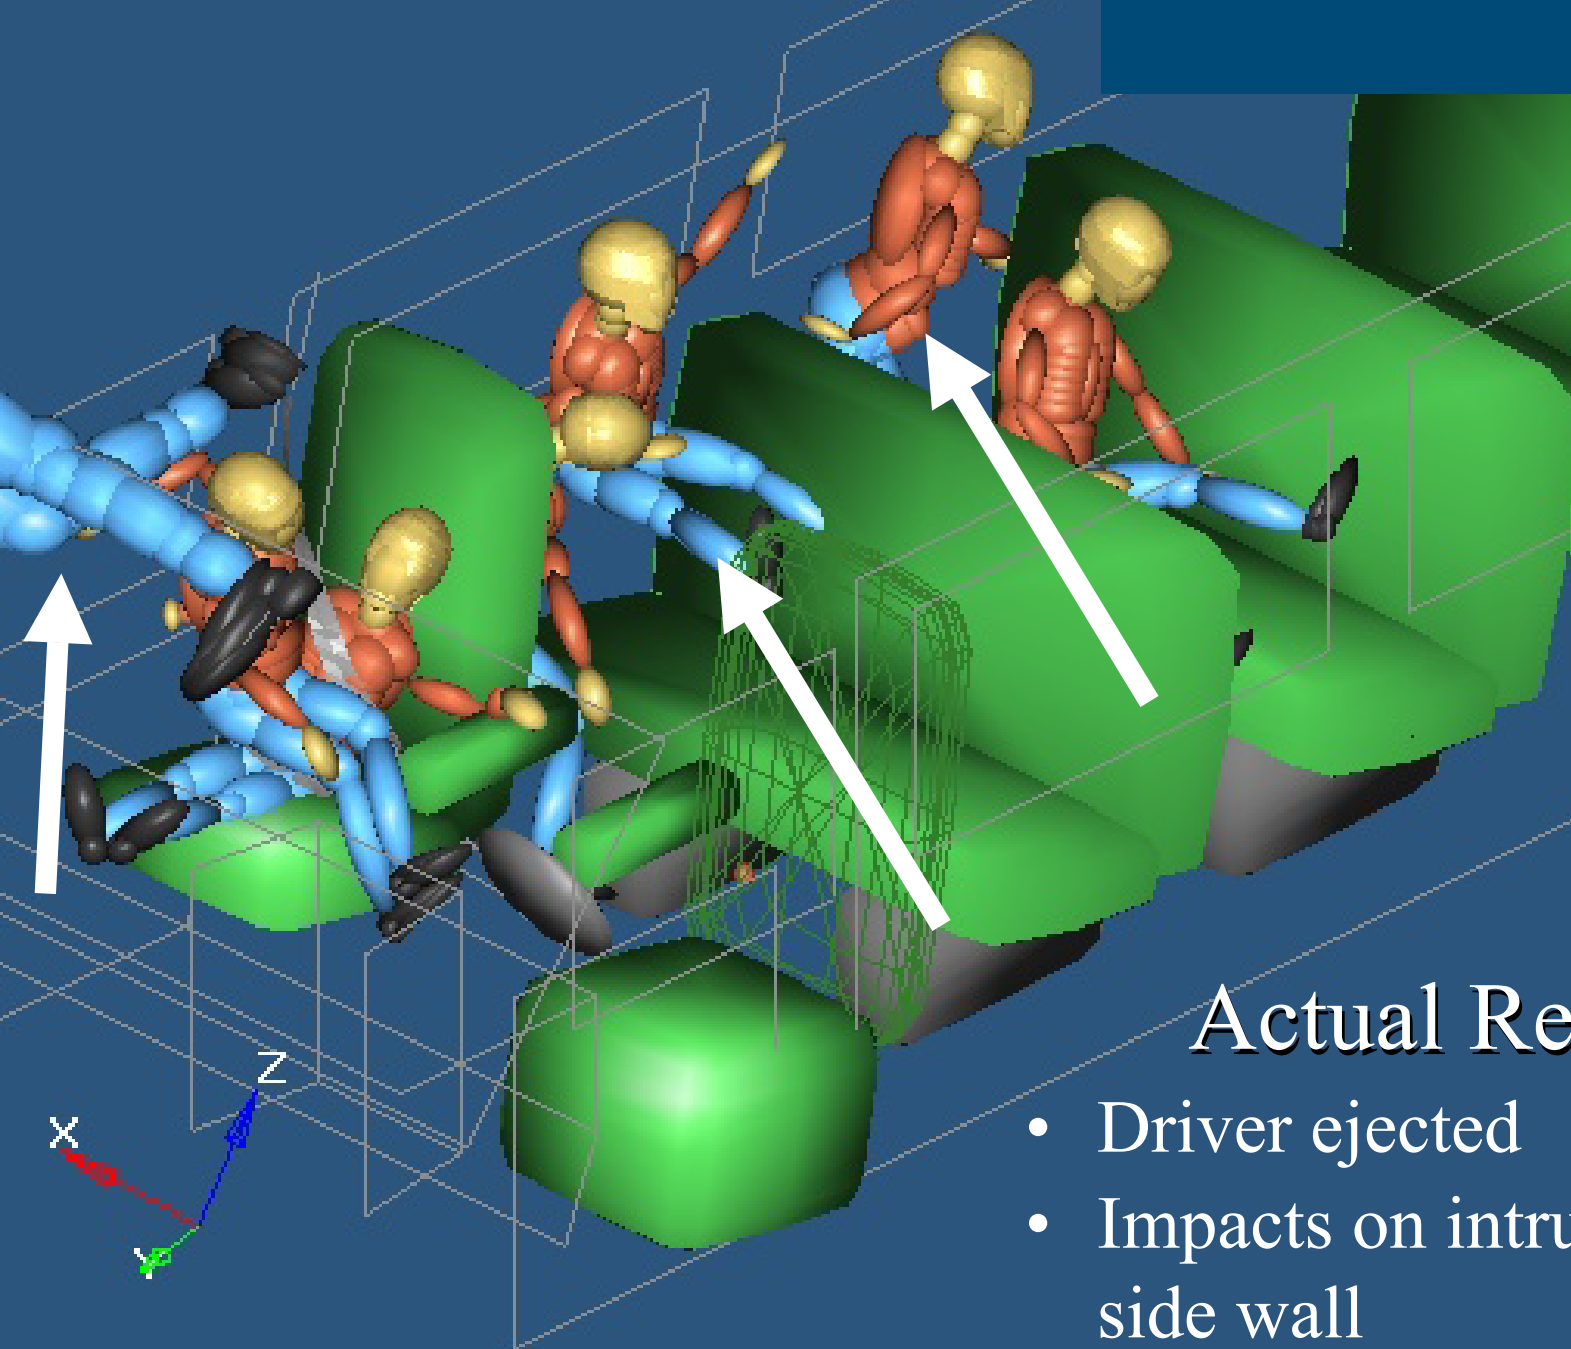
## Actual Restraint

- Driver ejected
- Impacts on intruding right side wall

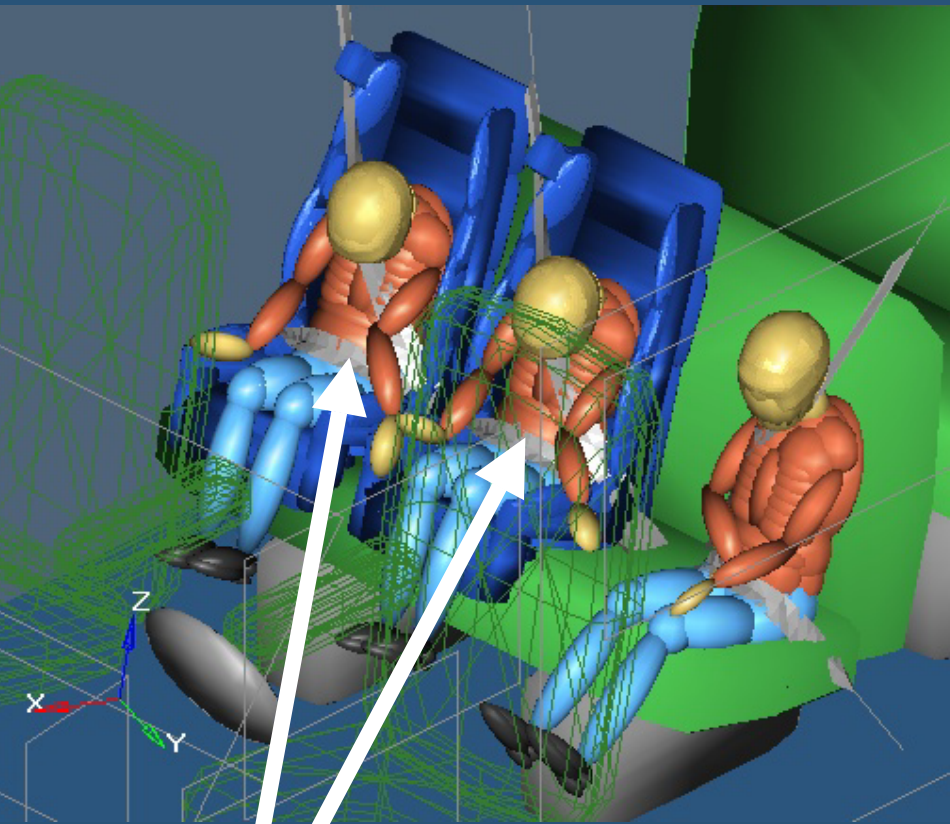
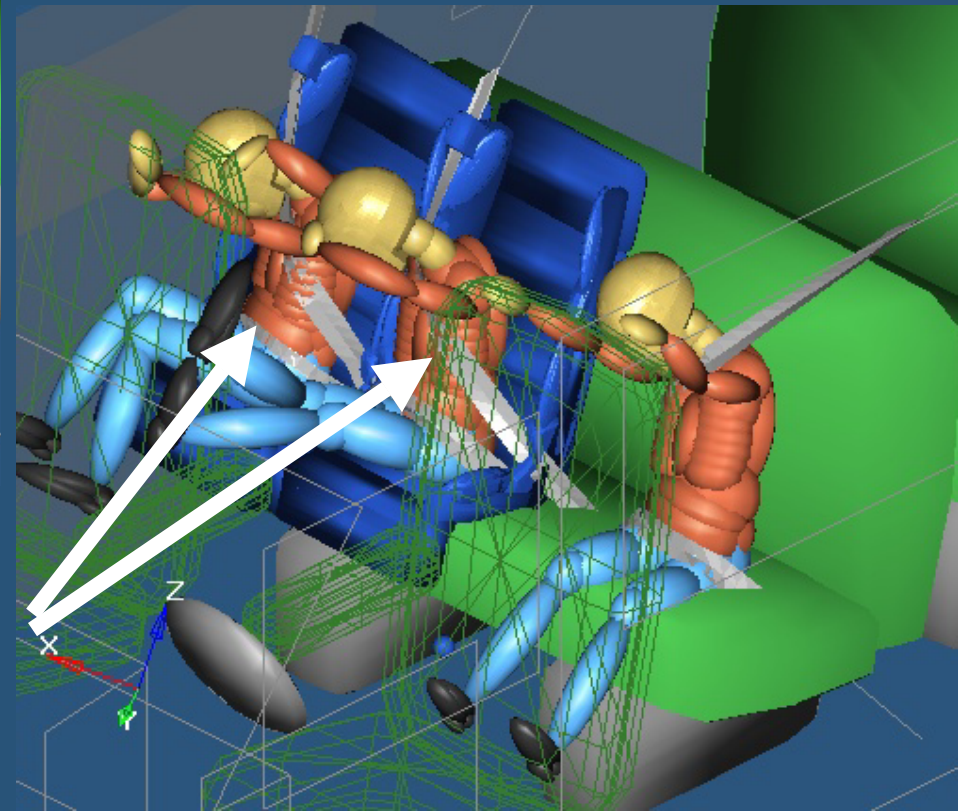
# Booster Seated Condition

## Booster seat condition – low injuries

- Proper positioning of restraints
- Increased lateral restraint from high-backed booster
- Injuries less severe for two occupants in high-backed booster seats

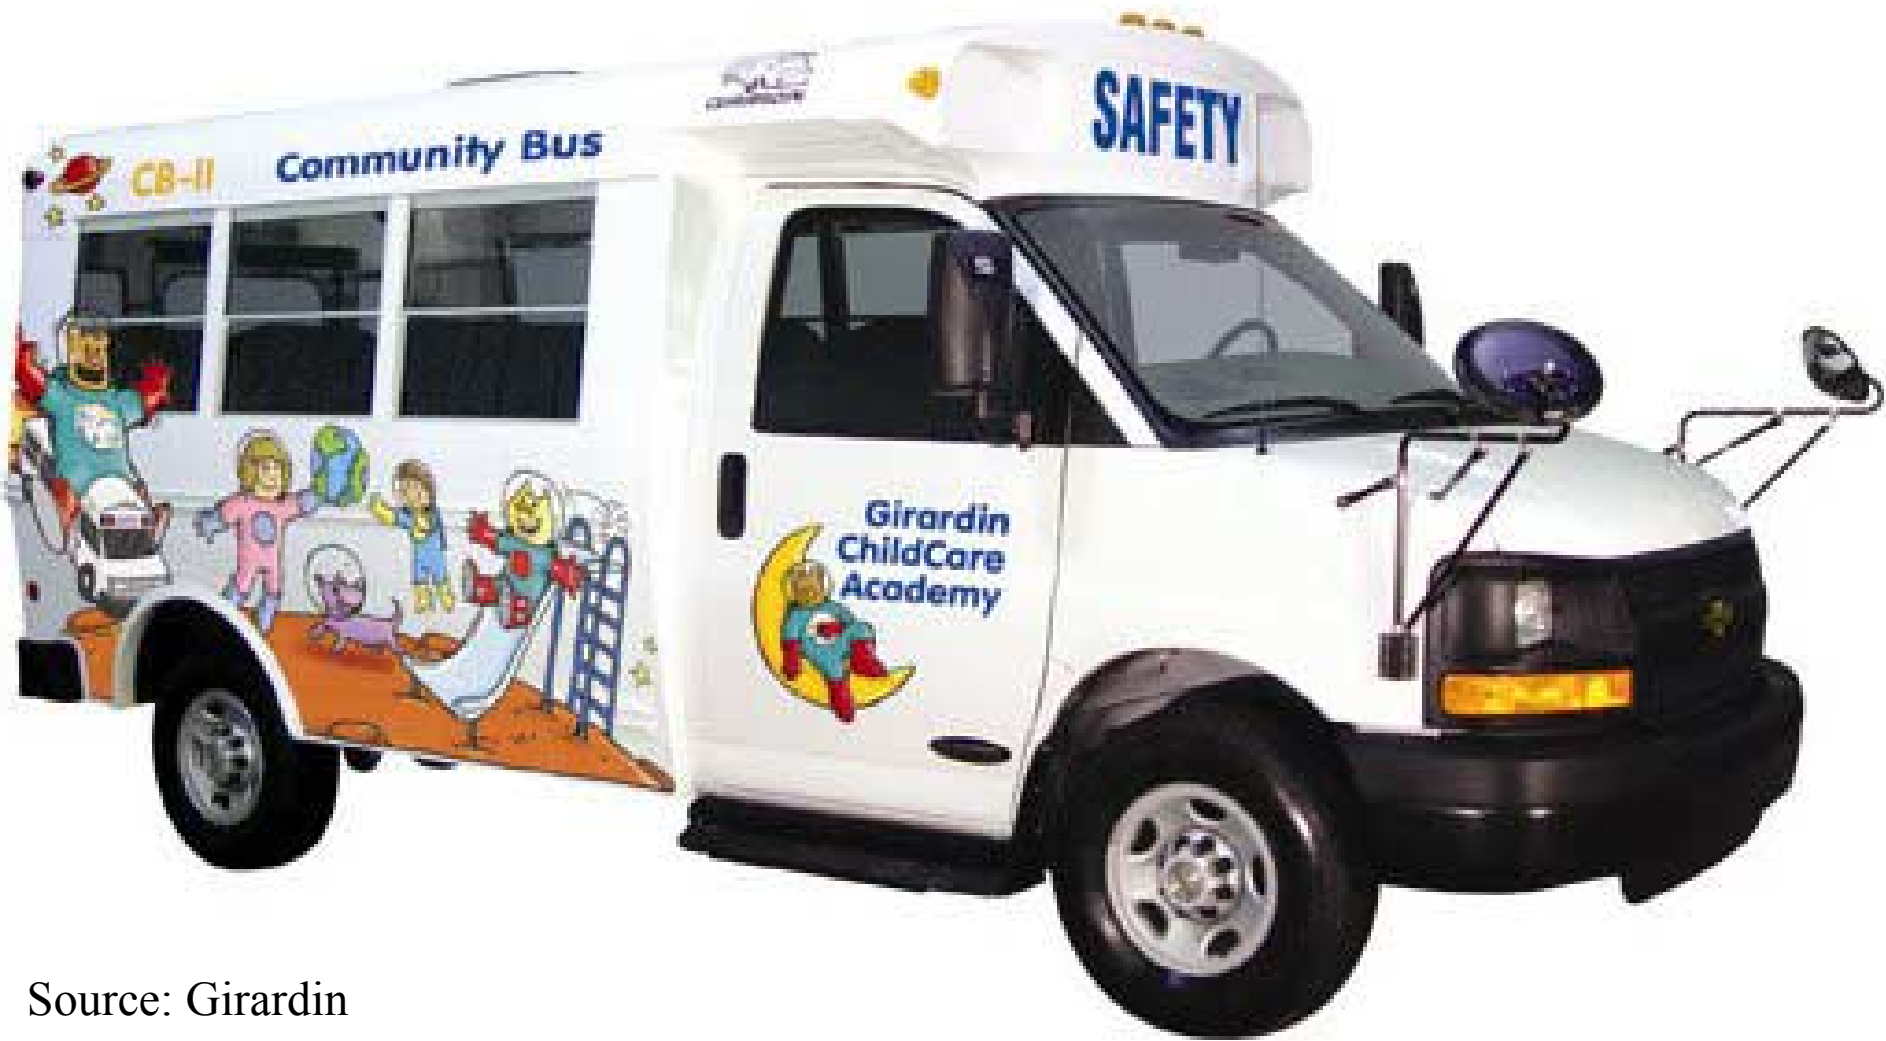
- School buses or equivalent should be used
- Multifunction school activity bus (MFSAB)

- School buses or equivalent should be used
- Multifunction school activity bus (MFSAB)
- 15-passenger vans do not provide equivalent protection
- Regular safety inspections
- Vehicle identification

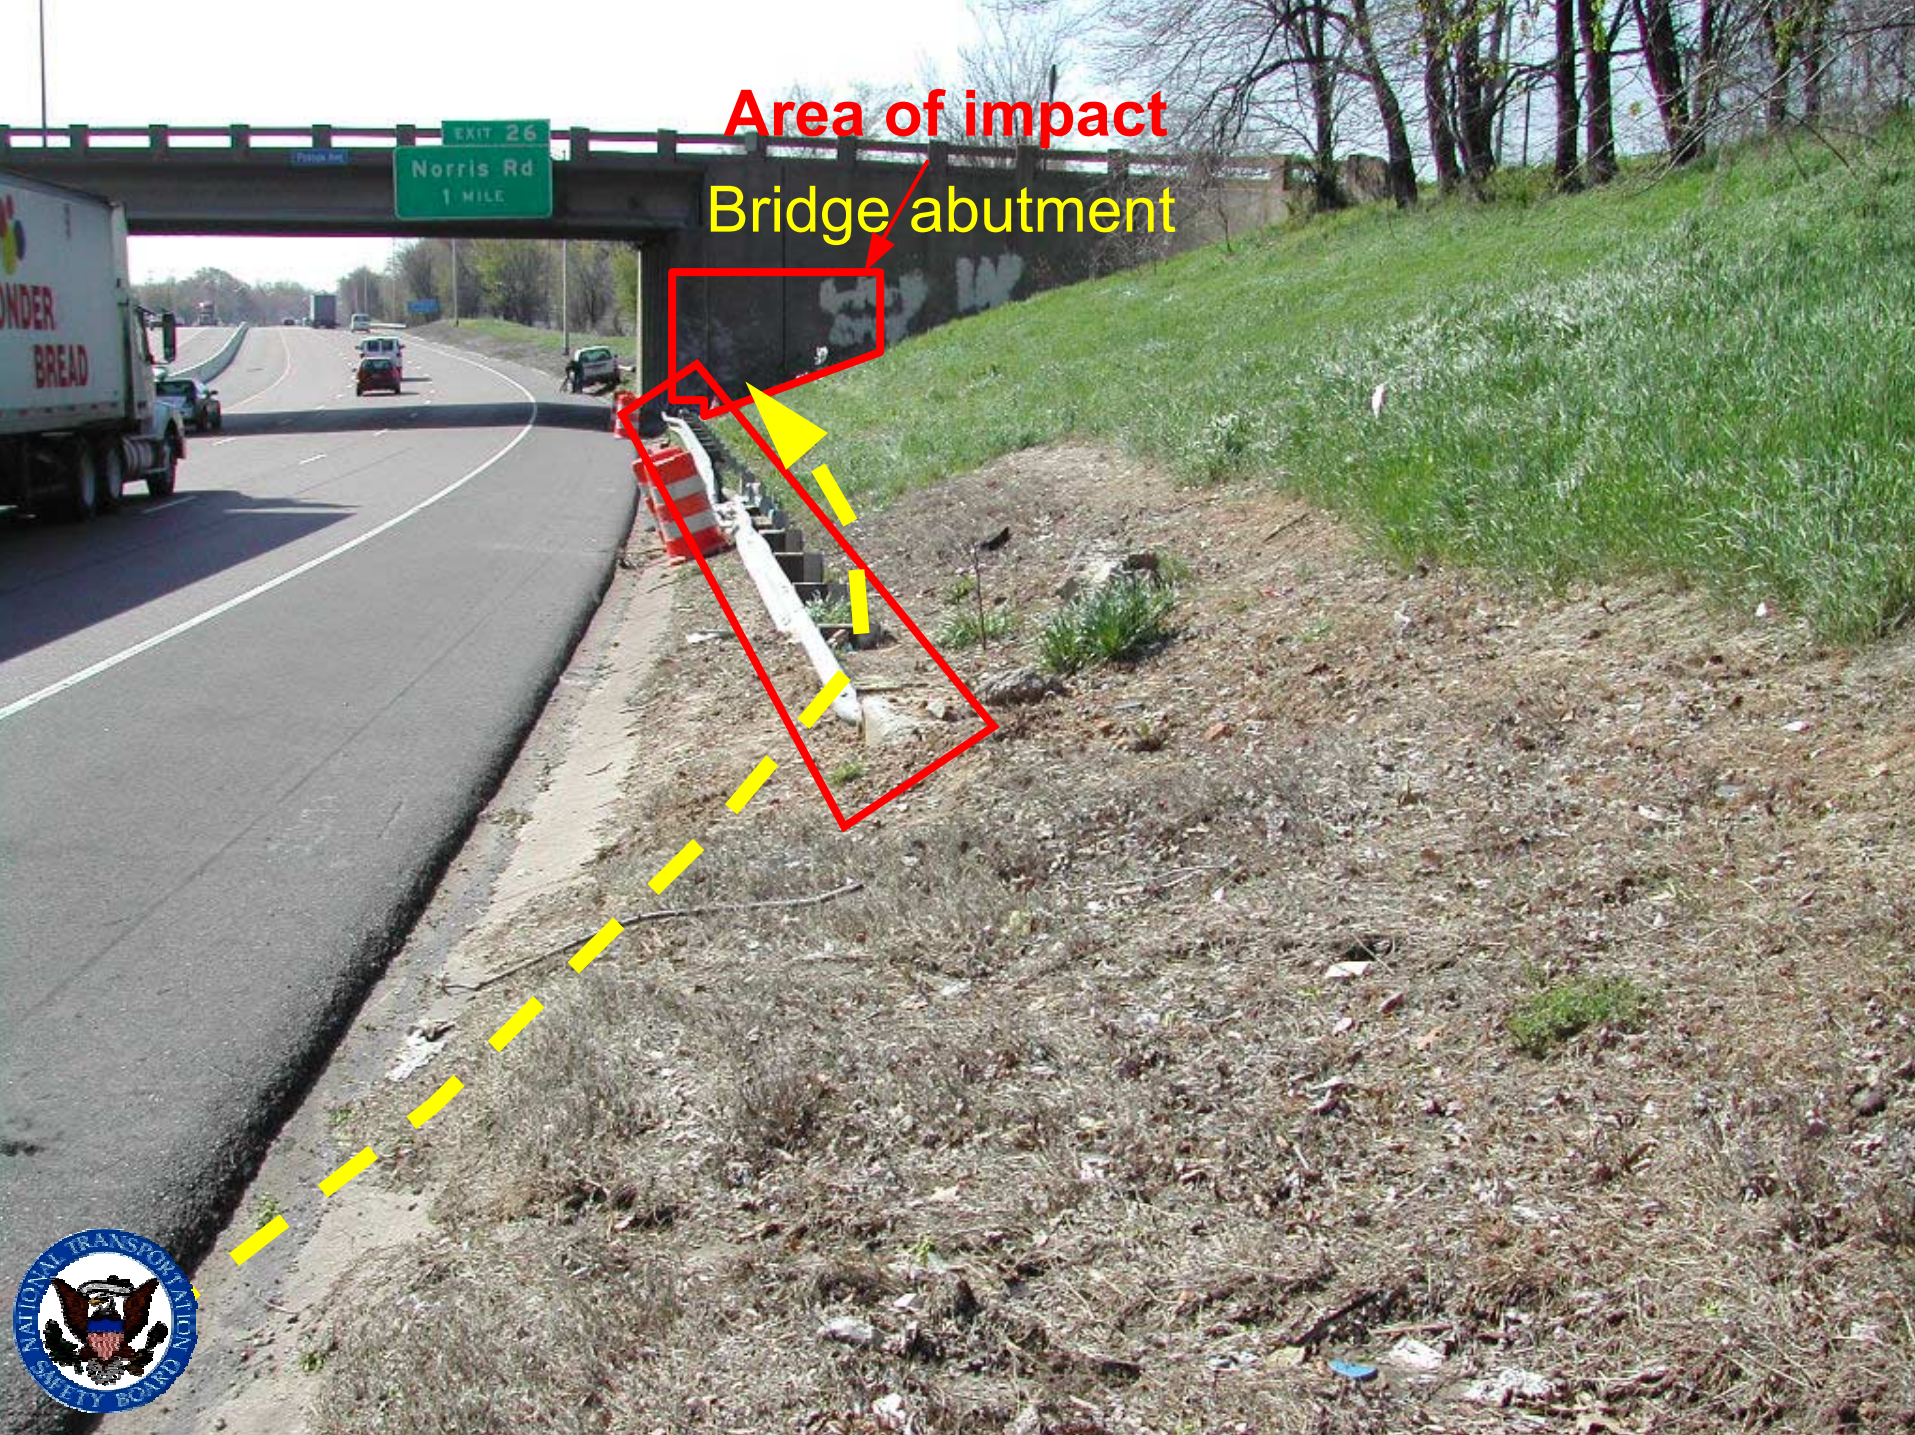
Area of impact

Bridge abutment

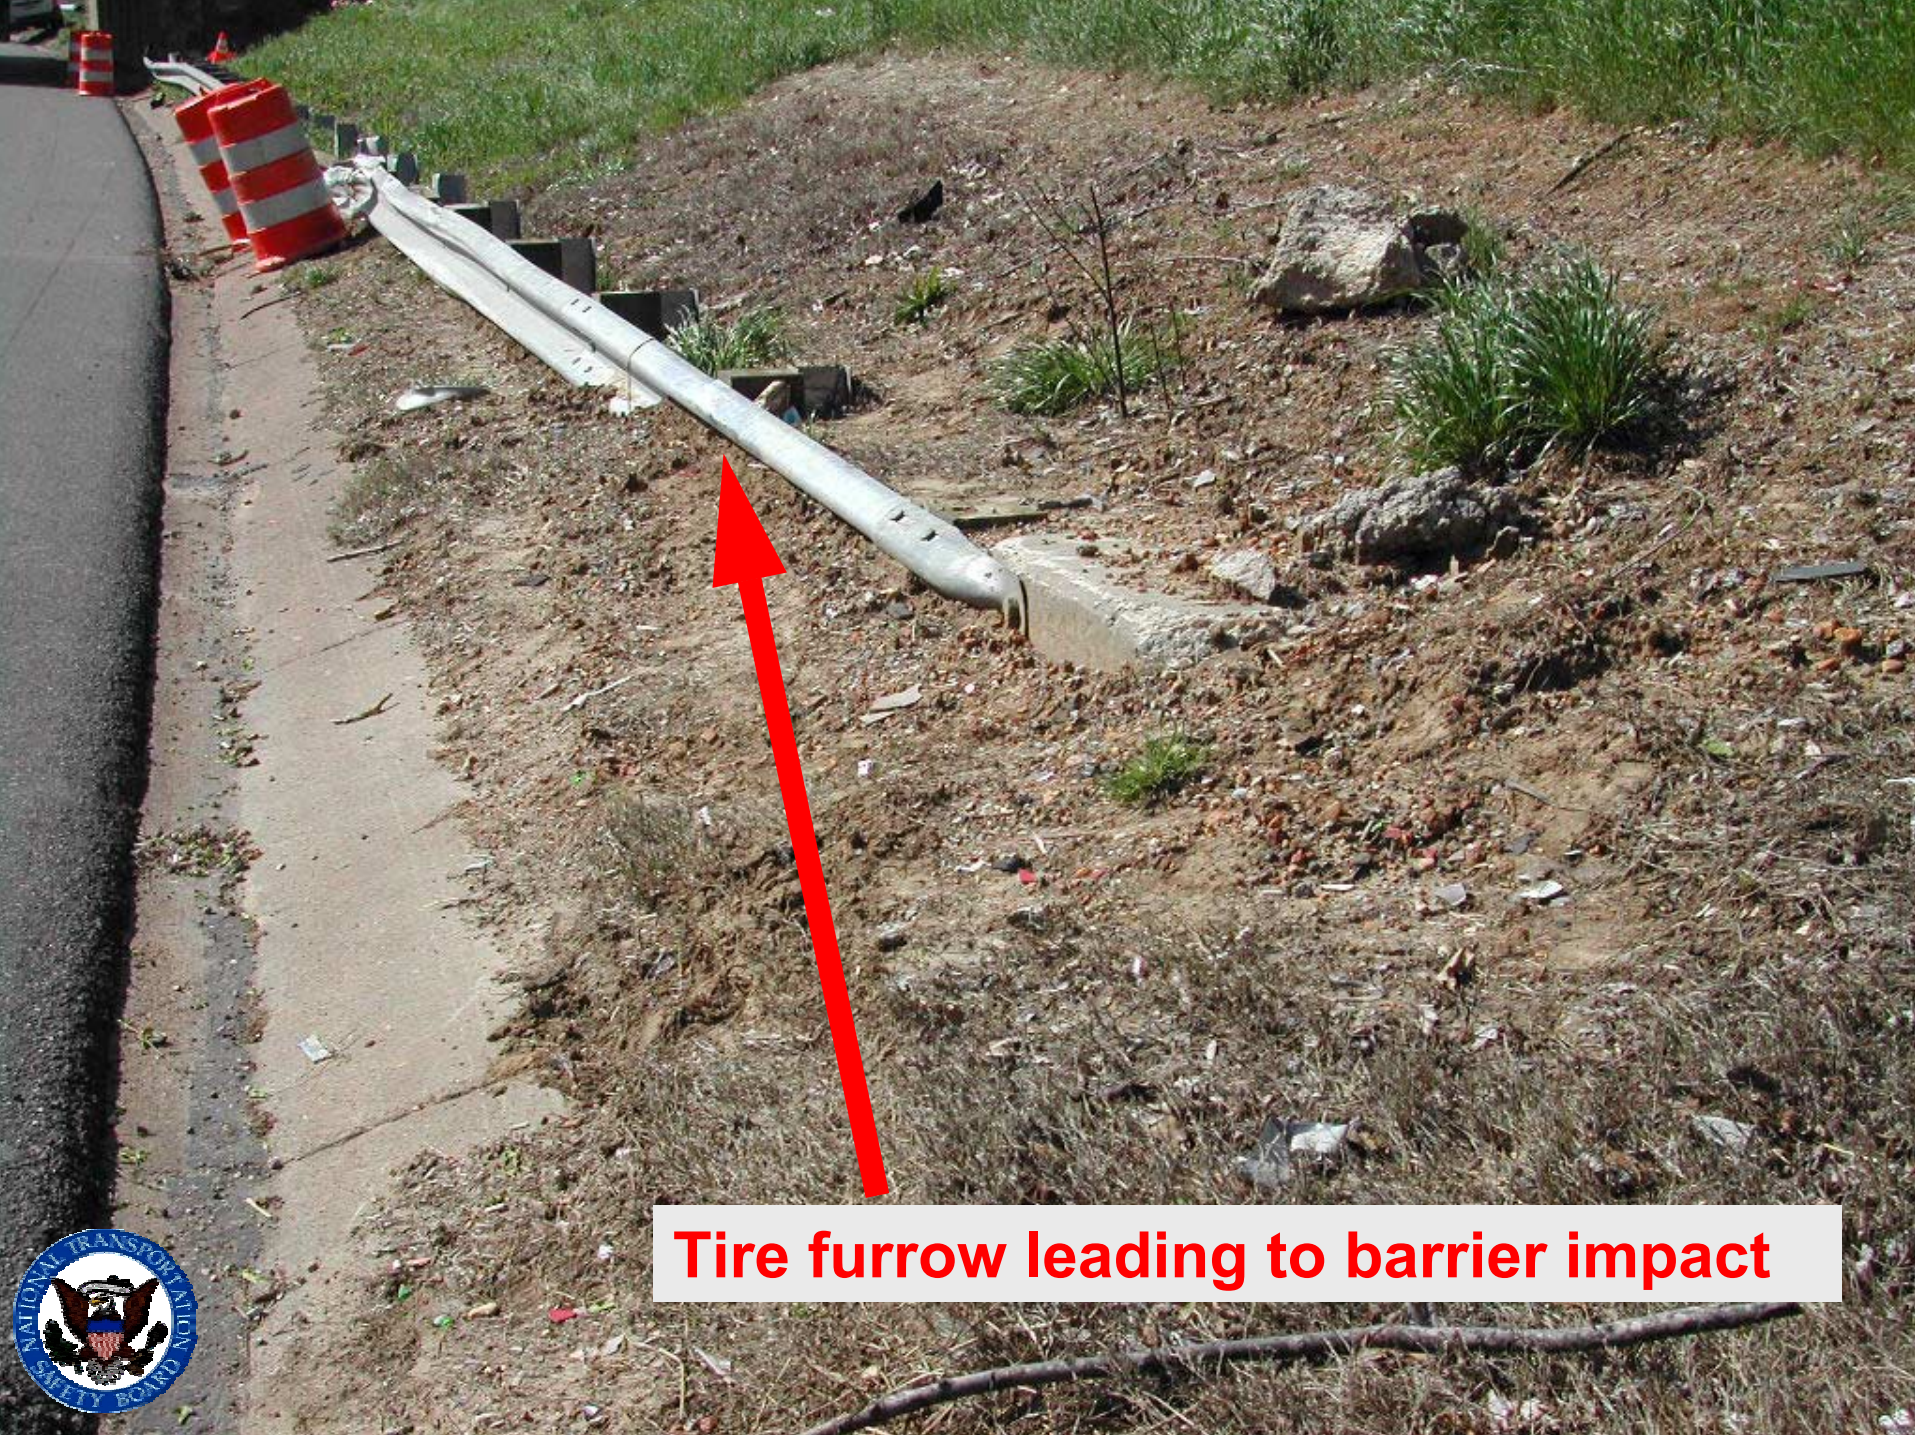
37 percent

26 inches

5 inches

Flares away from road

**Tire furrow leading to barrier impact**

- Steep 37-percent backslope
- Barrier located along horizontal curve
- Design of bridge abutment was same as a vertical wall

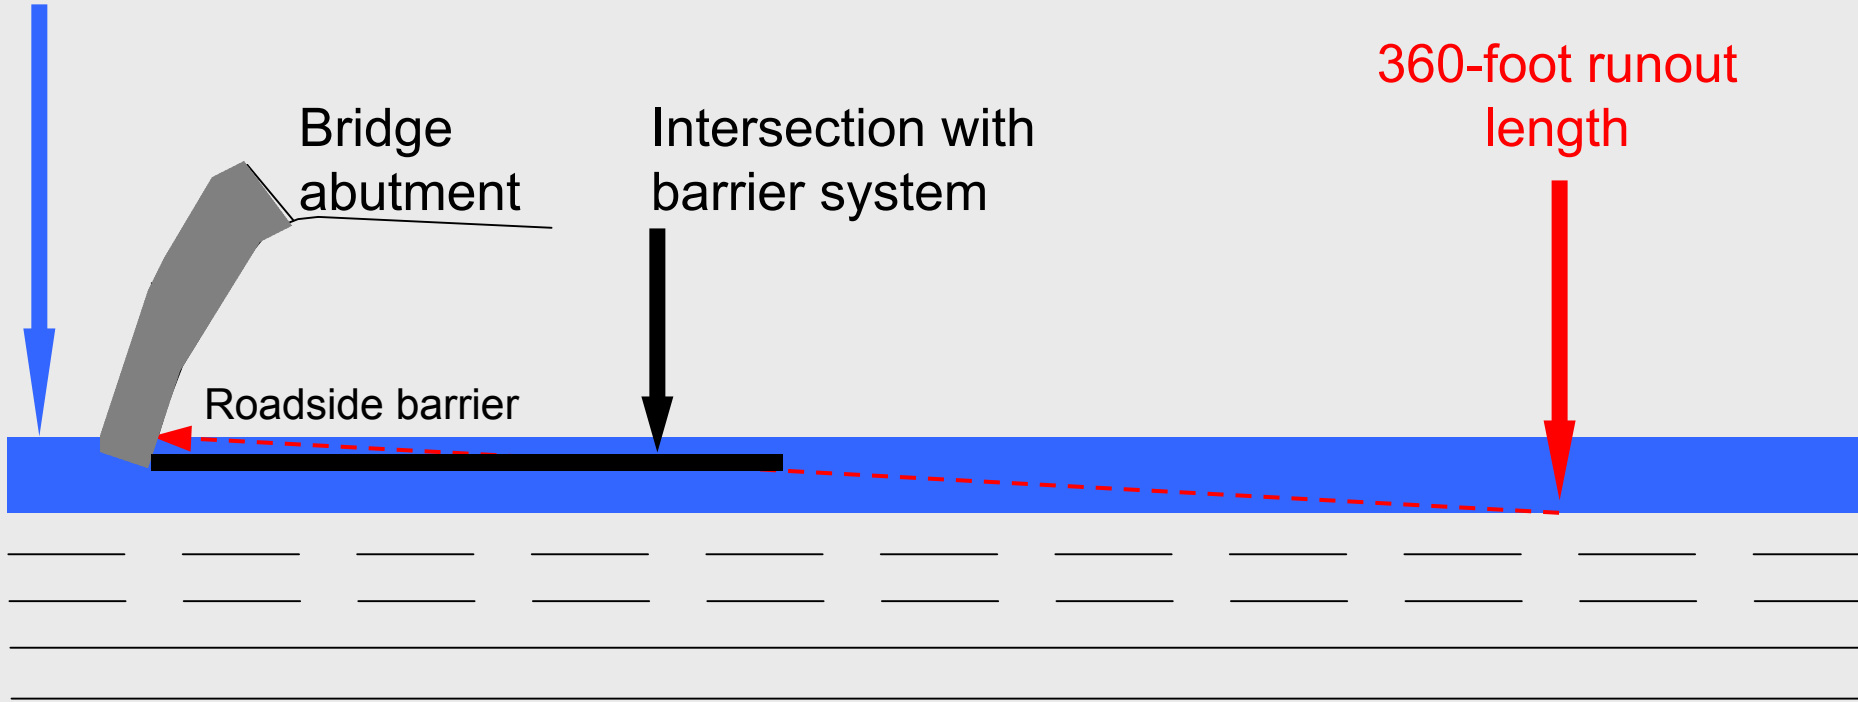
21-foot  
clear zone

Bridge  
abutment

Intersection with  
barrier system

360-foot runout  
length

Roadside barrier

Example of barrier length based on  
straight roadway alignment

- Provides tables and formulas to establish length of need for roadside barriers
- Focuses on barrier installations located along straight segments of roadway

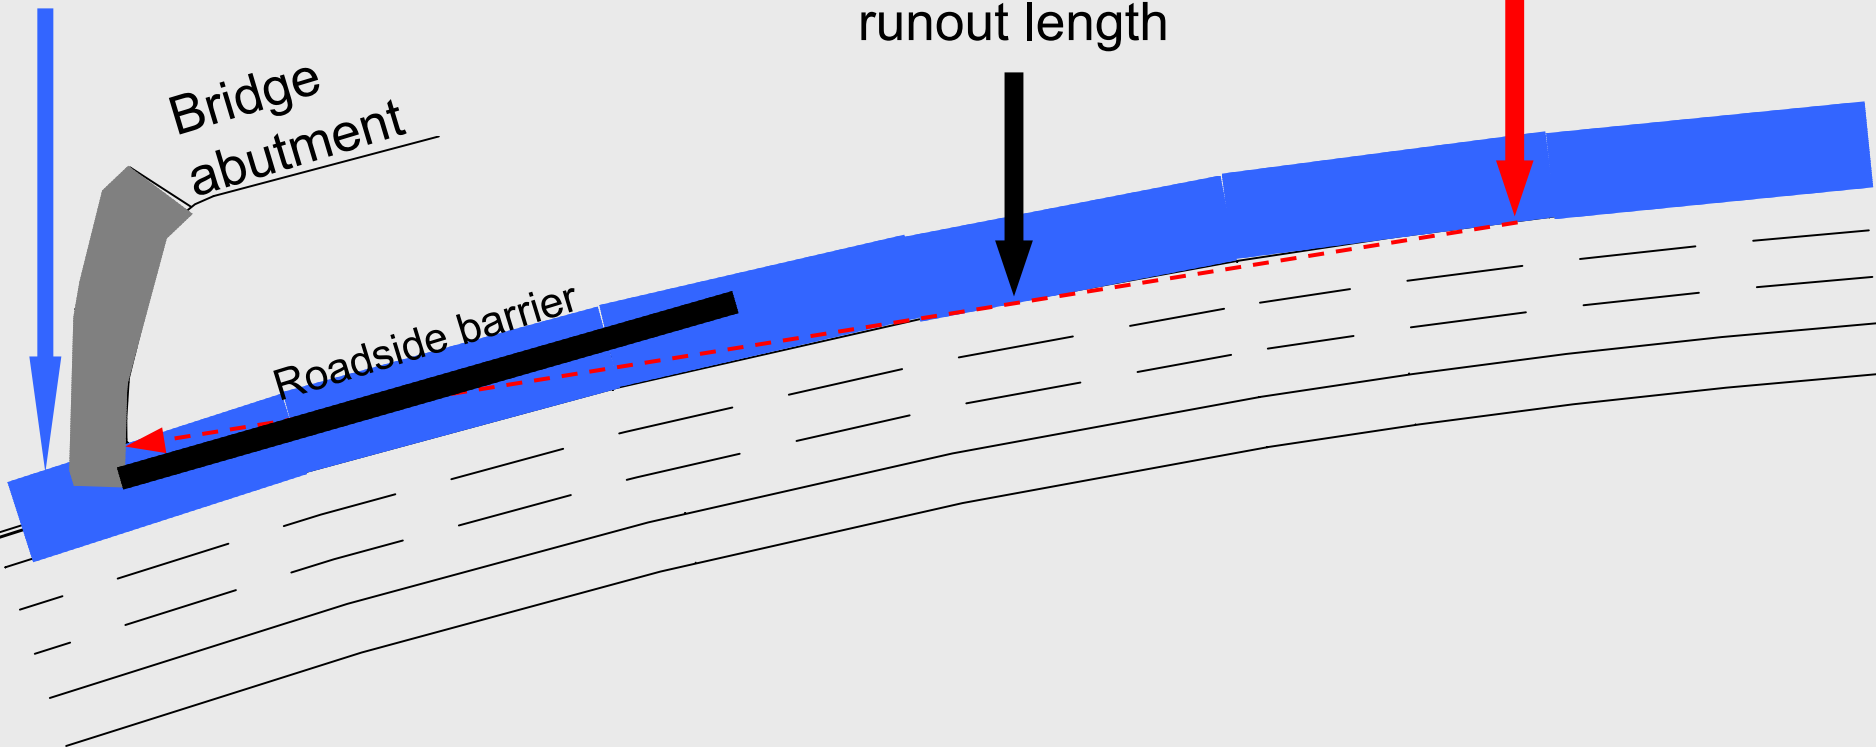
21-foot  
clear zone

Bridge  
abutment

Roadside barrier

Effective  
runout length

360-foot runout  
length

Southbound lanes of Interstate 240  
at the accident location
