Memphis, Tennessee  
15-Passenger Day Care Van  
Run-Off-Road Accident

April 4, 2002

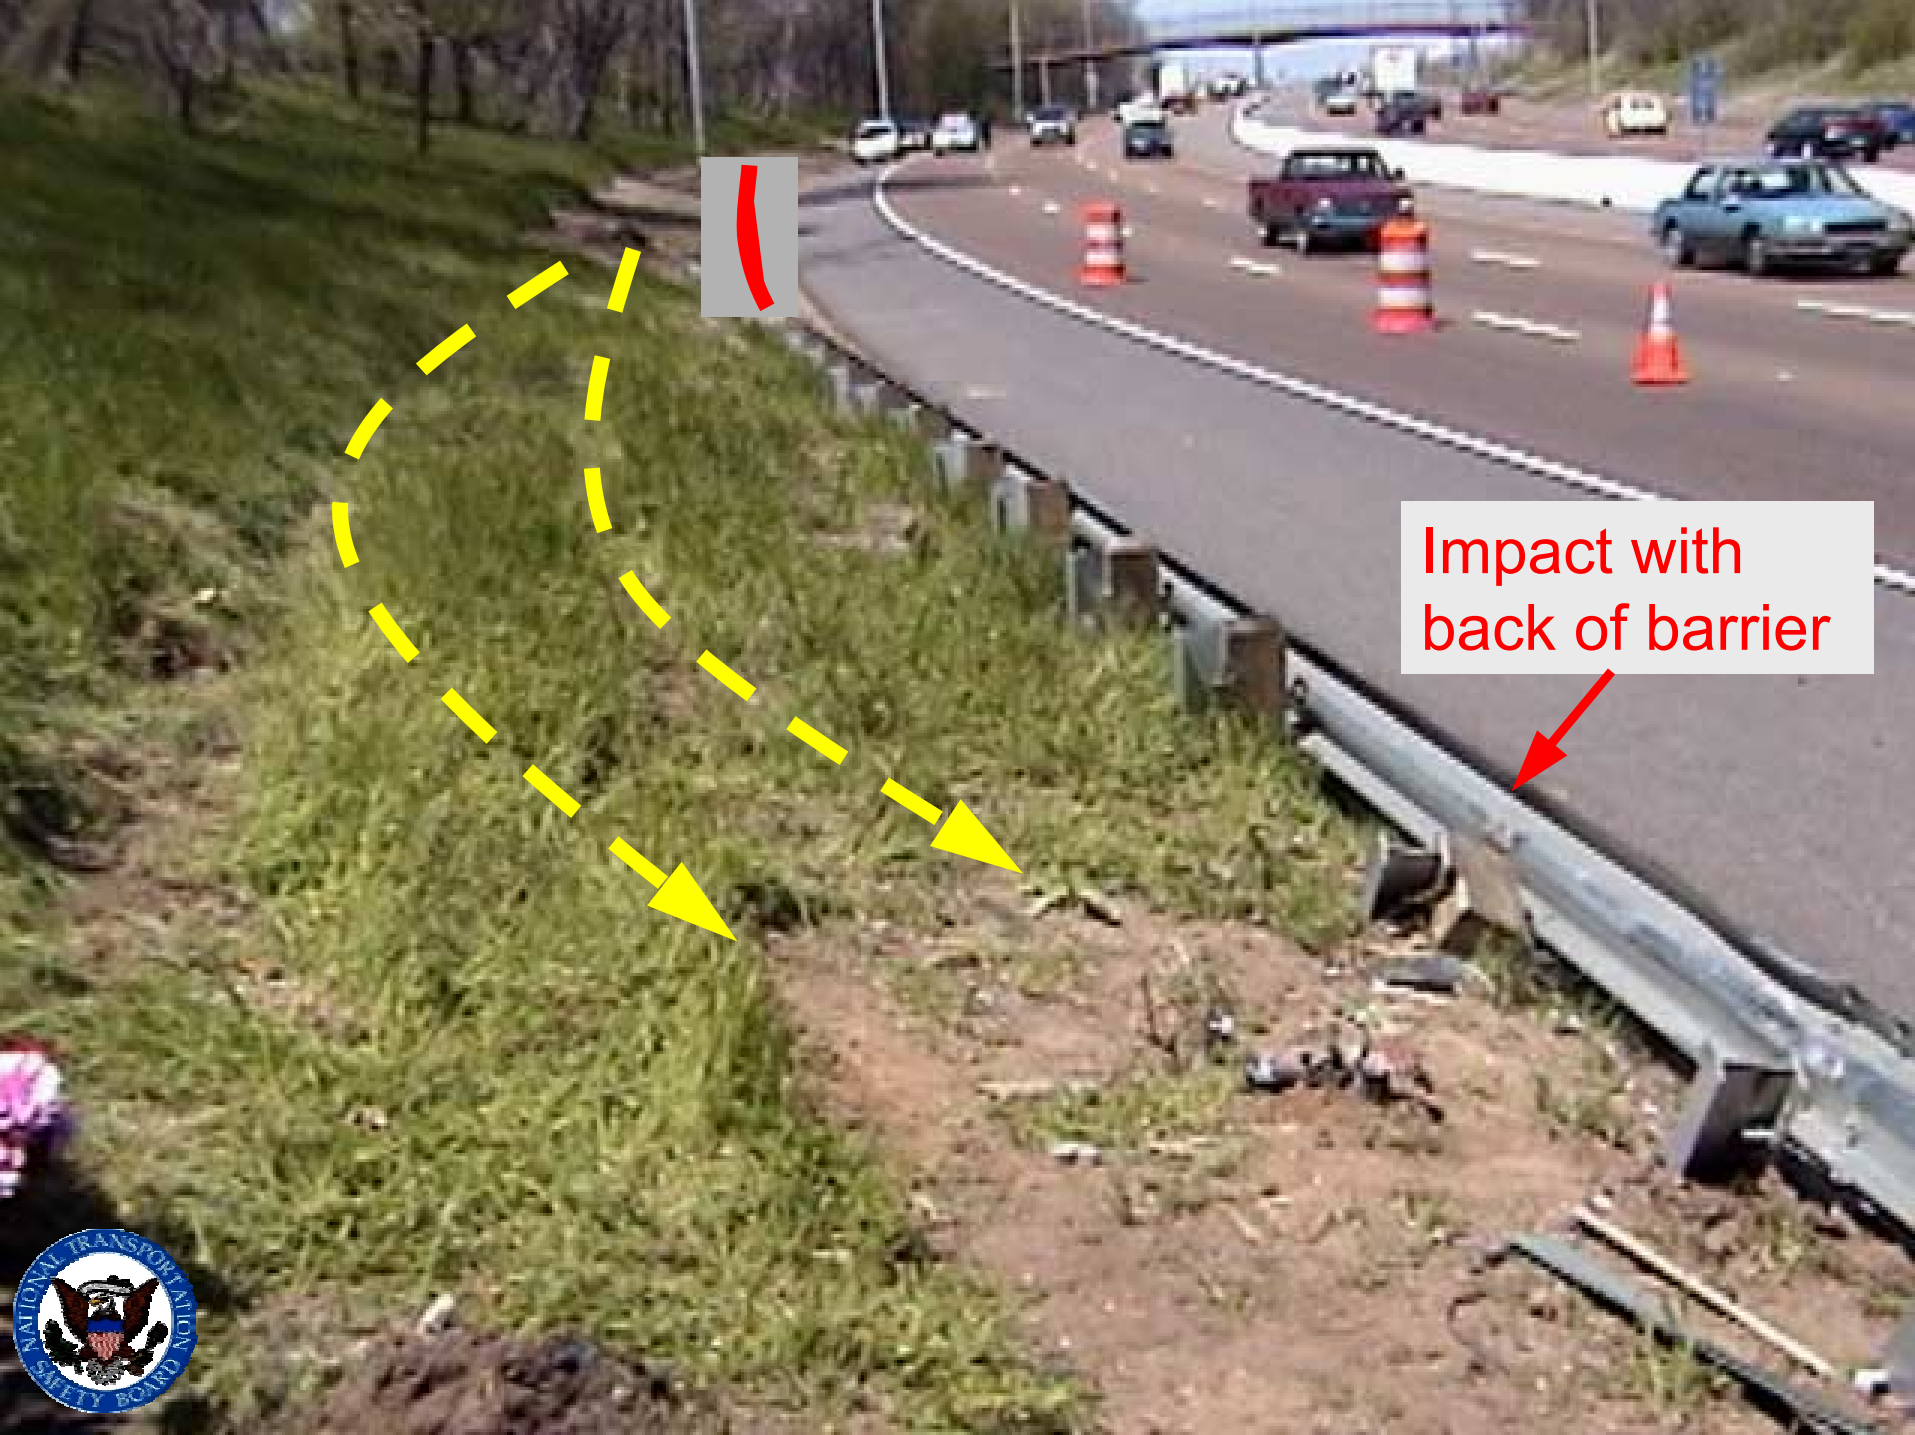
Impact with  
back of barrier
