Saving a Few, Before Losing Them All A Strategy for Setting Priorities

Disbursed throughout its 70,000 acres, Delaware Water Gap National Recreation Area (NRA) has 464 structures appropriate for human habitation that are in various states of repair and disrepair.

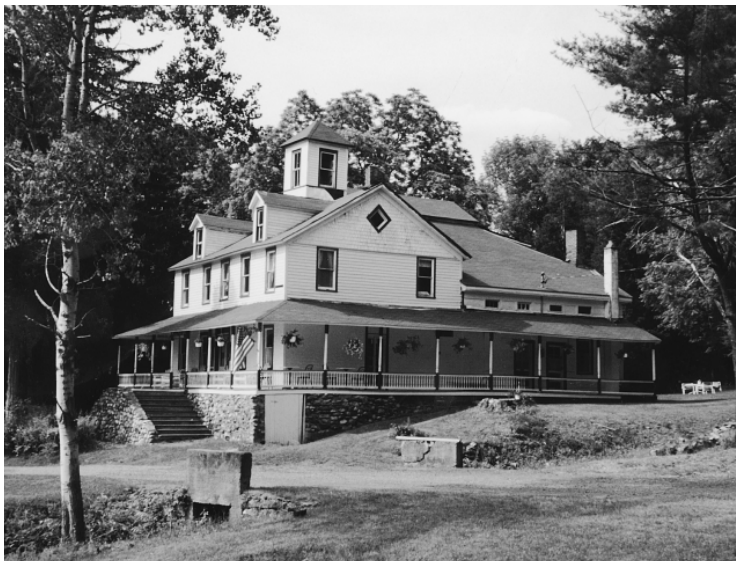
Vacant for years, the eclectic Delaware View House in Flatbrookville, NJ, had fallen into a state of disrepair. This former boarding house is now up and running as a country store under a historic lease. Some 31 “target properties” remain candidates for historic leasing. NPS photo.

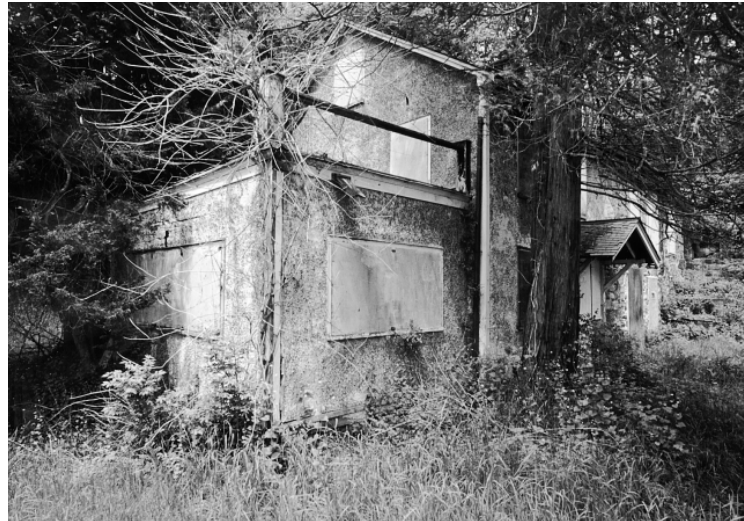
Herons Nest, built c. 1830 was converted to a summer retreat in the 1930's. Forest succession is strangling the building today. One of 31 vacant "target properties", it ranked in the lowest priority (Category C). NPS photo.
