**Information Circular 9446**

# **Proceedings: New Technology for Ground Control in Retreat Mining**

**Christopher Mark, Ph.D., and Robert J. Tuchman**

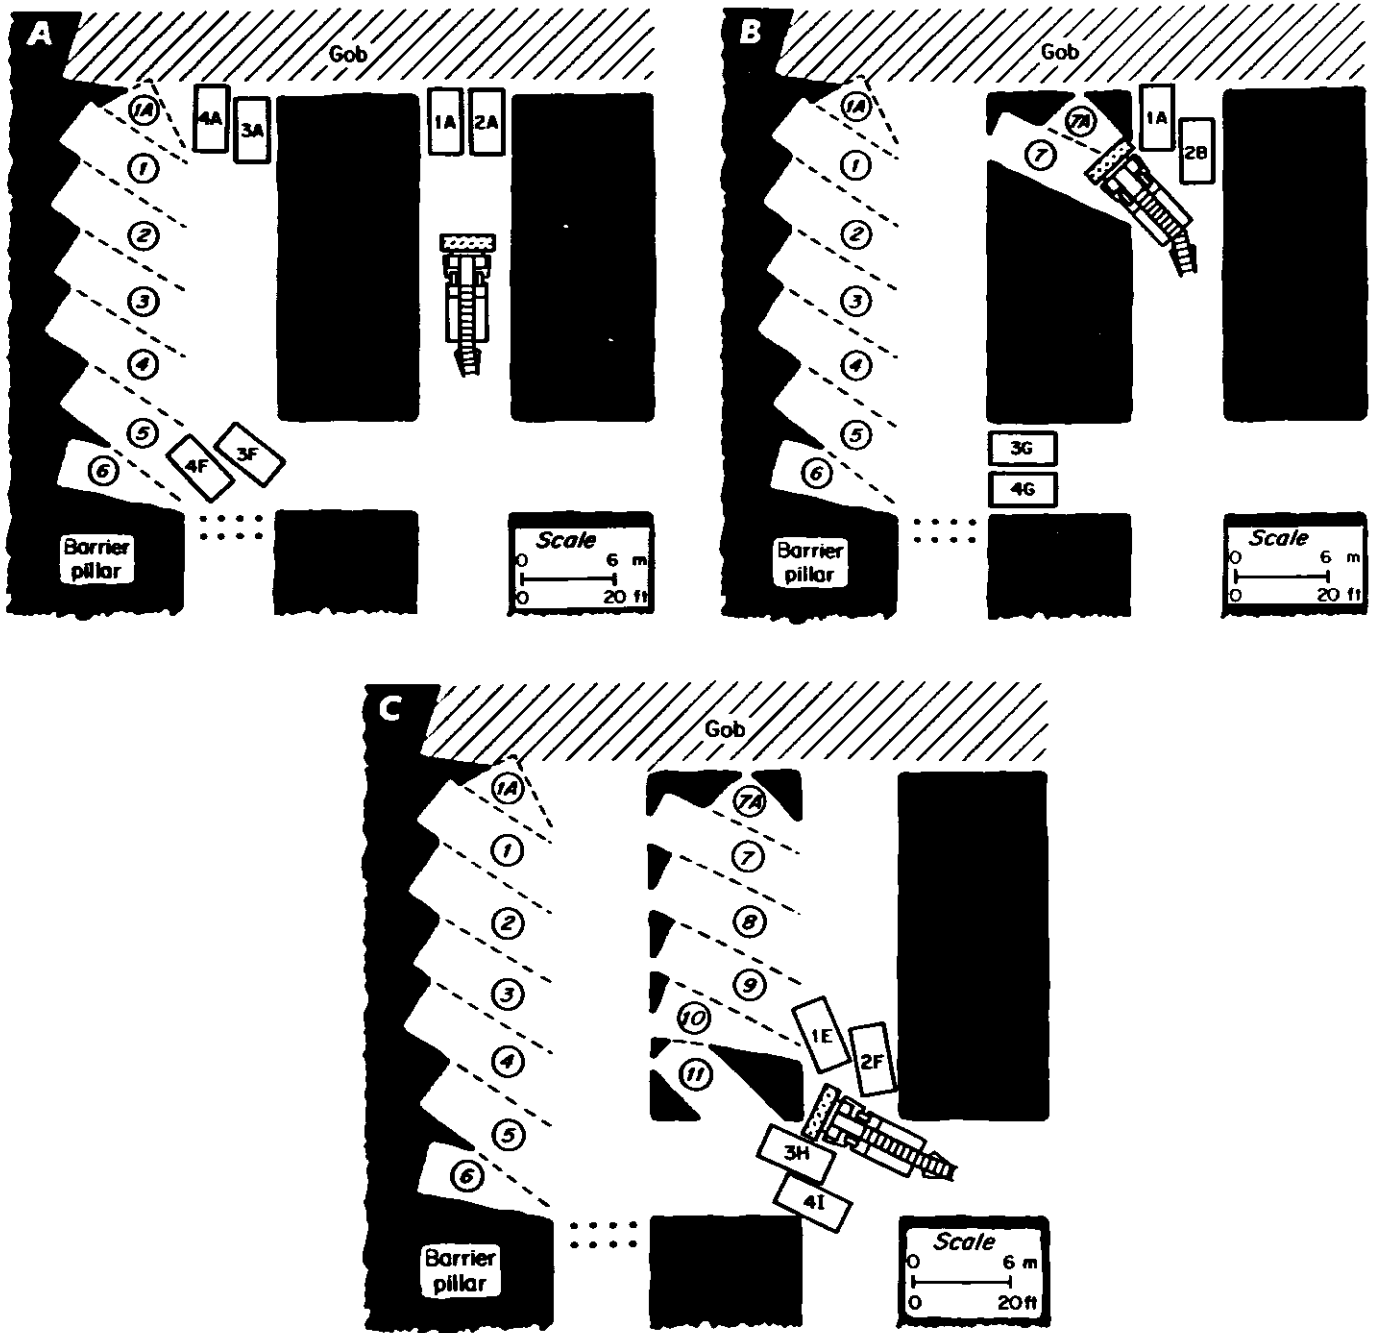
Figure 5.—Outside lift method. A, lifts 1-6; B, lifts 1-7A; C, lifts 1-push.

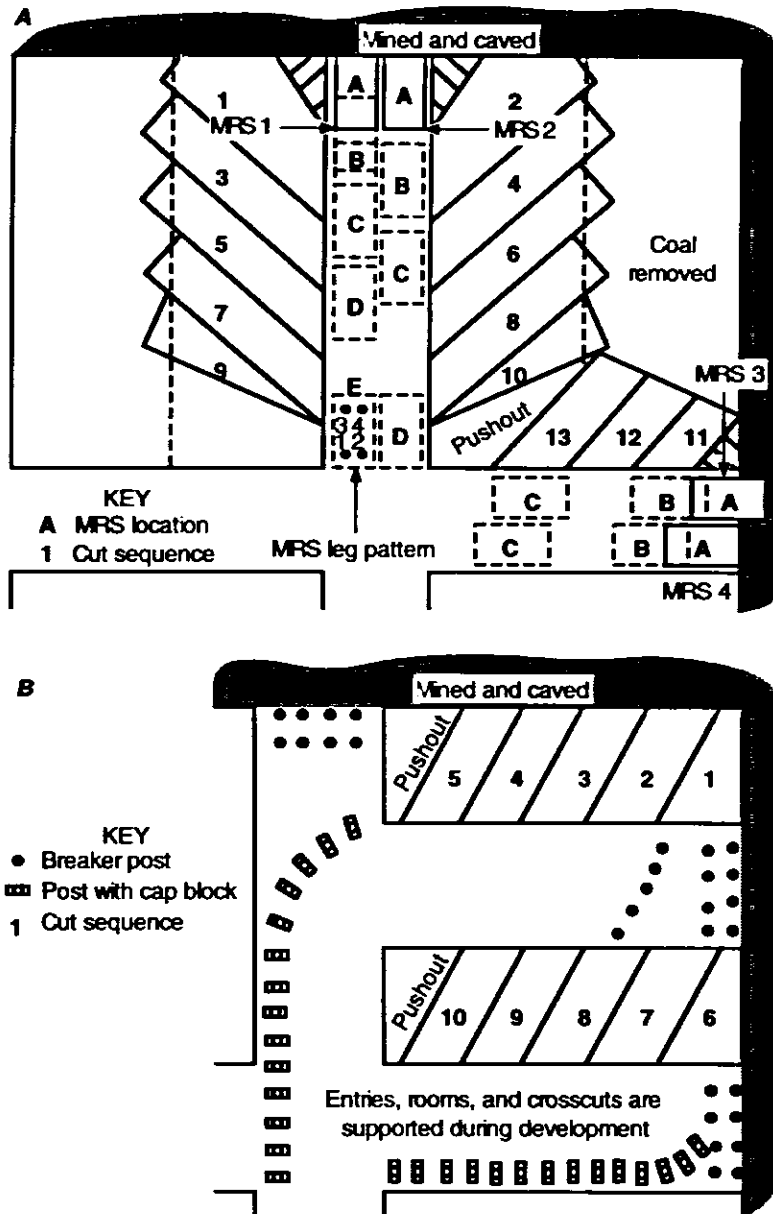
Figure 3.—Mining plan using (A) mobile roof supports and (B) posts.

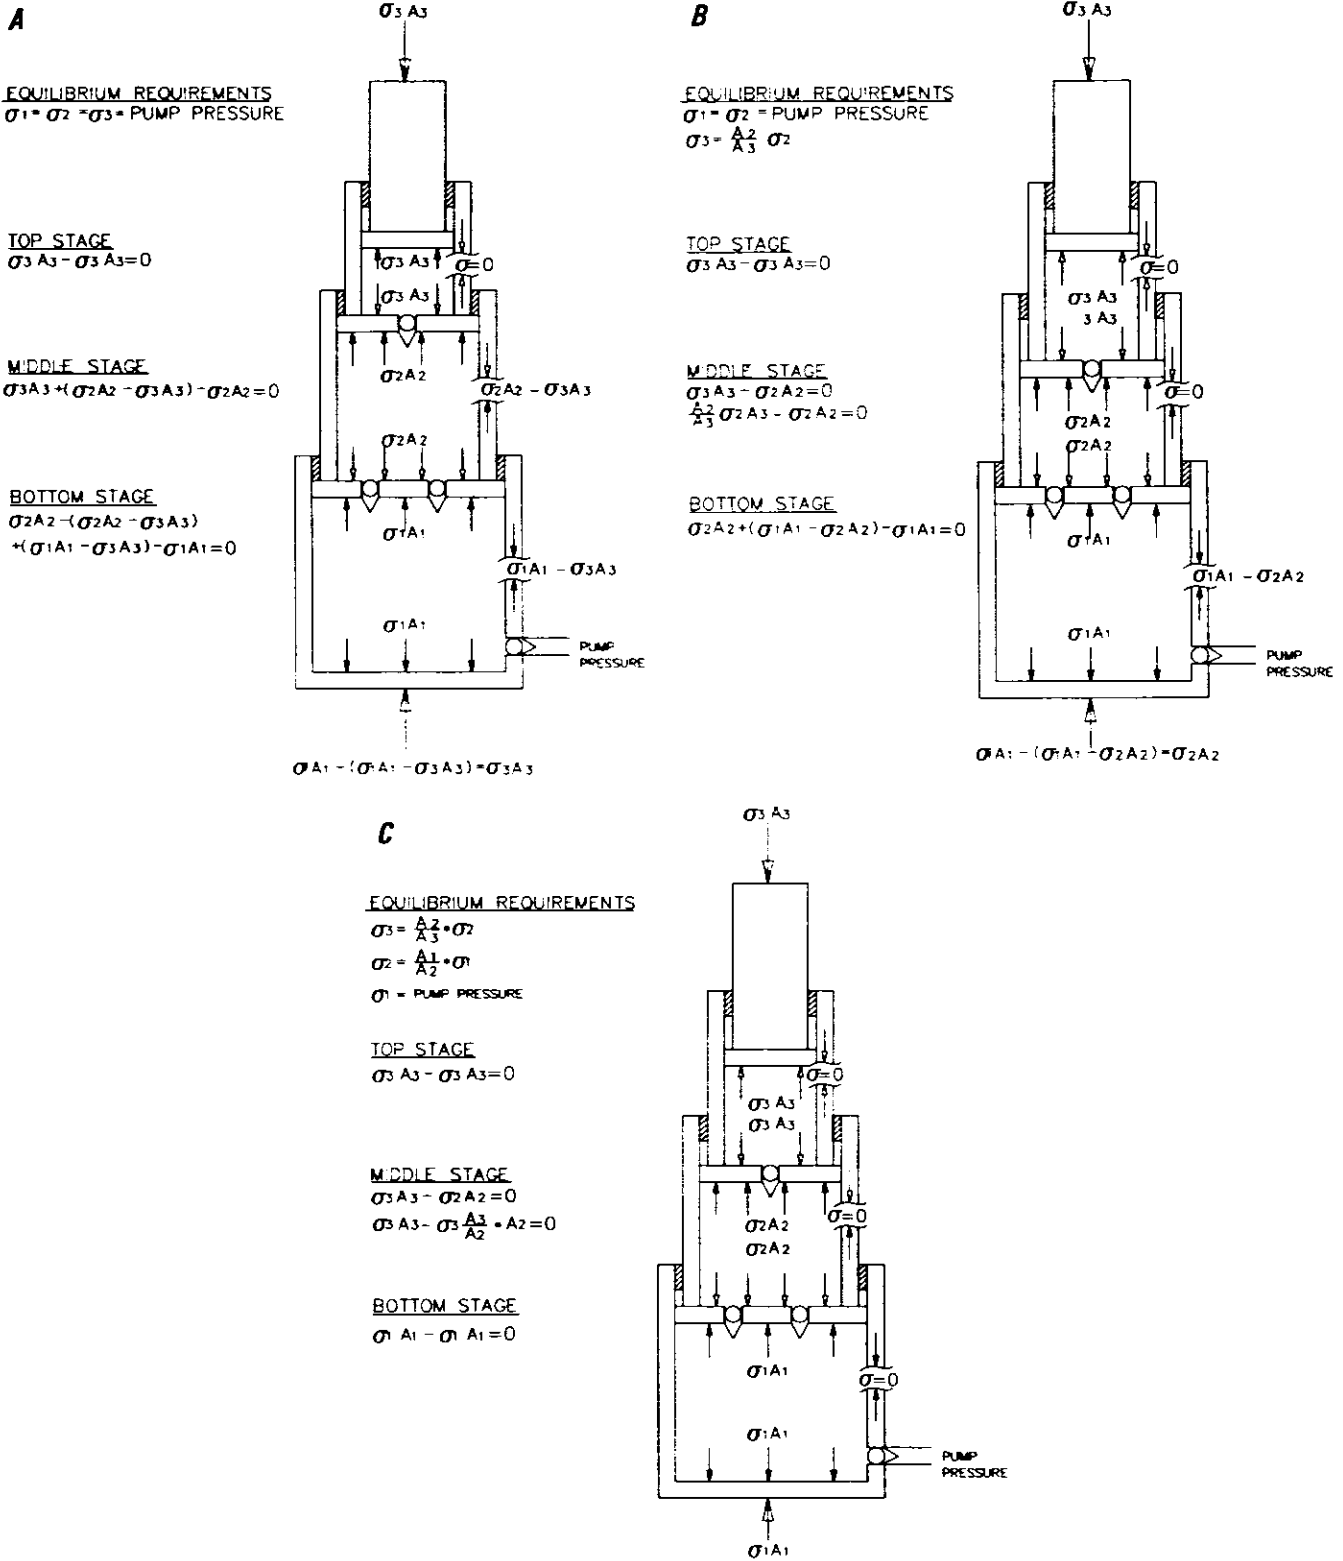
Figure 17.—Leg mechanics. A, bottom and middle stages fully extended; B, bottom stage fully extended; C, no stage fully extended.
