**Federal Building and Fire Safety Investigation  
of the World Trade Center Disaster**

**National Construction Safety Team  
Advisory Committee Meeting**

**Project 6 – Structural Fire Response and  
Collapse Analysis**

October 19, 2004

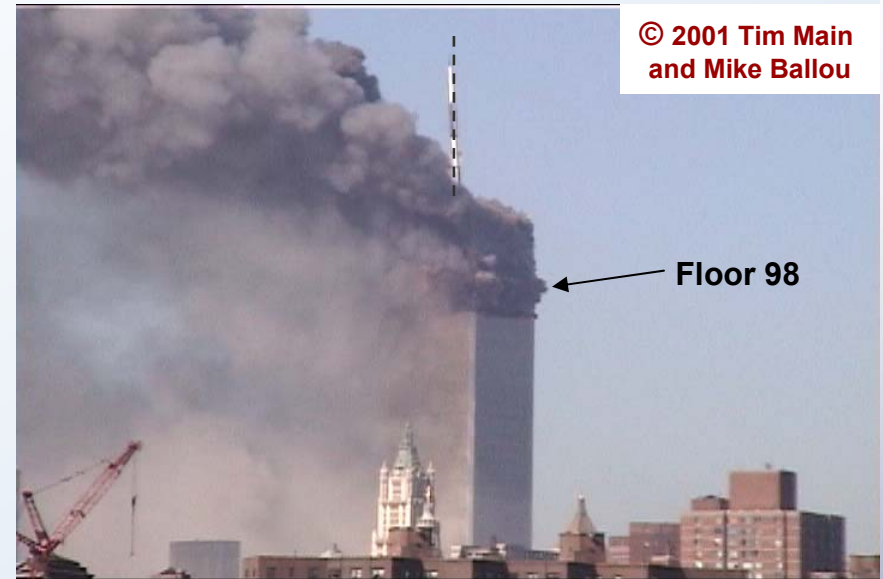
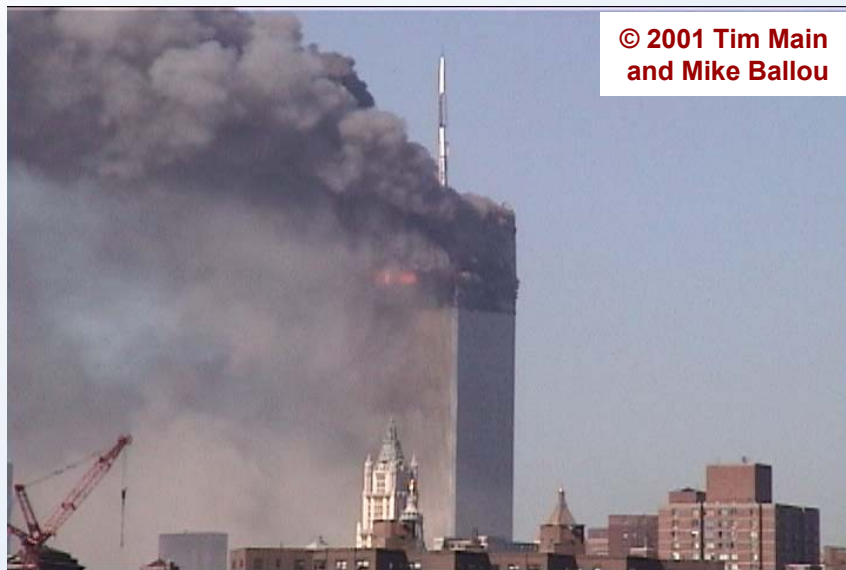
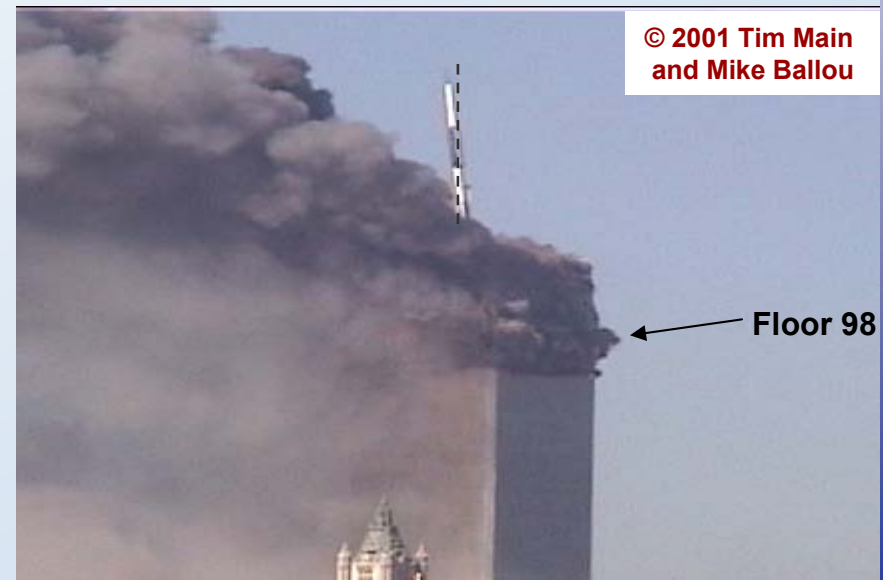
# WTC 1 Collapse

*Initiation of global collapse was first observed by the tilting of building sections above the impact regions of both WTC towers.*

WTC 1 tilted to the south in this view from the northeast.

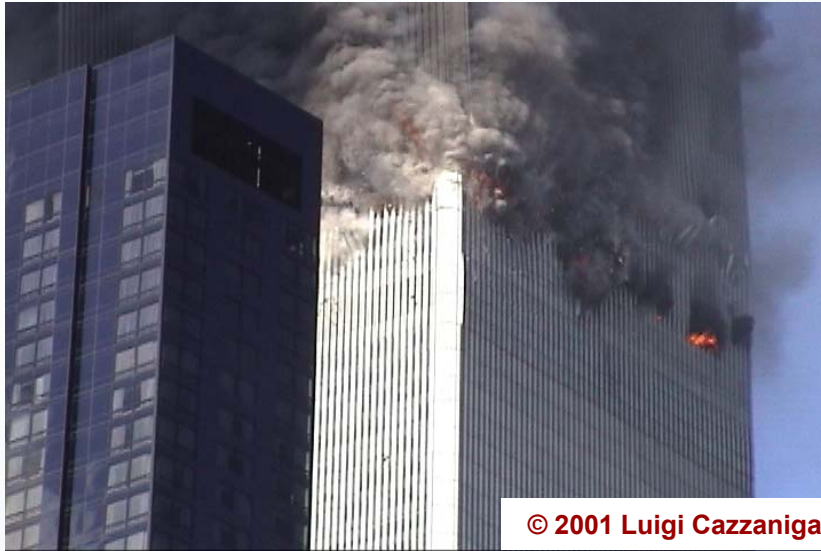
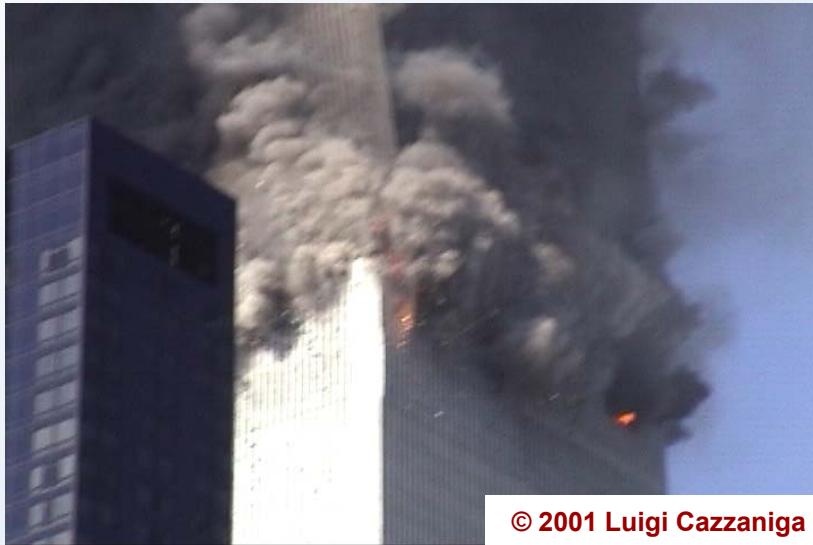
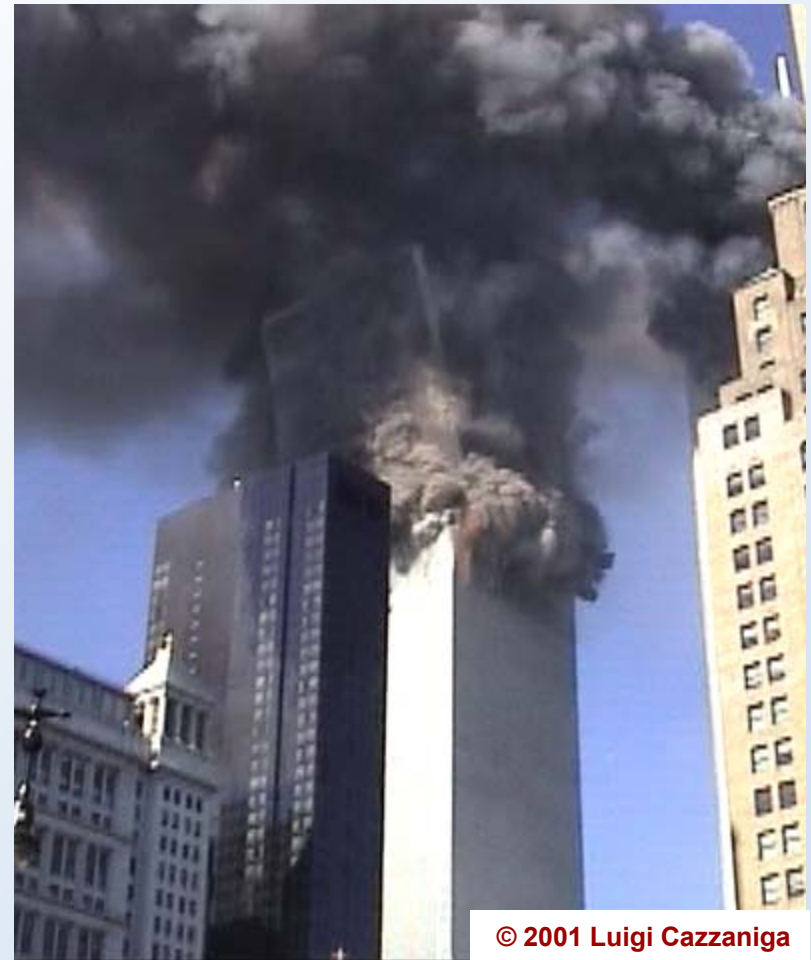
# WTC 2 Collapse

WTC 2 tilted to the east and south and twisted in a counterclockwise motion in this view from the northeast.

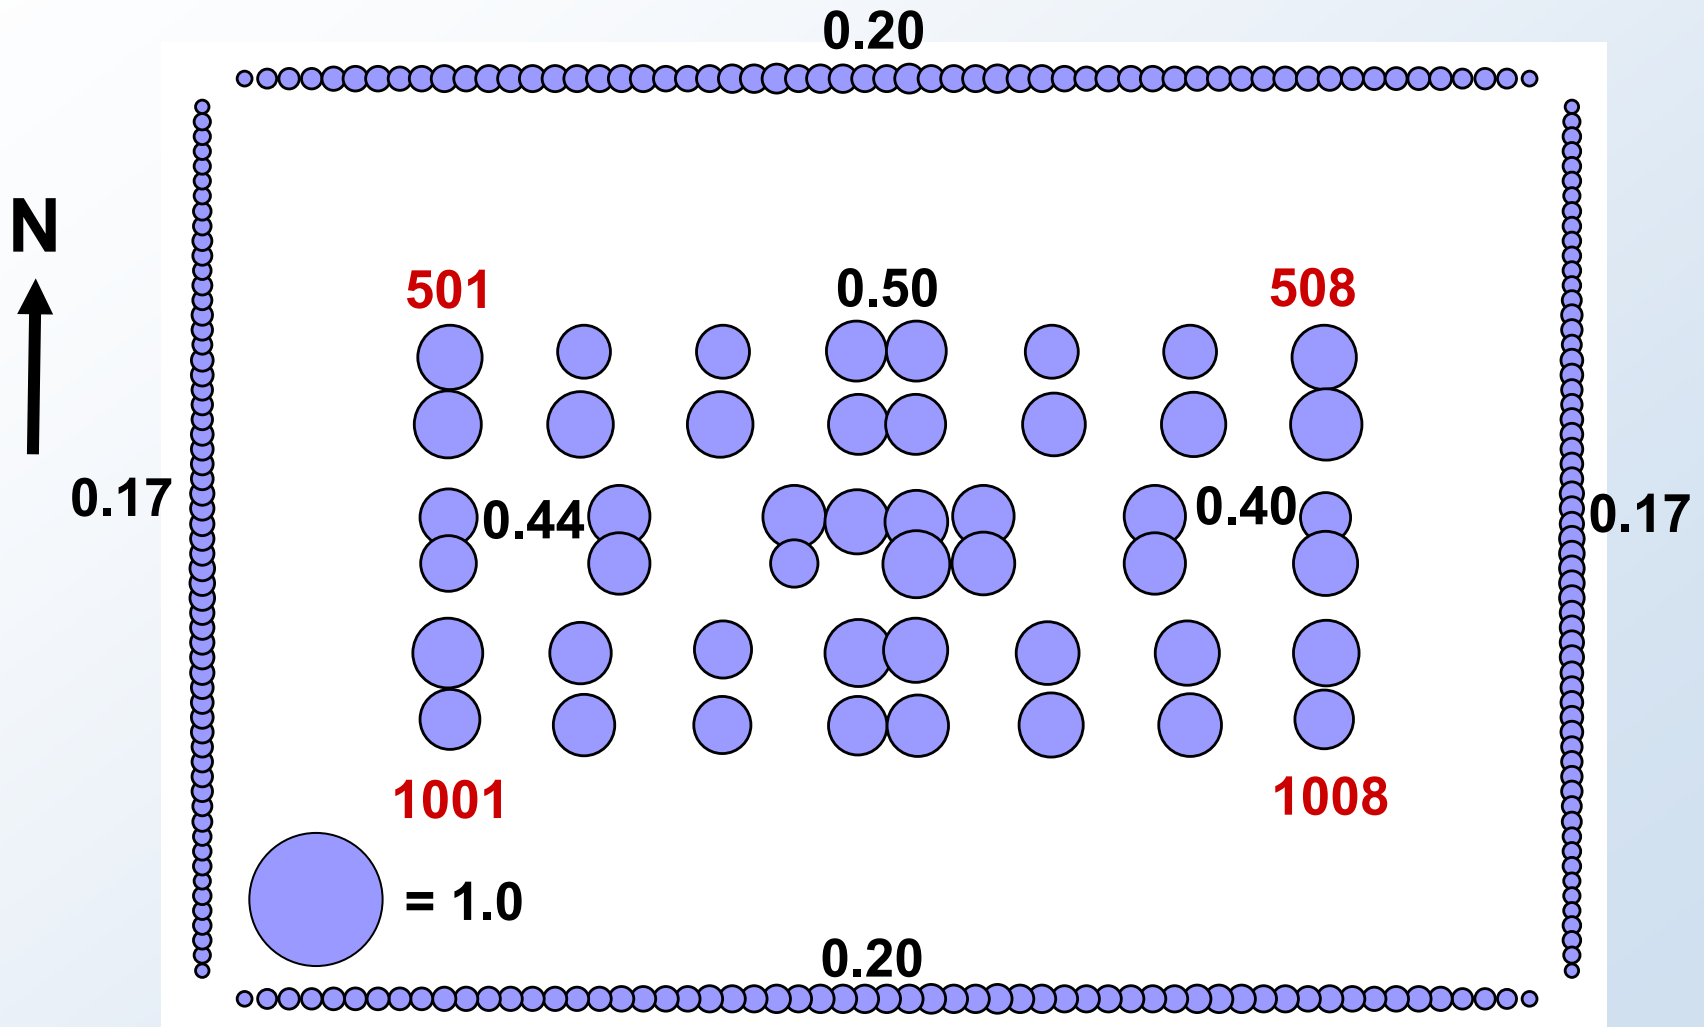
# Column Demand/Capacity Ratios Before Aircraft Impact in WTC 1 (Floors 93 to 98)

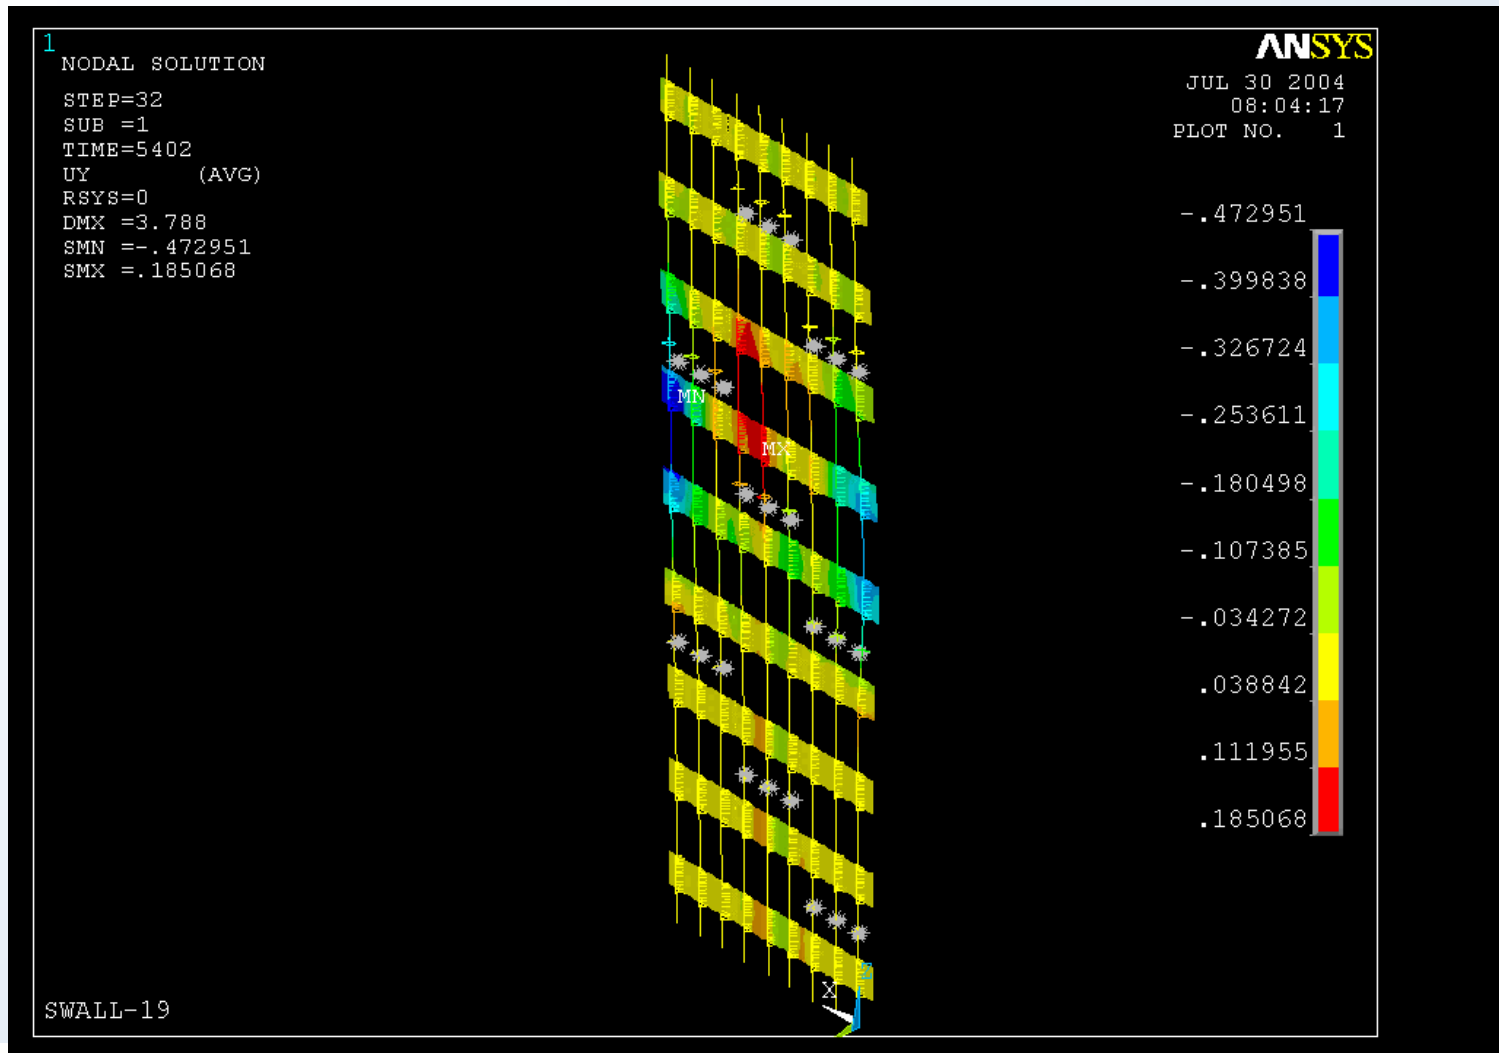
# Gravity, Thermal and Pushdown Load with 3 Floors Unrestrained by Floor Slabs

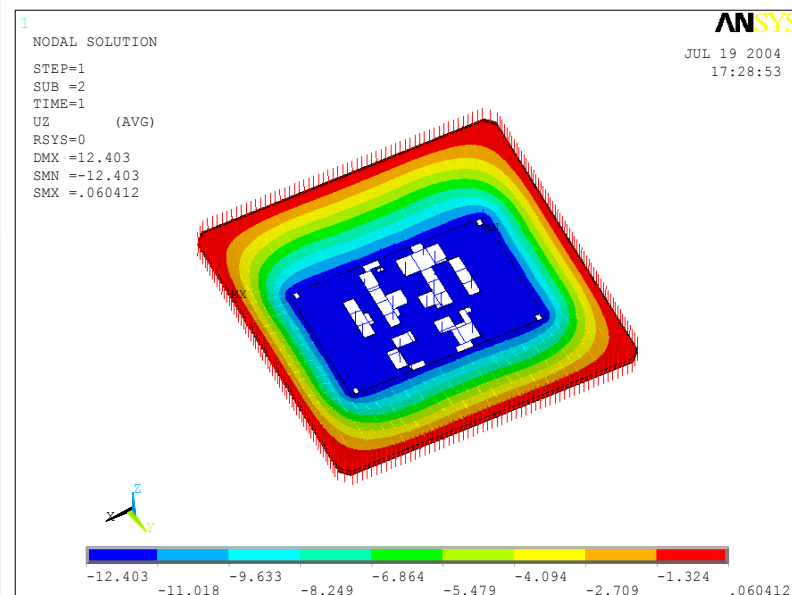
# Example Analysis of Load Transfer Between Core and Perimeter Columns

A 12 in. downward displacement of core columns was imposed, producing the following results:

- ❑ An additional horizontal force of 7 to 8 kip pulled inward on the perimeter columns near the center of the face.
- ❑ An additional vertical force of 7 to 8 kip on the perimeter columns near the center of the face.
- ❑ A downward displacement of the core columns results in horizontal pulling and vertical forces acting on the perimeter wall, which accumulate to produce substantial forces at and above the impact and fire zone.
