Assessment of Fish Habitat, Water Quality, and Selected Contaminants in Streambed Sediments in Noyes Slough, Fairbanks, Alaska, 2001-2002

Water-Resources Investigations Report 03-4328

By Ben W. Kennedy, Matthew S. Whitman, Robert L. Burrows, *and*
Sharon A. Richmond

Anchorage, Alaska
2004

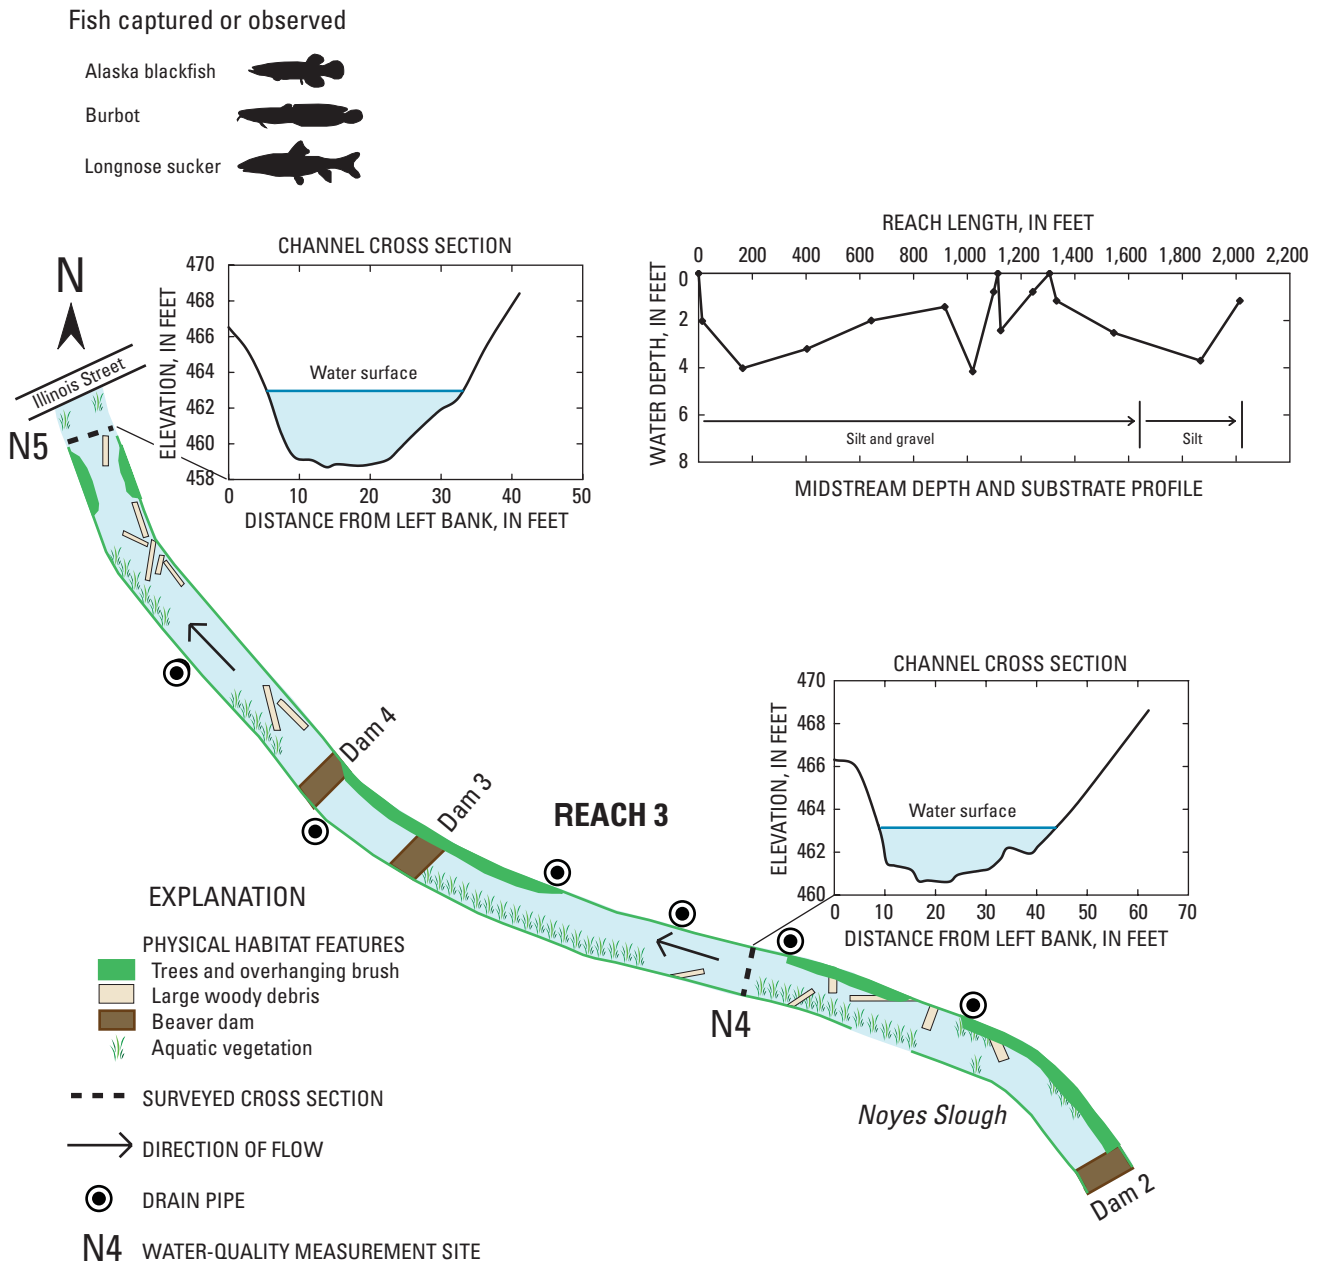
Figure 4. Channel characteristics, fish habitat, and types of fish present during summer 2001 in the 13 study reaches in Noyes Slough, Fairbanks, Alaska. The scale of features is exaggerated to improve presentation, but their distribution in relation to each other is as observed on site.

Twenty locations were noted where one or more drainpipes (culverts) enter the slough (figs. 4 and 5). The highest densities of culverts (six) are in two reaches—reach 3, between Minnie Street and Illinois Street, and reach 8, from the Aurora Drive bridge to about 1 mi (1.6 km) downstream of the bridge. Culverts periodically funnel urban runoff and drainage from low-lying areas into the slough. Urban runoff often includes a variety of organic pollutants, and storm runoff from heavy precipitation may flush stagnant water from low-lying swampy areas into the slough as well. Stagnant waters are usually low in pH and dissolved-oxygen concentration and often contain substantial quantities of dissolved solids. Thus, water quality may occasionally be degraded near culvert areas during storm runoff.

Although the maps of habitat characteristics in Noyes Slough did not quantify fish habitat, they show that a large amount of cover was available throughout its course (fig. 4). The variable depths and differing structural features provided conditions that may be suitable for fish species with different preferences, but shallow water at low flow may inhibit

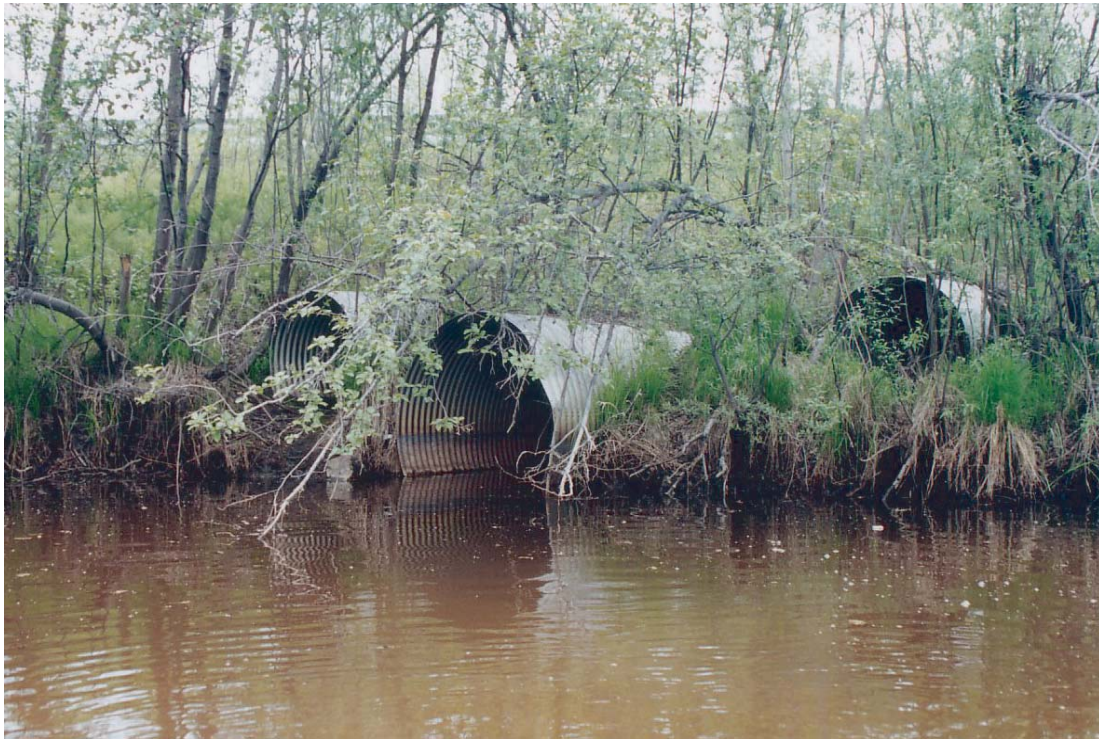
Figure 5. Culvert discharge into Noyes Slough near East College Road, Fairbanks, Alaska.

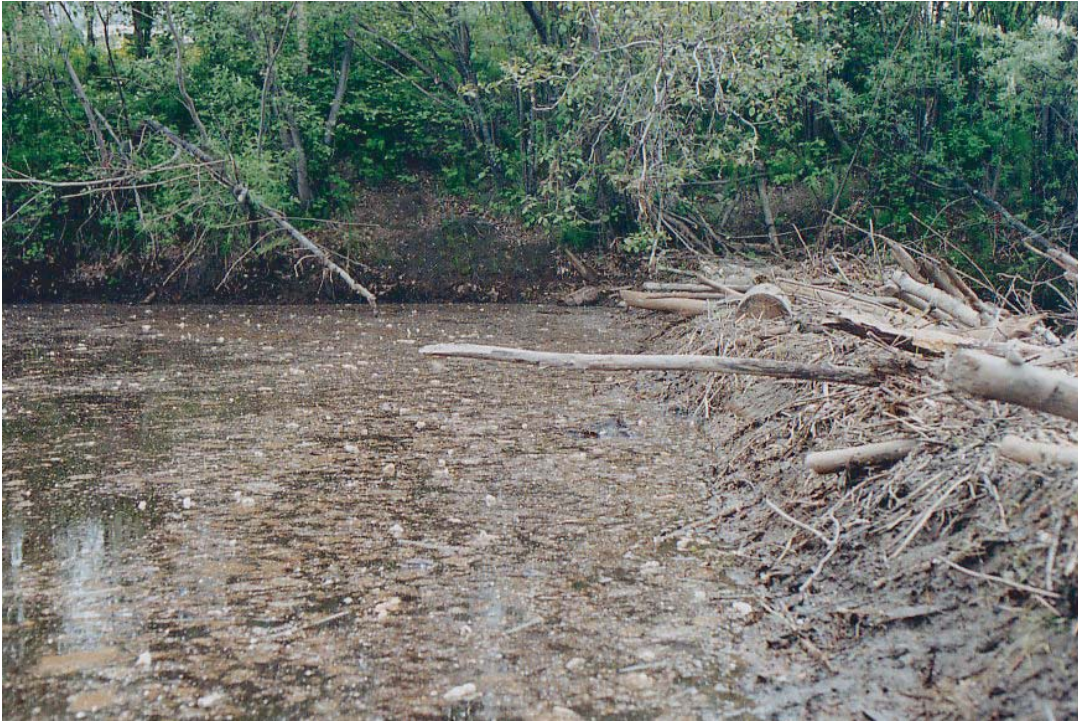
Figure 7. Beaver dam on Noyes Slough, Fairbanks, Alaska. The view is looking across the downstream side of Dam 7 in reach 9, just upstream from Deere Street. This was a likely barrier to fish movement at most streamflow levels during summer 2001.

Beavers were a primary factor shaping the physical characteristics of Noyes Slough. Although they helped increase the supply of woody debris, many of their dams probably were a hindrance to fish movement. However, as fish were found throughout most of the slough, the dams do not completely regulate distribution. The slough was effectively divided into disjointed units during low flow, with notable differences in water level and water quality on either side of most dams. Several groups of beavers were observed actively building dams in the summer of 2001 (fig. 8). Beavers likely will continue to influence slough characteristics.

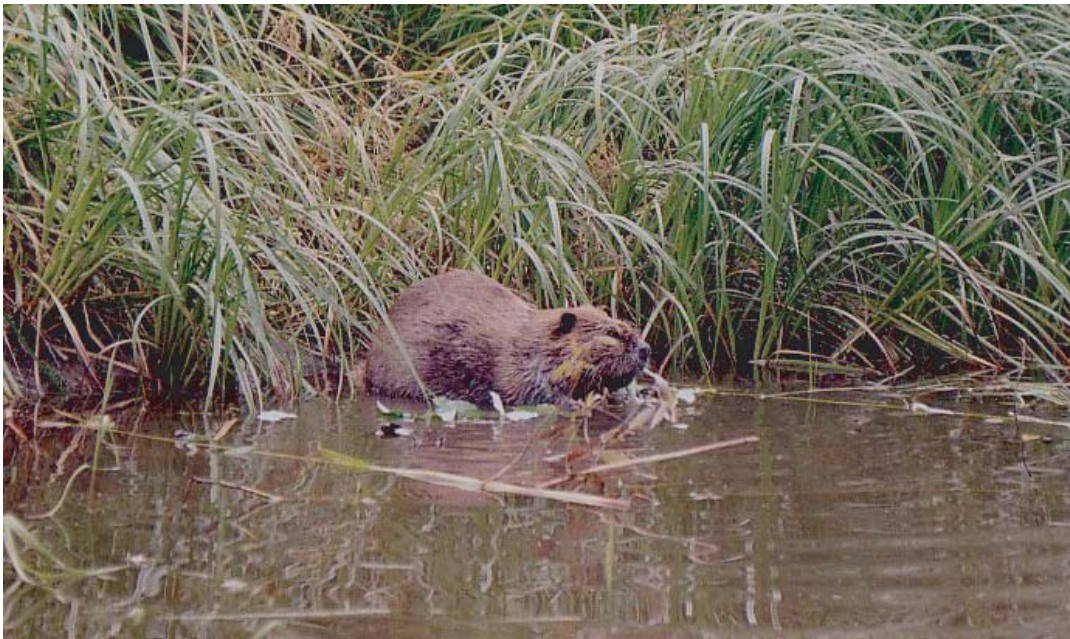
Figure 8. Beaver delivering brush to Dam 1 on reach 1, upstream of Minnie Street near the source of Noyes Slough, Fairbanks, Alaska.

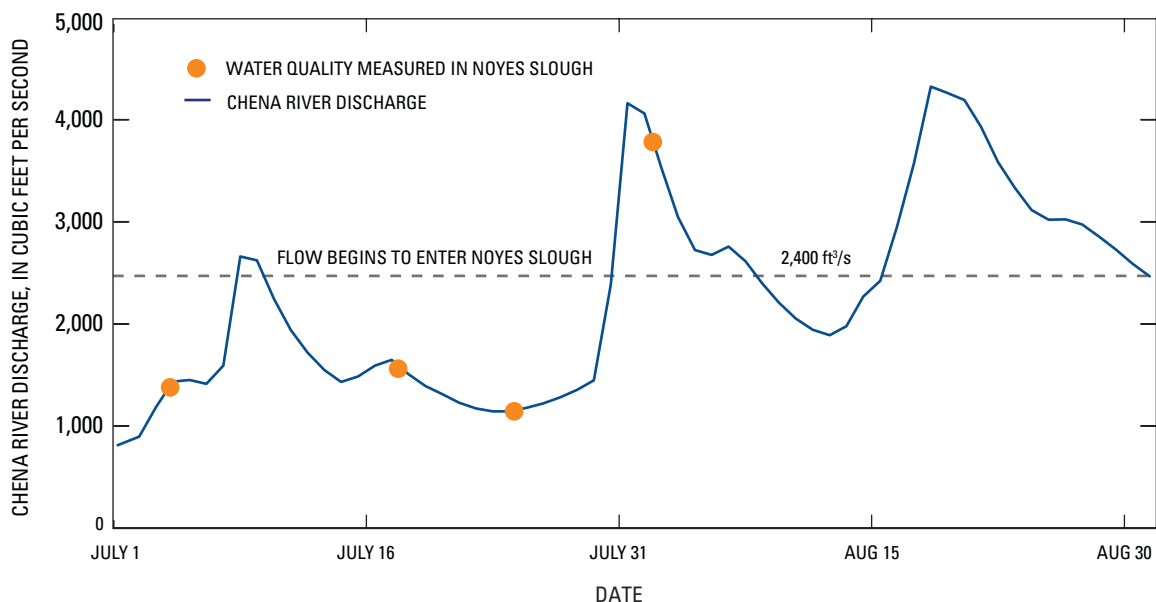
Figure 10. Discharge in the Chena River and dates of water-quality measurements during summer 2001 in Noyes Slough, Fairbanks, Alaska.

At a discharge of about 2,400 cubic feet per second, the Chena River contributes surface water to Noyes Slough.

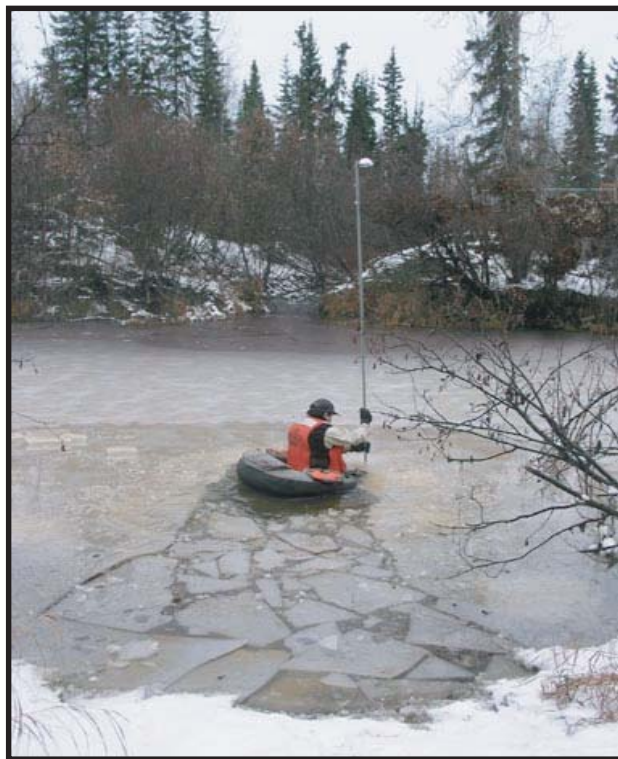
Figure 14. Sampling of streambed sediments under ice cover in Noyes Slough, Fairbanks, Alaska, October 2002.

2001b). In an attempt to reduce the effects of matrix interference, samples were analyzed at relatively large dilutions and many of the target analytes were diluted out or the minimum reporting limits were elevated due to the dilution. Because the analyses for organic compounds in samples collected during 2001 were largely unsuccessful, they are not presented in this report. During early June 2002, five sites were resampled for organic contaminants to determine if chlorophyll-matrix interference problems were reduced in samples collected just after spring break-up of ice cover. However, STL analytical reports indicated that matrix interference effects also were a significant problem for the June 2002 samples (Severn Trent Laboratories, 2002). To minimize chlorophyll levels, resampling of bed sediment for organic contaminants was then delayed until October 2002, when ice covered about 95 percent of the slough. All odd numbered sample sites, SED01 through SED23, were resampled through ice cover for organic contaminants, and one replicate sample was collected at the SED01 site, for a total of 13 samples. The replicate sample, SED01R, was composited from sediment about 10 cm below the bed sediment-water interface. Ice thickness averaged 2-15 cm and was breached with the assistance of an ice chisel or ice auger to gain access to streambed sediments (fig. 14).
