Appendix D

DETAILED AFFECTED ENVIRONMENT DATA

D.0 INTRODUCTION

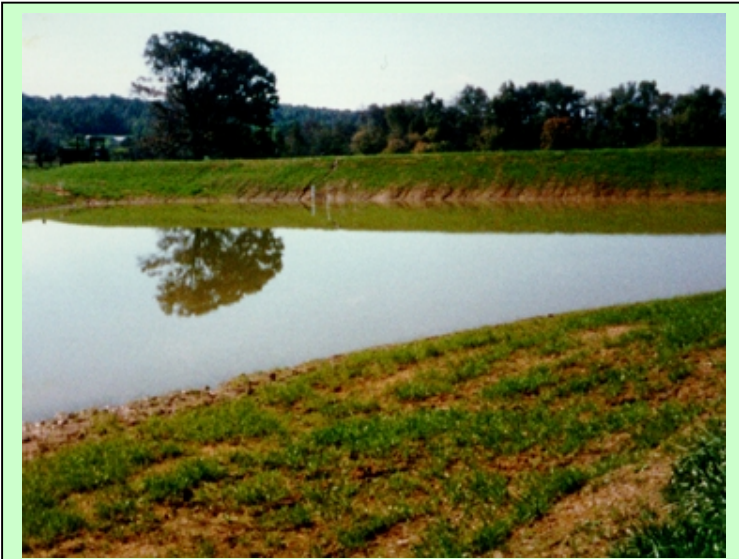
Fig. D.1-8 Example of an embankment pond

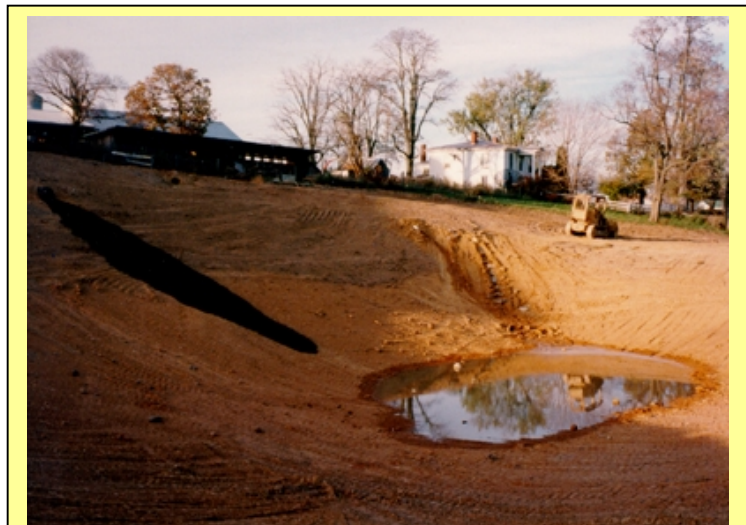
Fig. D.1-9 Example of a waste storage pond

The waste storage pond is found on the Martin farm, to the north of the town of Fairfield. The waste from the dairy on-site is collected and dried within the pond before eventually being applied to agricultural fields. There is no outflow from the pond and no stream channels are located nearby, although intermittent portions of Marlbrook Creek are a quarter of a mile away.

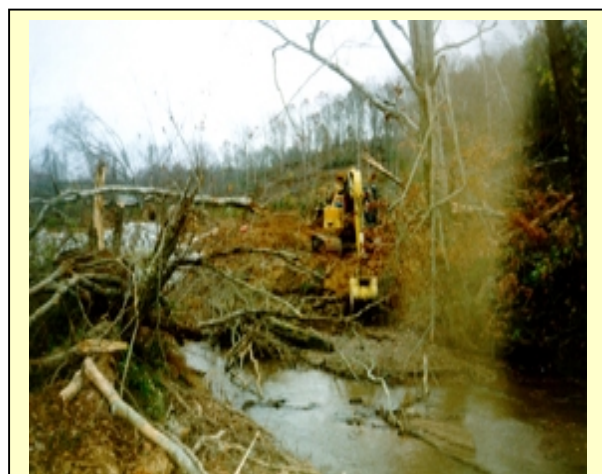
Fig. D.2-2 Backhoe removing woody debris, Hall County, Georgia

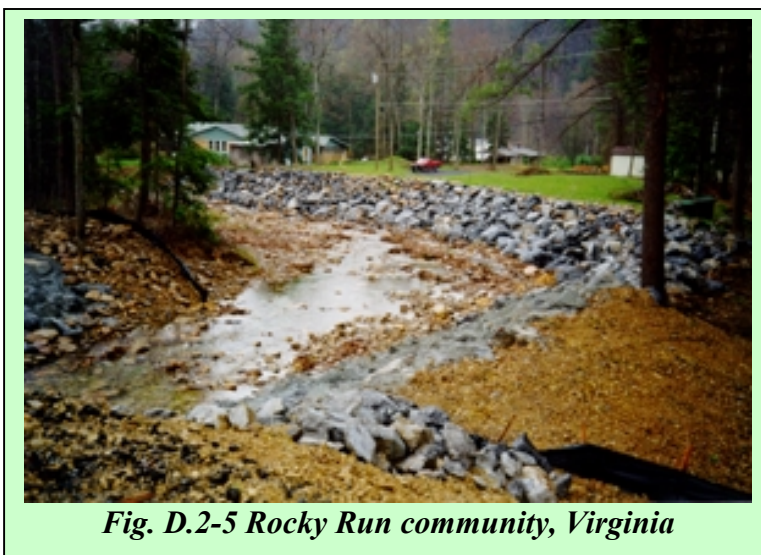
Fig. D.2-5 Rocky Run community, Virginia

Riprap and gabions were placed on streambanks (Fig. D.2-5) to stabilize the channel and to protect life and property from future damage. Yet, in September 1996, heavy rains from Hurricane Fran swelled Rocky Run and the existing practices protecting the community failed.
