Controlling Roof Beam Failures From High Horizontal Stresses in Underground Stone Mines

National Institute for Occupational Safety and Health
Pittsburgh Research Laboratory
Pittsburgh, PA

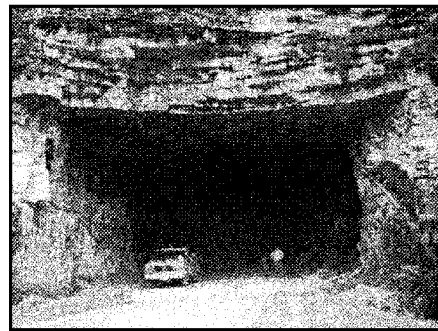
Not all limestone is massive; in fact, most limestone has horizontal layering that forms beams typically ranging from less than 0.15 to 0.6 m (0.5 to 2 ft) thick (Figure 1). Variations in roof beam thickness are caused by horizontal bedding planes of varying lengths and spacing. Some of these beams contain different numbers of vertical and subvertical discontinuities (vertical joints or fractures and subvertical crossbed planes). These fractures allow local sections of the immediate roof or rib to separate, forming prisms or wedges. These local wedge instabilities can suddenly fail without warning and are especially common in rib falls.

Figure 1 - Limestone mine portal showing a roof composed of numerous flat lying beams separated by bedding planes and ranging in thickness from 0.3 to 0.6 m (1 to 2 ft). It is estimated that greater than 95% of all underground stone mines have dips less than 10°.

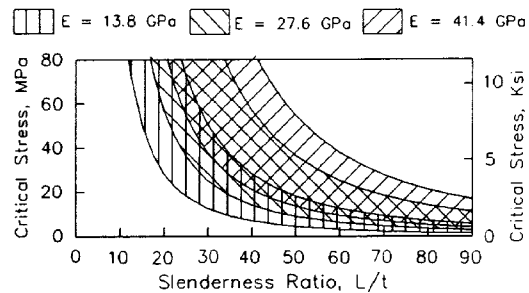
Using Euler's formula for both pin- and fixed-ended beams provides some general parameters related to stone roof beam stability. The strength of beams with different geometries and stiffnesses can be examined by plotting the critical stress at different beam slenderness ratios and elastic moduli. The critical stress for pinned and fixed-end beams is calculated by multiplying the beam length by 1 and 0.5, respectively. Figure 2 shows this relationship for three different elastic moduli: 13.8, 27.6, and 41.4 GPa (2, 4, and 6 Mpsi). The relative potential for buckling failure can be determined by evaluating the position of the calculated critical stress value. If the value plots below the strength/stiffness line, the beam has a low potential for buckling. Conversely, if the value plots above this line, the beam has a high potential for buckling.

Figure 2 - Critical stress conditions for beams of various geometries and stiffnesses from Euler's formula.

These calculations clearly show that increasing the stiffness and/or the thickness of these beams is expected to dramatically increase their strength and hence the stability of the roof. Certain types of rock bolts can act to join thin layers, enhancing roof strength by increasing its flexural stiffness. Therefore, strategies to increase roof beam strength can minimize roof beam failures from moderate to high horizontal stresses and lessen the exposure of underground stone miners to hazardous conditions.

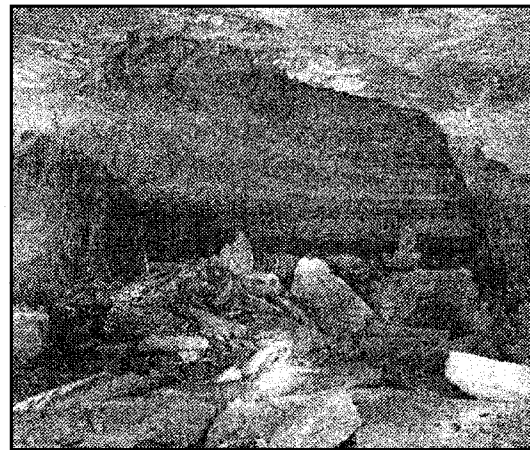
2. Oval or elliptical roof failures oriented perpendicular to maximum horizontal stress direction (Figure 4).

Figure 4. - If the roof is not reinforced properly with rock bolts, the beams can progressively fail higher into the roof until a stable roof beam is encountered. Here the roof fall has assumed an elliptical shape.

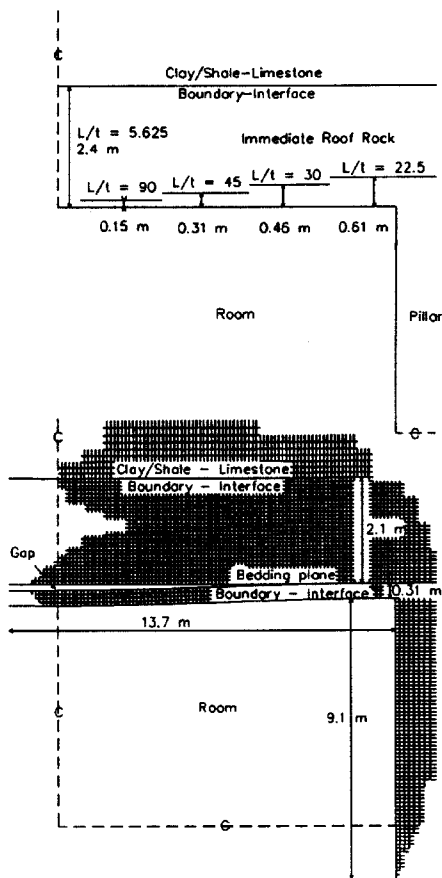
Figure 5 - Dimensions of five beams used in parametric investigations. At high horizontal stresses and slenderness ratios, the beams began to sag, creating a gap in the modeled roof.

The emphasis of these parametric investigations was to examine various shaped beams under varying regional horizontal stress conditions. In this study, five beam slenderness ratios were examined: 5.6, 22.5, 30, 45, and 90 (Figure 5). At high horizontal stress levels, the immediate roof beam began to sag,

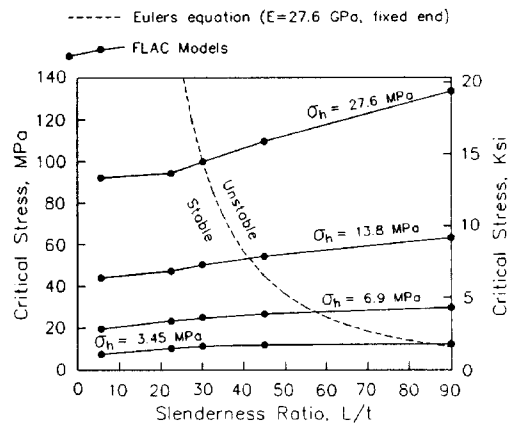
Plots of average maximum horizontal stress conditions for five different beam geometries and four applied horizontal stress conditions are shown in Figure 6. In this analysis, the critical stress is calculated for a material with a stiffness of 27.6 GPa (4 Mpsi) using a fixed-end condition. The fixed-end condition is thought to more closely represent the end conditions found in underground mines than the pinned-end condition.

Figure 6 - Potential stability to buckling failure of differently shape roof beams with a varying horizontal stress field, ranging from 3.45 to 27.6 Mpa.

This new analysis supplies a very instructive view of the relationship between beam strength, beam geometry, and the regional horizontal stress field. If two of the conditions are held constant, the third can be altered to determine how it can potentially influence the onset of buckling failure. For example, if the mine is subjected to a 13.8 MPa (2 Ksi) horizontal stress field and the beam has a stiffness of 27.6 GPa (4 Mpsi), then a 0.3 m (1 ft) thick beam in a room 13.7 m (45 ft) wide (slenderness ratio=45) will plot in the unstable zone, indicating a high potential for buckling failure. Conversely, if the beam is 0.6 m (2 ft) thick, the intersection point of the 13.8 MPa and the 22.5 slenderness ratio conditions place this beam in the stable zone,

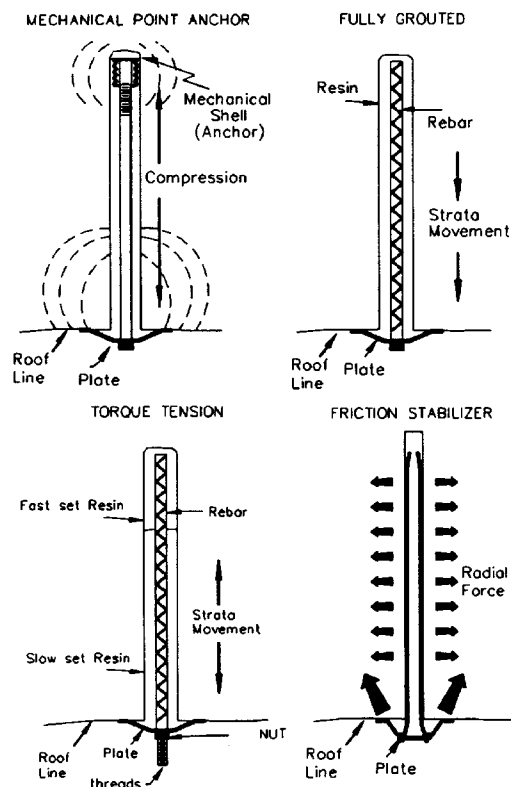
Figure 7. - Four common roof support systems: mechanical point-anchor, fully grouted resin, torque tension resin, and friction stabilizer bolts.

One way to evaluate the individual bolt performance is to examine their load distribution. For example, a mechanical point-anchor bolt compresses the beams between the anchor and the plate (Figure 7). Therefore, as the bolts resist sag the load is evenly distributed along the axis of the steel bar. The bar near the plate or in the threaded anchor section can stretch and fail when excessive loads are encountered. When this happens, the entire bolt loses all reinforcement value. The resin bolts distribute load in a very different fashion. Their resistance to sag is concentrated along that section of the bar where the beam separation is occurring. If the bar would happen to fail at this location, the rest of the intact bolt would still provide some resistance to separation at other locations in the bolted horizon. The friction stabilizers are unique in that they can gain pullout resistance in response to beam separation or lateral shifting. However, loss of contact with the host rock along the bolt axis can reduce its load-bearing capacity.

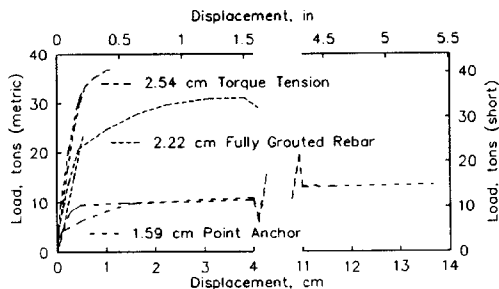
The characteristics of each of these supports are defined by their load-bearing capacity, stiffness, and postfailure characteristics. These characteristics were measured by conducting pullout tests (Figure 8) in the Greenbrier Limestone at NIOSH's Lake Lynn Underground Laboratory. The 1.59-cm (5/8-in) mechanical point anchor bolts displayed a low level of stiffness as the bolts elastically deformed approximately 0.5 cm (0.2 in), attaining a load of approximately 10 metric tons (11 tons). At this point, the bolts stretch and the anchors began to move or slip. These bolts displaced 14 cm (5.5 in) before failing. The 2.22-cm (7/8-in) fully grouted bolts are much stiffer, achieving approximately 22 metric tons (24 tons) of load at only 0.5 cm (0.15 in) of elastic deformation, primarily at the bolt head. One of the fully grouted bolts failed at this point; the other achieved over 4 cm (1.2 in) of plastic yield and gained an additional 10 metric tons (11 tons). The 2.54-cm (1-in) fully grouted torque-tension bolts were very stiff, achieving almost 35 metric tons (39 tons) of load at just over 0.5 cm (0.15 in) of elastic deformation. Both torque-tension bolts displayed very little plastic yield, displacing a total of only 1 cm (0.39 in) prior to failing between 36 to 37 metric tons (39 to 41 tons). The friction stabilizer bolts, i.e., split-sets and swellex bolts, rely on radial and frictional forces for anchorage. They are excellent at stabilizing wedges because of their ability to provide immediate resistance to deformation as a result of their high initial stiffness. This unique anchorage, however, does not provide very high load resistance, ranging between 4 and 12 metric tons (5 and 14 tons) (Scott, 1989; and Stillborg, 1992). These bolting systems can deform continuously for upwards of 5 cm (2 in) under constant load.

Figure 8. - Pull tests conducted on mechanical point anchor, fully grouted, and torque-tension bolting systems in limestone roof at the Lake Lynn Laboratory.

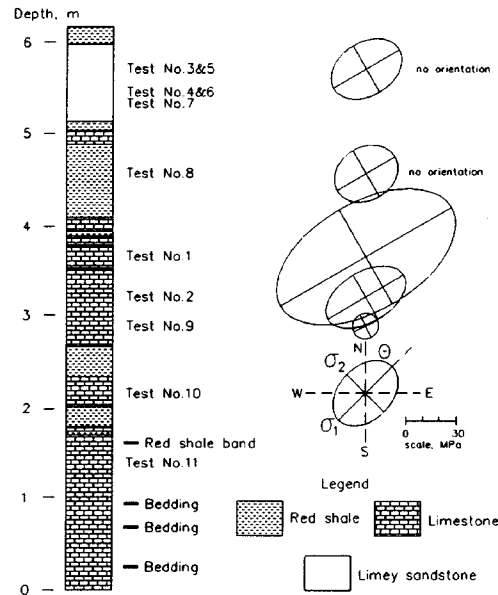
Figure 9. - Stress ellipses from six successful hydraulic fracturing tests within the roof of a Loyalhanna Limestone Mine.

Of the 11 tests, six produced enough data to estimate stress field orientations and magnitudes. Measurements of principal horizontal stress ranged from approximately 10 to 60 MPa (1.4 to 9 Ksi) with an average of approximately 25 MPa (3.6 Ksi). Of the five unsuccessful tests, three were due to our inability to propagate a fracture using pressures ot almost 69 MPa (10 Ksi). These are very high pressures and attest to the strong nature of the rock and the high in situ stress conditions. The other two unsuccessful tests were related to either problems with the fracture tool or hydraulic packers.

Of the six successful tests, stress field orientations could be determined from only four tests. Orientations were measured from the direction of vertical propagation produced during fracturing (Figure 9). All four vertical cracks propagated in the N45 to 65E direction. With the exception of test No. 9, all stress field values indicate that elevated horizontal stress conditions occur within this portion of the mine. In the case of test No. 1, the stress field was found to be extremely high. The reasons for this are still under investigation, but are undoubtedly related to the limestone beam-bending process, the location of the softened (fractured) zone within the immediate roof, the stress concentrations around the mine opening, and the variations in beam stiffness, i.e., stiffer layers store high levels of stress. The

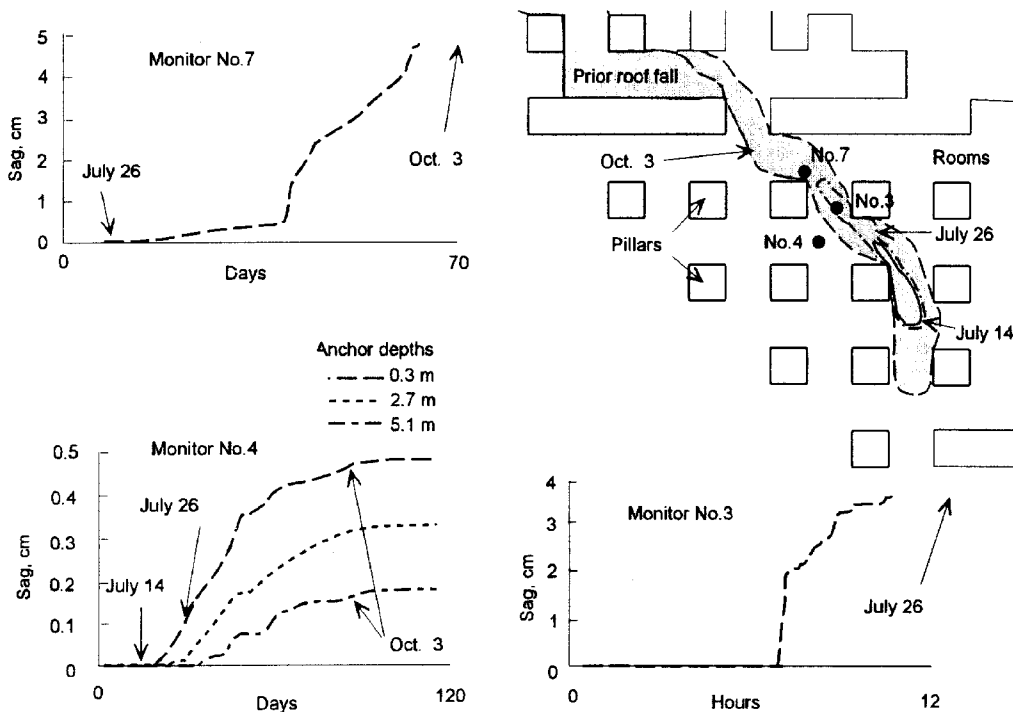
Data collected from three of these monitors are shown in Figure 10. Monitor No. 7 collected sag measurements for almost 70 days prior to total roof collapse. During this time, the roof sagged in three distinct phases. The first phase was marked by a slow but steady sag in the lower roof beam. At approximately 40 days there was a sudden increase in the sag of the beam. The third phase indicated that the beam sag velocity lessened, but

ended in total roof failure. A total of approximately 5 cm (2 in) of roof sag occurred prior to roof collapse. Data from monitor No. 3 showed a much different trend. Unlike monitor No. 7, this instrument was placed close to an existing failure; therefore, significant beam sag could have already occurred. The area began to "cut or rip" on July 26, rapidly extending the zone of failed roof. The roof associated with monitor No. 3 went from stable to unstable in a matter of 5 hours.

Monitor No. 4 was purposely placed slightly away from the main failure trend. The magnitude of sag measured from this instrument was 1/10 the magnitude of the instruments within the failure trend. However, these measurements did show that beam bending and associated shearing extended significant lateral distances on the order of 6 m (20 ft) from the fall's edge and 12 m (40 ft) from the center of the fall. This monitor also showed that while sag was initiated in the lowest beam, beam separations quickly moved much higher in the roof.

Figure 10. - Roof behavior associated with the large roof fall caused by high horizontal stresses.

Friction stabilizer bolts 2.4 m (8 ft) in length were installed in portions of the directional roof failure trend. Unfortunately, many of these bolts failed in the lower 1/3 of the bolt or at the location of the first major beam separation. Some of the bolts were stretched apart while others were sheared, indicating considerable shifting along the beam separations. In either case, these bolts were not of sufficient strength to resist the considerable beam sag.

The next bolt tried was a 1.59-cm (5/8-in) mechanical resin-assisted point anchor bolt 2.4 m (8 ft) in length. These bolts were similar in strength to the friction stabilizers, so they would have probably suffered from a similar fate. However, poor installation prevented this bolt from being placed in the high horizontal stress locations. The mechanical resin-assisted anchors were prone to spinners and could sometimes be pulled from their holes by mechanical scalers. It is thought that the limestone hole and the steel bar were both too smooth to allow the resin to bond well between the bolt and the rock, while the mechanical expansion shell seemed to have trouble anchoring into the limestone.

At this point, a new directionally controlled failure began to develop in another room. Mine management decided to try a much stiffer support, the 2.54-cm (1-in) torque-tension resin bolt. These bolts were quickly installed along the projected trend of the new directional failure zone. The fast-set resin along the upper bolt allowed the bolts to be tensioned to an estimated 5 metric tons (6 tons). This tensioning had the added benefit of pulling some of the loose lower beams together. Six RMSS's and three hollow inclusion cells were installed in this area to examine roof behavior. Additionally, a 10-m (30-ft) production bench was extracted to within 14 m (45 ft) of the bolted entry. Through the course of the 8-month monitoring period, stresses in the lower beams have changed as the roof was first loaded then unloaded as the bench extraction zone approached. Although the roof has shown some signs of localized cracking between the bolt heads, no beam collapses have occurred. Additionally, roof sag monitors have shown that very little sag has occurred in the bolted roof area. To this date, no torque tension resin bolts have failed.

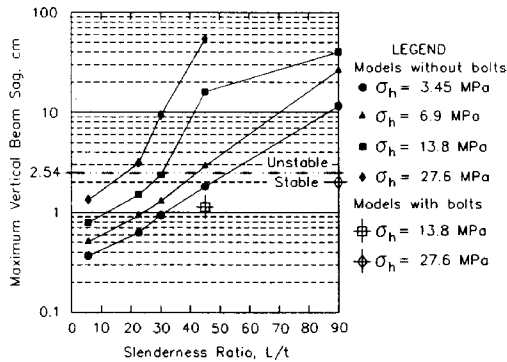
In the parametric investigations discussed earlier, elastic beam sag occurred in beams with different slenderness ratios and under different horizontal stress conditions. The maximum vertical beam sag for each condition was calculated and displayed in Figure 11. If a match is made between conditions where a beam has a high potential for buckling, as defined by the critical stress failure criteria, and maximum vertical beam sag, then all conditions that produced more than 2.54 cm (1.0 in) of sag would represent a failure beam. This value correlates well with the sag magnitudes measured in the test site, validating the numerical model's performance.

Figure 11. - Maximum vertical beam sag for several beam geometries and applied horizontal stress conditions with and without roof bolts.

These four rock reinforcement systems were run under two conditions presented previously where buckling failure was predicted by both the critical stress and critical displacement failure criteria. These two conditions represent a moderate failure potential, where horizontal stress was 13.8 MPa (2 Ksi) and the slenderness ratio was 45, and a very high failure potential, where the horizontal stress was 27.6 MPa (4 Ksi) and a slenderness ratio 90. All four bolts under both test conditions reduced maximum vertical beam sag to below the 2.5 cm (1 in) critical displacement failure criteria. That is approximately 1 cm (0.4 in) for the moderate failure potential conditions and 2.1 cm (0.8 in) for the very high potential failure conditions.

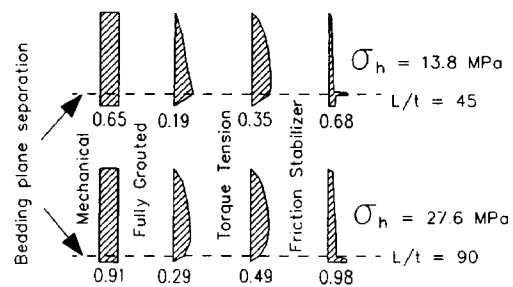
In addition to examining the influence of bolting on resisting beam sag, numerical simulations were used to evaluate the stability of the individual bolts. This was accomplished by determining the ratio of the axial load to the yield strength of each bolt at or near the beam's critical stress conditions (Figure 12). With a slenderness ratio of 45 and the horizontal stress field of 13.8 MPa (2 Ksi), the point anchor bolts were within 30% of achieving their maximum strength. Both fully grouted and torque tension resin bolts had more than 60% of their strength remaining, while one of the friction stabilizer bolts was at its yield strength. It is assumed that some bolts may fail when their yield strength is achieved and some additional yield takes place. In the case of the point anchor and friction stabilizer bolts, it may take additional sag to develop further plastic deformation before failure occurs. When the slenderness ratio was increased to 90 and the horizontal stress field was doubled to 27.6 MPa (4 Ksi), a different set of stability conditions was observed. The point anchor bolts were now at or close to yield. The resin bolts still had at least one-half of their strength remaining, while friction stabilizer bolts were in yield.

Figure 12. - Profiles of the average ratio of axial load to yield strength for four different bolt types placed under roof conditions that could potentially cause buckling failure of the lower roof beams.

The model results match well with field observations. These observations indicate that no resin bolts failed in the field test,

while considerable numbers of point anchor and friction stabilizer bolts failed. Bolt stability was directly related to load capacity. In some high horizontal stress conditions, the 6 to 12 metric tons (7 to 14 ton) of load capacity measured in the point anchor and friction stabilizer bolts was not enough to withstand loads generated by the deforming beams.
