CASE SUMMARY

NATIONAL ACCIDENT SAMPLING SYSTEM
CRASHWORTHINESS DATA SYSTEM

PSU 09 CASE NO. 142 A TYPE OF ACCIDENT car v. car, right angle

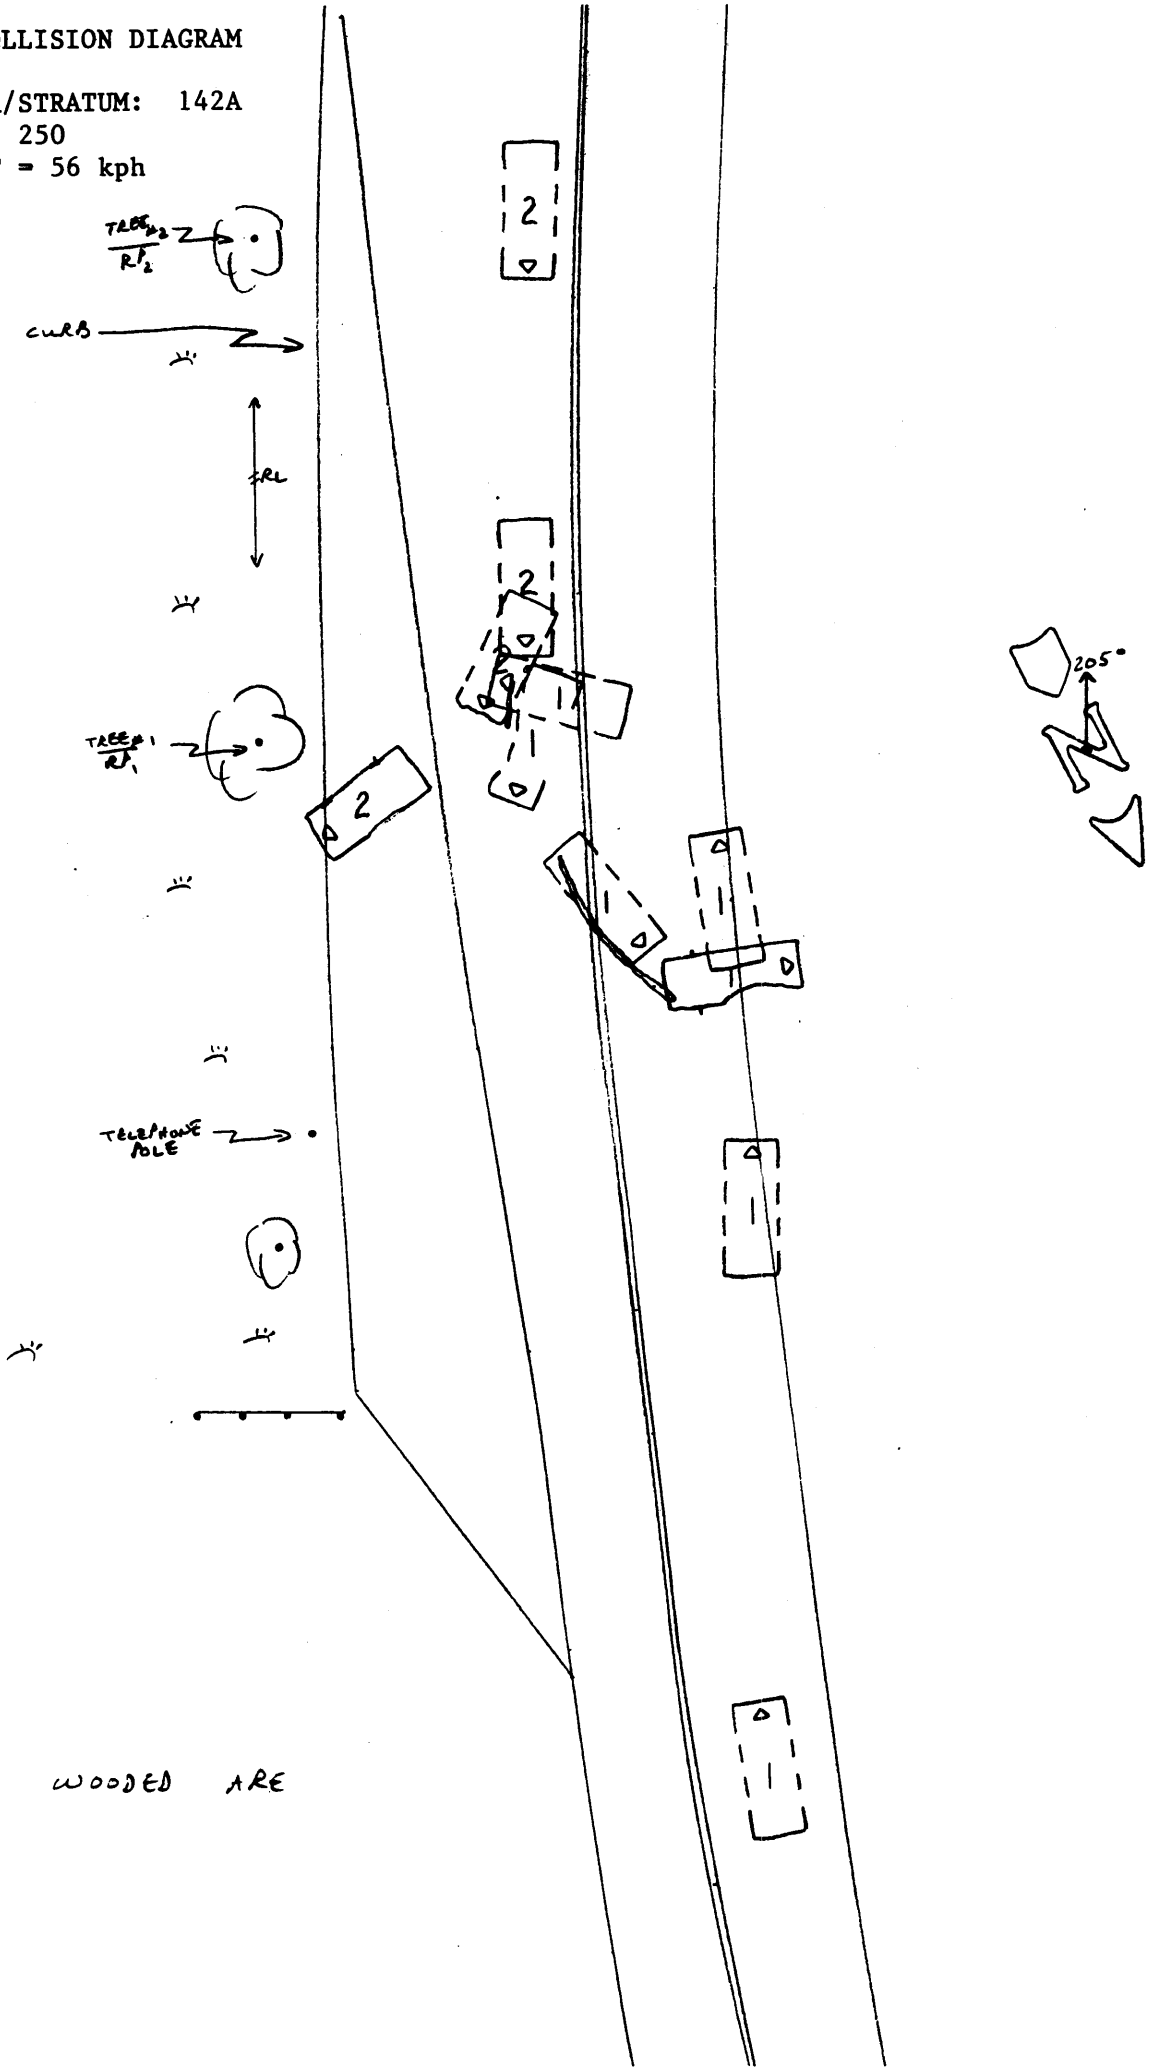
ACCIDENT COLLISION DIAGRAM
PSU #09
CASE NUMBER/STRATUM: 142A
SCALE = 1 : 250
SPEED LIMIT = 56 kph

V± was travelling south on a roadway. V2 was on the same roadway travelling in the opposite direction. V1 travels off the R roadside and over corrects to return to the roadway. V1 loses control and travels into the oncoming traffic where it was struck by V2. The vehicles sideslap and V1 travels back into the southbound lane. V2 travels off the eastside roadway where it comes to a stop up against a curb.

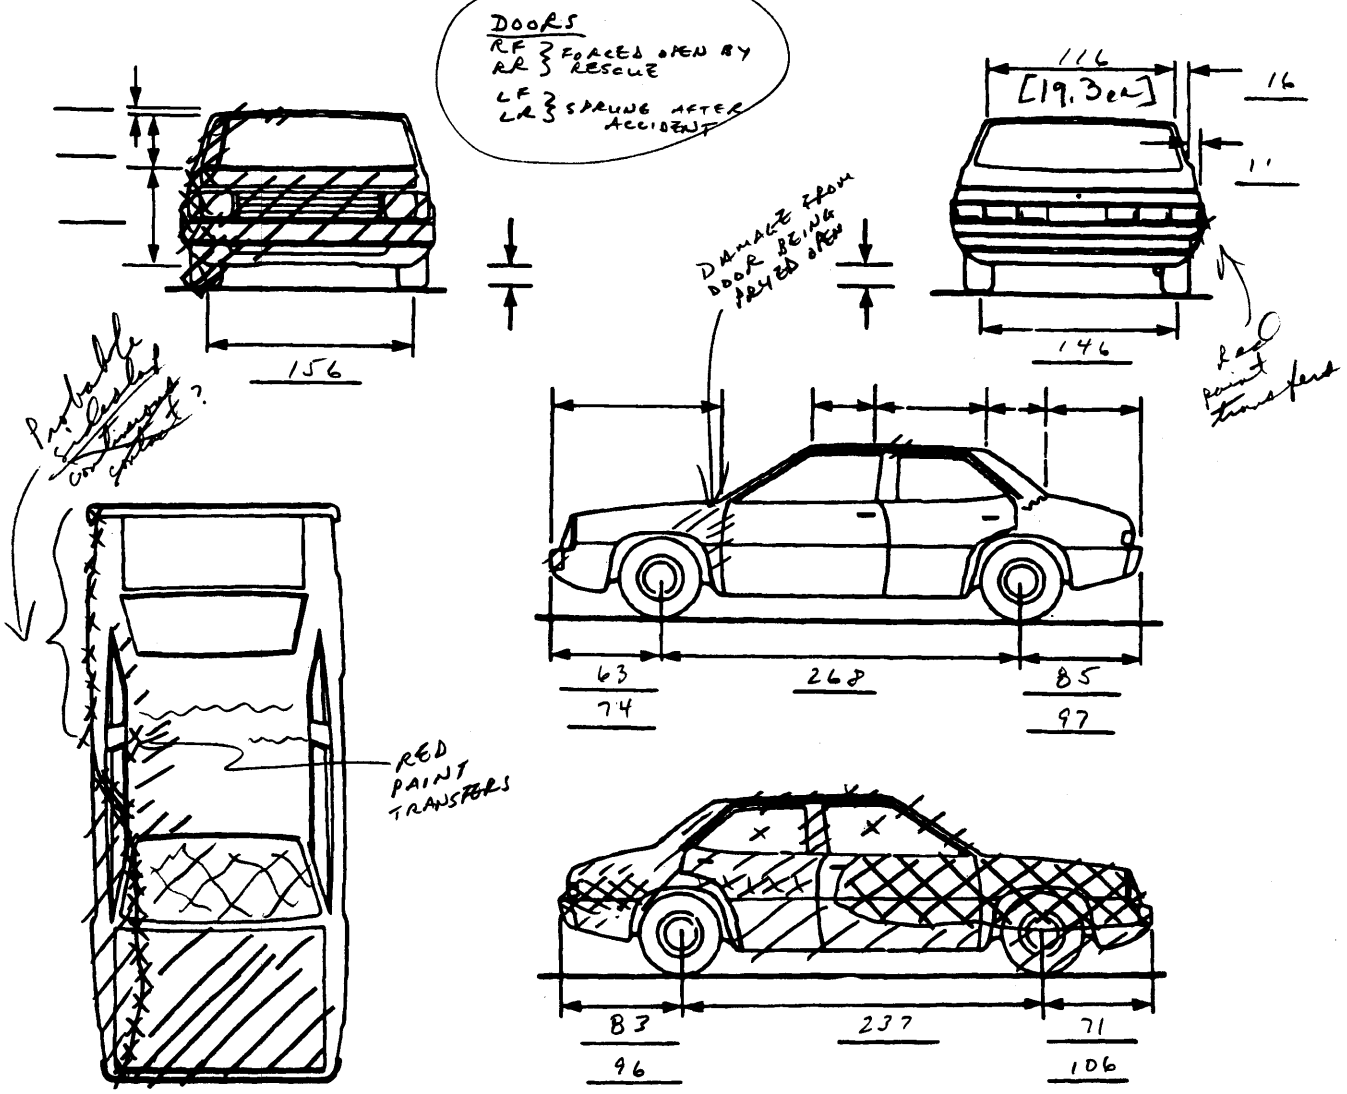
VEHICLE DAMAGE SKETCH

Specific Impact No.	Location of Direct Damage	Location of Field L
1	(R) STARTS 242 cm FORW of (B) STRINGLINE,	(R) STARTS 218 cm FORW of (B) STRINGLINE,
	GOES FORW 190 cm	GOES FORW. 186 cm
2 sideswipe	(R) STARTS 13 cm FORW of (B) STRINGLINE, GOES FORW 168 cm	NOT ACCOMP (OBSCURED BY POST-IMPACT DAMAGE, RESCUE DAMAGE TO A/R DOOR)

Specific Impact Number	Plane of Impact C-Measurements	Direct Damage Width (CDC)	Direct Damage Max Crush	Field L	C_1	C_2	C_3	C_4	C_5	C_6	±D
1	MIDDOOR	190	C_4	186	17	61	59	62	60	34	+89
	-FS	—	—	—	1	1	1	0	0	11	—
	-STAND ADJ	—	—	—	15	15	15	15	15	15	—
	RESULT	190	C_4	186	1	45	43	47	45	8	+89

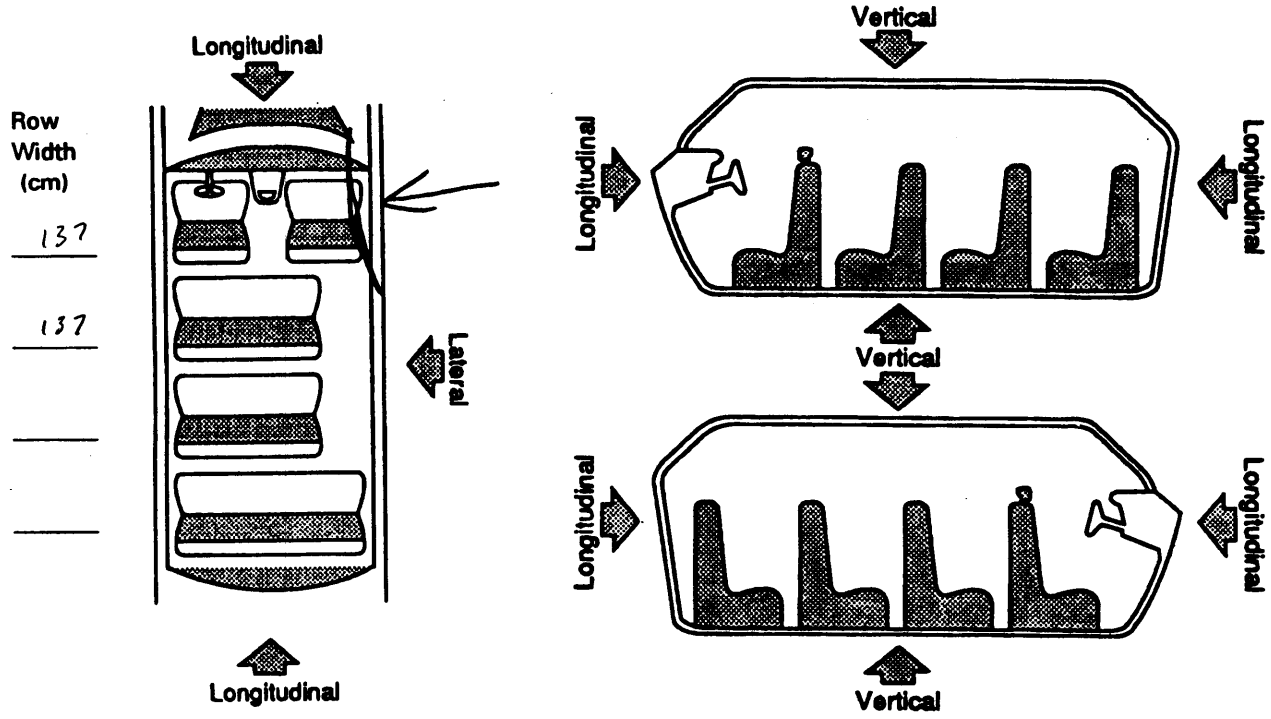
INTRUSION WORKSHEET

LOCATION OF INTRUSION	INTRUDED COMPONENT	COMPARISON VALUE	–	INTRUDED VALUE	=	INTRUSION	DOMINANT CRUSH DIRECTION
13	A Pillar	120	–	PP (TO OPP OUTER @ mid LEVEL)	=	32 (3)	Lat
	Left Side Panel	128	–	95 TO Opposite	=	37 (1)	
	Door Panel	129	–	93 To opp Floor side	=	36 (2)	
	Roof side Rail	106	–	96 To opp	=	10 (7)	
	Sill/Floor Pan	130	–	98 To opp inner	=	32 (4)	
	B Pillar	131	–	118 To opp INNER Sill	=	13 (5)	
23	Door Panel	129	–	130 "	=	0	
	Sill/Floor Pan	130	–	119 "	=	11 (6)	
	Roof Side Rail	106	–	TOP outer to opp outer	=	0	Lat
			–		=		
			–		=		
			–		=		
			–		=		
			–		=		
			–		=

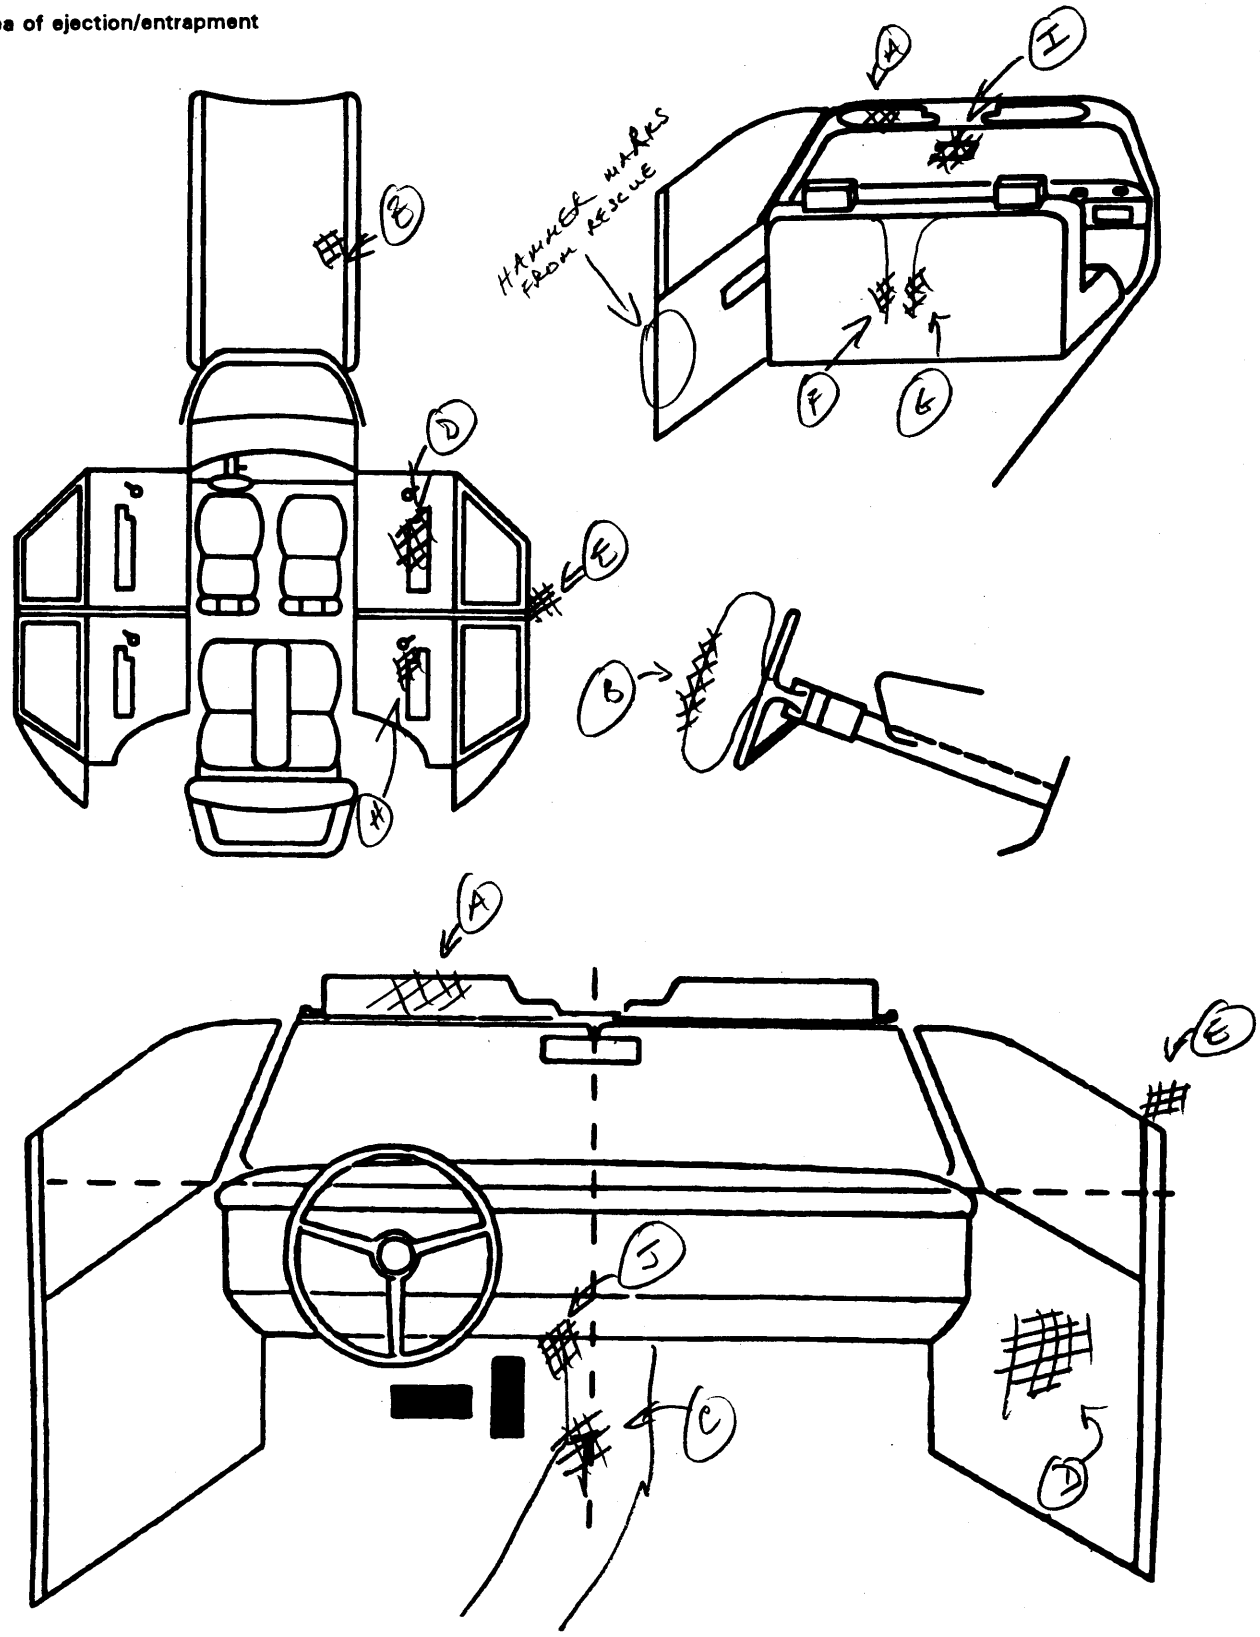
VEHICLE INTERIOR SKETCHES

Contact	Interior Component Contacted	Occupant No. If Known	Body Region If Known	Supporting Physical Evidence	Confidence Level of Contact Point
A	03	1	Head	MIRROR BROKEN	2
B	45	1	Head/chest	Deployed	2
C	57	2	(D) Leg	Bent towards the (L)	1
D	31	2	(R) Side	Deformed	1
E	54	2	Head	Imprint, Blood, Hair, gloss	1
F	40	3	Leg	Deformed, Scuff	1
G	40	3	"	" , SCUFF	1
H	31	3	(R) side	Deformed outward	2
I	02	1 or 2	Head	off Support	3
J	10/57	1	(R) leg	Deformed	1
K					
L					
M					
N

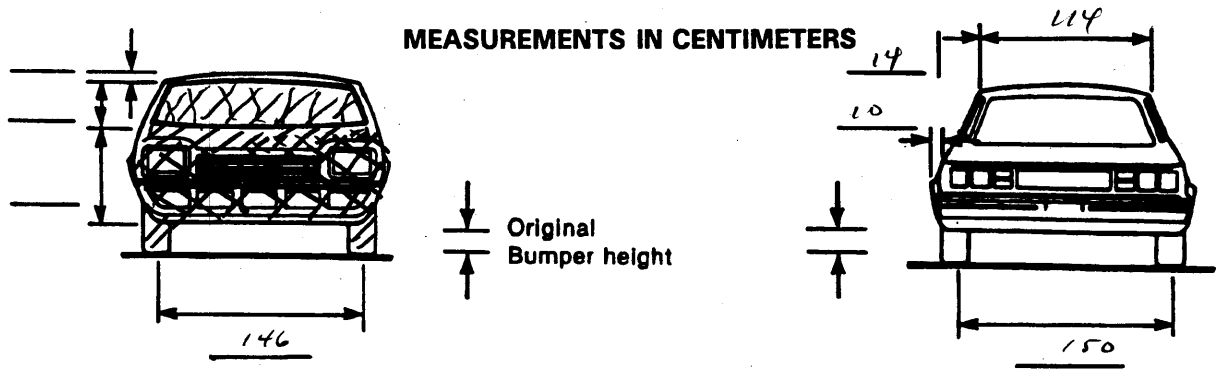
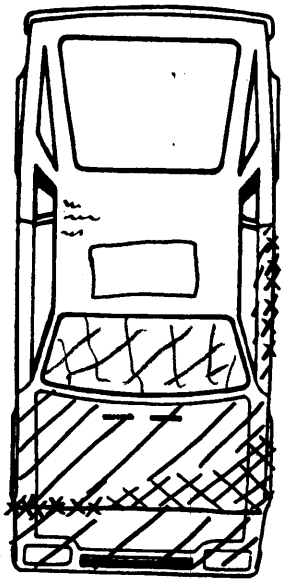
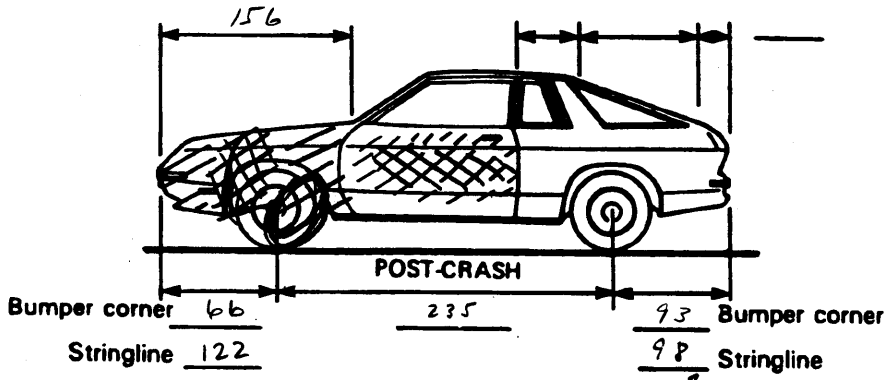
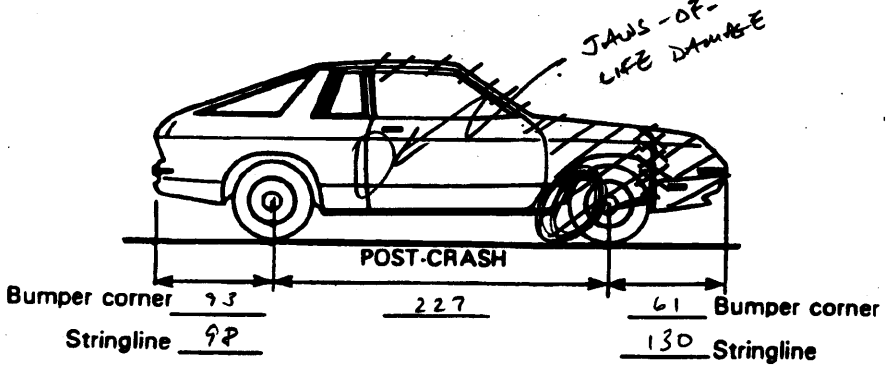
VEHICLE DAMAGE SKETCH

Specific Impact No.	Location of Direct Damage	Location of Field L
1	(F) BC TO BC	(F) BC TO BC
2	(L) STARTS 73 cm FORW OF (B) AXLE,	(L) STARTS 63 cm FORW OF (B) AXLE,
	GOES FORW 96 cm	GOES FORW 134 cm

Specific Impact Number	Plane of Impact C-Measurements	Direct Damage		Field L	C_1	C_2	C_3	C_4	C_5	C_6	±D
		Width (CDC)	Max Crush								
1	BUMPER LEVEL	145	C6	136	55	50	53	56	65	73	0
	-FS	-	-	-	11	2	1	1	2	11	-
	SPACE BETWEEN + BUMPER COVR & BMPR	-	-	-	4	7	9	10	11	12	-
	RESULT	145	C6	136	48	55	61	65	74	74	0
2	MID DOOR	96	5	134	1	4	3	4	4	3	-2
	-FS	-	0	-	0	0	0	0	0	2	-
	-STAND ADJ	-	1	-	1	1	1	1	1	1	-
	RESULT	96	4	134	0	3	2	3	3	0	-2

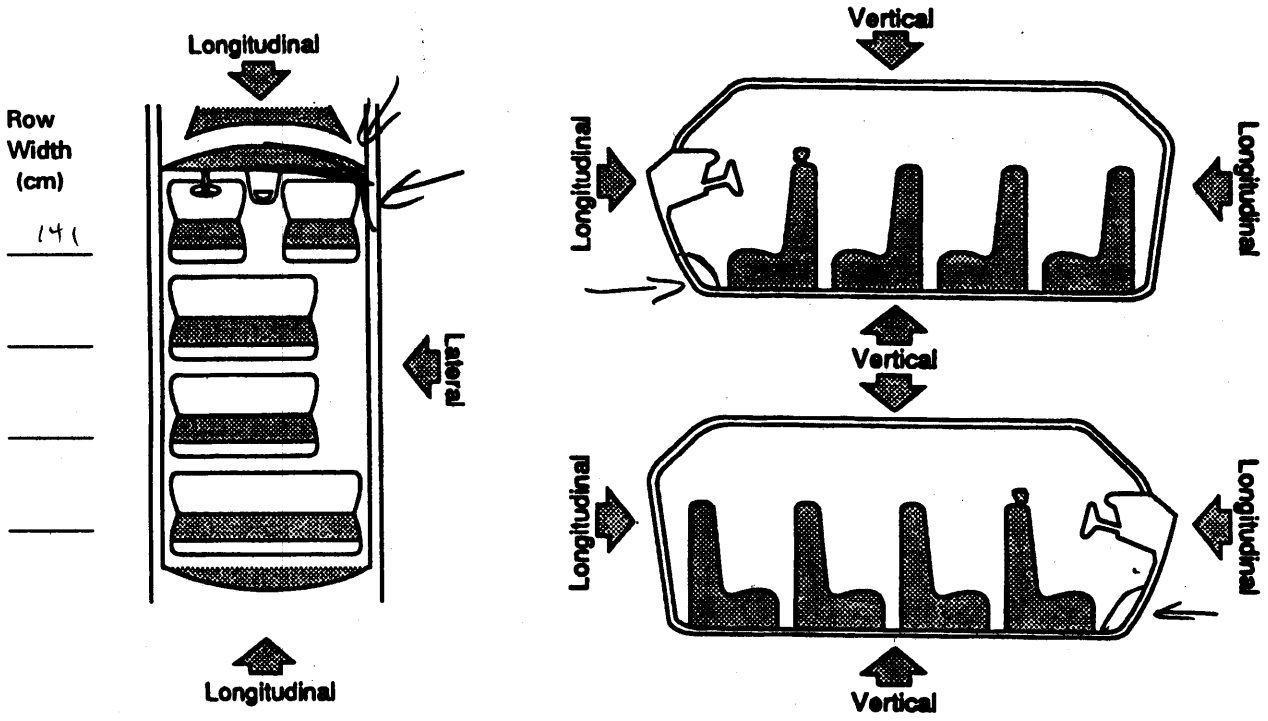
INTRUSION WORKSHEET

LOCATION OF INTRUSION	INTRUDED COMPONENT	(All Measurements Are In Centimeters) COMPARISON VALUE		INTRUDED VALUE		INTRUSION	DOMINANT CRUSH DIRECTION
11	Toe Pan	152	−	133 to Sill	=	19 ②	Long
13	Toe Pan	152	−	125 Mid To Lower	=	27 ①	Long
13	ⓡ Inst. Panel	105	−	90 "	=	15 ④	"
~~12~~	ⓒ Inst. Panel	~~98~~	−	~~98~~ Mid Sill	=	~~0~~	"
13	Floor Sill	55	−	43 to Hump	=	12 ⑤	Lat
13	Kick Panel	55	−	37 "	=	18 ③	Lat
			−		=		
			−		=		
			−		=		
			−		=		
			−		=		
			−		=		
			−		=		
			−		=		
			−		=
