Rock Mechanics
in the National Interest

Geomechanics of Large Stone Structures: A Case History from the Washington National Cathedral

ABSTRACT: The Washington National Cathedral is one of the largest masonry structures in the USA, and like many of its European Gothic counterparts, it required nearly a century to construct. The design was altered during this period, resulting in greater loadings than were originally anticipated on the soil beneath the foundation. When signs of continuing differential settlement were observed in the early 1990's, the Cathedral approached the US Bureau of Mines (now the National Institute for Occupational Safety and Health (NIOSH)) for assistance in monitoring the movements of the massive towers and walls. An array of dual-axis tiltmeters was installed about 40m above ground level to measure wall and tower inclination, with the data sent over a dedicated phone line to the NIOSH Pittsburgh Research Laboratory for processing. Mechanical gages and string-potentiometers are also being used to measure motion across cracks and joints, and differential pier settlement is being monitored with optical-level surveying. Data have now been collected for almost

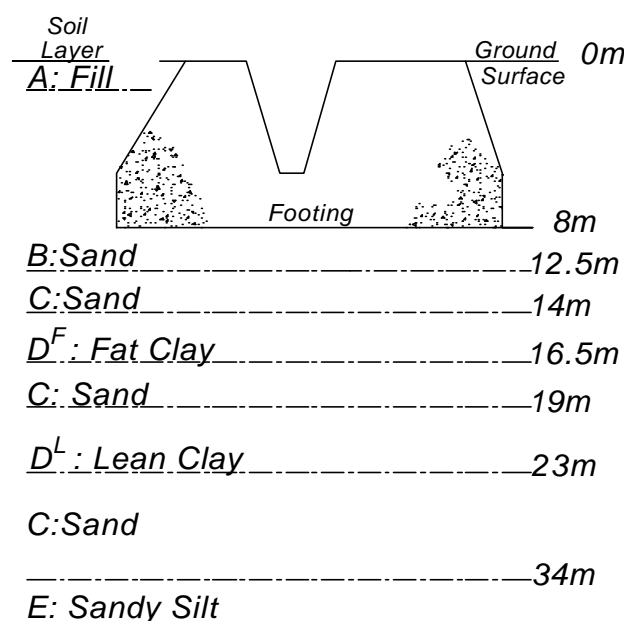
Figure 5. Soil section obtained from test boring near the west towers.

The differential settlement is largely a consequence of several crucial, early decisions made by the Cathedral architects. The first of these, a determination made around the time of the original design (1907), is linked to the positioning of the Cathedral on the building site. The south transept arm lies at the summit of a long, steep hill extending away from the end wall of the transept (Fig. 4) that was filled to furnish a more-or-less level building site. Secondly, no core samples were taken of the subsoil below the foundations during any stage of construction. Instead, the foundation was designed using information obtained from test pits. The Cathedral is sited on one of the highest elevations in the District of Columbia, and thus it might appear that bedrock would lay close to the surface. However, the test pits showed that the upper 10 m of ground consisted of layers of relatively competent silty sand and clayey sand. It was assumed that these soils continued down to bedrock. In fact, test borings taken by Schnabel Engineering Associates (1994) near the west towers found that the hard shale bedrock is 35 m deep, and that the lower 25 m of soil includes layers of "fat" (fine-particle high-plasticity) and "lean" clays. Laboratory testing indicated that the clay soils display primary and secondary consolidation behavior, and that they are overconsolidated. Figure 5 is an idealized soil section based on those borings, and Table 1 shows representative geotechnical properties.

Table 1. Properties of soil layers beneath the west towers shown in Figure 5 (Schnabel Engineering Associates, 1994).

STRATUM	Soil Classification[1]	Penetration Resistance [2]	Plastic Limit	Liquid Limit
B (Sand)	SC + SP	10 to 30	-	-
C (Sand)	SM, SC+SP	8 to 100+	8 to 13	30 to 36
D^F (Fat Clay)	CH	6 to 12	31 to 33	53 to 56
D^L (Lean Clay)	CL	15 to 42	-	-

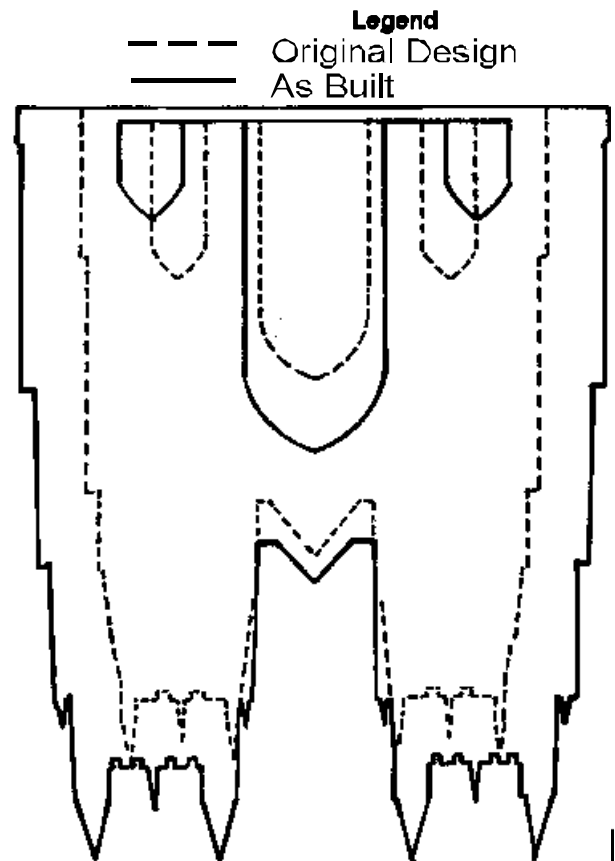
Figure 6. Comparative west-front facade profiles for Washington National Cathedral

Certainly the most significant decision influencing the settlement rate of the west towers was made after the footing had already been placed. Shortly after the appointment of the third group of principal architects, Philip Frohman (1921) argued that the size of the west towers should be dramatically increased on the basis of aesthetics: "The whole front has a narrow, constricted appearance... it seems lacking in that beauty and grandeur which should be possessed by the facade of a great cathedral." In a letter to Frohman from one of his partners written in 1925, Donald Robb supported Frohman's aesthetic view, but warned that: "There is the matter of the foundation mat already in place.... If the necessary extensions to this mat are poured within a short time, they will have ample time to come to their permanent level [of strength] before the superstructure is added."

Unfortunately, this advice was not followed. Ultimately, the upper portion of the great concrete footing was modified to accept the enlarged towers, but the lower portion of the footing (its critical 21 x 49 m "footprint" on the soil 8 m below the surface) remained unaltered. The west towers, which were finally completed in 1989, are close to 10 m taller and wider than the originally proposed facade (Fig. 6).

While the original design of the mat footings gave a uniform bearing pressure of 29 T/m^2 beneath the crossing tower, and presumably the same for both west towers, the bearing pressure of the revised west tower design (including the footing) is estimated to be 47 T/m^2.

Computation of the predicted settlement of the west towers, using the laboratory soil strength values, indicates that a primary consolidation of approximately 75 mm would have been expected. The primary consolidation should have been essentially complete after six years. The long-term secondary consolidation is predicted to be about 10 mm over next 10 years, followed by a further 10 mm over the next 100 years.

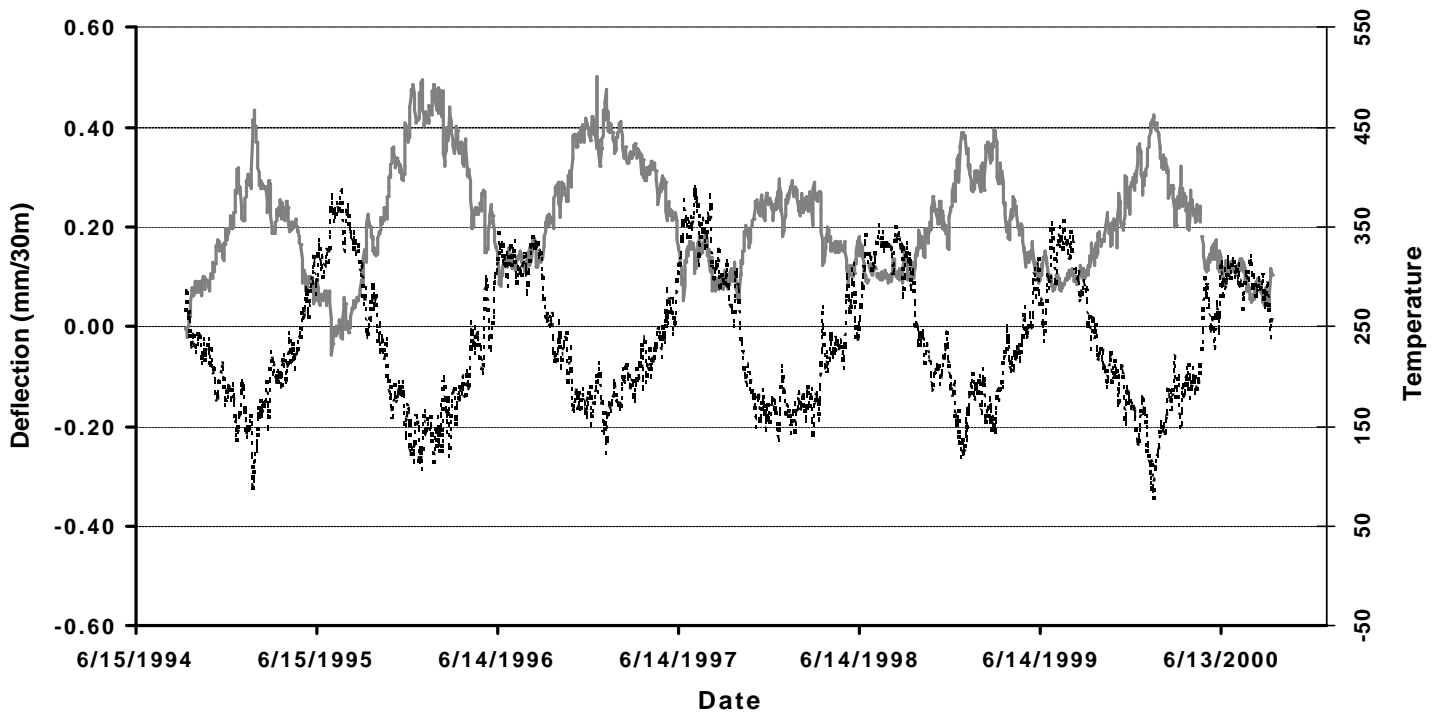
Figure 7. Inclination variation and instrument temperature (uncalibrated) vs. time from southwest tower tiltmeter. East/west inclination (west is positive) is indicated by the solid trace above the graph axis. Temperature variation is indicated by the broken trace.

The tiltmeter data display the highest seasonal (and daily) variations of any of the instruments. The maximum yearly range of east/west inclination of the southwest tower is 4.2(10)-4 radians, which corresponds to 12 mm of lateral movement at an elevation of 30 m (Fig. 7). However, regression of the data obtained over the entire study period indicates that the net change in tilt has been negligible. The trace of north/south south-west tower inclination indicates less seasonal variation than along the east/west axis.

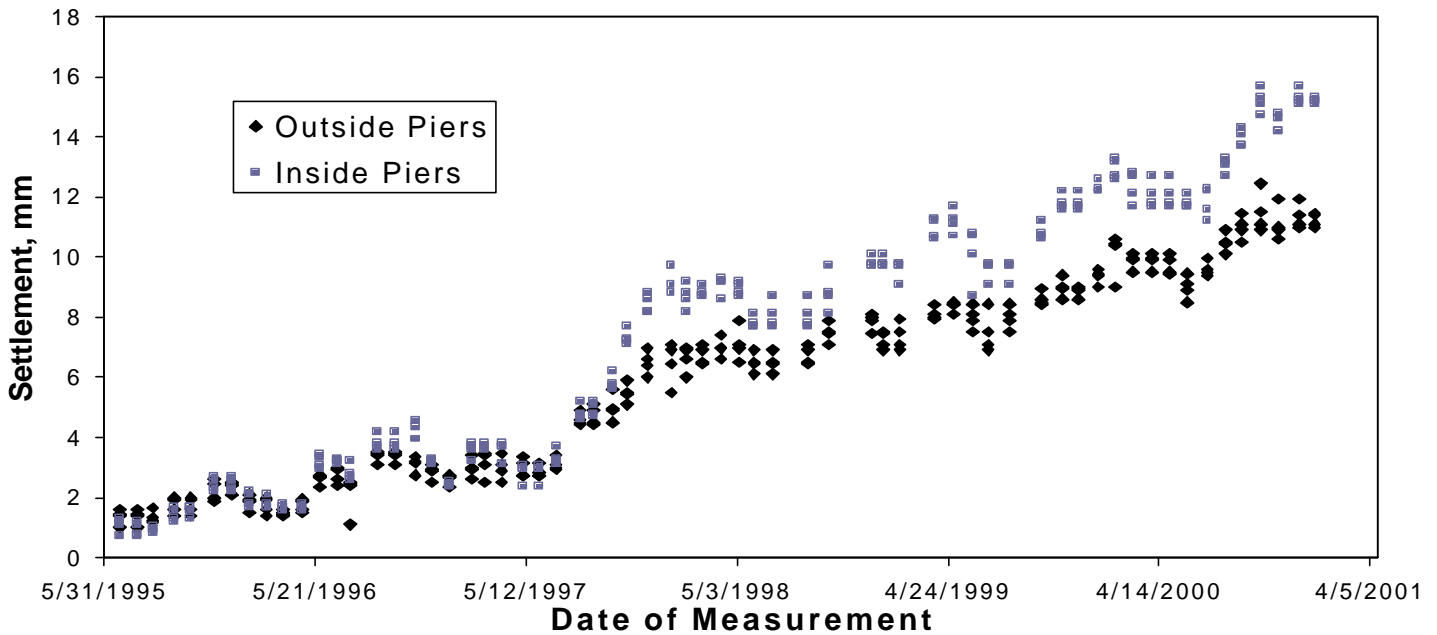
Figure 8. Level elevation measurements from the piers supporting the west towers. The "inside piers" are located closer to the longitudinal centerline of the Cathedral, the "outside piers" are located closer to the wings.

much less pronounced. However, ongoing slow settlement is clearly evident in the data. Regression lines through the measurements on each of the eight supporting piers indicates that the average rate of differential settlement during the last six full years is approximately 1.4 mm/year (Fig. 8). The r-squared for these regressions averaged 0.8. The measured rate is slightly greater than the calculated value of 0.9 mm/year for secondary settlement during this period. While there is no evidence yet that the rate of secondary settlement is diminishing, the current rate is appreciably less than it was during the period of primary settlement (when it averaged about 8 mm/year).

The data also indicate that the eight piers are settling at slightly different rates. The average for the outer four piers ranged from 0.118 to 0.123 mm/year, while the inner four rates range from 0.153 to 0.156 mm/year. It appears that the concrete mat foundation, which is believed to be unreinforced, is bowing slightly in response to the soil pressure.

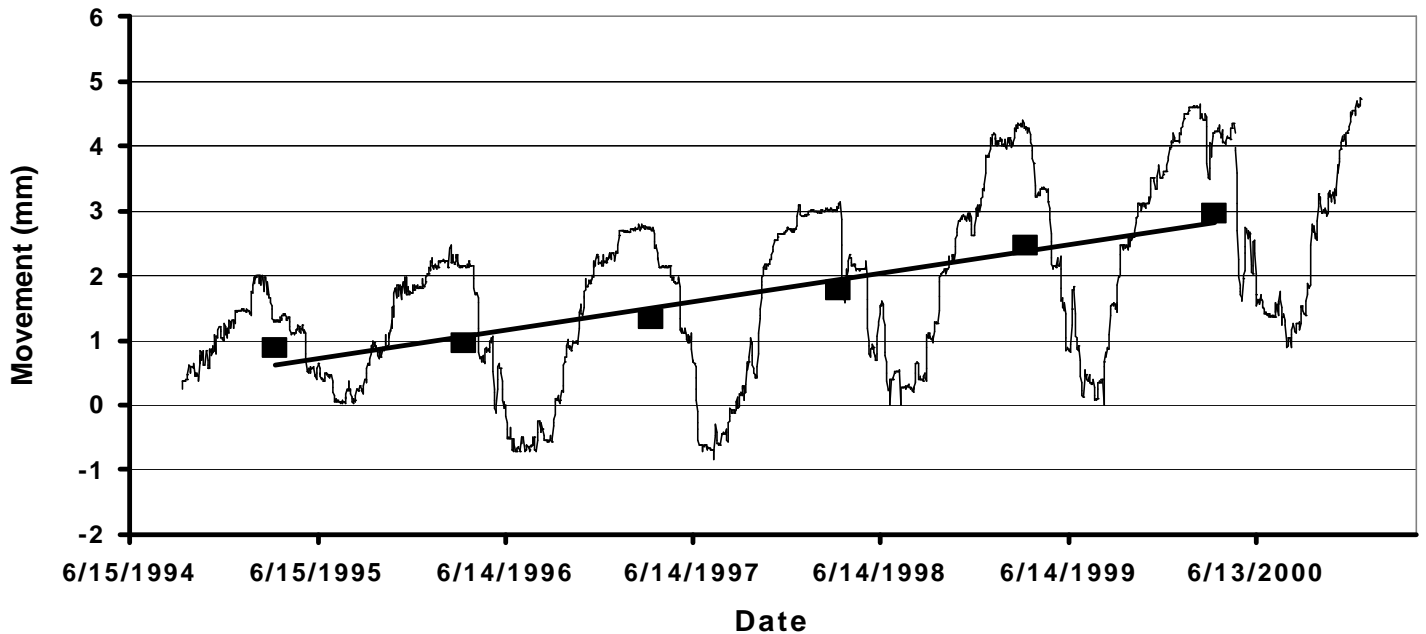
Figure 9. Gap movement (in mm) vs. time measured by a string potentiometer installed over the nave high vault adjacent to the south-west tower. Annual averages and the regression line through them are also shown.

The automatic, effectively-continuous data recording from the string potentiometers has been effective in showing long-term crack opening trends. For example, regression of data from the string potentiometer located over the high vault adjacent to the south-west tower indicates a rate of 0.43 mm/year (r-squared = 0.95 based on yearly averages). The

maximum yearly range, due to seasonal effects, is as much as 4.5 mm/yr (Fig. 9). The less frequent mechanical measurements broadly agree with the string potentiometers.
