Investigation of a rock-burst site, Sunshine Mine, Kellogg, Idaho

D.F.Scott & T.J.Williams
Spokane Research Center, National Institute for Occupational Safety and Health, Wash., USA

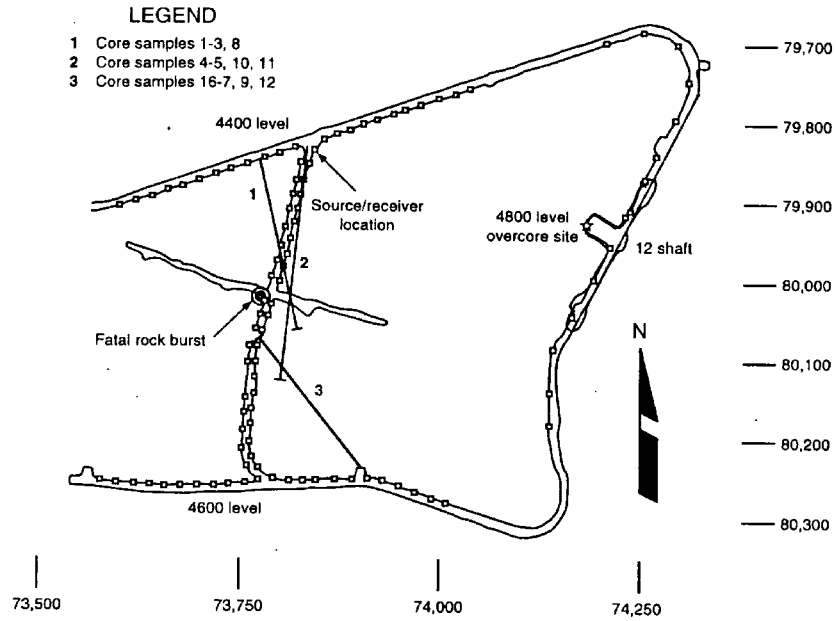
Figure 2.—Location of fatal rock burst and source and receiver sites for seismic tomography survey

The May 13 rock burst was located by a macroseismic system and was calculated to have originated at about 73775E, 80021S,

and -1373 m below the collar of the Jewel shaft (figure 2). The macroseismic system is designed to record digitized waveforms sensed by triaxial geophones and to target mining-induced events large enough to cause damage to mine structures. These events range from Richter magnitude 0.5 to 2.5 and have frequencies between 1 and 500 Hz. Accuracy is about plus or minus a 30-m radius.

A two-dimensional survey was completed on the 4400 and 4600 levels. The third dimension of the survey was between levels, where the geophones were located on one level and signals were generated on the other (figure 2).

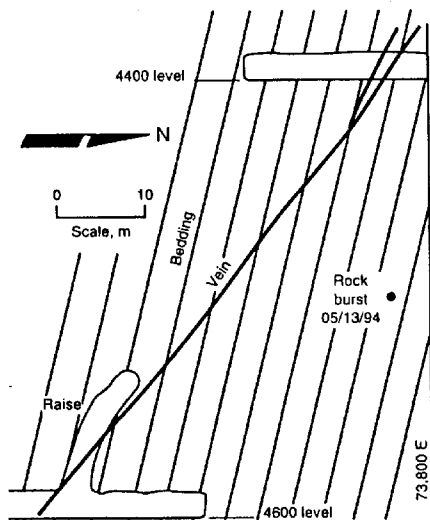
Figure 4.—Geologic cross section looking west and showing relationship of bedding to vein and mine workings

In the Coeur d'Alene Mining District, this formation has a history of increased rock-burst activity relative to other stratigraphic units. Soft argillite is interlayered randomly throughout the quartzite. The average strike of the Revett in the pillar is nearly east and average dip of bedding is about 77° to the south. The vein, which consists of tetrahedrite, galena, and gangue, strikes about N 80° W and dips about 55° to the southwest. On the 4400 level, 6 m east of the top of the projected raise from the 4600 level, a right-lateral, strike-slip fault strikes nearly north and dips 35° to the east, offsetting the vein by 1.2 m. Figure 4 is a cross section looking west and shows the relationship of bedding to the vein and workings.

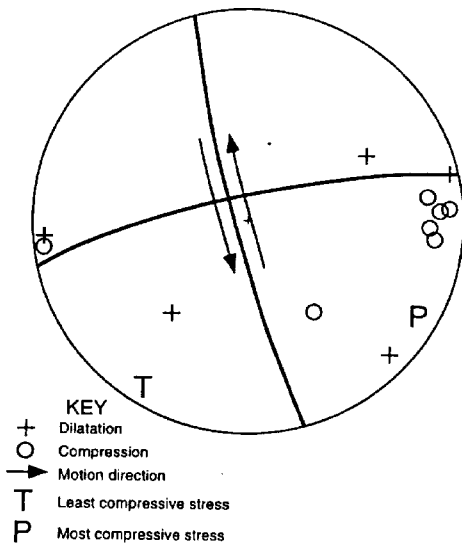
The solution presented is one of four possible solutions and was generated by FPFIT/FPPLOT software (Reasenberg and Oppenheimer, 1986) developed by USGS. Since the event occurred outside the geophone array and at approximately the same level as some of the geophones, the solutions are not well constrained. The surviving miner's account of rock motion during the event indicates that a shock wave was generated from the north and struck him in the back as he was facing south. Based on the miner's account of the motion and knowledge of typical regional stress distributions, a left-lateral, strike-slip movement oriented N 15° W, or a right-lateral, strike-slip movement oriented N 78° E seems to be a probable fault-plane solution (figure 5).

Figure 5.—Fault-plane solution for fatal rock burst.
