RI 9625

Using Ground Penetrating Radar for Roof Hazard Detection in Underground Mines

By Gregory M. Molinda, William D. Monaghan, Gary L. Mowrey and George F. Persetic

PITTSBURGH RESEARCH CENTER

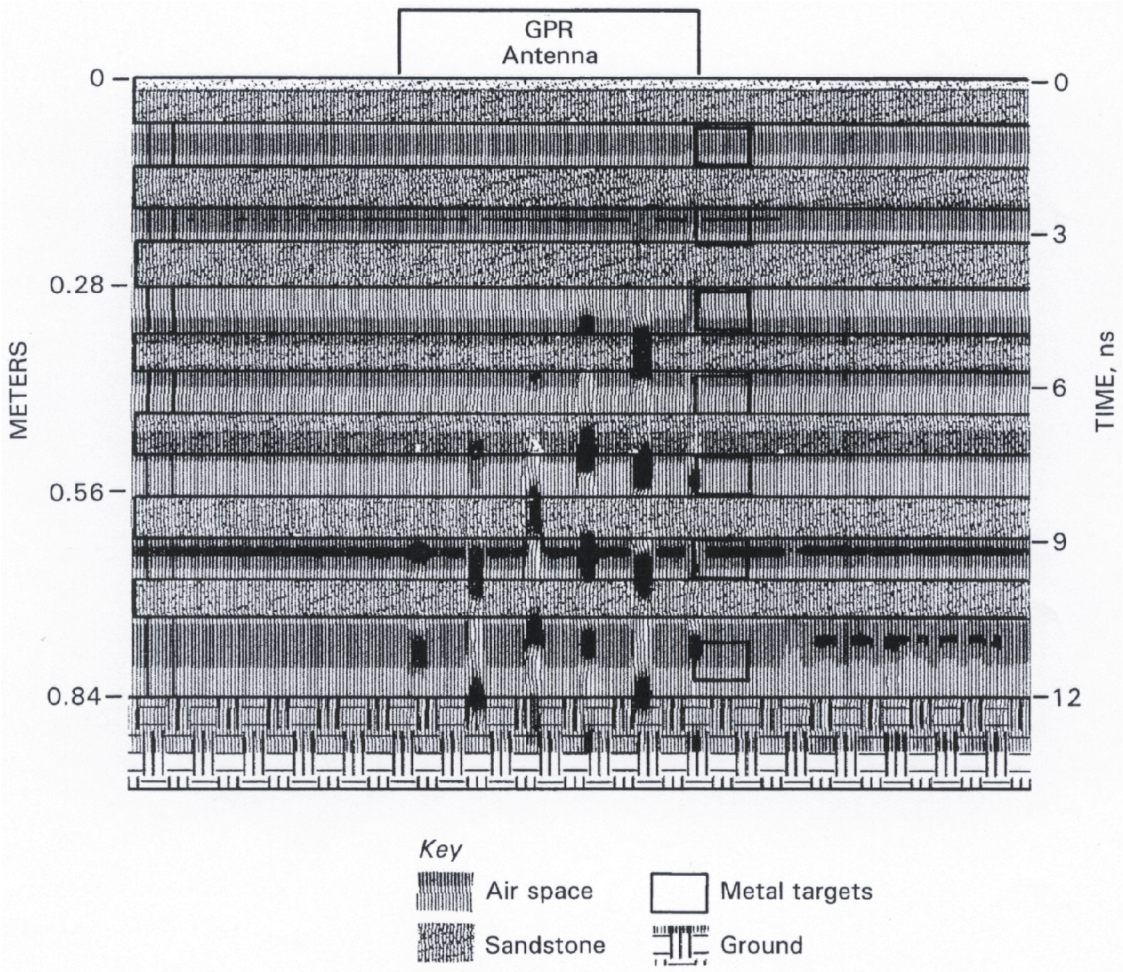
The overlay was constructed by scaling the total height of the stack (84 cm (33 in)) to match the total height range of the GPR survey (12 ns). The top of the stack is visually picked on the GPR record by the first reflection. Targets are identified by disturbances in the record, which represent reflections of the pulse. Whereas the general target locations are easily identified as significant disruptions in reflecting boundaries on the radar record, it is difficult to delineate the individual slab (6.4 cm (2.5 in) thick) and air gap (5.7 cm (2.25 in) thick) boundaries. The record shows numerous "false" slab boundaries and gives the appearance of numerous stacked slabs. This is probably due, again, to interference of reflected energy from the top and bottom of slabs. This problem of complicated geometry will be seen again in the coal roof test sites. Part of the problem lies in the interpretation criteria. When using the dynamic record, the eye is drawn to areas of high- and low-signal amplitude. Postprocessing can eliminate many extraneous interfaces. The interfaces between air and sandstone slab are not clearly delineated. Without the benefit of the known stack boundaries, it would be difficult to accurately recreate the stack. It can also be seen that all radar data are garbled below the target. This may be explained by transmission interference and reverberations of energy that have passed through the target. The remaining energy is reflecting back to the surface, but is also reflecting back off of the target bottom. As mentioned before, it is the contrast in dielectric constant between components that makes a good reflecting surface. Conducting materials present an effective barrier to radar transmission (i.e., water-bearing zones, pipes). For this reason, the metal foil of the target was easily seen. The metal target also formed an effective barrier to radar transmission to reflecting surfaces below it. That is why the reflecting surfaces below the target are obscured. Although the contrast between sandstone (5 ns/0.3 m (1 ft)) and air (2 ns/0.3 m (1 ft)) is great, the complex reflecting patterns obscure the reflecting surface. The sandstone stack is a complicated series of reflecting surfaces that is not easily delineated by GPR.

Figure 4.—Radar record of Collier Stone Quarry sandstone stack with actual slab locations drawn as overlays.

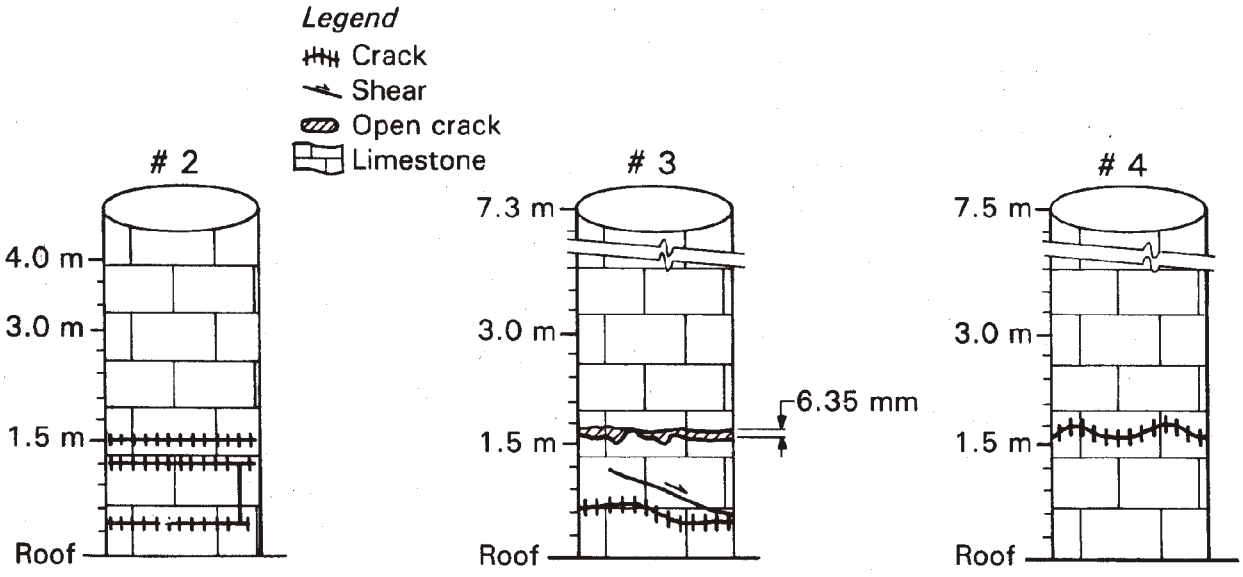
Figure 6 shows the roof features in the logs of stratascope holes Nos. 2-4. There was no access to hole No. 1 because of ground deformation instrumentation. A prominent fracture shows up in all three holes at 1.5-1.7 m (5.0-5.5 ft). This fracture is a large open break in hole No. 3, with broken rock and water leaking out. Figure 7 is a stratascope photograph of the feature. The structure is a bed separation with a joint abutting and stopping. Small rock fragments are also present. Other smaller fractures occur from the roof up to 1.7 m (5.5 ft), as detected by stratascope. There are no fractures detected above 1.7 m (5.5 ft). The large fracture at 1.7 m (5.5 ft) depth appears to be an extensional break due to roof sag, and the fracture appears on the radar record at hole No. 2 at approximately 1.5-2.4 m (5-8 ft) (figure 8). The data were taken with a 500-MHz antenna with a range of 3 m (10 ft) into the roof. Figure 9 is the GPR record for the survey at hole No. 3. The fracture at 1.7 m (5.5 ft) appears as a zone covering approximately 15-30 ns (0.6-1.5 m (2-5 ft)). No other features appear clearly on the record.

Figure 6.—Stratascope logs of bed separations in the roof at Lake Lynn limestone mine.

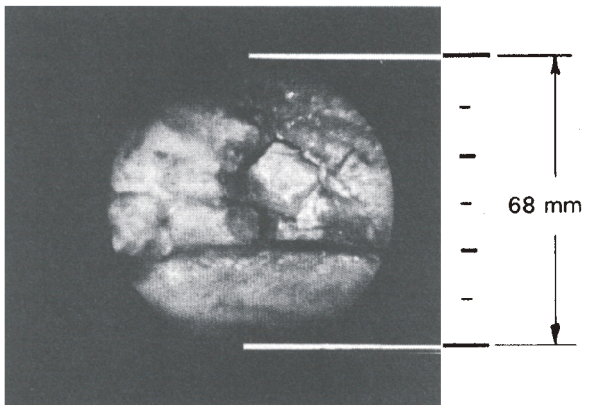
Because the roof consists only of limestone, there is none of the bedding interference as seen with the sandstone air stack at the Collier Stone Quarry. The fracture appears to have made the reflection on the record, but it appears as a multiple reflection and not the clean interface seen in figure 7. This is probably due to the fragmented nature of the bed separation and joint intersection. Better resolution of this large feature is necessary, but this "recognition" is useful. From a data-quality standpoint, the contrast in material properties from a fracture in a single media is a good situation for radar reflection interpretation. A possible remediation for this 1.5-m (5-ft) thick slab would be

Figure 7.—Stratascope image of large open crack 1.7 m (5.5 ft) into the roof at Lake Lynn limestone mine at hole No. 3.

roof bolting, but the radar record indicates a slab anywhere from 0.6-2.4 m (2-8 ft) thick. Roof bolts would have to be at least 2.4 m (8 ft) long to consider the worst case. By contrast, an 2.4-m (8-ft) bolt could be excessive if the slab was 1.2 m (4 ft) thick.

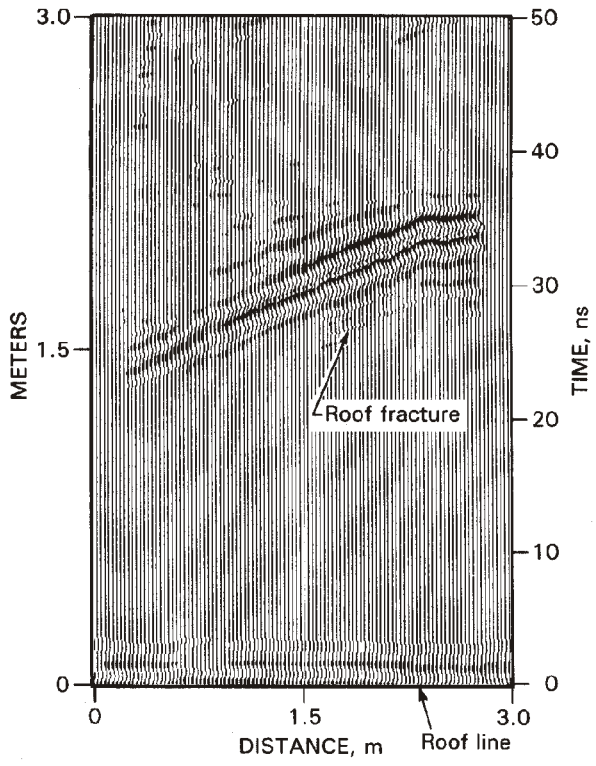
Figure 8.—GPR record at hole No. 2 at Lake Lynn showing crack reflections.

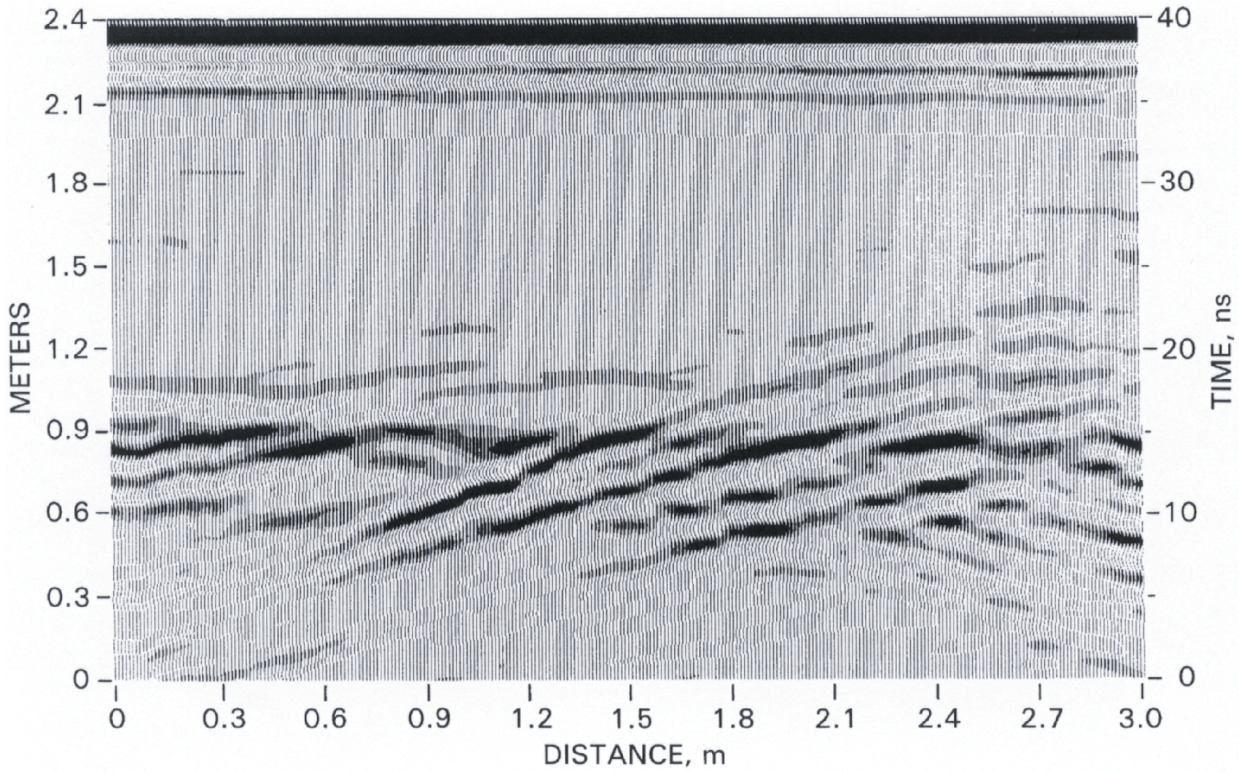
Figure 9.—GPR record at hole No. 3 at Lake Lynn.

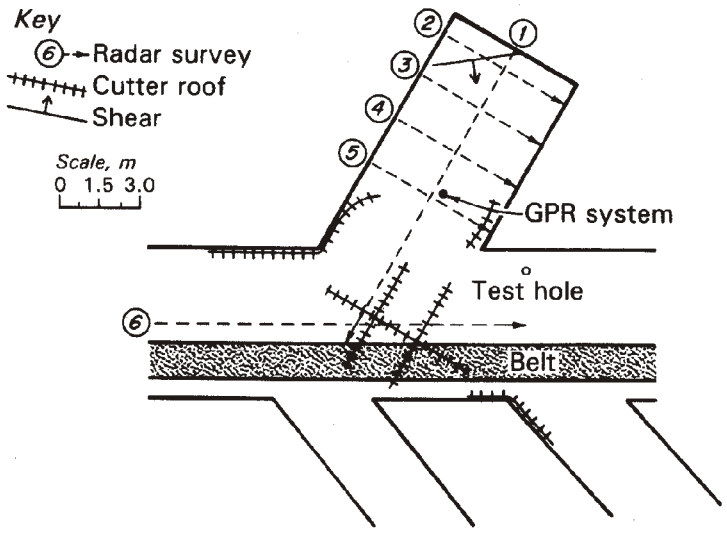
Figure 10.——GPR survey lines and roof damage at RoxCoal Coal Mine.

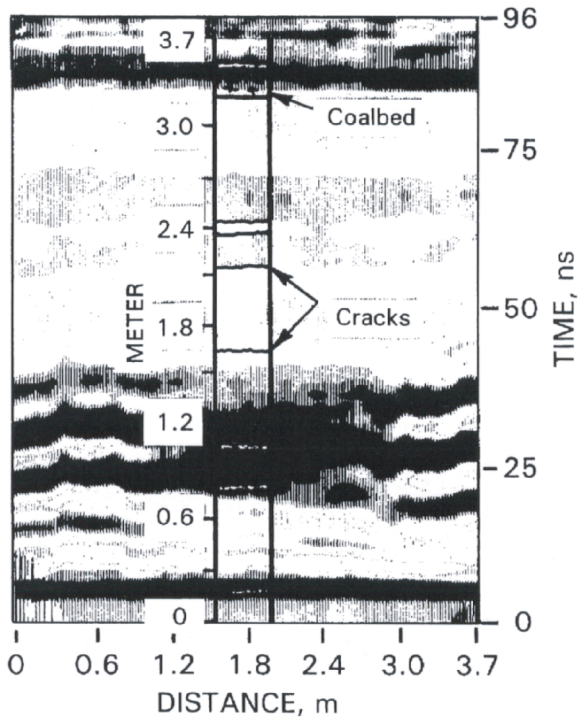
The best data were obtained from location 4 using the 300-MHz antenna. Figure 11 shows a thick reflecting layer from 0.7-1.4 m (2.3-4.5 ft) up into the roof. Another prominent reflecting layer occurs from 3.2-3.5 m (10.5-11.5 ft). Verification of the roof features was obtained from a stratascope log of a nearby test hole, which was overlain on the radar data. There are a number of cracks logged, as noted up to 3.7 m (12 ft) in the test hole. From 0.8-1.1 m (2.5-3.5 ft), there are several large open cracks in the bolted roof. One crack has water leaking from it. It appears that the broad radar band is a reflection surface for this fracture zone. Again, these bands are broad and "smeared" out and represent only the same "zone" as the fractures. Other fractures at approximately 1.8, 2.1, and 2.4 m (6, 7, and 8 ft) are not represented as reflection surfaces. The band on the radar record at 3.2-3.5 m (10.5-11.5 ft) is the reflection surface of the rider seam above the main seam. There is good correlation

between the radar record and stratascope log. The location of the rider seam is important to roof control at this mine. The roof bolters track the rider position with blind test holes on regular intervals to avoid anchoring roof bolts into the rider seam.

Figure 11.—GPR record of immediate roof at location 4 in RoxCoal Coal Mine with lithology and roof cracks from stratascope hole overprinted.

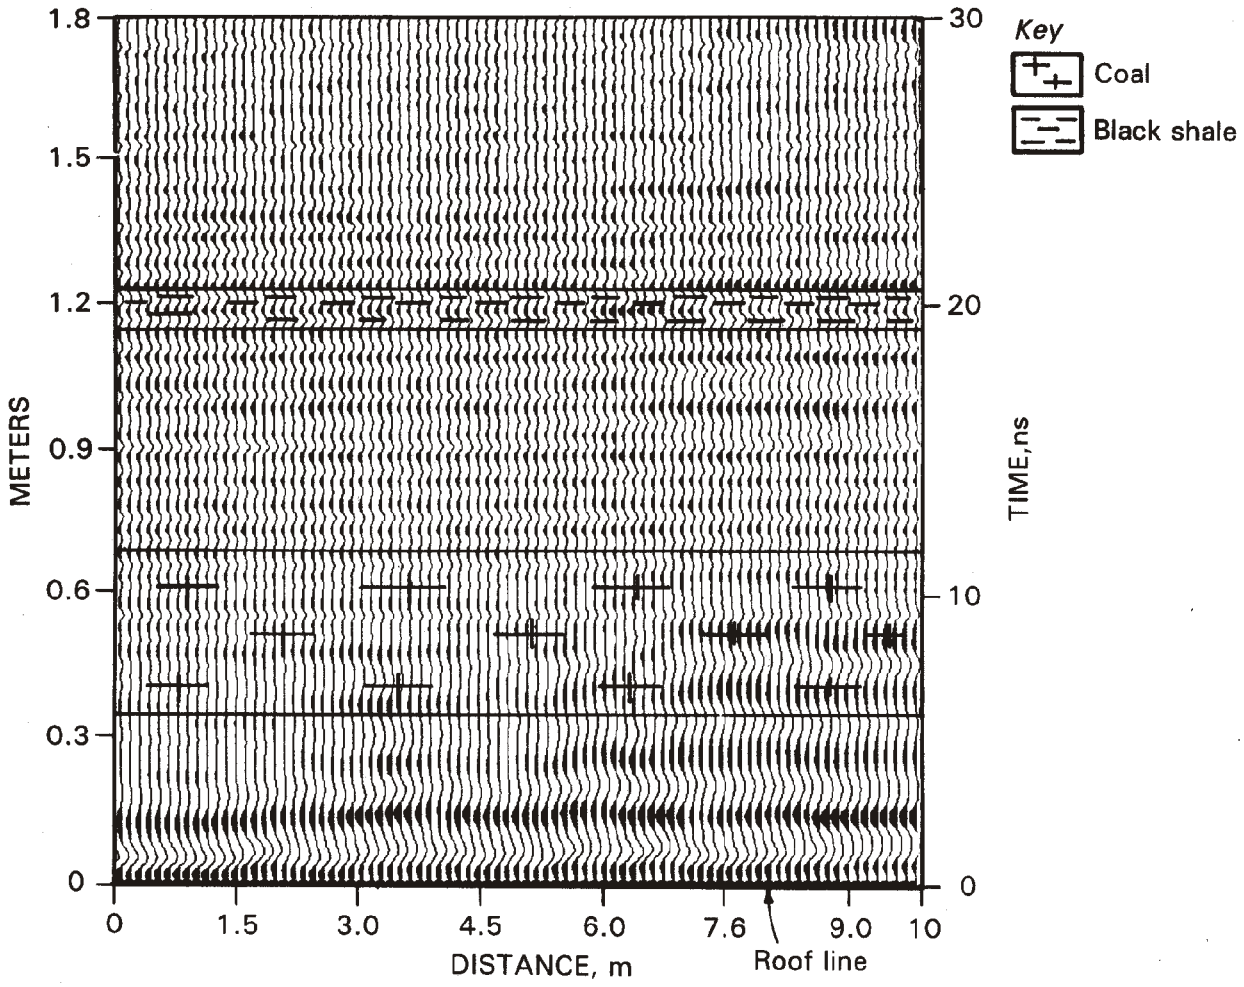
The 900-MHz antenna generally provides the best resolution, but sacrifices depth of penetration. It seems best suited to zones of 0.9-1.2 m (3-4 ft) into the roof (figure 14). The higher frequency radar detects discontinuities (most likely bedding) within the strata and generates numerous reflections. These minor reflections may be mistaken for significant features, like faults or lithology changes. Additionally, no prominent reflections are present to signify the rider coal seam. The rider seam may be important for strata control for several reasons, including bolt anchorage and potential head coal.

Figure 14.—900-MHz GPR record at the SRCM with overlay of lithology.

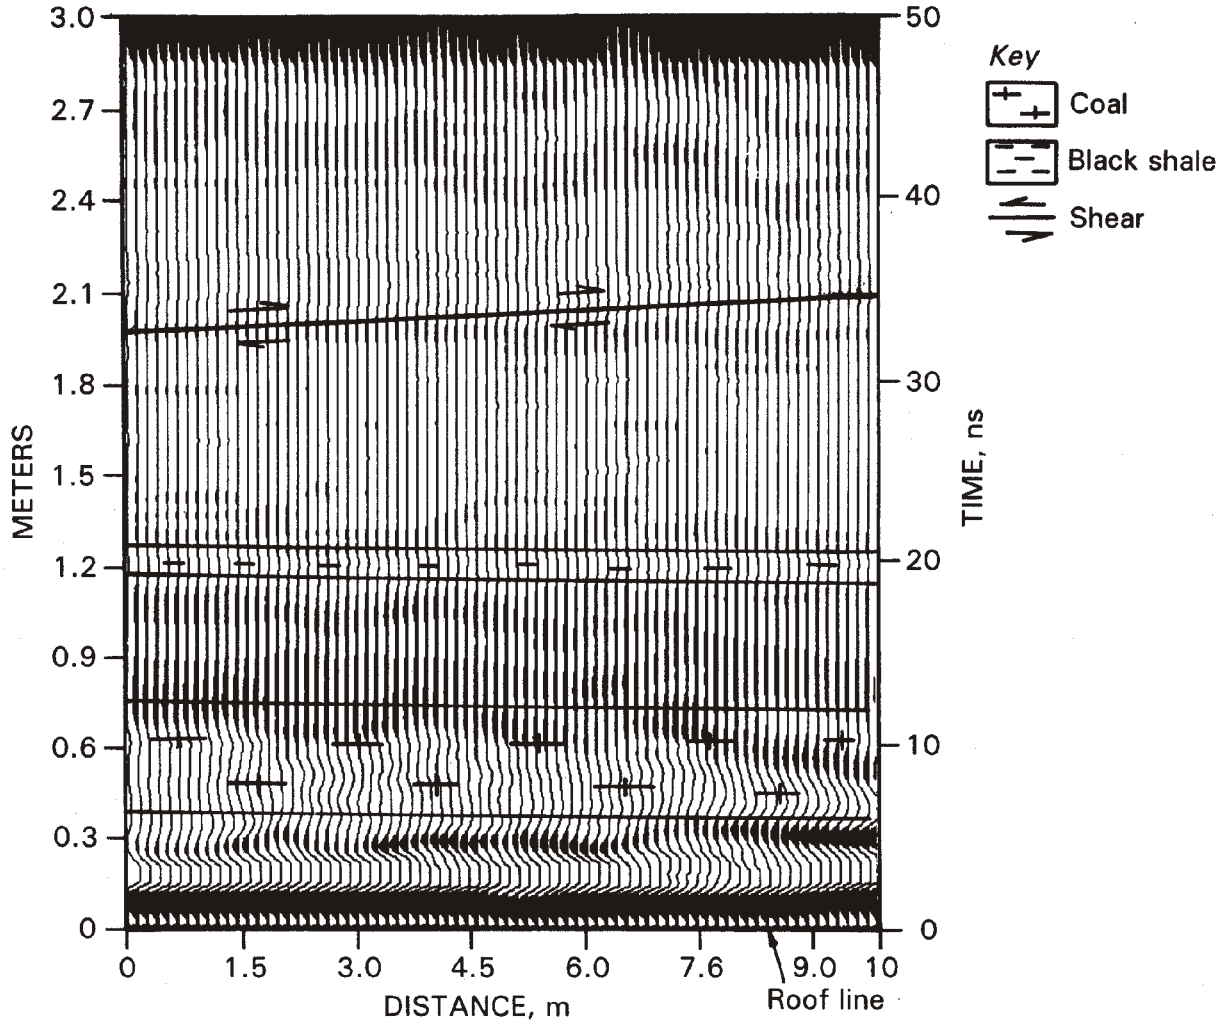
Figure 15 is a radar record made with a 500-MHz antenna, which has a range of 3 m (10 ft). Starting at the roof line (0 m), the black band is the initial pulse reflection. Above that, a reflection band represents the rider bed at 0.3-0.9 m (1-3 ft). Again, the rider sequence shows as a smeared-out band instead of the sharply defined boundaries of the rider bed. A low-angle bedding shear at approximately 2.1 m (7 ft) corresponds to a weak reflection, but this could be coincidental. Reflections throughout the record above 0.8 m (2.5 ft) do not represent significant discontinuities and, therefore, in the absence of ground truth could be misinterpreted.

Figure 15.—500-MHz GPR record at the SRCM with overlay of lithology.

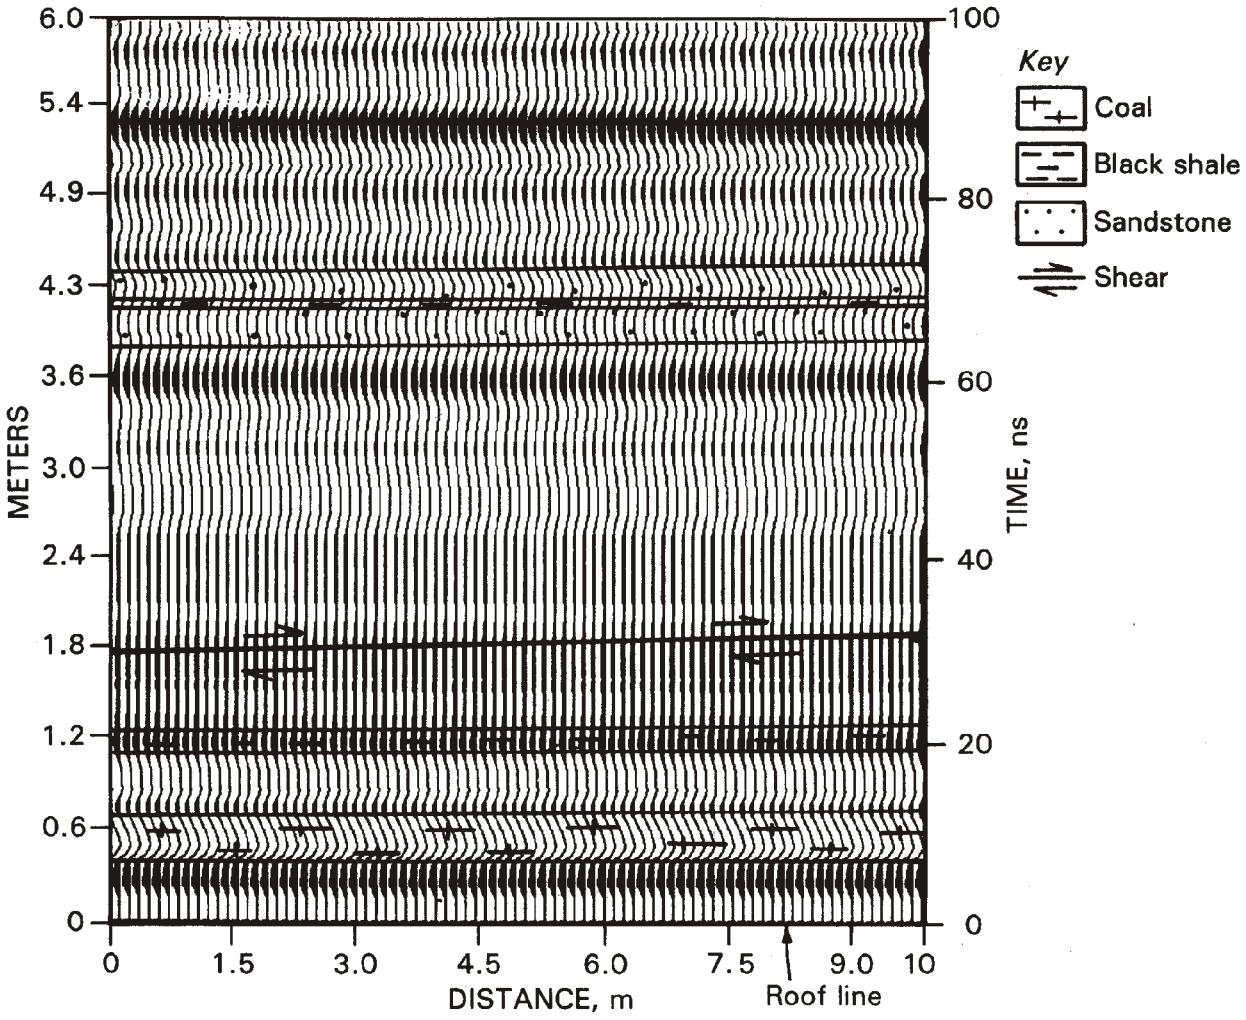
Figure 16 is a record generated by a 300-MHz antenna with a range of 6.1 m (20 ft) into the roof. This antenna theoretically has the poorest resolution, but has the greatest range. The overlay shows an offset correlation of the rider bed with the radar record. At 4-4.6 m (13-15 ft) up into the roof, there is a sandstone bed. As a reflector this bed should stand out. There is a good reflector in the general vicinity at 3.8 m (12.5 ft), just offset from the location of the sandstone.

An explanation for this offset and others is that the assumption of using one dielectric constant for the entire roof sequence is not a good one. There are numerous rock types in the sequence with presumably different dielectric constants. A more accurate measure of their electric properties may allow more accurate matching of the lithology to the travel time GPR record.

Figure 16.—300-MHz GPR record at the SRCM with overlay of lithology.
