CASE SUMMARY

NATIONAL ACCIDENT SAMPLING SYSTEM
CRASHWORTHINESS DATA SYSTEM

PSU 49 CASE NO. 243C TYPE OF ACCIDENT Car/Car - Head-on (Multiple impacts)

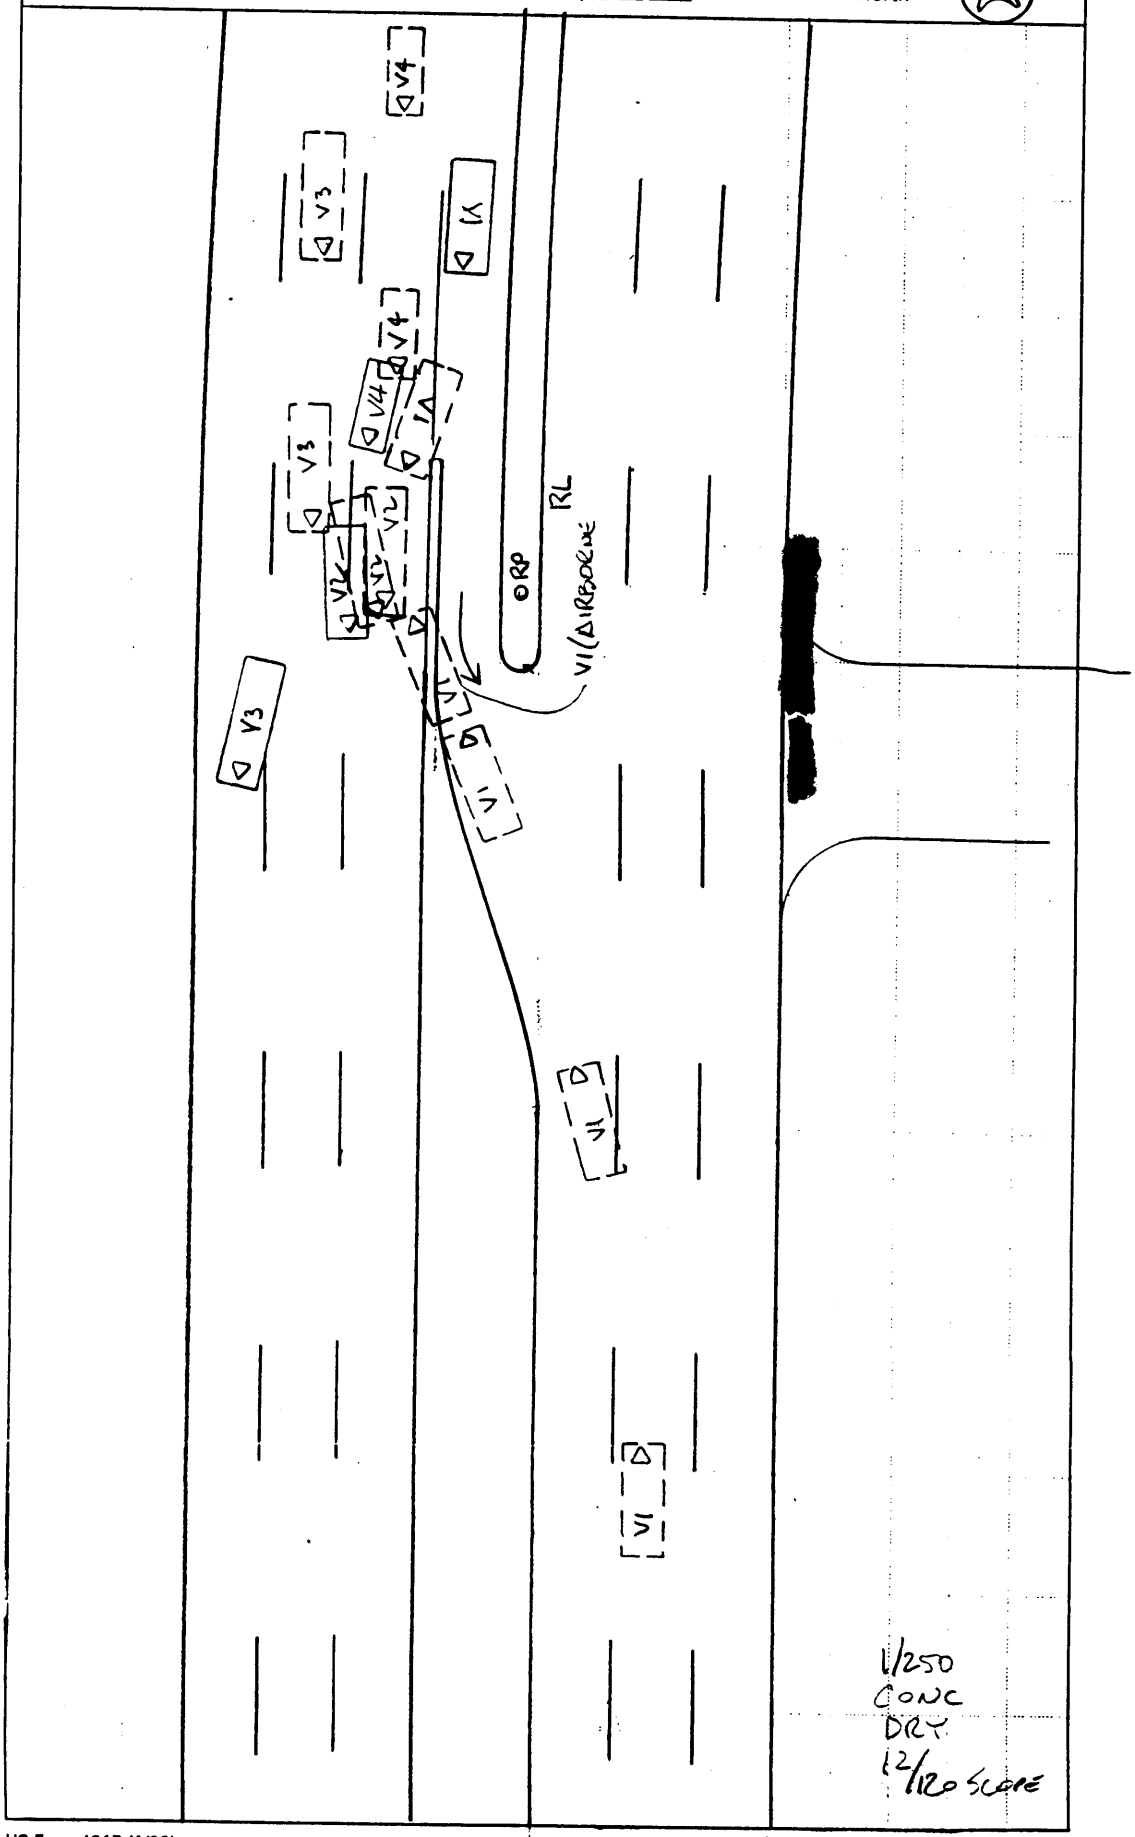
PSU No. 49 Case Number—Stratum 243 C

V1 was traveling north on a divided concrete urban street. V2, V3 and V4 were traveling south on the same street. V2 and V4 were in the inside lane and V3 was in the center lane. V1 struck the center concrete median and became airborne. While it was in the air, V1 crossed over into the inside southbound lane and the front of V1 struck the front of V2. This impact caused V2 to move slightly to its right and the right rear of V2 struck the left side of V3. After striking V2, V1 rotated clockwise and V1 was struck by the front of V4. The rear right occupant of V1 and both occupants of V2 were transported. The driver of V2 was admitted and died approximately eleven days later. The rear left occupant of V3 was treated at the scene and released. V1 and V2 were towed. V3 and V4 were driven.

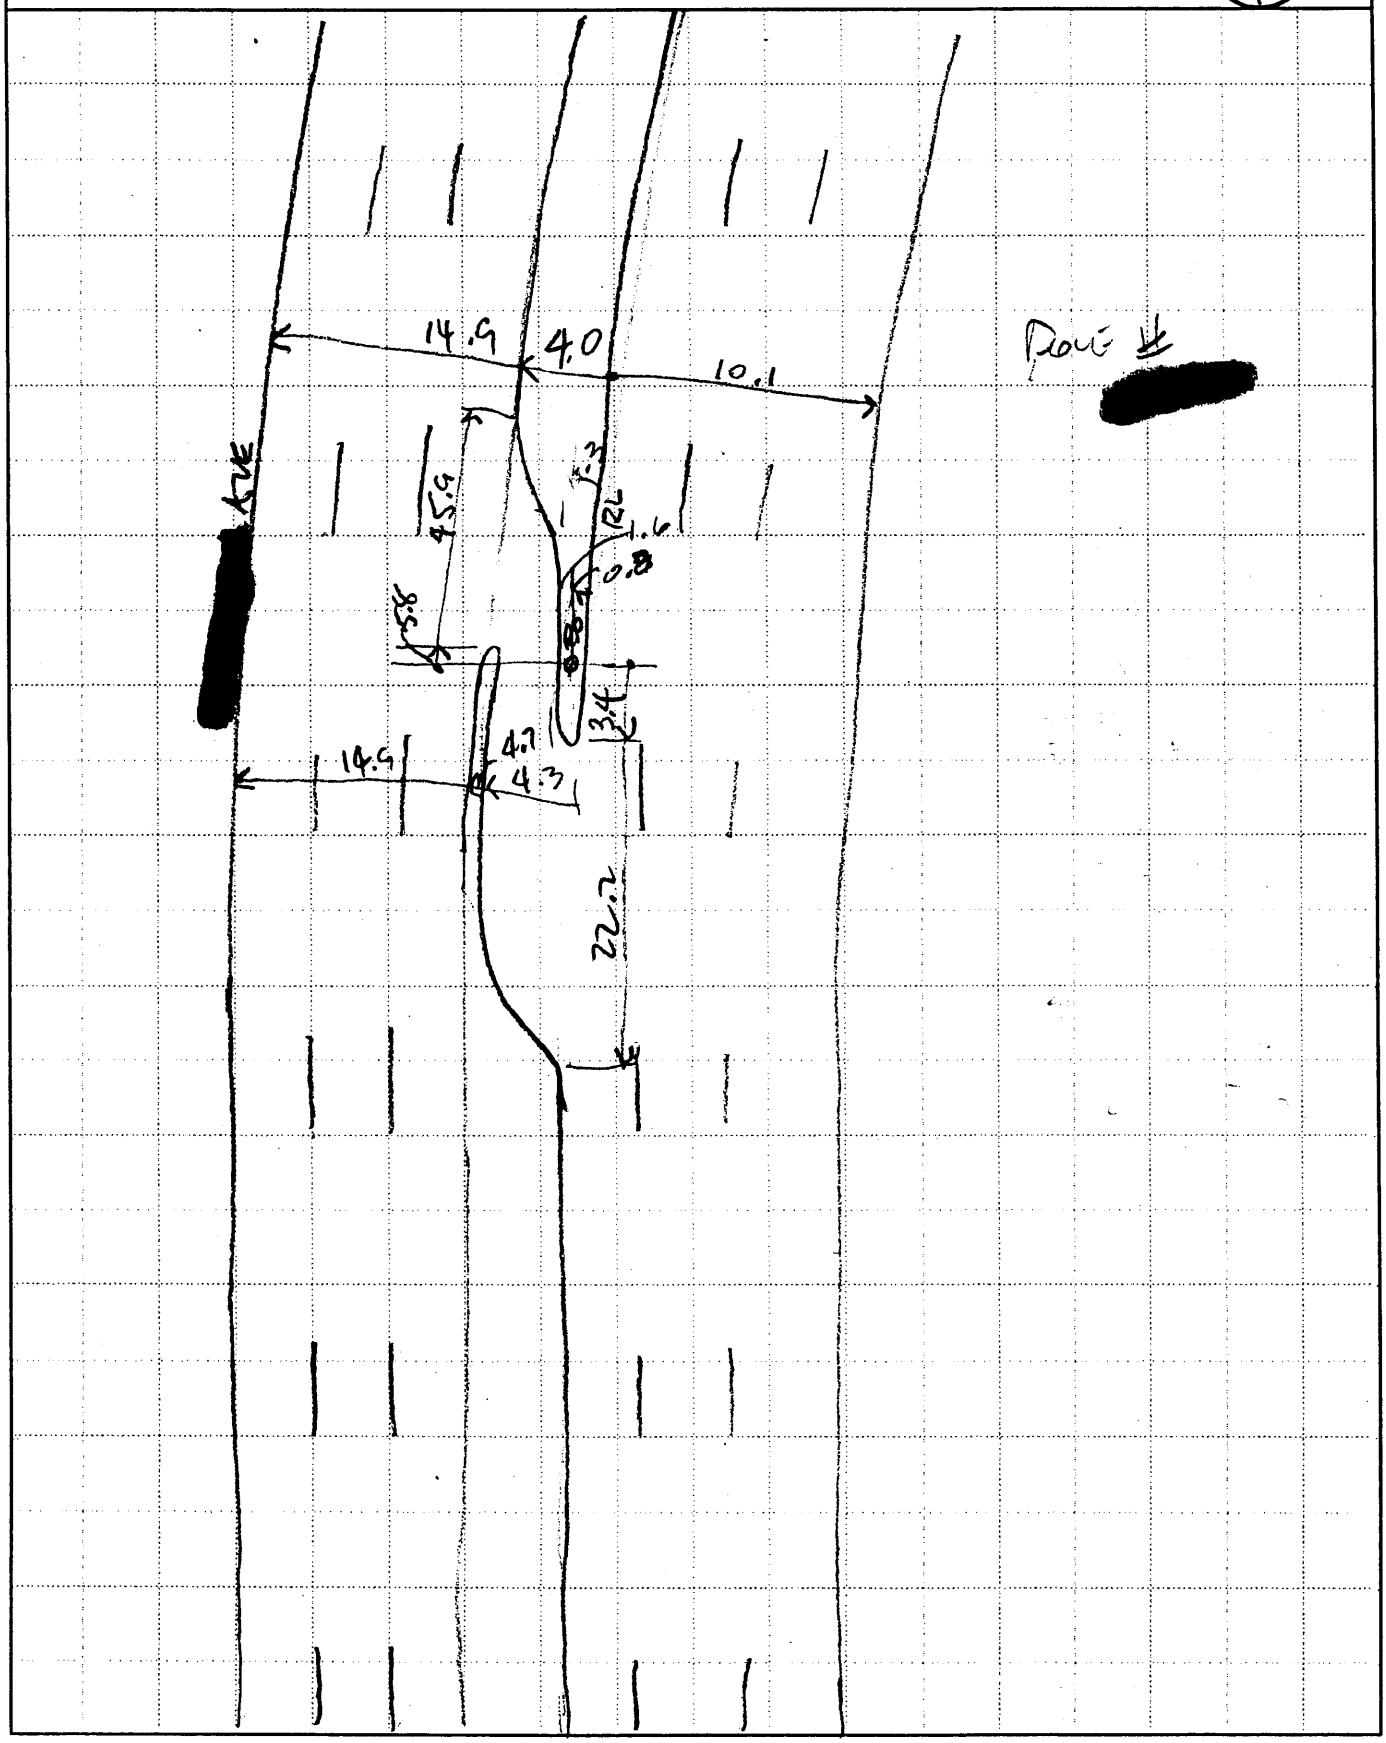
PSU No. 49 Case Number—Stratum 243C Indicate North

VEH. #1	VEH. #2	VEH. #3
Heading Angle	10°	190°	190°
Surface Type	CONC		
Surface Condition	DRY		
Grade (v/h) Measurement (between impact and final rest)	-12/120	-14/120	-12/120
Grade (v/h) Measurement (at location of rollover initiation)

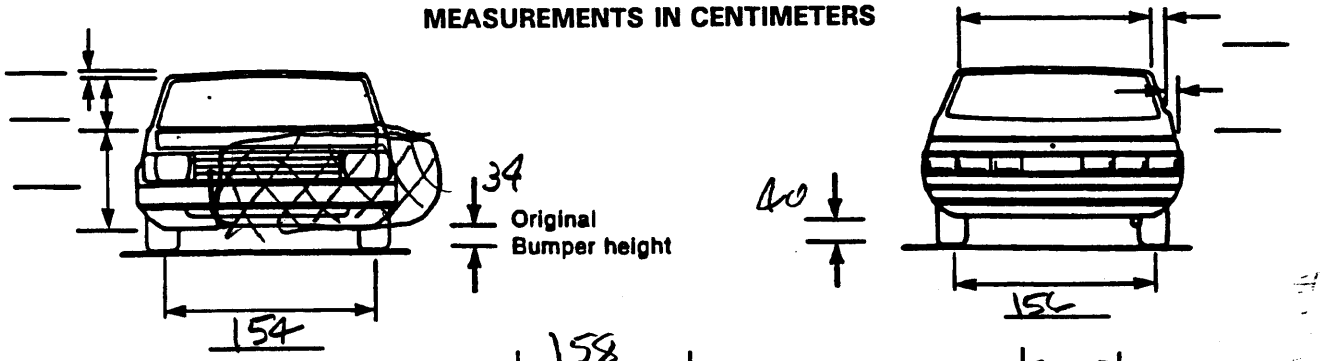
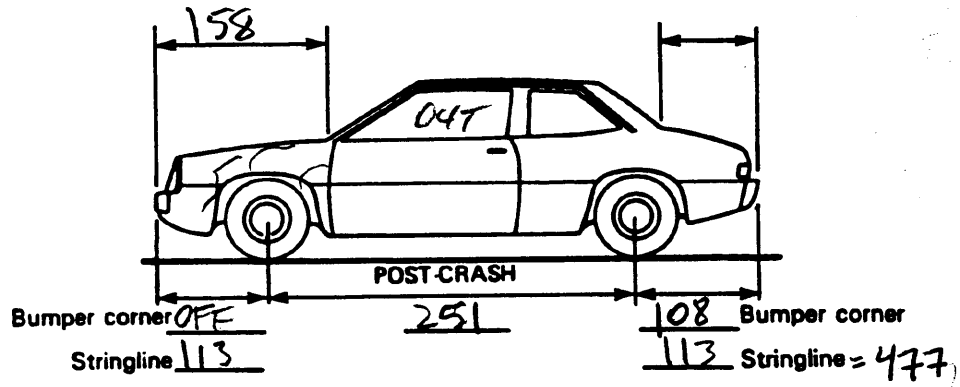
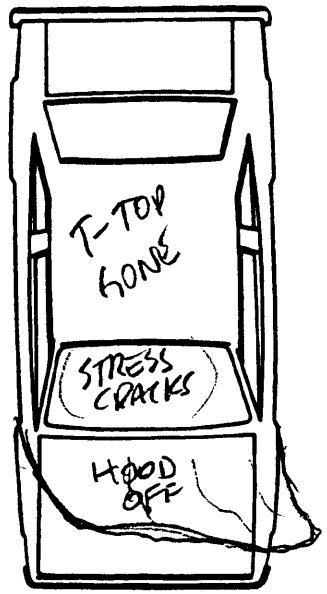
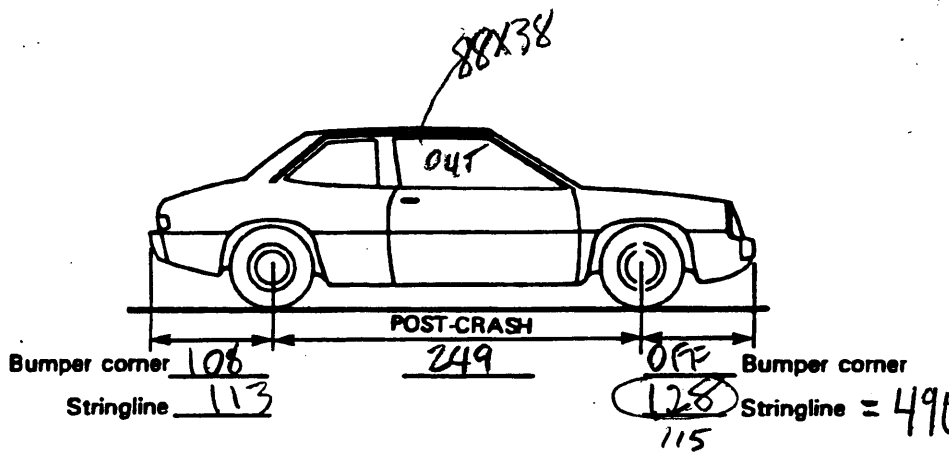
VEHICLE DAMAGE SKETCH

Specific Impact No.	Location of Direct Damage	Location of Field L
1	ENTIRE FRONTAL PLANE	SAME
2	RR WHEEL	SAME

Specific Impact Number	Plane of Impact C-Measurements	Direct Damage Width (CDC)	Direct Damage Max Crush	Field L	C_1	C_2	C_3	C_4	C_5	C_6	±D
1	UPPER RADSHPT	158	C5	133	58	57	60	64	68	64	0
1	F.S.				38	37	36	36	37	58	
1	FINAL				20	20	24	28	31	26

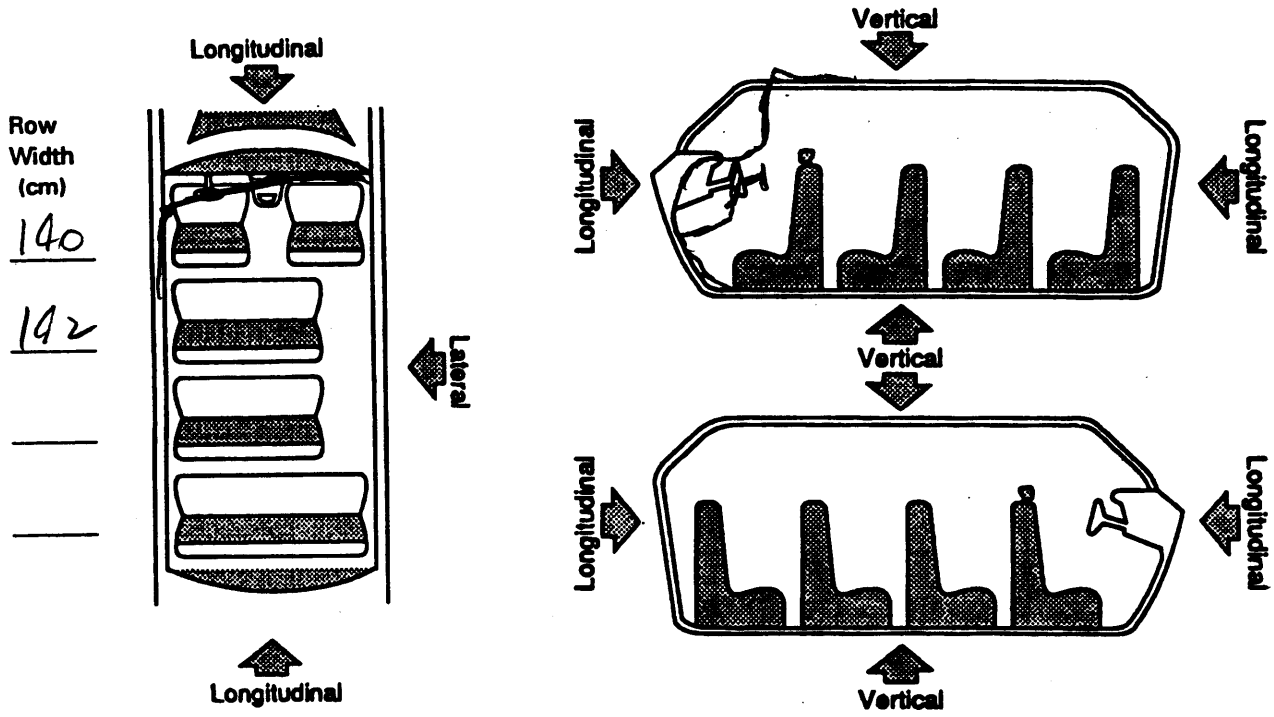
INTRUSION WORKSHEET

LOCATION OF INTRUSION	INTRUDED COMPONENT	(All Measurements Are In Centimeters) COMPARISON VALUE	–	INTRUDED VALUE	=	INTRUSION	DOMINANT CRUSH DIRECTION
11	"A" PILLAR 06	184	–	155	=	29 2	LONG
11	L-DASH 02	181	–	159	=	22 3	LONG
11	STR WHL 01	167	–	153	=	14 6	LONG
11	TOE PAN 05	126	–	112	=	14 7	LONG
11	SIDE PANEL 27	50	–	46	=	4	LAT
11	W.S. 14	184	–	154	=	30 1	LONG
11	W.S. HDR 15	154	–	148	=	6 9	LONG
12	G-DASH 03	194	–	182	=	12 8	LONG
12	W.S. HDR 15	159	–	156	=	3	LONG
12	W.S. 14	200	–	184	=	16 5	LONG
13	R. DASH 04	182	–	176	=	6 10	LONG
11	DOOR 10	140	–	120	=	20 4	LAT
			–		=		
VEHICLE REMOVED PRIOR TO PHOTOS OF INTERIOR - COULD NOT BE RELOCATED -

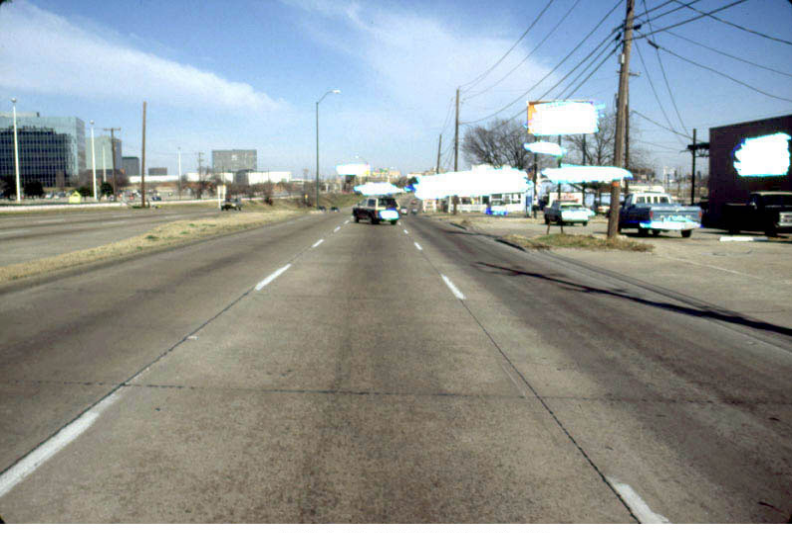
Slide No.	Vehicle No.	Direction of Picture	Description of Slide Subject Matter
1	1	N	Pre-impact travel path of V1
2-4	1	N	Path into impacts
5-7	1	N	V1 at impacts with curb and area where vehicle becomes airborne prior to impact with V2
8	1	N	Area of impact with V2
9-10	1	N	Path from impact with V2 to final rest and final rest area
11-13	1	S	Opposite views
14-15	2 & 4	S	Pre-impact travel path of V2 and V4
16-17	2 & 4	S	Path into impacts
18	2 & 4	S	V2 at impact with V1 and V4 at impact with V1 and V1 final rest area
19-20	2 & 4	N	V2 and V4 opposite views
21	3	S	Pre-impact travel path of V3
22	3	S	Path into impact
23	3	S	V3 at impact with V2
24	3	N	V3 opposite view
25-32	1		Frontal views showing damage from impact with V2
33	1		Front-left view
34	1		Left side view
35	1		Rear-left view
36-37	1		Rear views
38	1		Rear-right view
39-41	1		Right side views
42-43	1		Front-right views
44	1		View of windshield damage
45	1		View of T-top

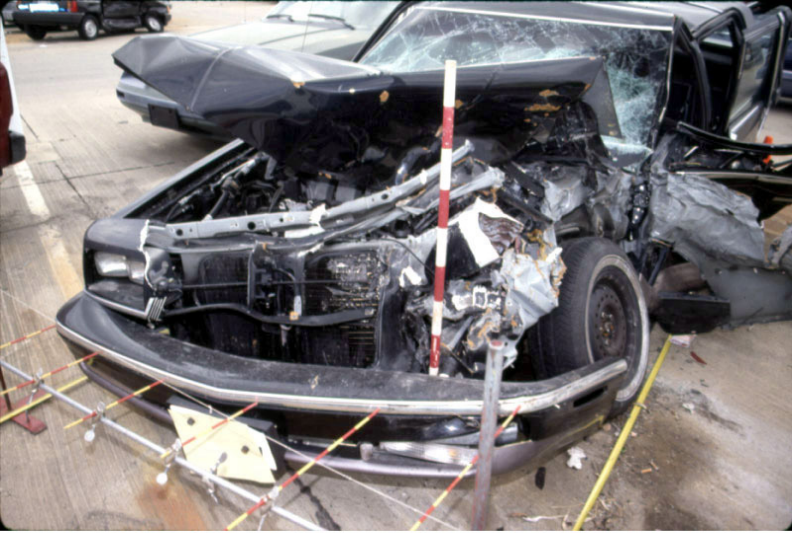
PSU 49-243C (1993) #69
Best Available

46-48	1		Views of front bumper cover
49-67	1		Interior views showing possible occupant contact points
68-74	2		Frontal views showing damage from impact with V1
75-76	2		Front-left views
77-81	2		Left side views
82	2		Rear-left view
83-85	2		Rear views
86	2		Rear-right view
87-89	2		Right side views of damage from impact with V3
90-94	2		Additional right side views
95	2		Front-right view
96	2		View of damage to windshield NOTE: After measuring exterior and interior damage to V2, and measuring damage to interior, police officers arrived at the vehicle to search V2 for jewelry which was supposedly in the vehicle and the NASS researcher left and returned later that day, but the vehicle had been removed from the pound and could not be located.
97-100	3		Exterior views - damage repaired
101-113	3		Interior views - no contacts noted V4 was not inspected - unable to locate
